Duquesne Light Company Beaver Valley Power Station

Reply to Notice of Violation Inspection Report 50-334/89-24 Letter Dated January 23, 1990

## Description of Violation (50-334/89-24-01)

#### NRC Inspection Report 50-334/89-24

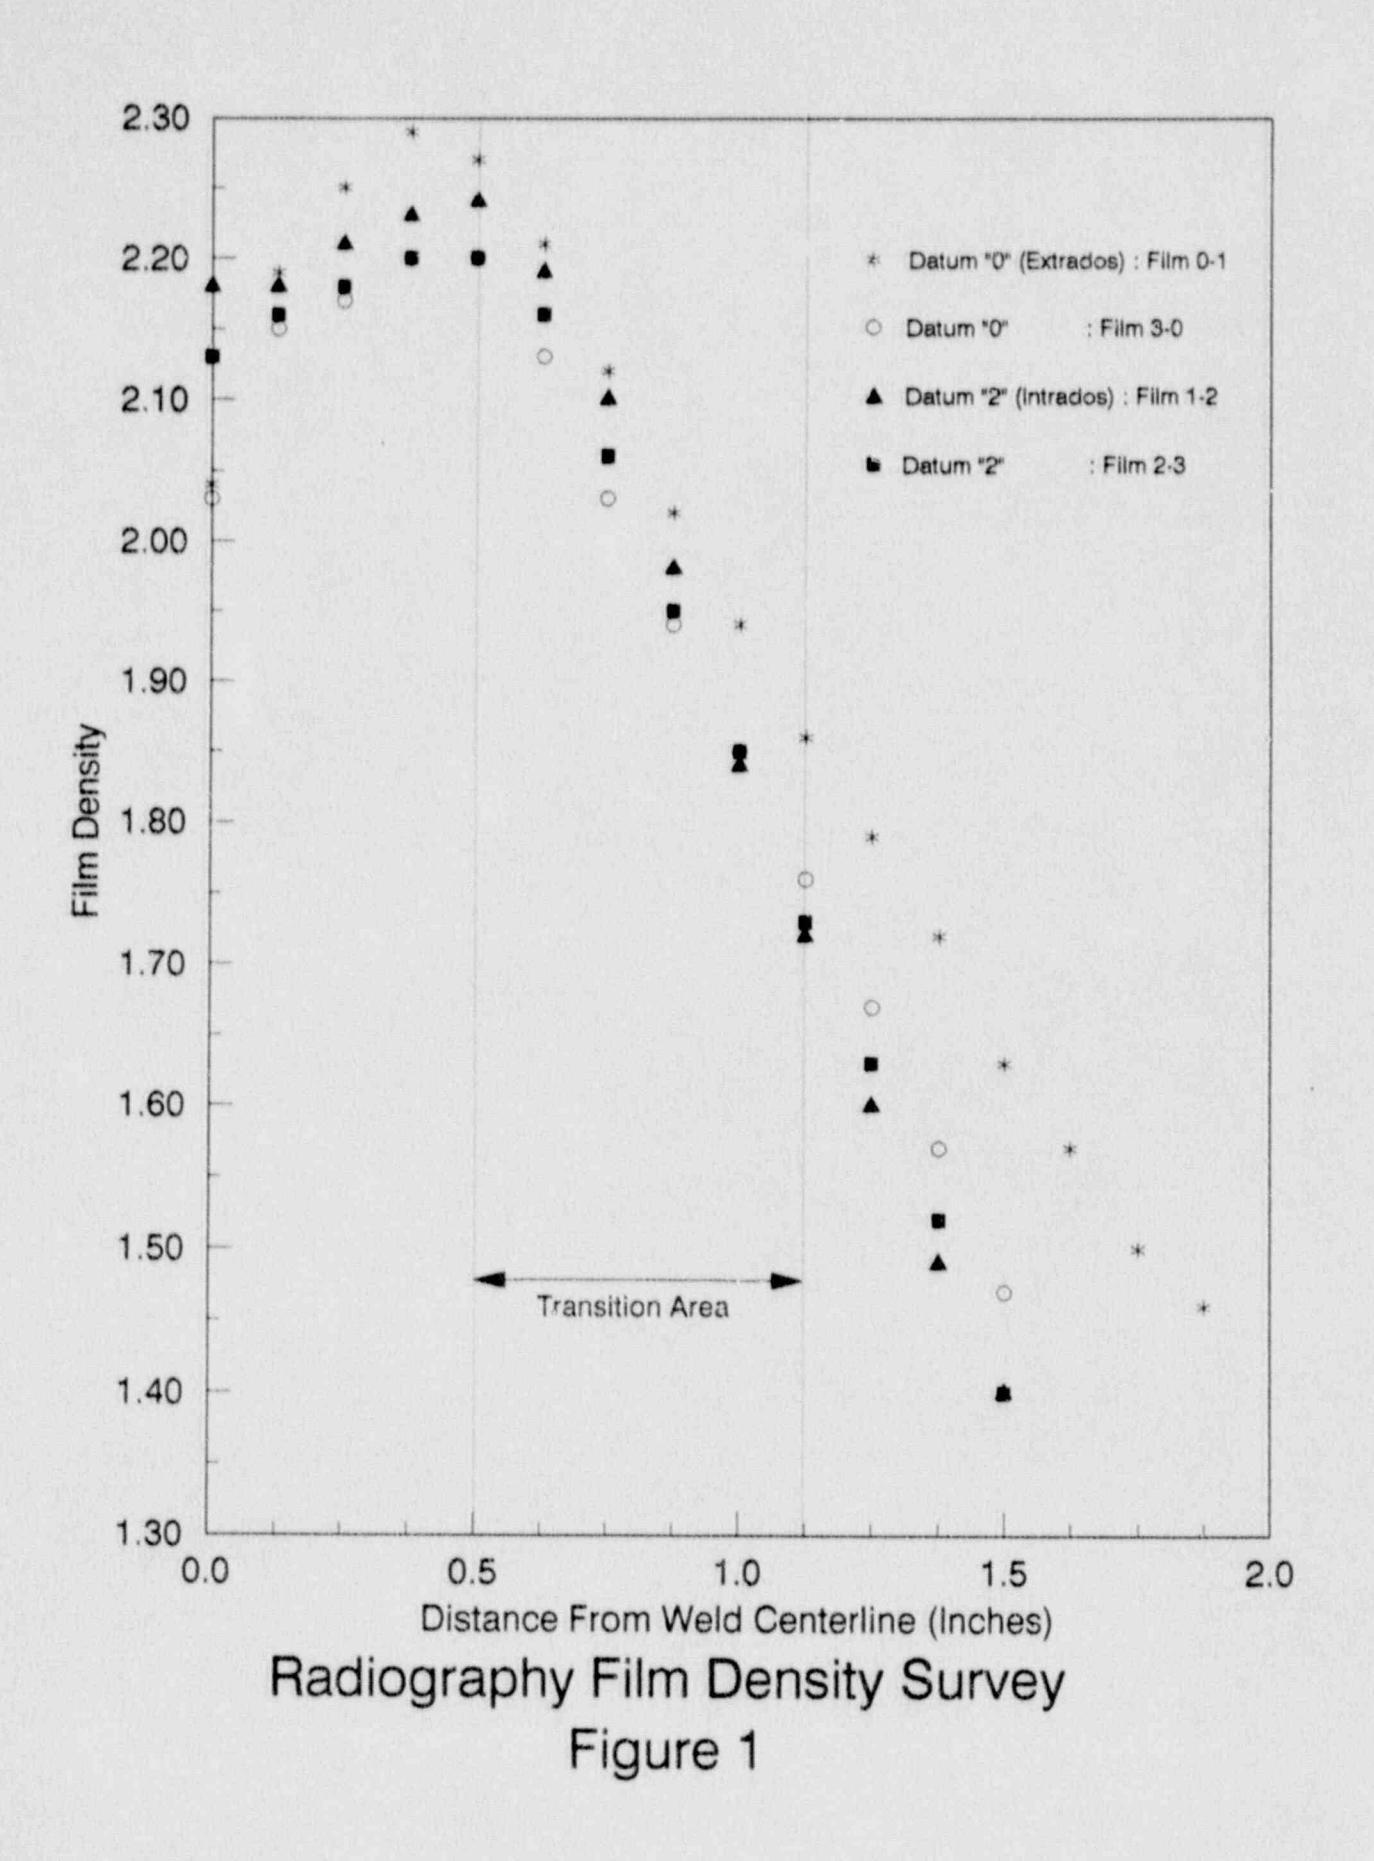
The radiography films for the completed weld were examined for sharp density changes indicating a steep transition angle. There was nothing visually apparent. Film density surveys were taken from the centerline of the weld to the edge of the film at the datums 0 and 2 (Extrados and Intrados, respectively) on each of two films covering these locations. The surveys extended to 1 1/2 inches off the weld centerlines. The density change due to the transition angle is expected in the area 1/2" to 1 1/8 inches off the centerline. The density survey readings, shown in Figure 1, were as expected for a properly machined contour.

- 3. The radiography film density survey indicates no significant density change differences between the datum 0 (extrados) and datum 2 (intrados) locations.
- 4. The UT profiling of the elbow mock-up was able to produce near shape contours of the ID surface sufficient to interpret ultrasonic results. However, determining the angle of the transition from the counterbore diameter to the mill surface inside diameter was not possible for several reasons.
  - A. The distortions caused by welding and the presence of the weld root penetration.
  - B. The differing part contours at the intrados and extrados.
