April 20, 1990

Subject: McGuire Nuclear Station Unit 2 Docket No. 50-370 Licensee Event Report 370/90-04

Pursuant to 10 CFR 50.73 Sections (a)(1) and (d), attached is Licensee Event Report 370/90-04 concerning Power Mismatch Exceeding Technical Specification Limits because of a Design Deficiency. This report is being submitted in accordance with 10 CFR 50.73(a)(2)(i)(B). This event is considered to be of no significance with respect to the health and safety of the public.

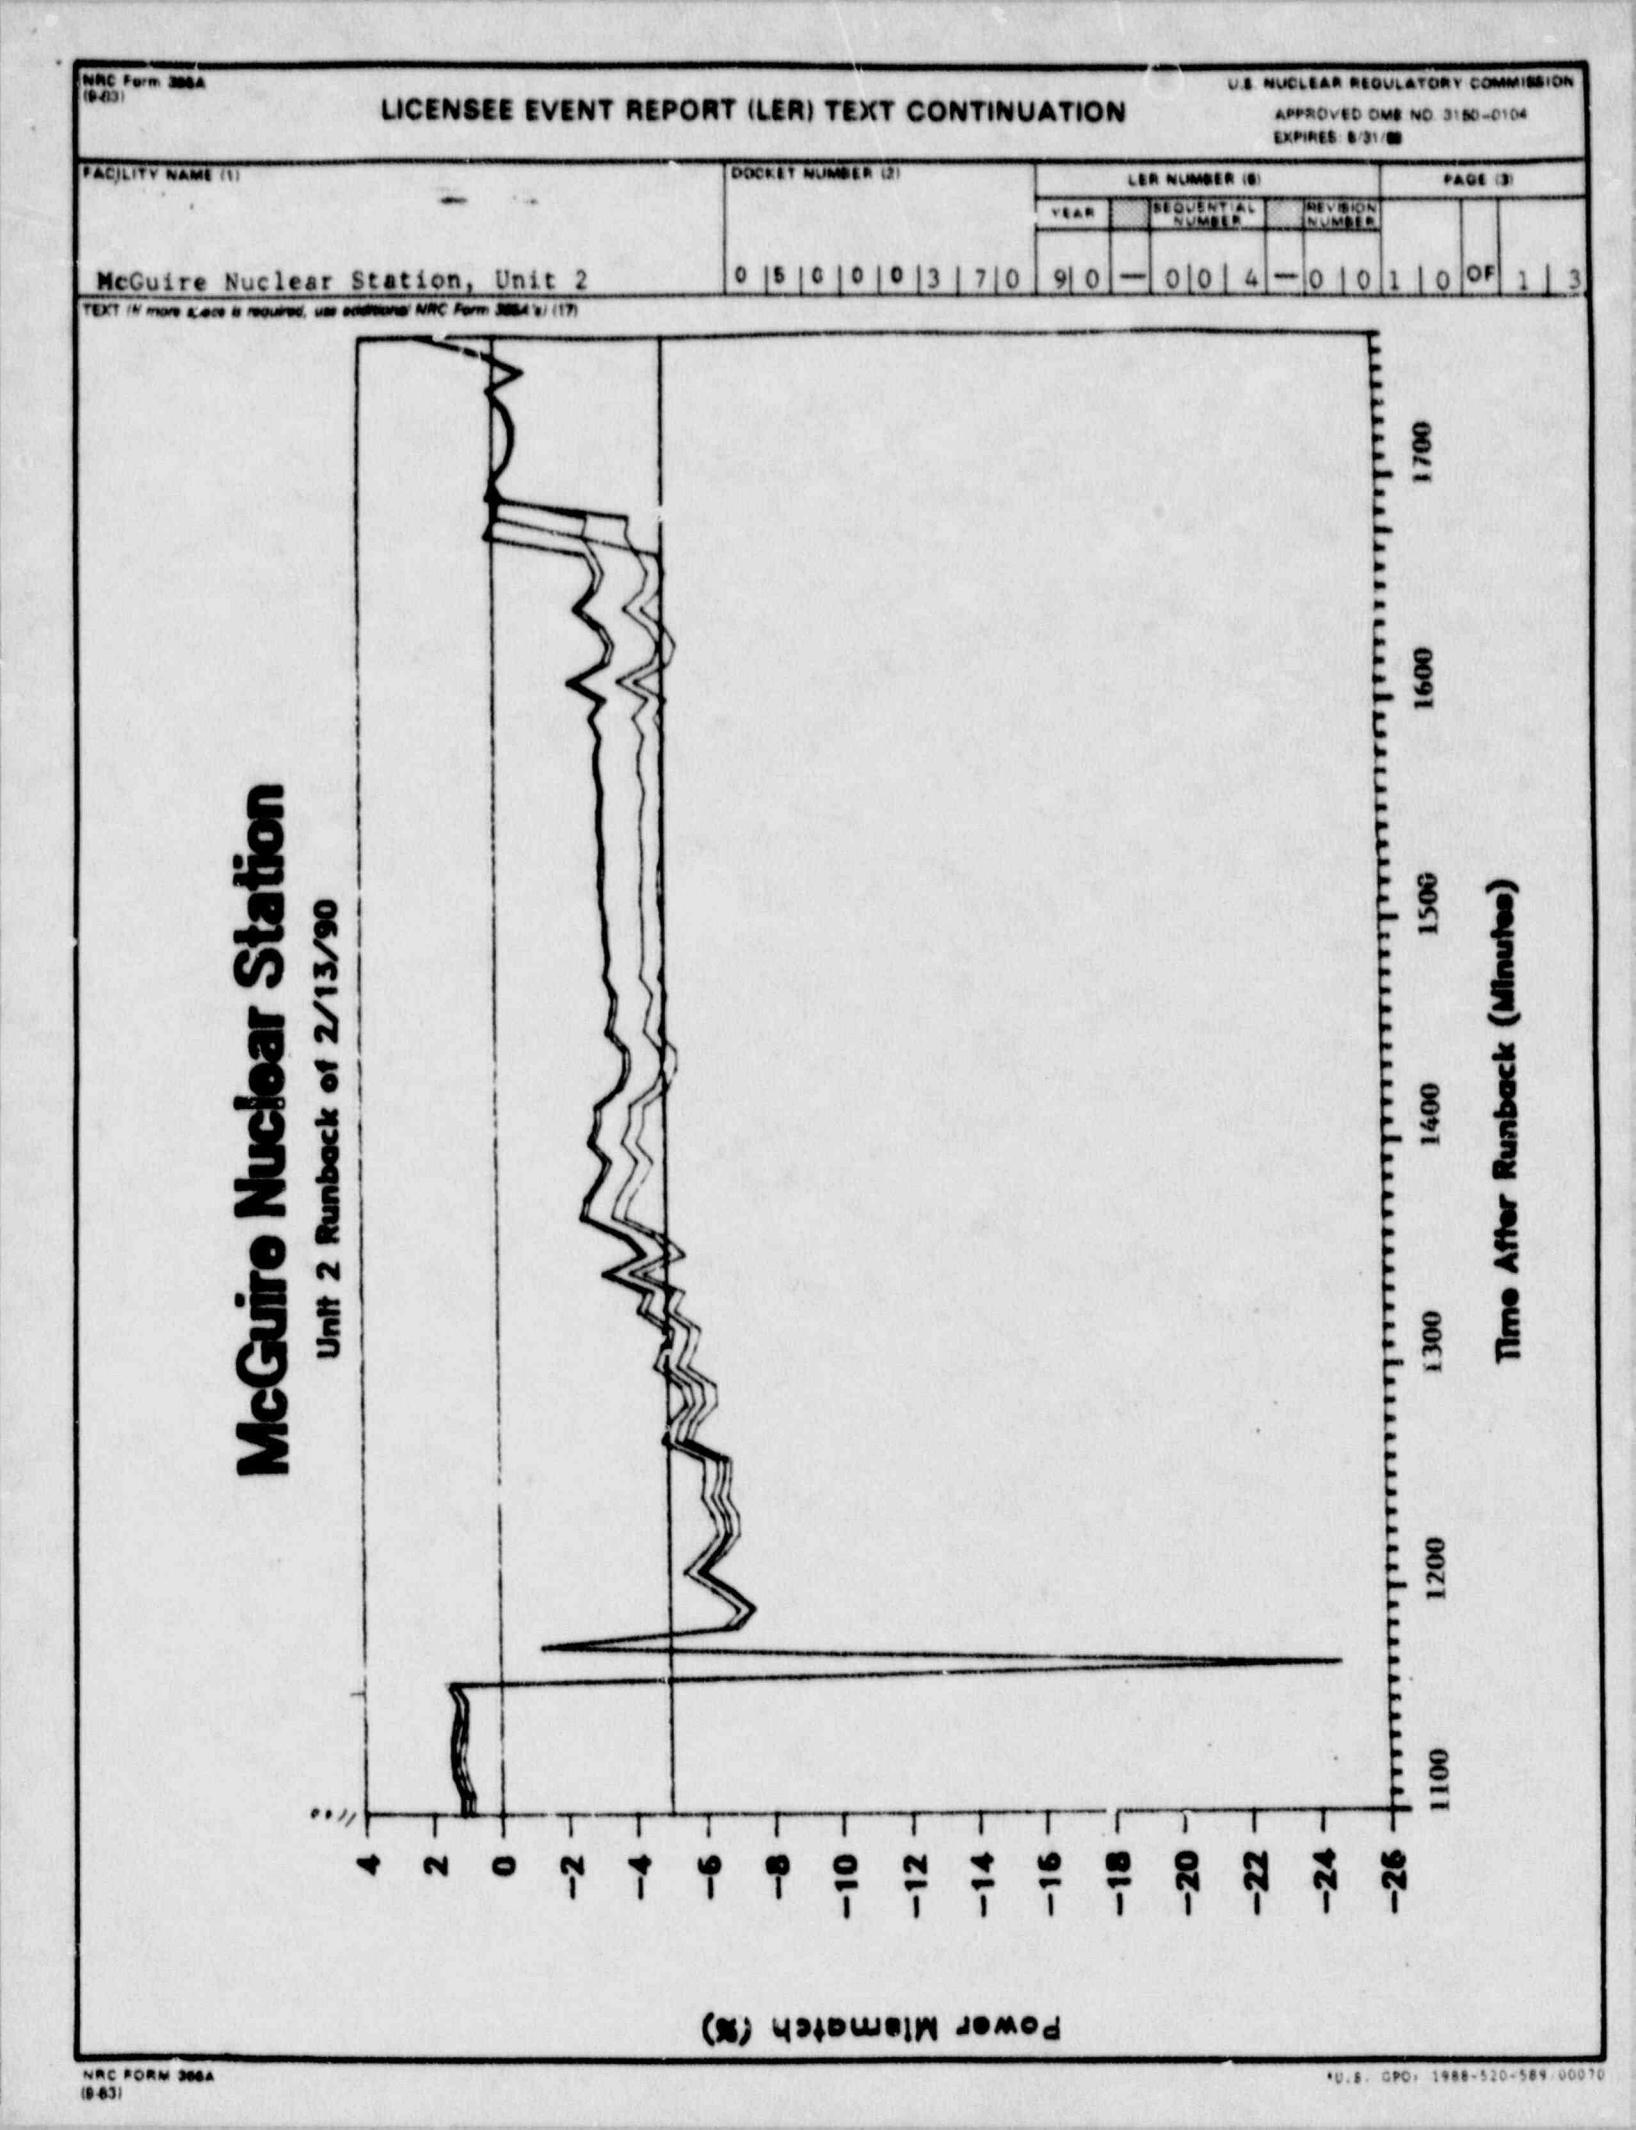
Fower Mismatch values addressed in this paragraph and the graph on page 10 of 13 were obtained from the Operator Aid Computer (OAC) all points data base by Performance personnel after the event occurred. This information is not available to Operations personnel. Between 1150 and 1310, during rod withdrawal, the Power Mismatch oscillated between -7.5 percent and -5.0 percent for all four channels; however, the trend was toward -5.0 percent. At certain times during this period, some channels were recorded with a value of -4.0 percent. By 1335, all four channels had returned to within the ±5.0 percent difference band. From 1415 to 1635, the Power Mismatch for one channel, Channel 42, oscillated from -4 percent to -5.3 percent. This was recorded for 12 five minute intervals. At 1750, all four channels spiked to +5.2 percent, but then returned to -3.8 percent which was the value prior to the spike. (See Table on page 11 of 13.)
