December 17, 1981 Fort St. Vrain Unit No. 1 P-81318

REPORTABLE OCCURRENCE 81-072 ISSUE 0 Page 1 of 4

REPORT NO. 50-267/81-072/03-L-0

During a routine surveillance check performance on November 17, 1981, the setpoint of the PCRV rupture disk assembly M-11701 was found to be 847 psig. Since this setpoint is higher than the 832 psig ± 1% allowable by Fort St. Vrain Technical Specification LSSS 3.3, Table 3.3.1.2(c), it is being reported per Fort St. Vrain Technical Specification AC 7.5.2(b)1.

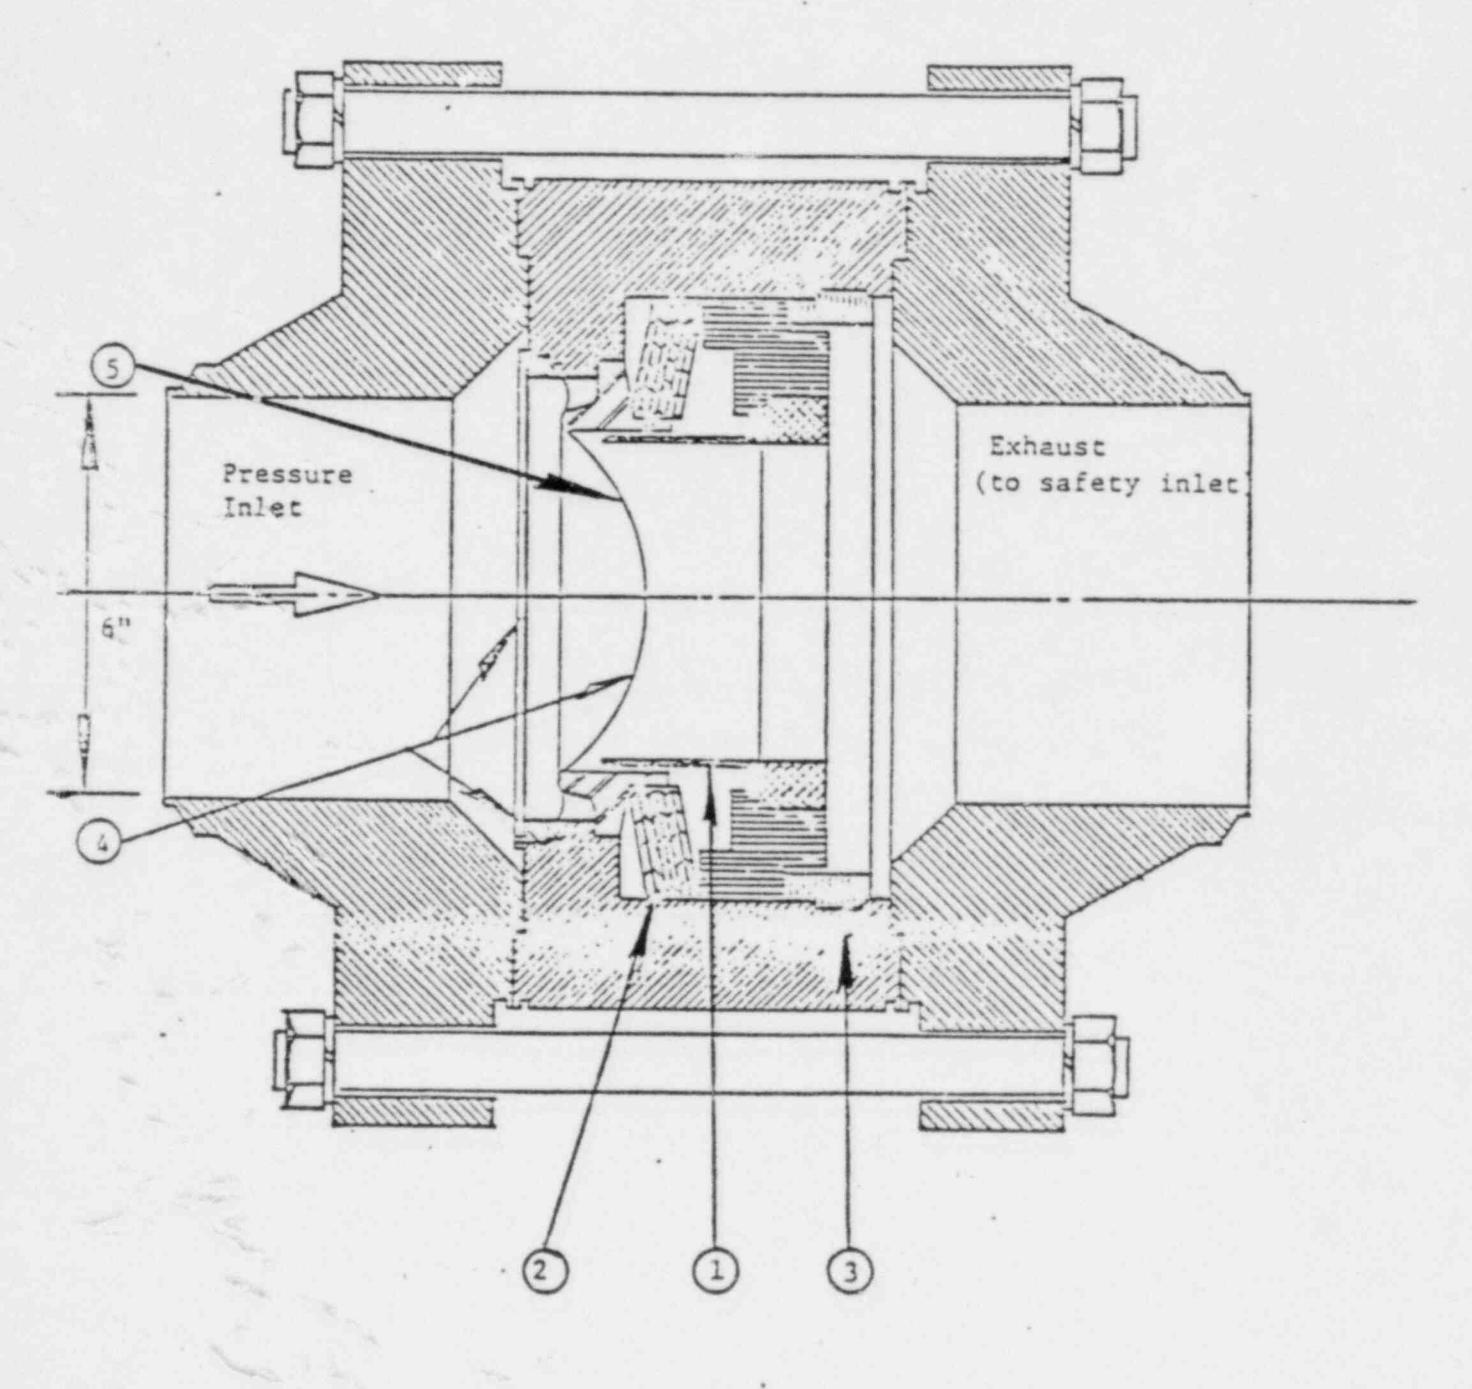
FIGURE 1

With the reactor shutdown and depressurized for scheduled maintenance, the high set rupture disk M-11701 was removed from service for a scheduled surveillance calibration bench test. The "as found" pressure setpoint was 847 psig. The acceptance criterion of LSSS 3.3, Table 3.3.1.2(c) requires the set pressure co be 832 psig + 1% (824 psig to 840 psig).

Refer to Figure 1. Before the test gas pressure is applied, the cutter, ①, is removed, and a special ring is installed to limit the travel of the Belleville washers ②. The washers snap-over when the set pressure is reached. Adjustment of the set pressure is made by positioning of the threaded ring ③. When the set pressure is reached, the diaphragm and washers travel a few thousandths of an inch, which produces an audible "thump." The plant instrumentation personnel know from previous experience that the setpoint of the Belleville washers decreases slightly with subsequent snap-overs during testing. Therefore, the snap-over test was conducted two additional times with snap-overs occurring at 831 psig and 831 psig, respectively. The last two tests were within the specified acceptable range. The average of the three tests was 836 psig, which is satisfactory, so no further adjustments were required. The remainder of the surveillance was completed, and the rupture disk assembly was returned to service.

The rupture disk movement setpoint being out of tolerance was caused by drift of the Belleville washer operating point over the period since its' last calibration surveillance.

The snap-over test was conducted three times with the last two of the tests within the required setpoint band. The remainder of the surveillance was completed, and the rupture disk assembly was returned to service.

An evaluation of the rupture disks is being conducted by the Public Service Company of Colorado's Nuclear Engineering Division. The results of this evaluation will be included in a future supplemental report.
