Three Mile Island Unit 2  
Response to ACES Questions

PLANT NAME: Three Mile Island Nuclear Generating Station, Unit 2  
LICENSING STAGE: OL  
DOCKET NUMBER: 50-320  
REQUESTED COMPLETION DATE: October 15, 1976  
REVIEW STATUS: Hydrologic Engineering Section, HME -- Complete

Three Mile Island Nuclear Station (TMI)  
Docket Nos. 50-289 and 50-320

SURFACE FEATURES OF TOE PROTECTION - SURVEY RESULTS - G.A.I. JUNE 1976

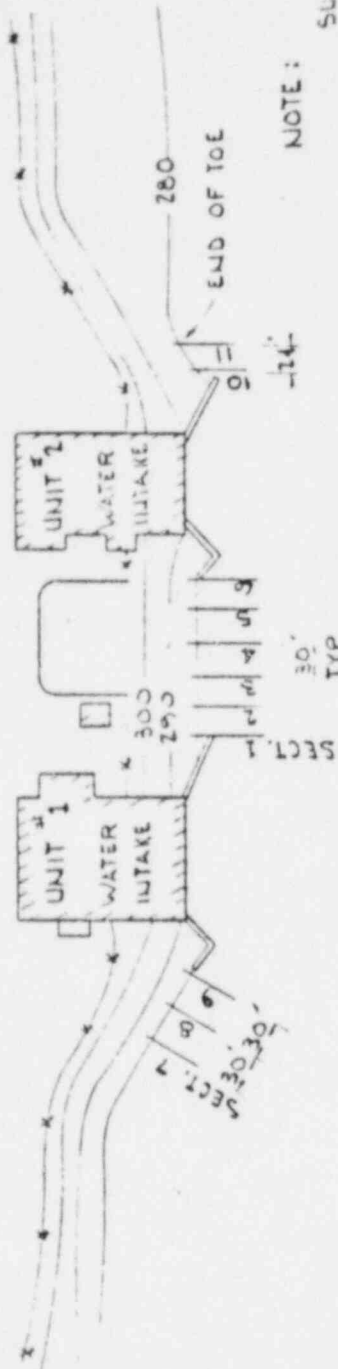
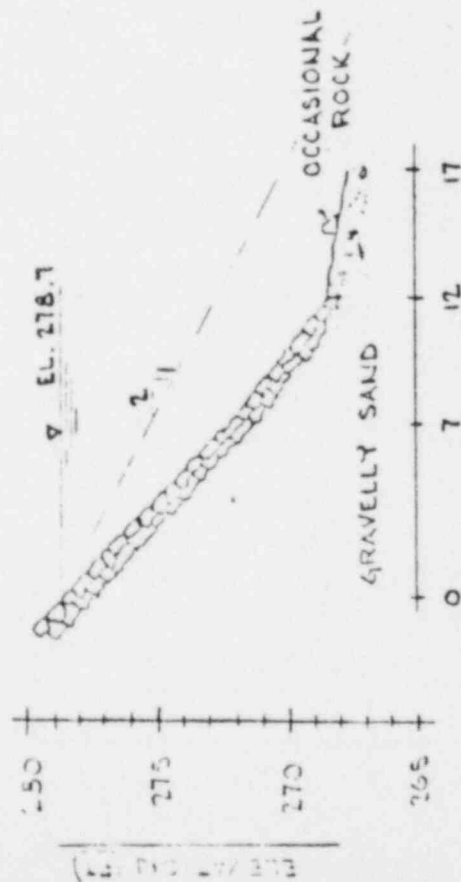
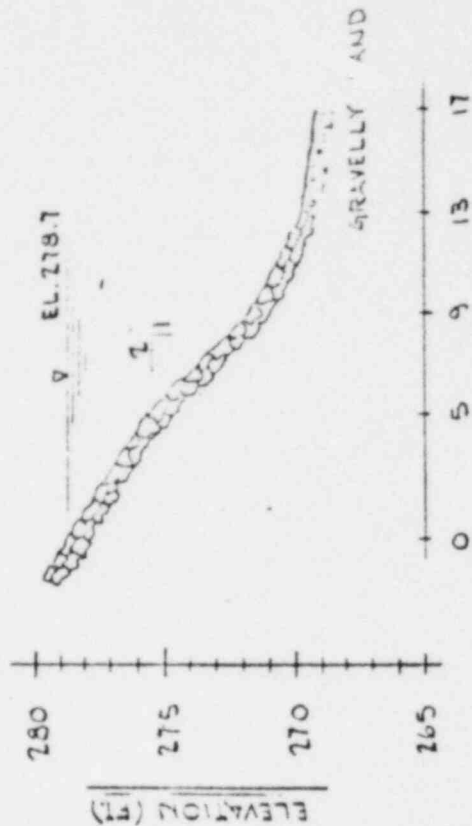
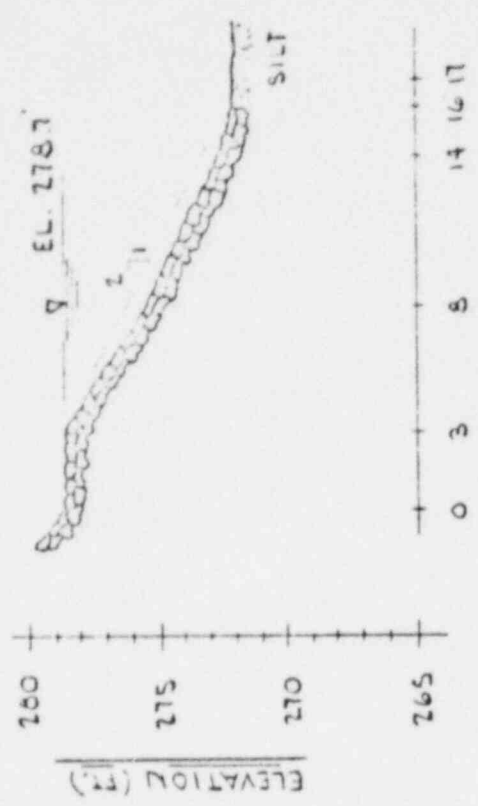
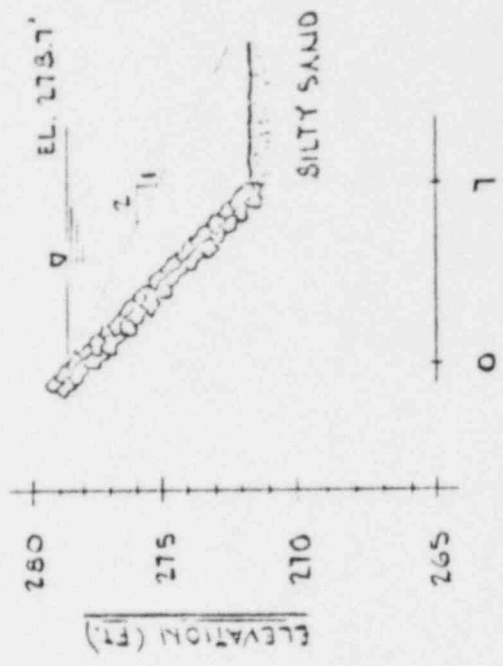
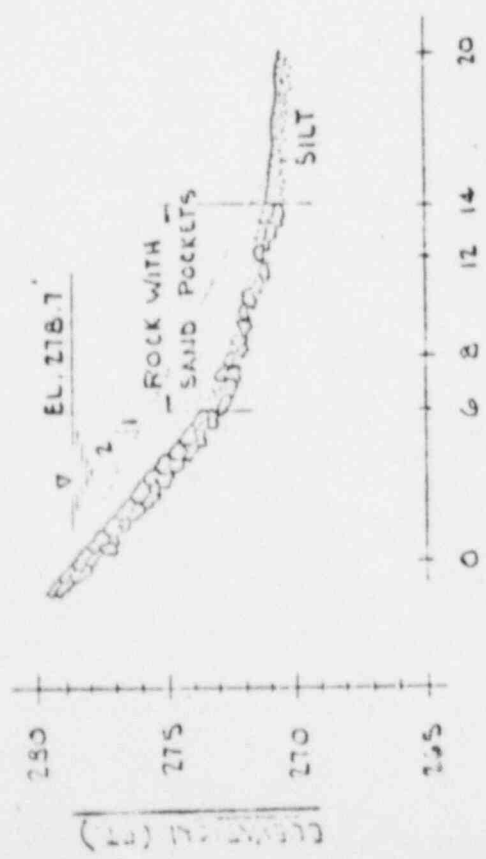
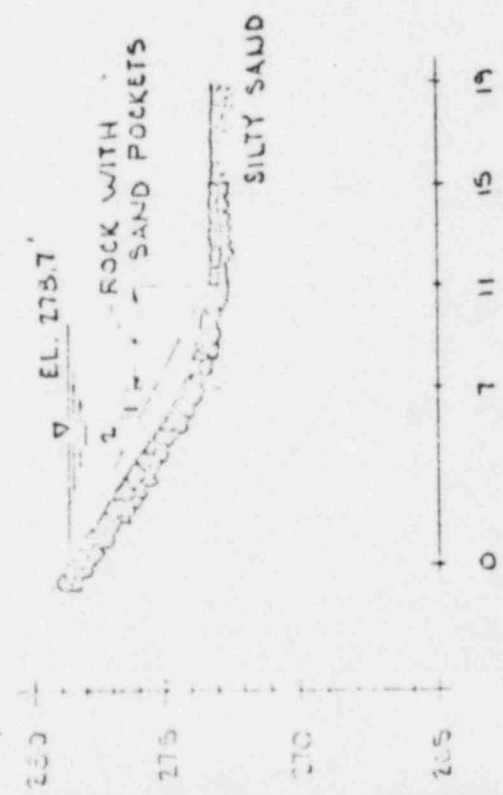
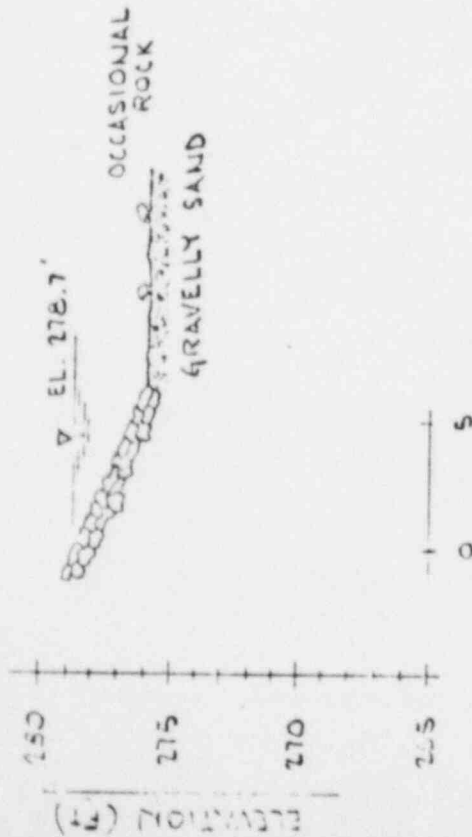
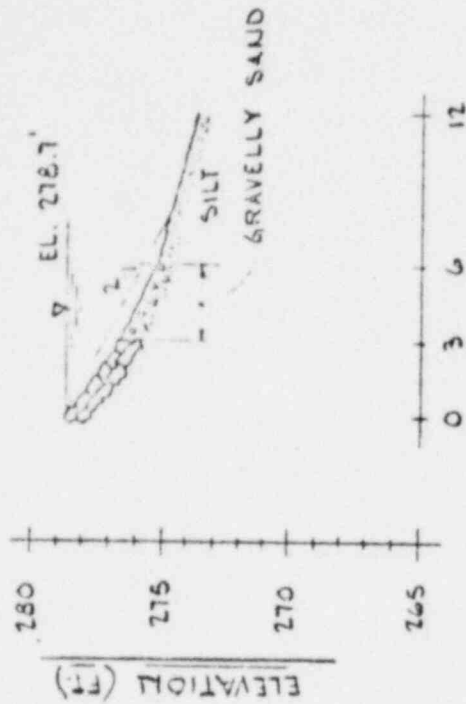
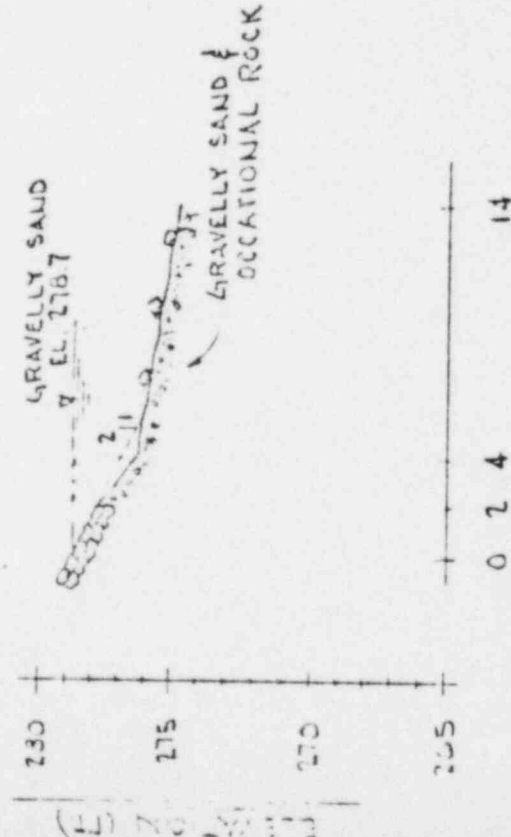
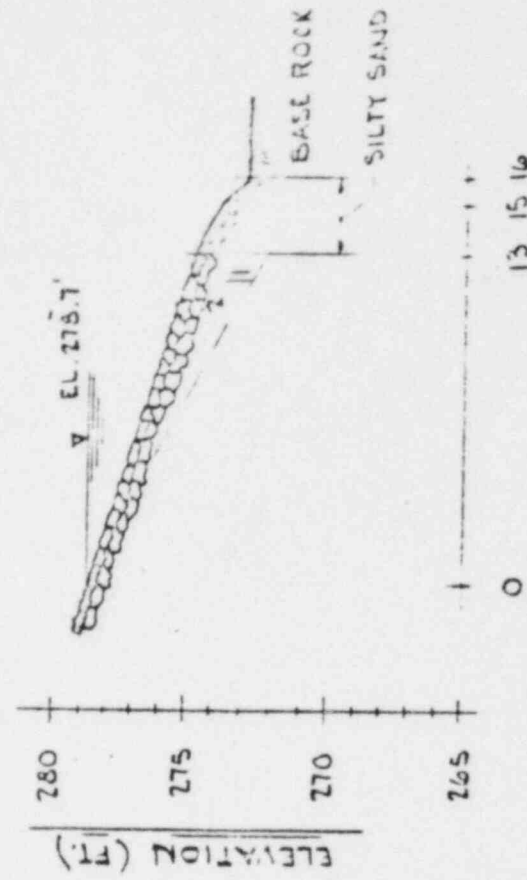
Attached are drawings which show the results of the post repair toe survey recently conducted. It can be seen from these drawings that between the intake structures the dike toe slopes more steeply than specified. Therefore, we plan to correct the toe slope at the same time that repairs to dike's east exposure are accomplished. These repairs will be completed by April 30, 1977.
