UNITED STATES OF AMERICA NUCLEAR REGULATORY COMMISSION

In the Matter of) VIRGINIA ELECTRIC AND POWER COMPANY) Docket Nos. 50-338 O.L. (North Anna Nuclear Power Plant,) Units 1 and 2)

NRC STAFF TESTIMONY OF WARREN S. HAZELTON AND CLIFFORD D. SELLERS REGARDING TURBINE DISC CRACKING

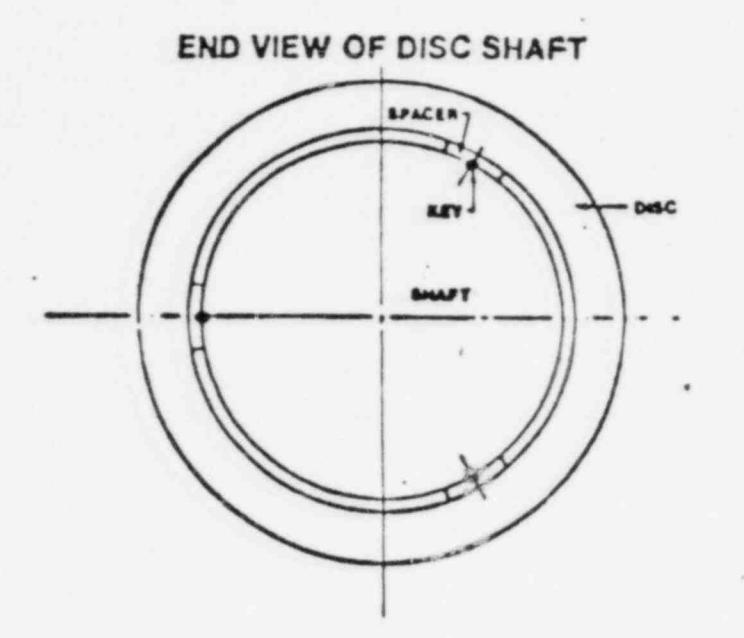
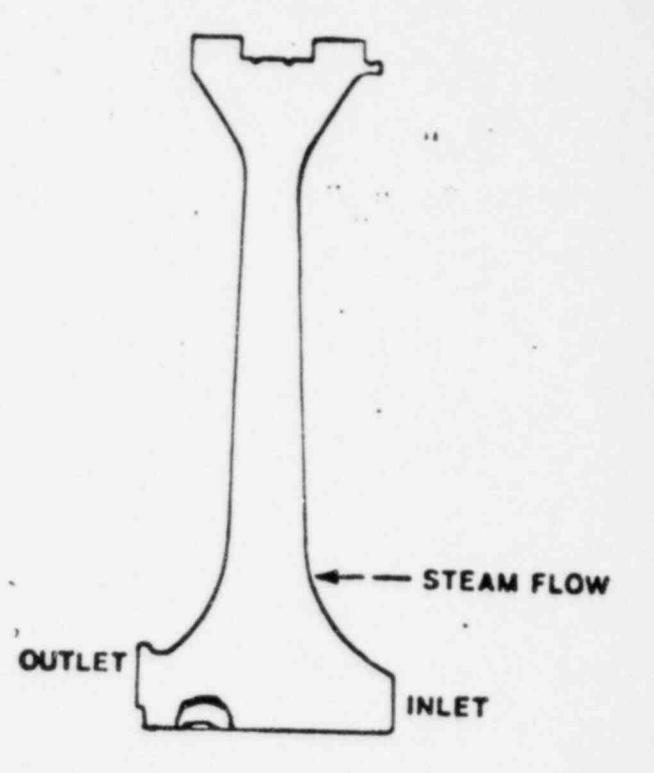
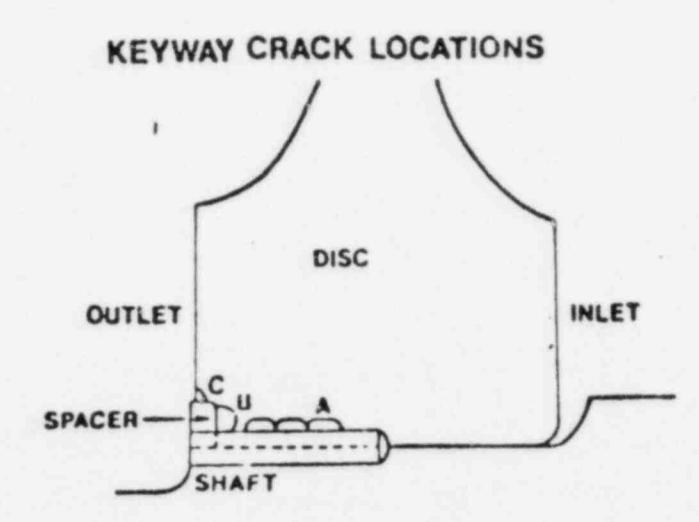
Figure I

- 0. How do you estimate the size of crack necessary to cause disc failure?
- A. The crack size (A crit) that could cause disc failure depends on several parameters. The calculations relating these parameters use the well proven concepts and methods of linear elastic fracture mechanics (LEFM). It is important to note that a critical crack for failure could be a long, shallow one, or a short, deep one. The shape of the crack is, therefore, very important. Accordingly we first note the shape of the real cracks and then perform our calculations to determine what the critical depth would be, for a crack with such shape. This is discussed in more detail later, but it should be noted that cracks are found in two typical locations, in the keyways cut into the disc bore, or in the bore away from the keyways. A schematic drawing of a typical turbine disc showing these locations is provided in Fig. 1.

BORE CRACK LOCATION
