| TITLE | LE PHIPPS BEND NUCLEAR PLAN'T GEOLOGIC FOUNDATION REPORT FAULT DESCRIPTIONS | | | | REPORT NO. CEB 81-47 PLANT/UNIT PBN SAR SECTION(S) 2.5.2 | | |

TENNESSEE VALLEY AUTHORITY

PHIPPS BEND NUCLEAR PLANT GEOLOGIC FOUNDATION REPORT DESCRIPTION OF FAULTS 1-29

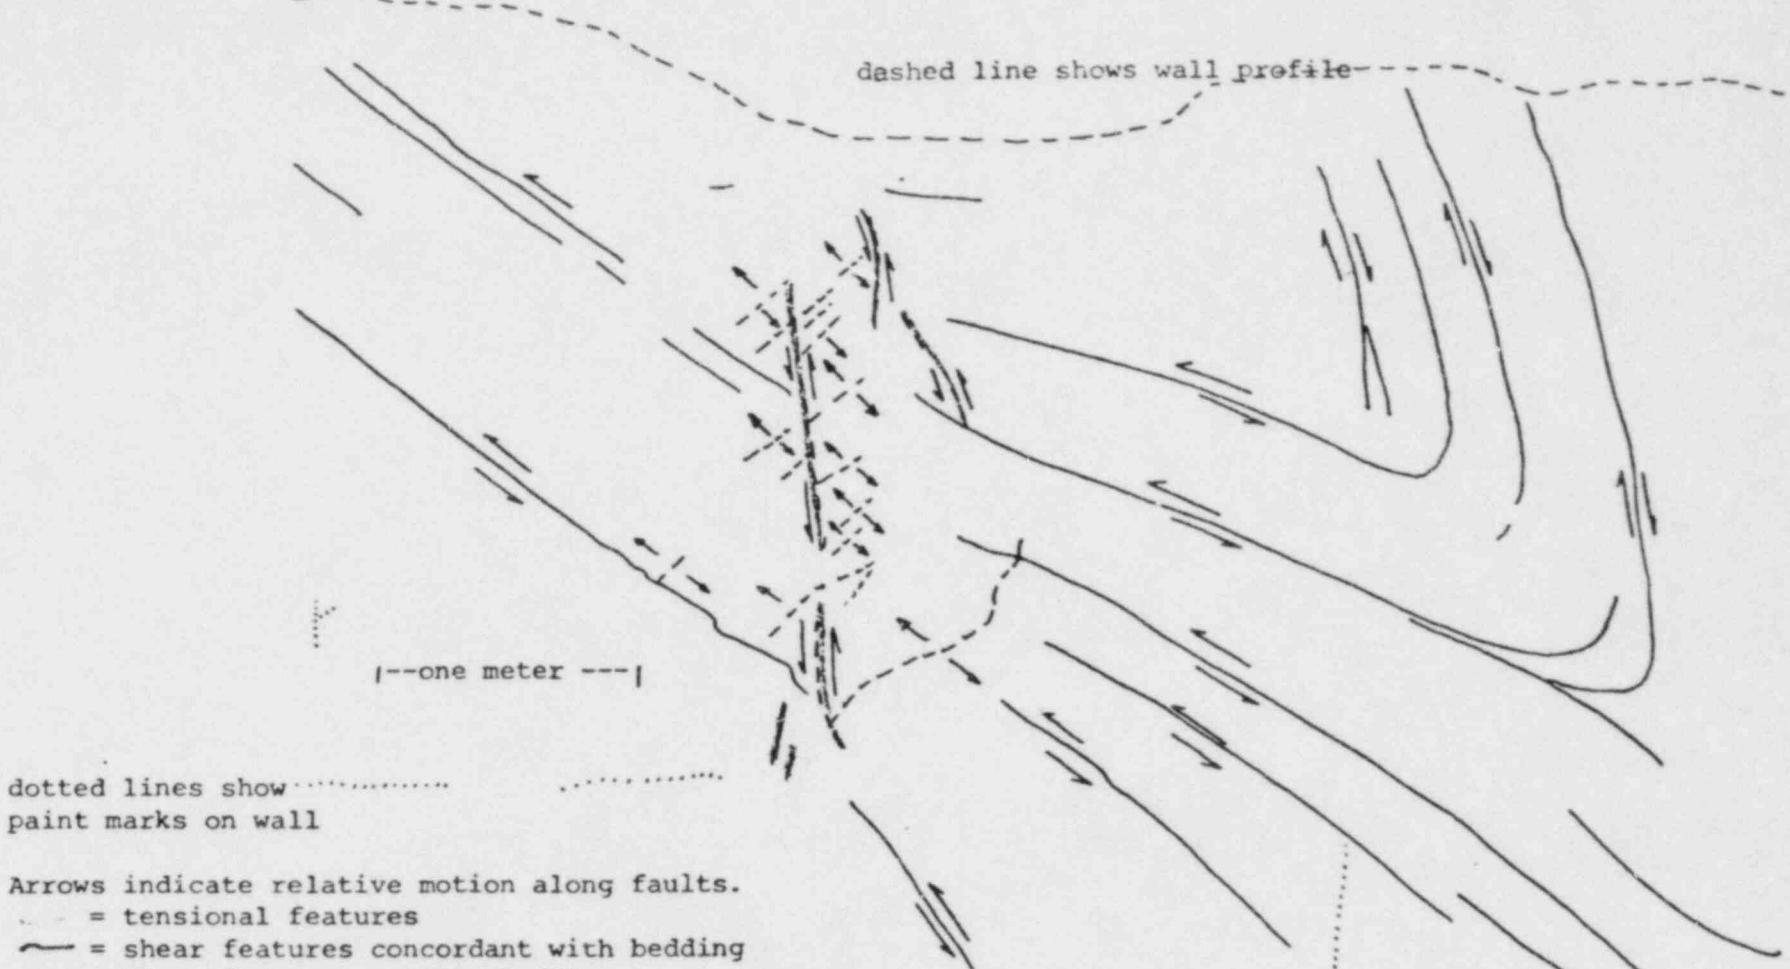
STRUCTURE SKETCH OF MAJOR FEATURES AT SITE 2. View is toward the northeast

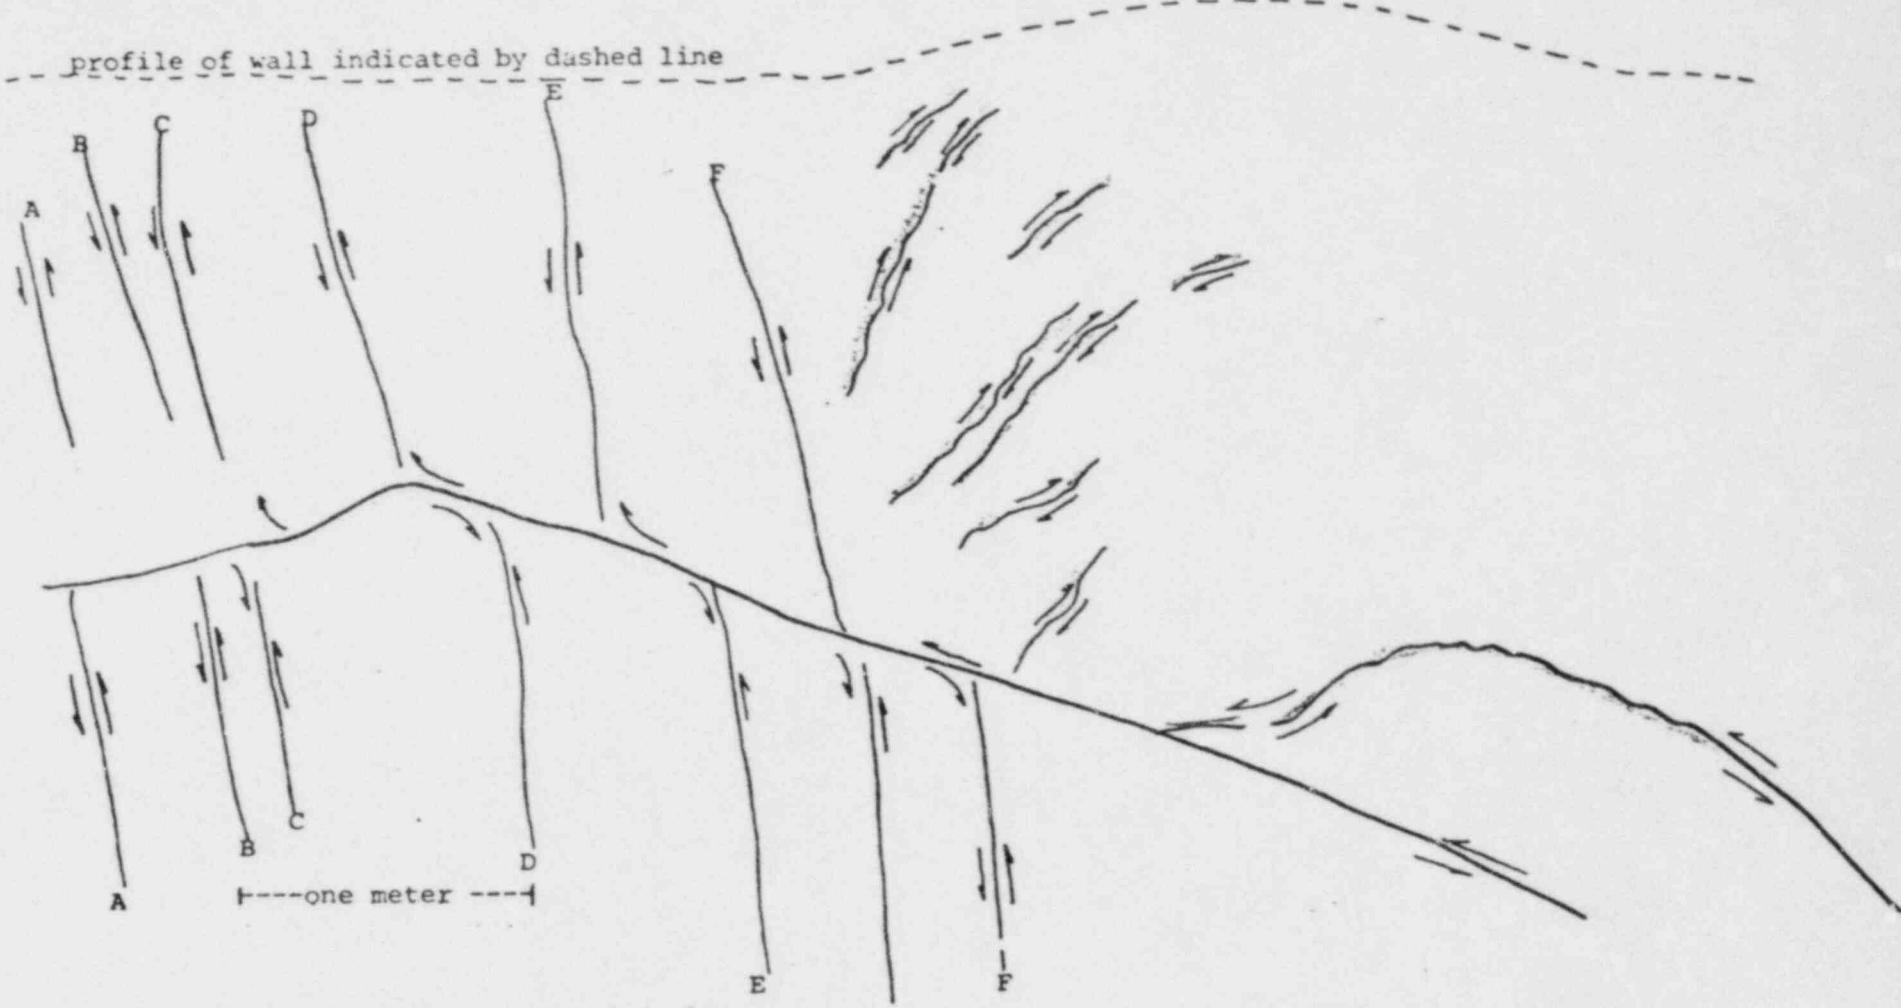
STRUCTURE SKETCH SHOWING MAJOR FEATURES AT SITE 3. View toward the northeast.

Arrows indicate relative motion of faults.

Letters show correlations of bedding plane calcite-filled fractures. Note how displacement along fault marked in red () decreases toward the north where its displacement is translated into bedding plane motion by ramping upward into bedding plane faults labelled A - F. Faults shown in green (----) are folded or tilted by drag effect associated with the anticline present here.
