KANSAS GAS & ELECTRIC COMPANY
WOLF CREEK GENERATING STATION

ULTIMATE HEAT SINK
FILL SPECIAL PROCEDURE

SU8 0001

**WOLF CREEK GENERATING STATION
 UNIT NO. 1
 FINAL SAFETY ANALYSIS REPORT**

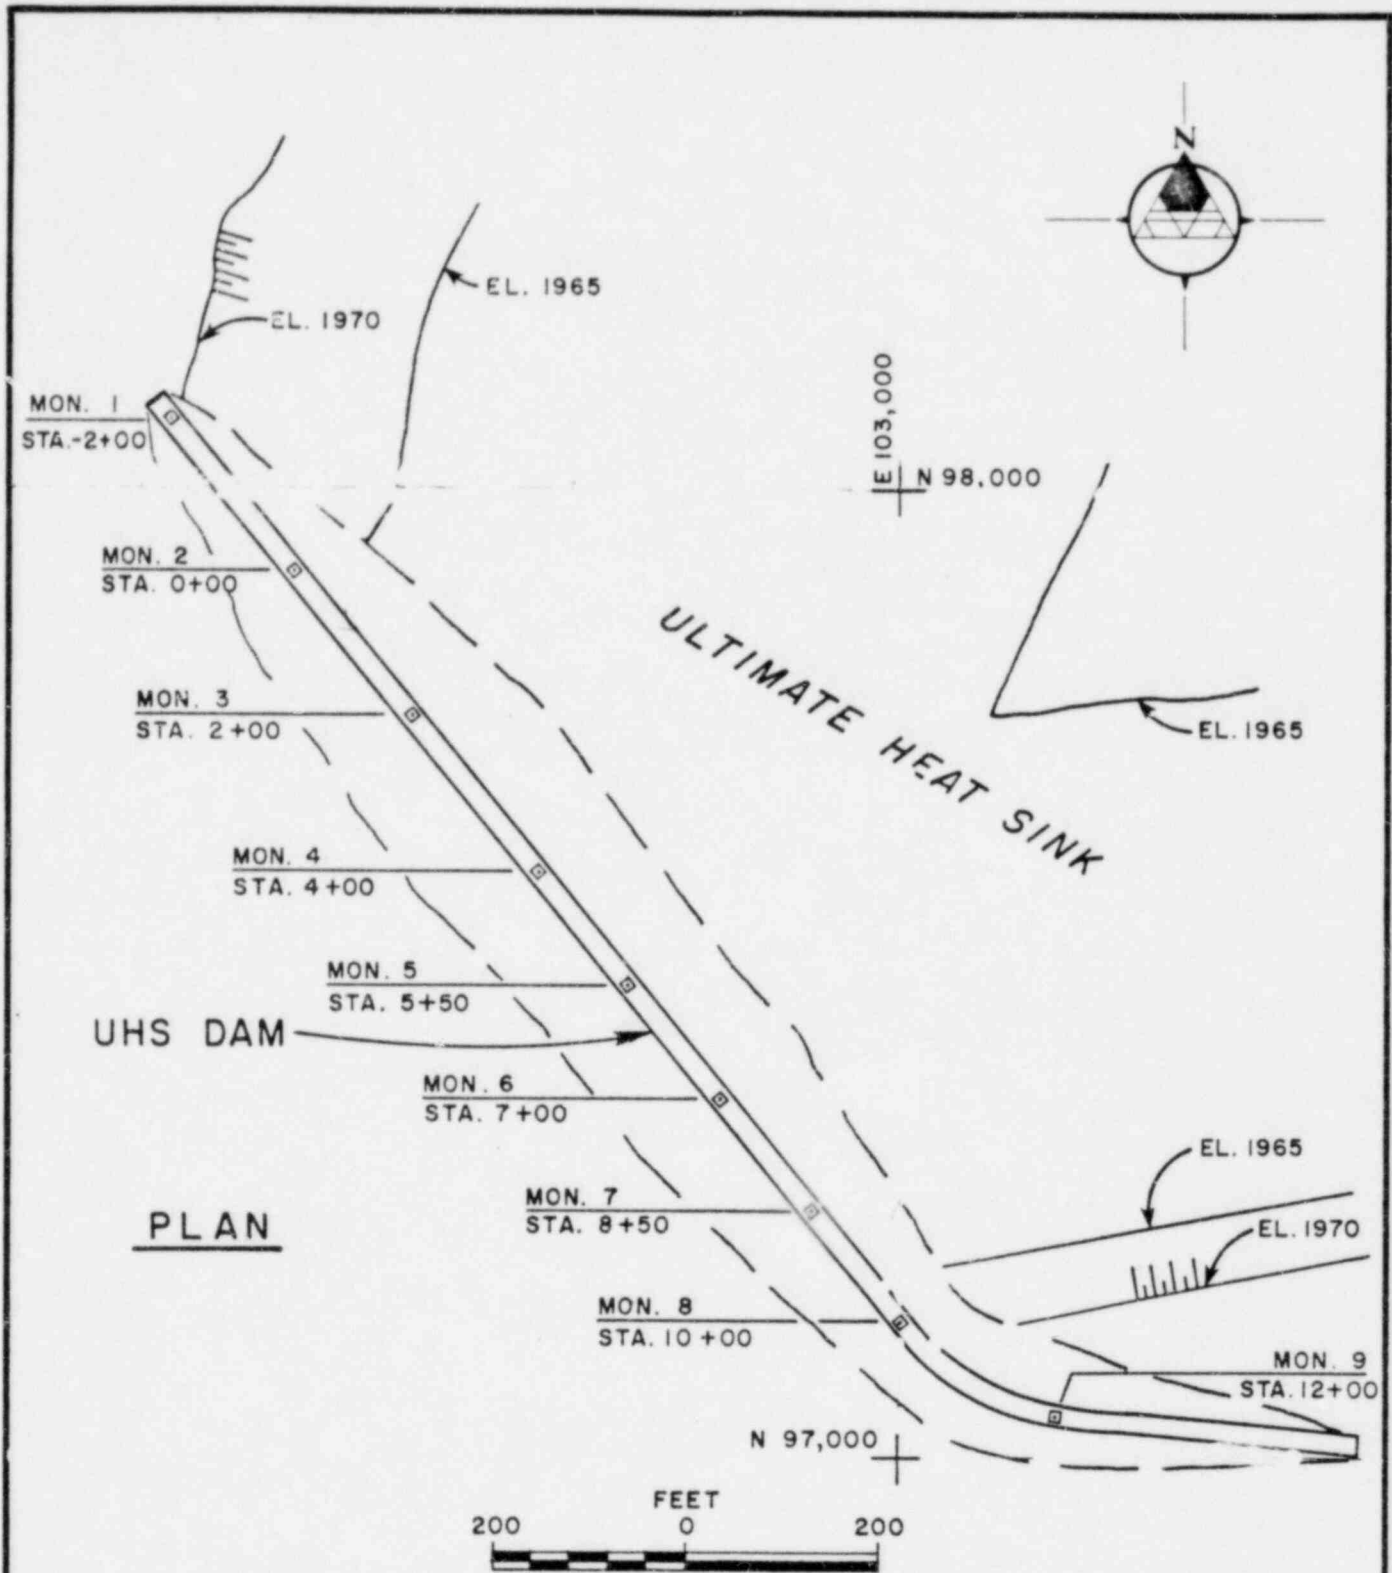
FIGURE 241.24.4-1

4. No estimates of deformation of the UHS dam during filling were made. The locations of movement monuments are provided in Figure 241.24-4-1, and the measured deformations for each monument are presented in Tables 241.24-4-1 through 241.24-4-4. From these tables, it may be seen that the vertical movements during the filling period are on the order of less than 0.5 inch and on the order of 0.1 inch during the observation period (Table 241.24-4-2). The UHS dam has been constructed with a conservative 3.5 percent camber, so that the crest elevation will remain above elevation 1970.0 feet, as described in Sargent & Lundy Report No. SL-3831, Paragraph 2.2.3.5 (which is provided in response to Question 241.25).

The observations of the horizontal movements for September 24, 1980 (Table 241.24-4-4) show deformations up to 3 inches along the axis of the UHS dam and deformation close to 1 inch transverse to the axis of the UHS dam. However, the survey data for the prior and subsequent periods, including the observation period, show movement on the order of 1 inch or less. It is, therefore, felt that the data for September 24, 1980 does not reflect actual movements. Actual movements should, therefore, be considered on the order of 0.5 inch for vertical displacements and 1 inch or less for horizontal displacements.

These recorded horizontal and vertical movements are considered normal and have no impact on the safety of the UHS dam.

**MOVEMENT MONUMENT LOCATION
 UHS DAM**
