Subject: Preliminary Case Study Report on Solenoid Valve Problems at U.S. Light Water Reactors

Page
EXE	CUTIVE		Y		vii
12345	INTR DESC USE SOLE OPER FAIL	CODUCTION CRIPTION OF SOLE NOID-OP CATING EL URES OR	OF EQUIP NOID-OPER ERATED VA XPERIENCE DEGRADAT	MENT ATED VALVES (SOVS) LVE FAILURE MODES: APPARENT AND ROOT CAUSES : SIGNIFICANT EVENTS INVOLVING COMMON-MODE IONS OF SOVS	1 3 8 10 11

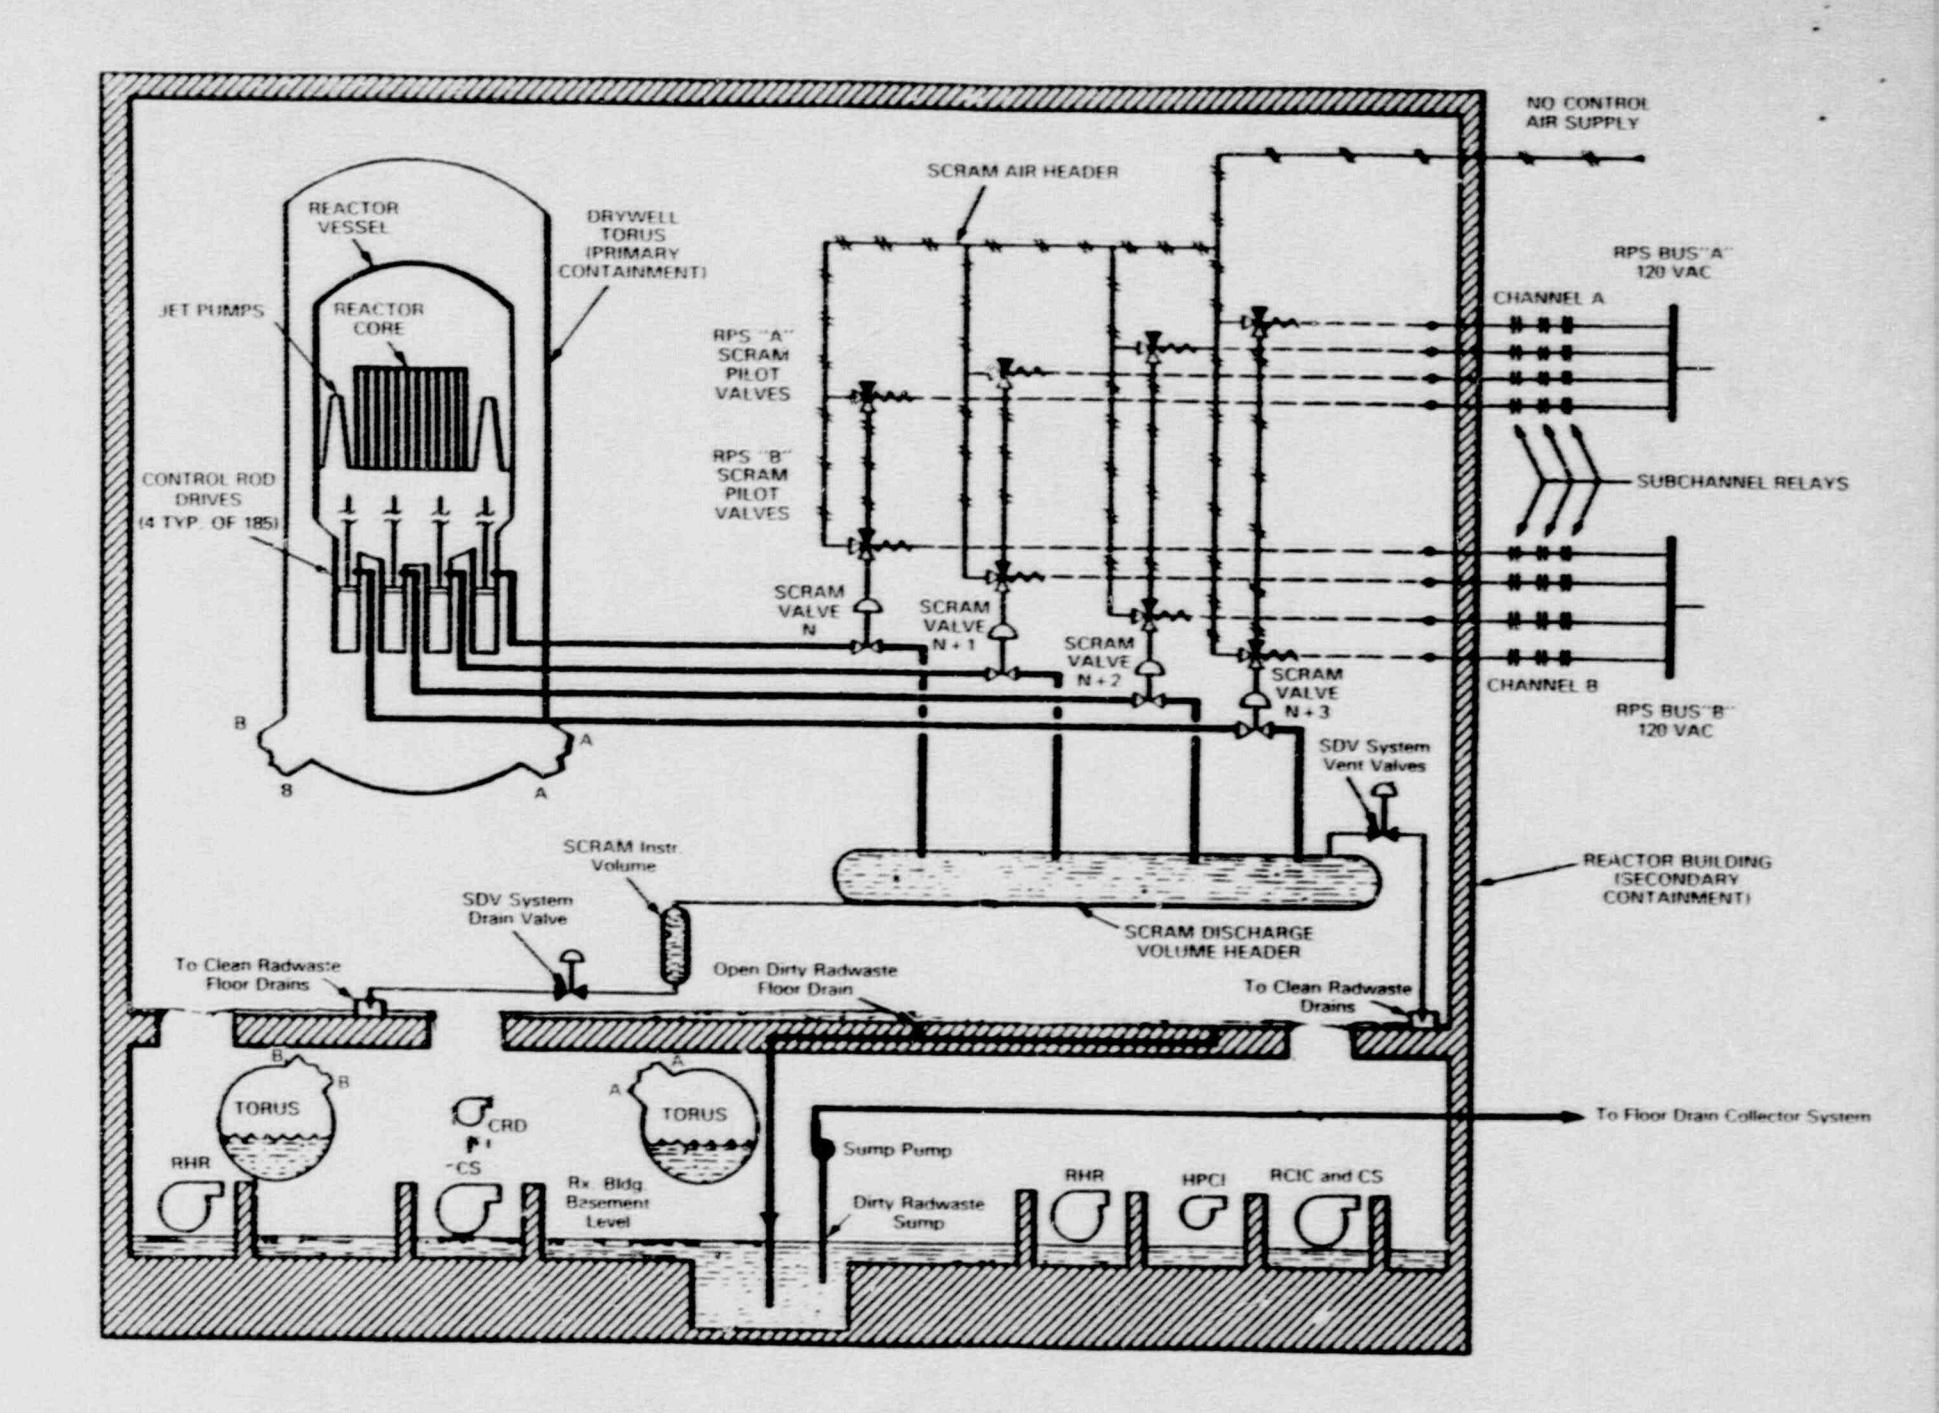
Figure 7 BWR SCRAM System-Illustrating Leak Path Outside Containment

Discussion with GE** has indicated that since Information Notice 85-95 was issued, BWR owners have made improvements in their SDV systems so that there are redundant SDV vent and drain valves at all U.S. BWRs (vs. only one vent and one drain valve per SDV header in the early 1980's). However, it is not certain that all U.S. BWRs have manual handwheel overrides for the SDV vent and drain valves to limit reactor water leakage outside primary containment in the event of a common-mode failure of the SOVs piloting the SDV vent and drain systems.
