SUBJECT: REPORT AND STAFF EVALUATION - NEW YORK STATE DEPARTMENT OF LABOR RADIATION CONTROL PROGRAM

Report on Auburn Steel Company Incident, February 21, 1983 Prepared by Staff of Radiological Health Unit, DOSH

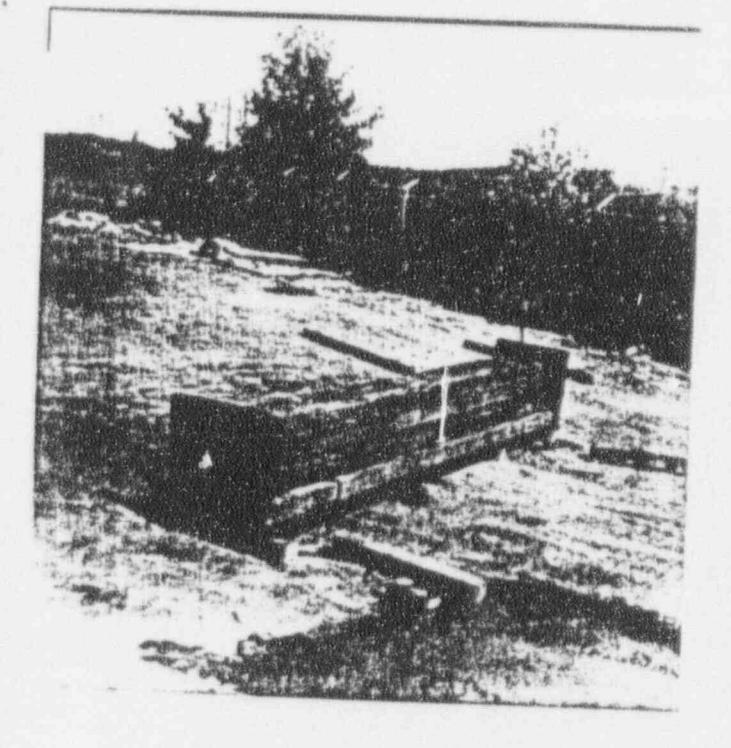
STEEL BILLETS PARTIALLY COMPRETED CONTAINER Figza

The billets from Heats #65 and 66 were placed in custom-built steel crates. These crates were welded together on site and met the DOT criteria for a well constructed container (see Figure 2).
