*****	Milistone Nuclear Po	wer station Unit 2		0 5 0 0	0336	1   OF	1915			
Reactor	Trips on Steam Gene	rator Low Water Level								
EVENT DATE (5)	LER NUMBER (6)	REPORT DATE (7)	OTHER	FACILITIES IN	VOLVED (8)					
MONTH DAY YEAR	YEAR SECUENTIAL NUMBER	NUMBER MONTH DAY YEAR	FACILITY NAM	AE S	0 5 0 0	0	r r			
0 2 2 2 9 3	9 3 0 0 4	0 2 0 7 0 2 9 3			0 5 0 0	0				
OPERATING	THIS REPORT IS BEING SL	BMITTED PURSUANT TO THE R	EQUIREMENTS OF 10 OFF	i § (Ctielók ane	i or more of the	toliowing	0011			
MODE (8)	20 402(b)	20 402(b)	X 50.73(a)(2)(iv)		73 71(b)					
POWER	20.405(a)(1)(0	60-38(c)(1)	50.73(a)(2)(v)		73.71(c)					
LE VEL 11010	20 406(a)(1)(0)	50.36(c)(2)	50.72 (a)(2)(v		OTHER (Specify in					
	20-405(a)(4)(iii)	50.73(a)(2)(I)	50.73(#)(2)(vi	(A))	Text NRC Form 366A.					
	20 405(a)(1)()v)	50.73(a)(2)(0)	50.73(a)(2)(v)	(8)						
<b>日本人民的公司</b>	20 405 (a) (1) (iv)	50.73(a)(2)(iii)	50.73(a)(2)(x)

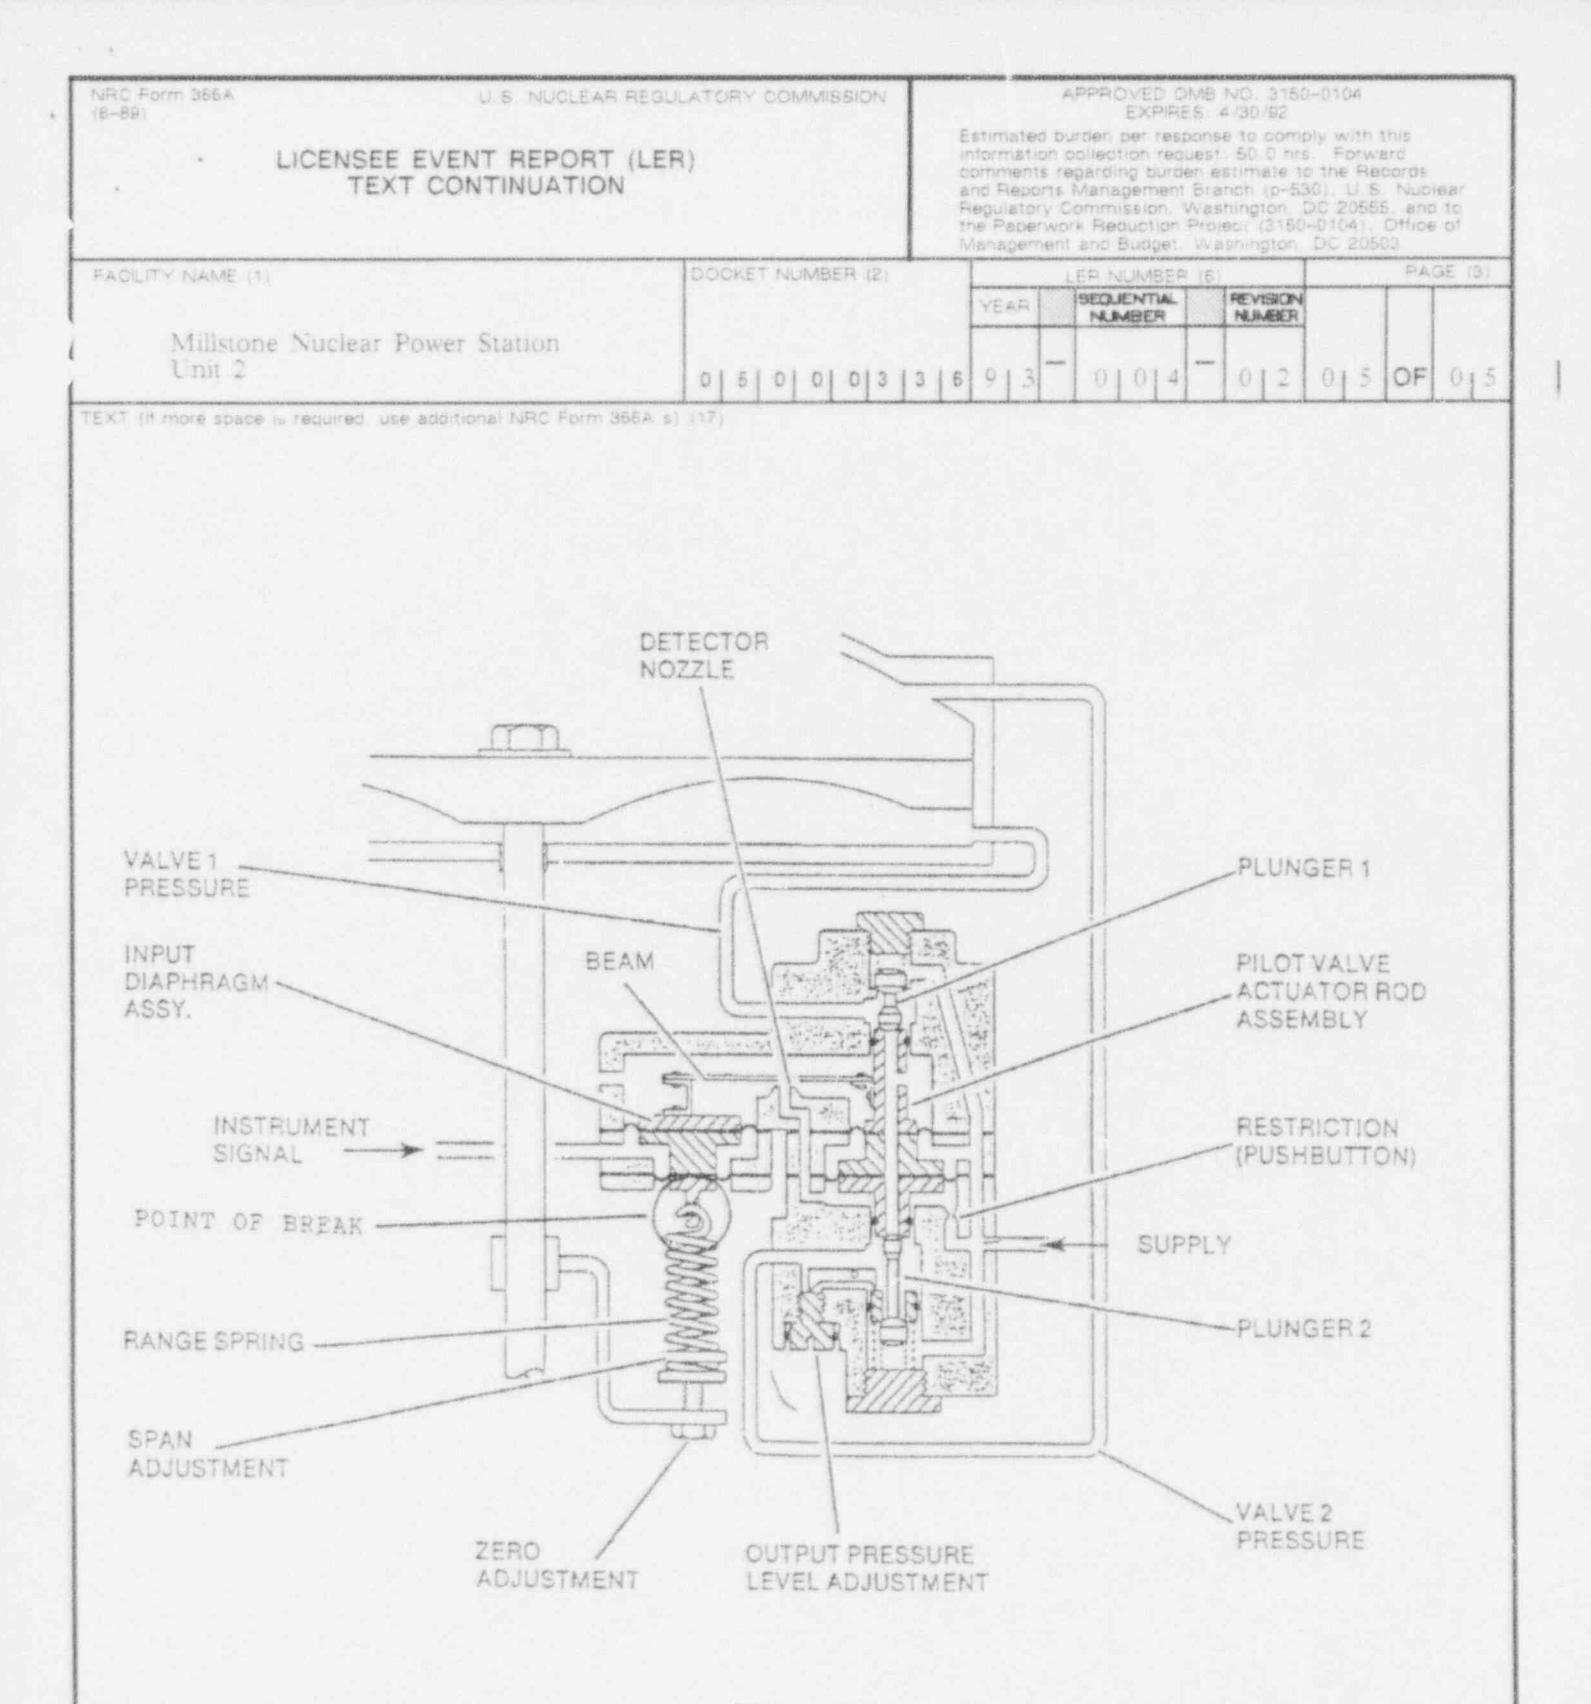
Figure 1 Atmospheric Steam Dump Valve Positioner

The cause of the initiating event on February 22, 1993, was the "A" steam generator ADV failing open. The ADV failed open when the spring attachment fitting broke at the point where the spring attaches to the inner diaphragm assembly. The break at the attachment point resulted from a combination of misalignment of the feedback spring and bending of the range spring attachment (possibly during installation), and positioner vibration during normal plant operation. See Figure 1 for a diagram of the AEV valve positioner.

The valve positioner for the "A" steam generator ADV was replaced and the feedback spring was realigned. The valve positioner for the "B" steam generator ADV was replaced, and the as found feedback spring alignment was satisfactory.

a) The ADV (PMMS)	Positioners have been ad and will be replaced every	ded onto the Produc outage	tion Maintenance Management System
<li>b) All license generatori will affect</li>	ed operators have received s with emphasis placed on level response.	specific classroom t how the differences	raining on the construction of the new steam between the old and new steam generators
In additio steam gen training h upgraded generators transients	on, specific classroom train herator response has been to as been received by all ex- to represent the changes to s. Normal/routine simulate	ing on Main and Au received by all licens cept one licensed op n level control which or training will furthe	exiliary Feedwater Controls emphasizing sed operators and associated simulator erator. The simulator model has been resulted from the replacement of the steam or enhance the operators' response to level
The final	operator is scheduled to re	eceive the specific si	mulator training during the month of July.
