(NRL Memorandum Report 4062)
→ NUREG/CR-0968

Fractographic and Microstructural Analysis of Fatigue Specimens of A302 Grade B Steel Tested in Air at Room Temperature

G. GABETTA AND V. PROVENZANO

September 28, 1979

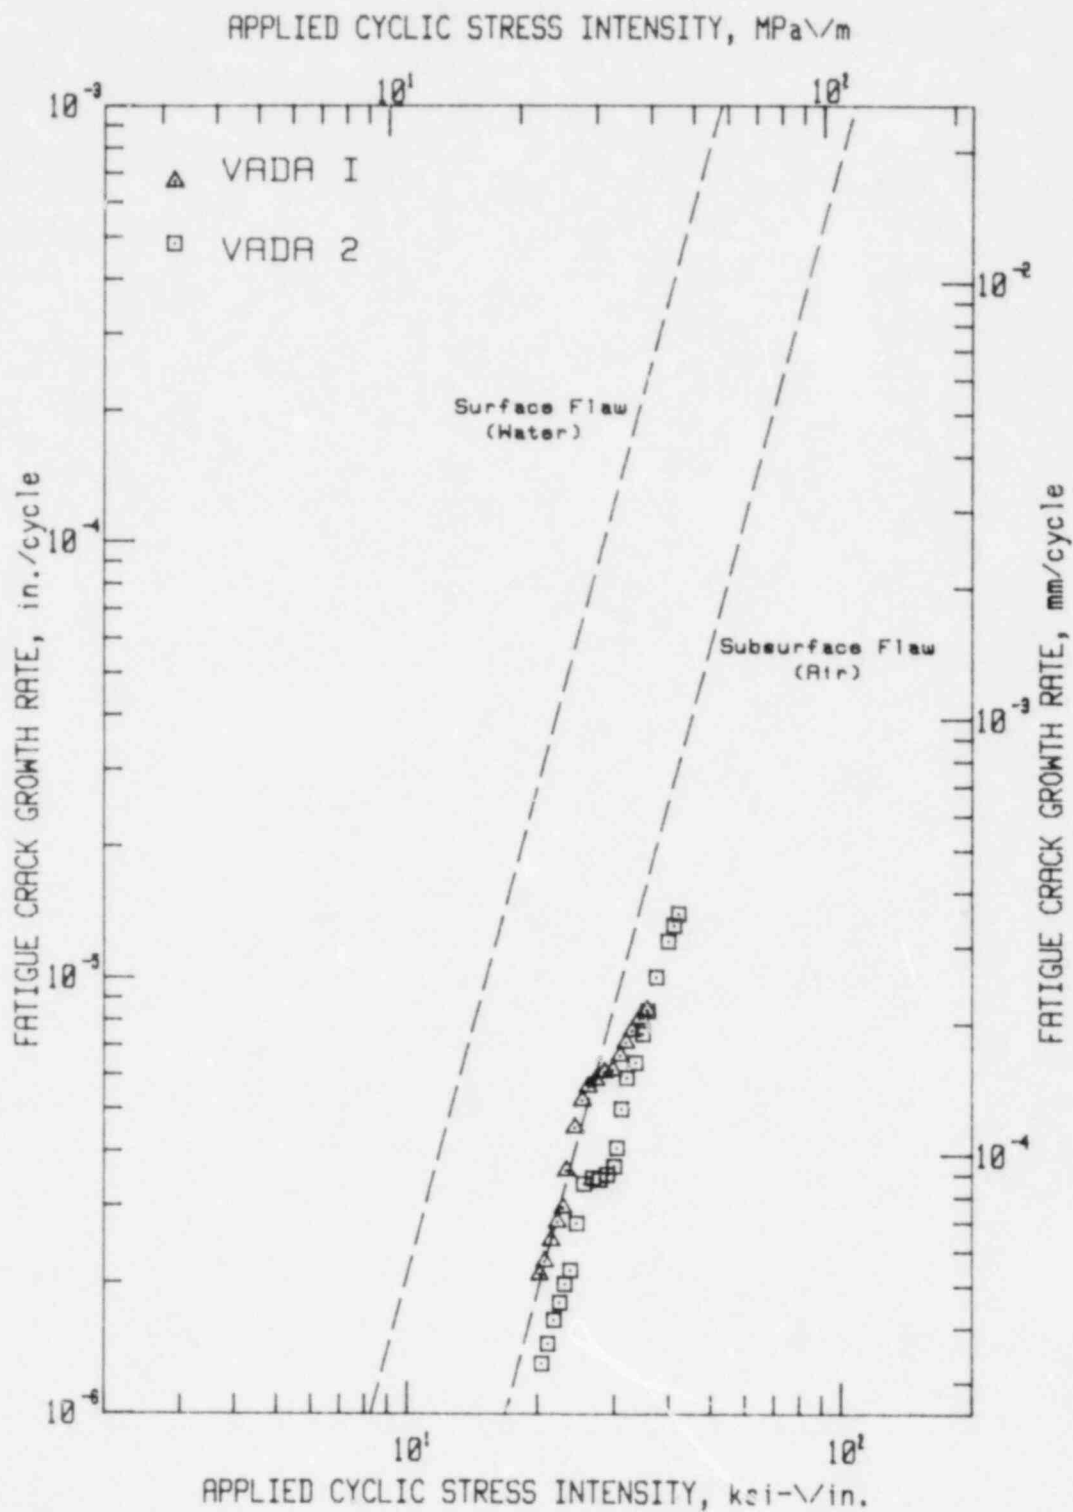
The FCP data obtained from the specimen tests are presented in Figs. 2 and 3. As shown by both figures, all of the crack growth data fell close to the ASME Section XI air line. The crack growth rates for the first set of specimens (Specimen VADA1, cut in the T-L direction, and Specimen VADA2, cut in the L-T direction) ran roughly parallel to each other for most of the ΔK range, with the T-L specimen (VADA1) exhibiting the higher crack growth rate (Fig. 2). The crack growth rates for the second set of specimens (VAB1, cut in the T-L direction, and VAB2 cut in the L-T direction) were about equal for ΔK values below 33 MPa \sqrt{m} (30 ksi $\sqrt{in.}$). Above this ΔK value, the crack growth rate of the T-L specimen

Fig. 2 Fatigue crack propagation data of A302-B ferritic steel tested in air at room temperature both for the T-L (VADA1) and L-T (VADA2) directions with the higher starting ΔK value ($22 \text{ MPa}\sqrt{\text{m}}$).

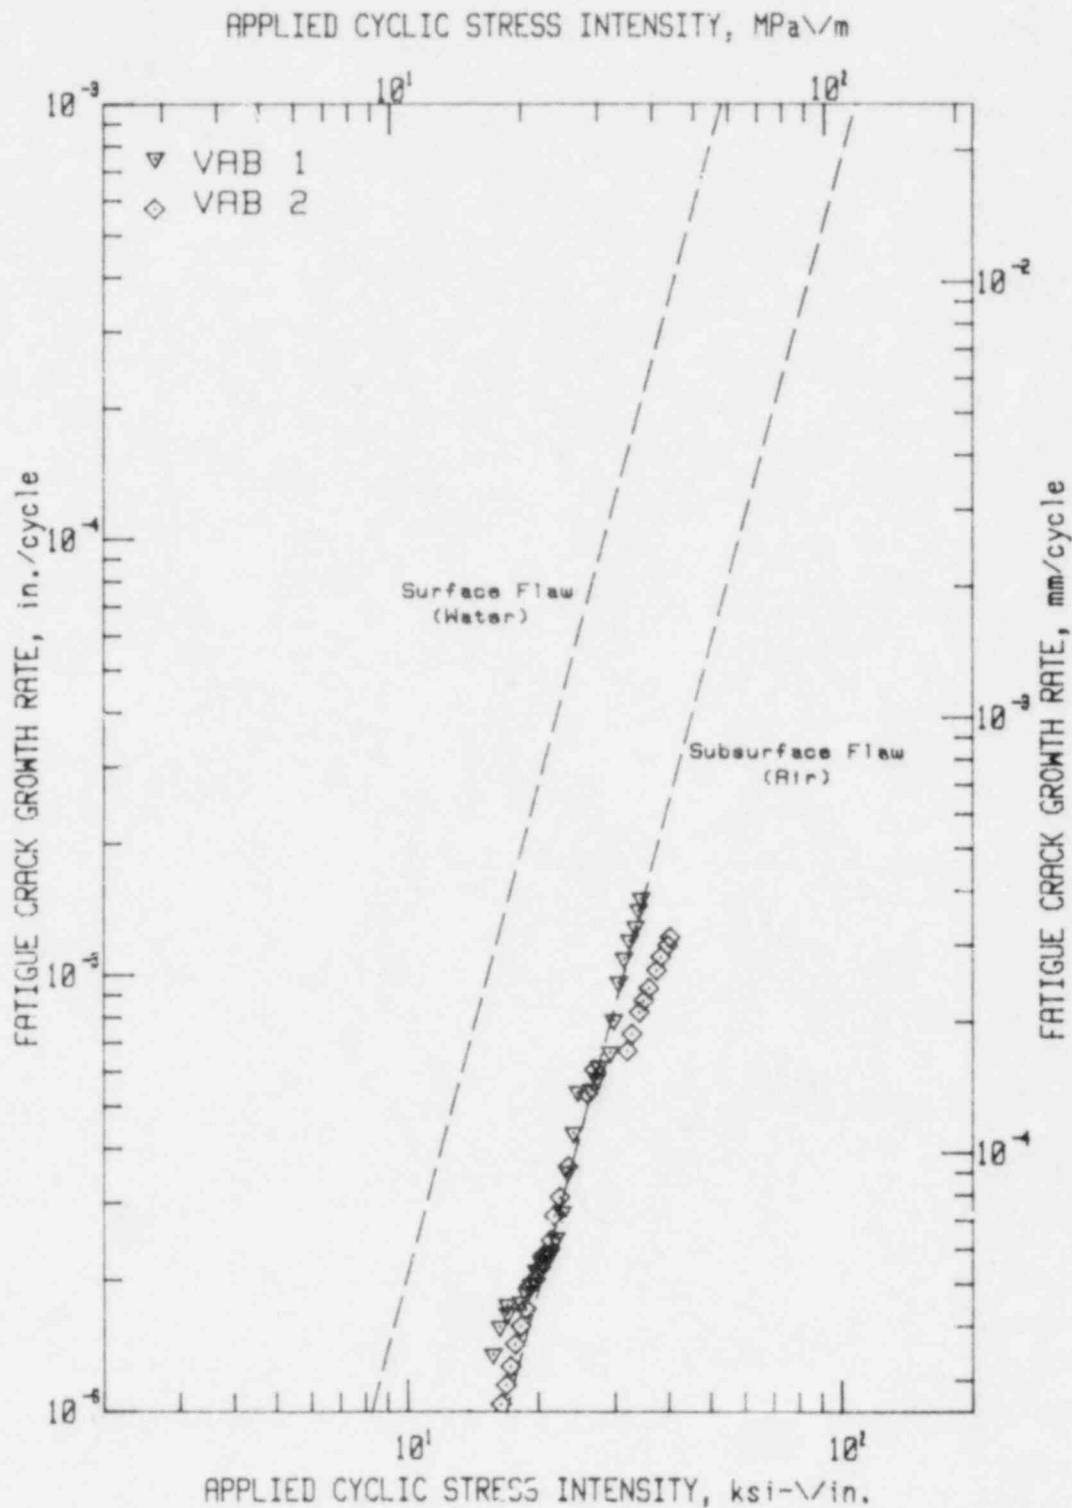
(VAB1) was higher (Fig. 3). The difference in the crack growth behavior in the two sets of specimens was not large. It is interesting to point out however, that a lower starting ΔK resulted in a higher growth rate (the starting ΔK for VAB1 and VAB2 was $16.5 \text{ MPa}\sqrt{\text{m}}$ while for VAD1 and VAD2 it was $22 \text{ MPa}\sqrt{\text{m}}$). Since the basic objective of the mechanical tests was to investigate the effect of specimen orientation on the fatigue behavior the effect of starting ΔK on FCP will not be critically evaluated in this report.

Fig. 3 Fatigue crack propagation data of A302-B ferritic steel tested in air at room temperature both for the T-L (VAB1) and L-T (VAB2) directions with the lower starting ΔK value (16.5 MPa√m).

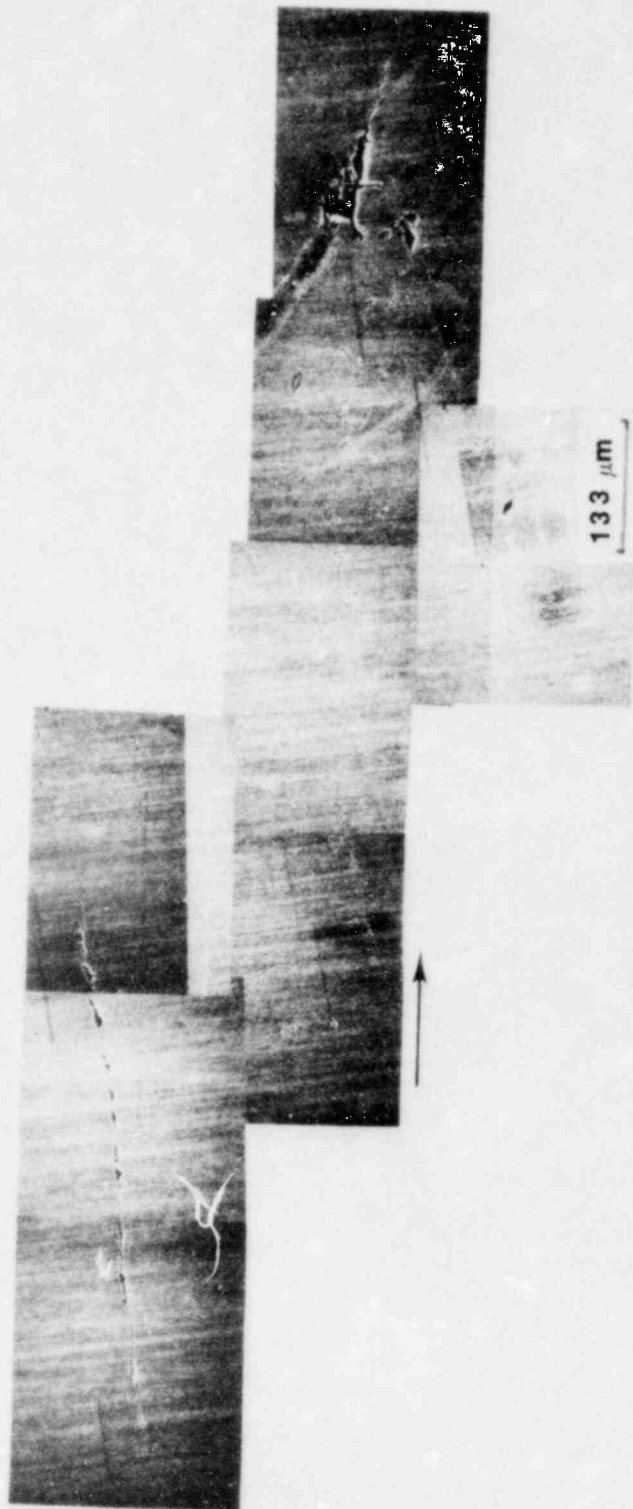
The relationships between the crack path and the microstructure are illustrated by the photomicrographs shown in Figs. 4 and 5. The photomicrographs in Fig. 4 refer to specimen VAB1 (T-L) while the micrographs presented in Fig. 5 refer to specimen VAB2 (L-T). The two crack profiles show that extensive crack branching is present in both specimens. The degree of crack branching, as indicated by the secondary cracks, becomes more pronounced in the high ΔK region. In the region of high ΔK , where the crack propagation rate is higher, the microcracks associated with crack branching are smaller in size and required a higher magnification to reveal their presence. The reduction in the average size of the microcracks in the high ΔK regime did not appear to have affected the crack propagation behavior. Crack branching usually has the effect of slowing the crack propagation rate by distributing the stresses at the crack tip; this did not seem to have been the case in these two specimens.

Fig. 4 Fatigue crack profile close to the crack tip of VAB1, T-L specimen. Arrow indicates direction of macroscopic crack propagation. Series of SEM micrographs show extensive microbranching near crack tip region; some branching runs perpendicular to main crack path.

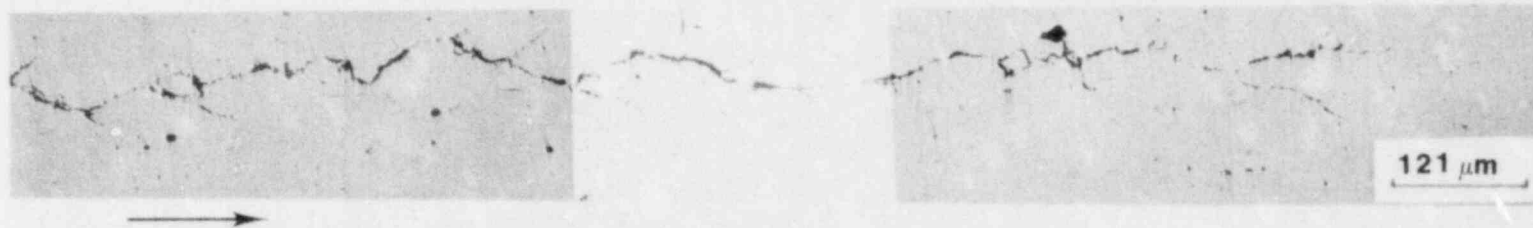
Fig 5 Fatigue crack profile close to the crack tip of VAB2, L-T specimen. Arrow show direction of macroscopic crack propagation. As in the case of the specimen cut in T-L direction, series of SEM micrographs show extensive micro-branching along the main crack path.

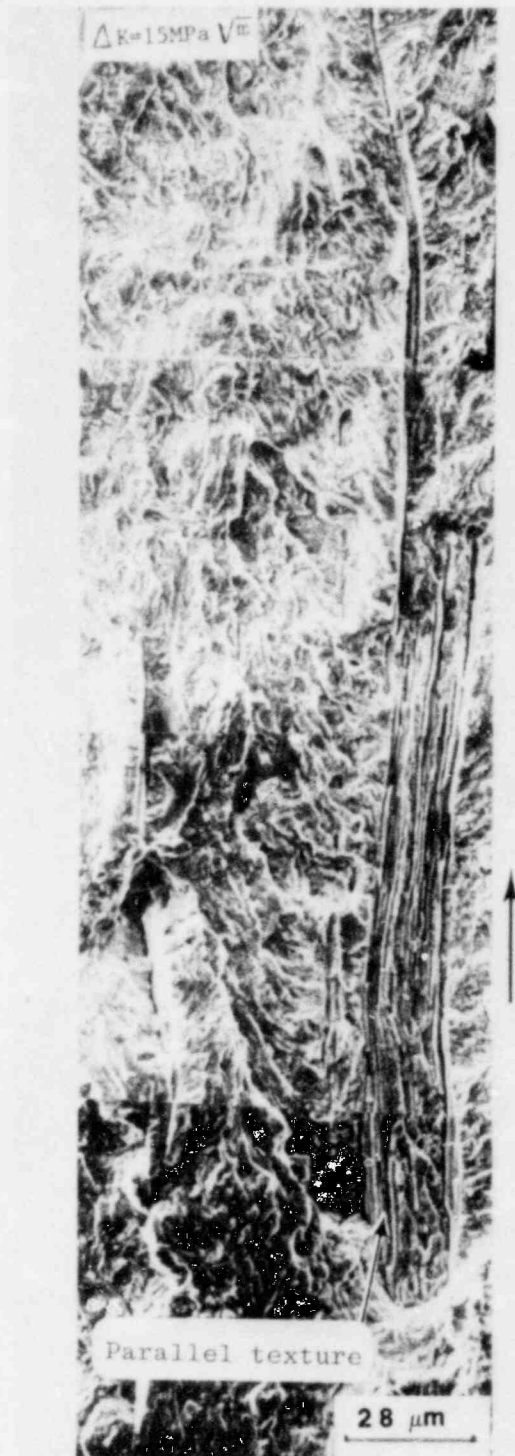
The significant fractographic features observed in the SEM examinations of fracture surfaces are summarized by the micrographs presented in Figs. 6-8. In the T-L specimen (VAD1), a microstructural texture running parallel to the macroscopic crack propagation direction is present (Fig. 6). In the second set of tests the T-L specimen (VAB1) shows an increase in the crack growth rate at ΔK values of $25\text{-}30 \text{ MPa}\sqrt{\text{m}}$ (Fig. 3) that coincides with the appearance of the parallel texture in the fracture surface (Fig. 7). In the L-T specimen (VAB2), whose corresponding crack growth rate was lower the parallel texture was absent. The failure mode for T-L specimen was transgranular with secondary cracking perpendicular to the macroscopic crack propagation direction (Fig. 8). Similar fractographic features have been observed in other ferritic steels tested under analogous experimental conditions [5,6].

Fig. 6 Fracture surface of A302-B ferritic steel specimen cut along T-L direction (VADAI) tested in air at room temperature with higher starting ΔK value. Arrow shows direction of macroscopic crack propagation. SEM micrographs clearly show inclusion bands in the fracture surface that run parallel to the macroscopic crack propagation direction.

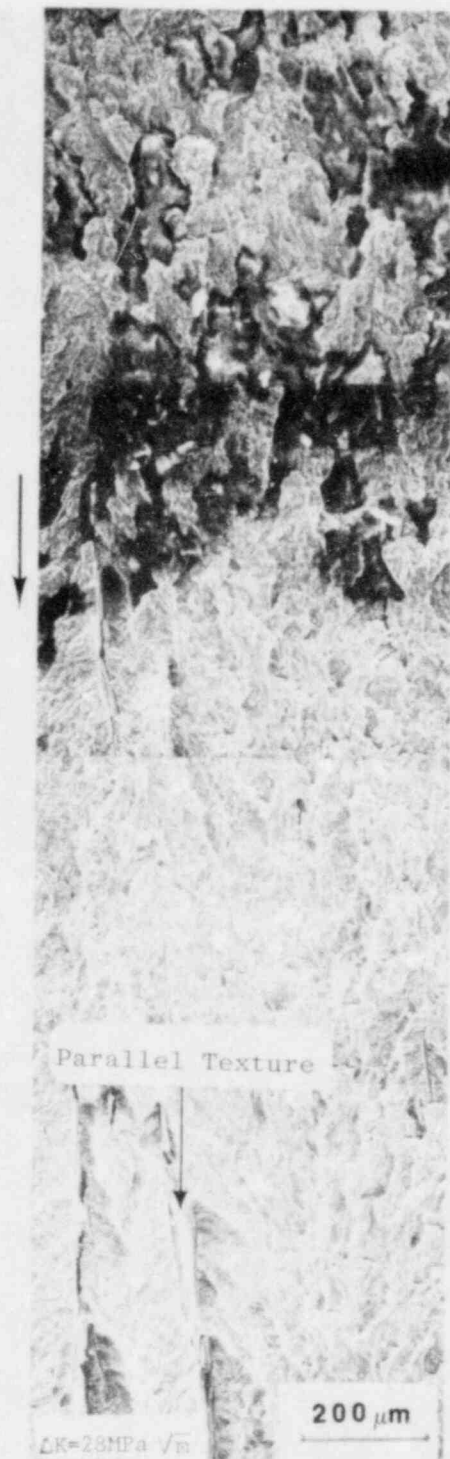
As observed above, the fracture surface of T-L specimen (VAB1) is characterized by a parallel texture when ΔK exceeds a minimum value in the range of $25\text{-}30 \text{ MPa}\sqrt{\text{m}}$. This texture is thought to arise from inclusion bands that are present in the rolled material. These inclusions became elongated during the rolling procedure. To see if the parallel texture is indeed the result of the inclusion bands, the fracture surface was analyzed with an X-ray microanalyzer that is attached to an AMR 1000 scanning electron microscope. The results of the X-ray microanalysis are summarized in Fig. 9. The analysis confirms that the parallel features were manganese-sulfide inclusion bands.

Fig. 7 Fracture surface of A302-B ferritic steel specimen cut along T-L direction (VAB1), tested in air at room temperature with the lower starting ΔK value. Arrow shows direction of macroscopic crack propagation. Series of SEM micrographs show transition region corresponding to 25-30 $\text{MPa}\sqrt{\text{m}}$ ΔK value, where inclusion bands begin to appear in fracture surface.

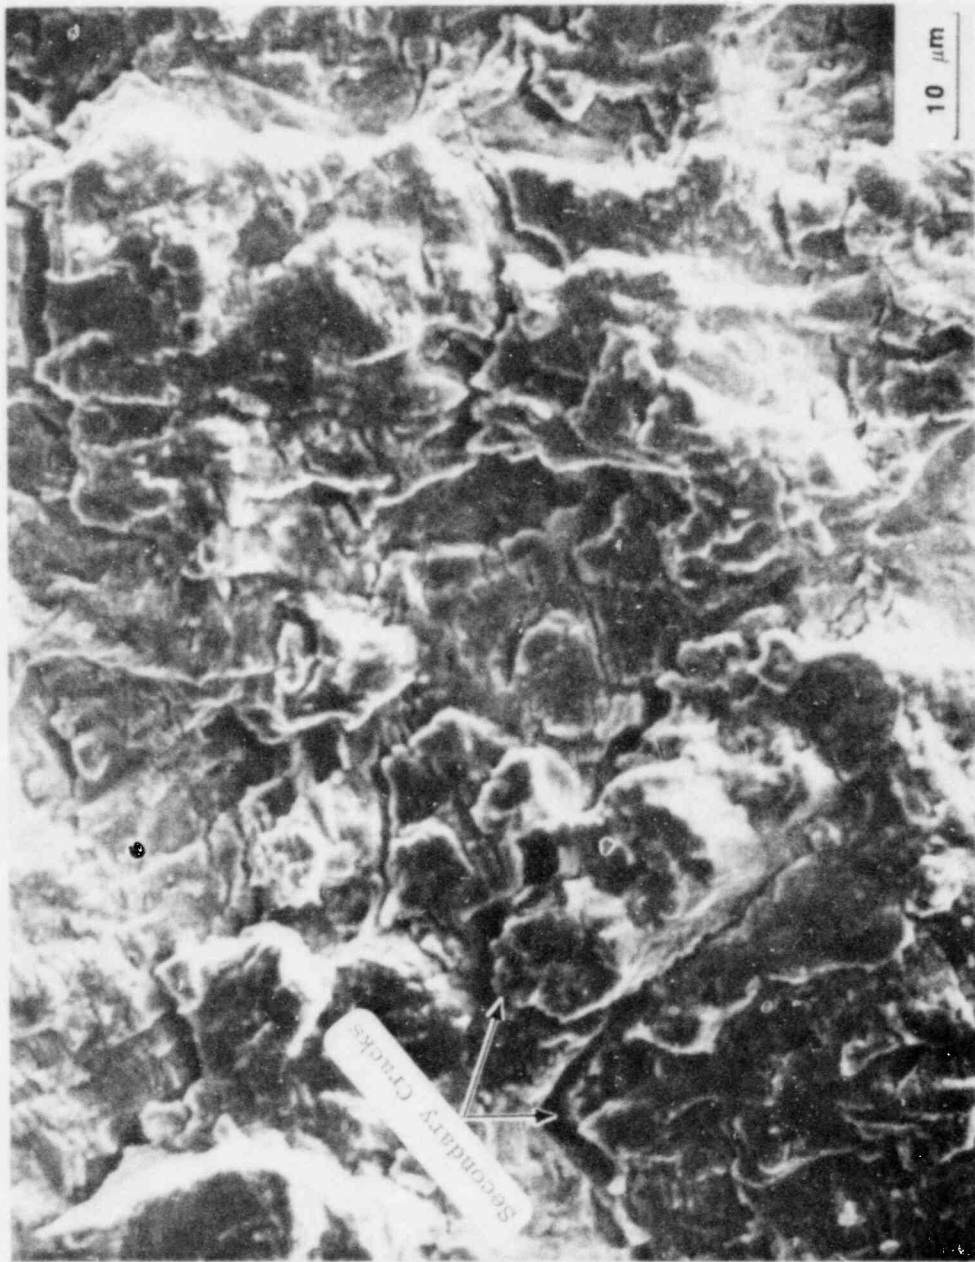
Fig. 8 Fracture surface of A302-B ferritic steel specimen cut along the L-T direction (VADA2), tested in air at room temperature with higher starting K value. Arrow shows direction of macroscopic crack propagation. SEM micrographs illustrate transgranular failure mode with fatigue striations and extensive secondary cracking perpendicular to main crack path. These fractographic features are typical of ferritic steels tested under analogous conditions.

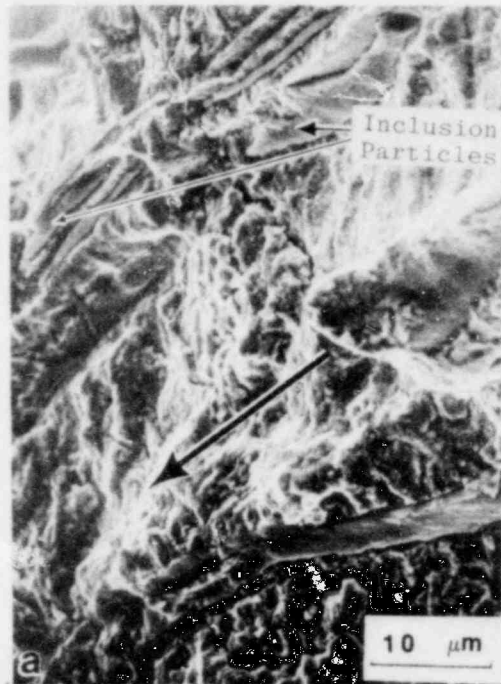
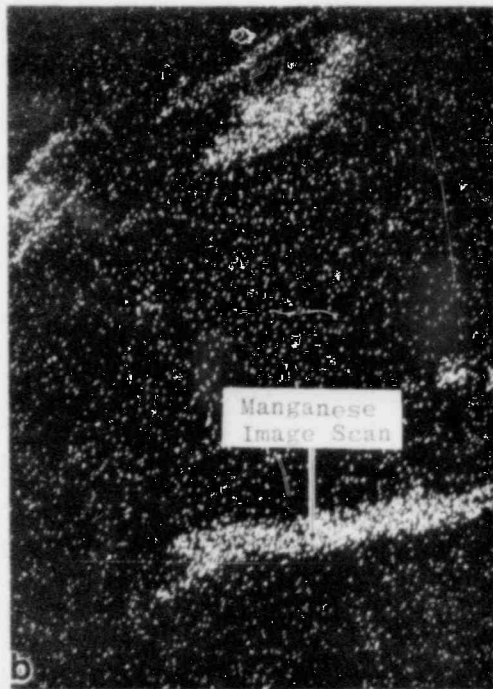
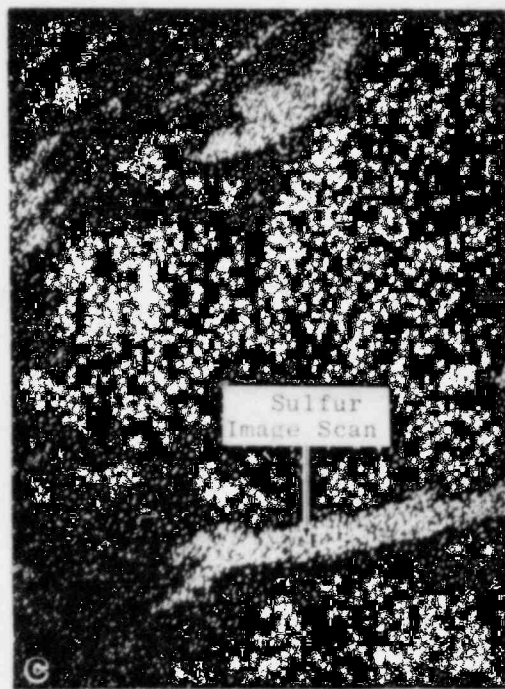
It appears, therefore that inclusion bands are the primary cause for the increase in the crack growth rate above a minimum ΔK value. It is believed that a preferential decohesion process occurs at the inclusion-matrix interface, which become activated above some threshold stress level and resulted in higher crack growth rates. This threshold stress is probably a measure of the bond strength between the inclusion and the material matrix. The inclusion effect is directional,

Fig. 9 Fracture surface and corresponding energy dispersive X-ray point maps of A302-B ferritic steel specimen cut along T-L direction (VAB1). Arrow shows macroscopic crack propagation direction. SEM micrograph on top of the figure (micrograph a) clearly shows inclusion bands in the fracture surface that run parallel to the macroscopic crack propagation direction. Lower two micrographs are image scans obtained through energy dispersive X-ray microanalysis showing that inclusion bands are manganese (left) and sulfur (right) second-phase particles.

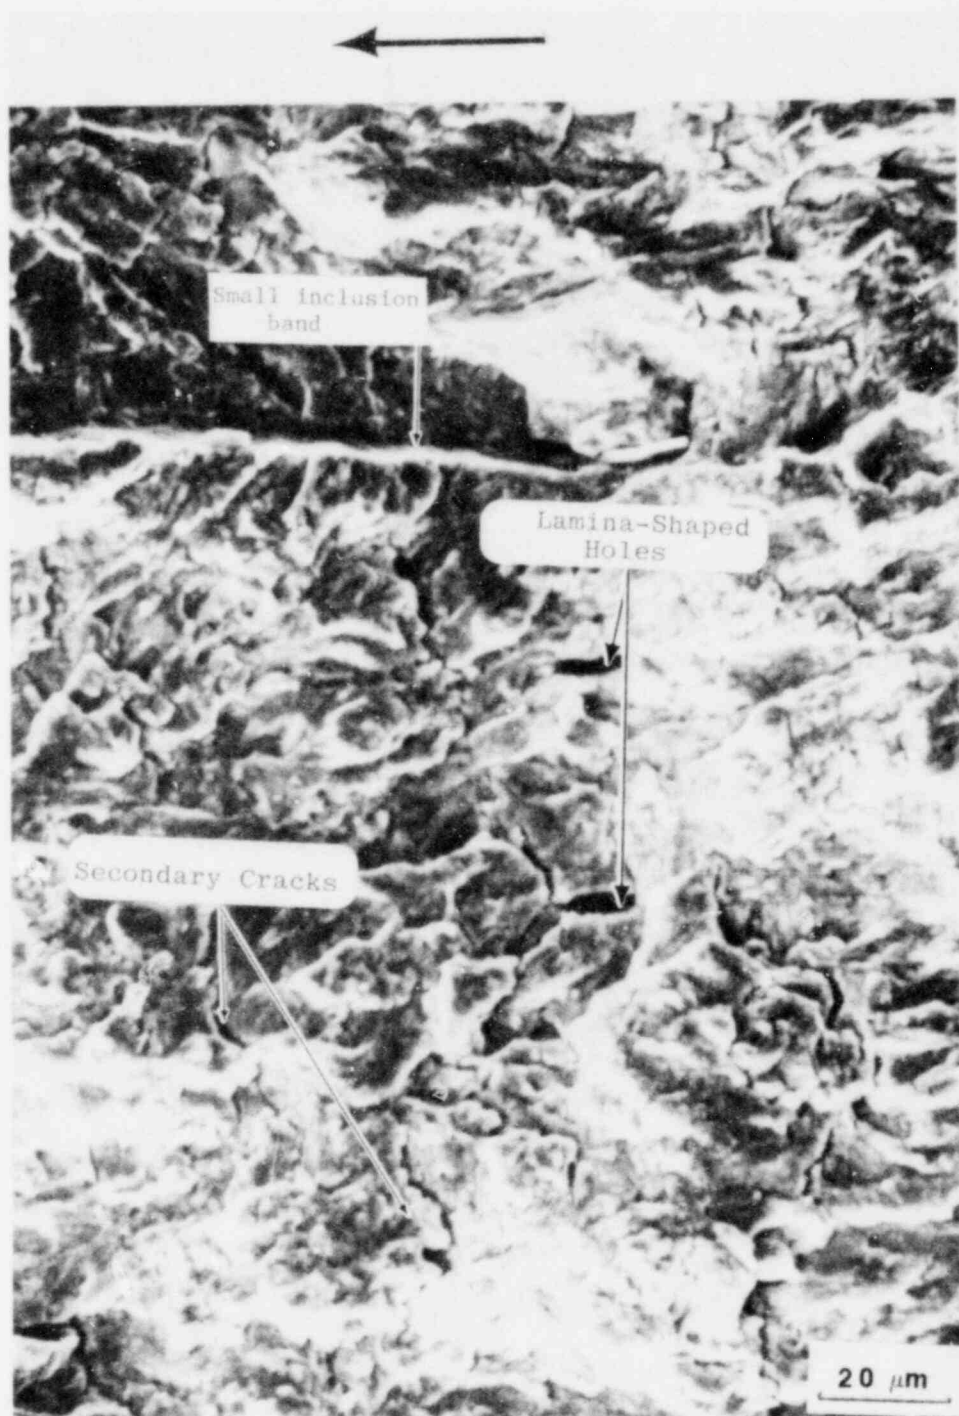
The SEM micrograph shown in Fig. 10 typifies the fractographic features observed in the L-T specimens (VADA2 and VAB2). As illustrated by the micrograph, only a small inclusion band was present though some lamina-shaped holes were seen. These holes are believed to represent the inclusion bands that are oriented perpendicular to the crack plane. Since most of the inclusion bands in the L-T specimens are preferentially oriented perpendicular to the main crack path, the few bands that resided along the crack plane did not seem to have had an affect on crack propagation behavior.

Fig. 10 Fracture surface of A302-B ferritic steel specimen cut along L-T direction (VADA2) tested in air at room temperature. Arrow shows direction of macroscopic crack propagation. SEM micrograph shows small inclusions and lamina-shaped holes present in the fracture surface. The lamina-shaped holes are believed to represent the inclusion bands that are oriented perpendicular to main crack plane.
