#### NEW ENGLAND POWER COMPANY

HARRIMAN DAM

SUMMARY OF STATIC AND SEISMIC STABILITY ANALYSES

MAY 1982

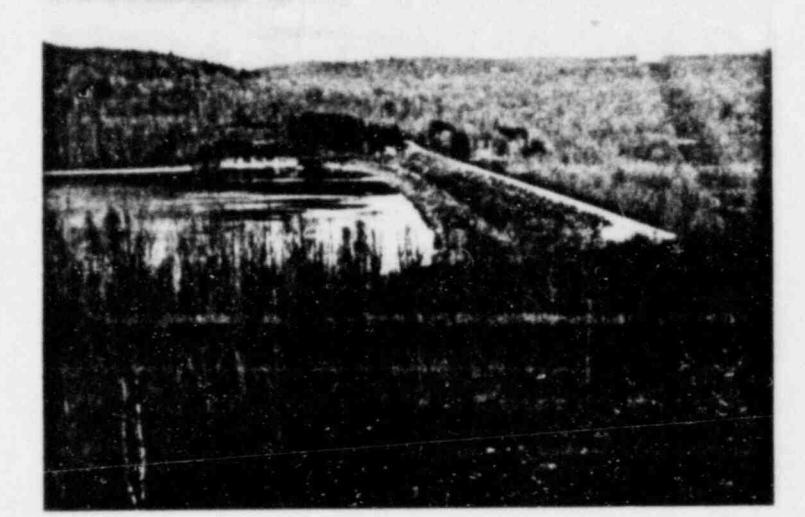
PHOTO 1

Crest of dam. View from left (East) abutment, Fall 1979.
