SUPPLEMENTAL REPORT OF ULTRASONIC INDICATIONS IN THE TOP HEAD WELD VC-TH-1-2 AT JA FIT2PATRICK POWER STATION

June 15, 1990

General Electric Nuclear Energy 175 Curtner Avenue San Jose, California 95125

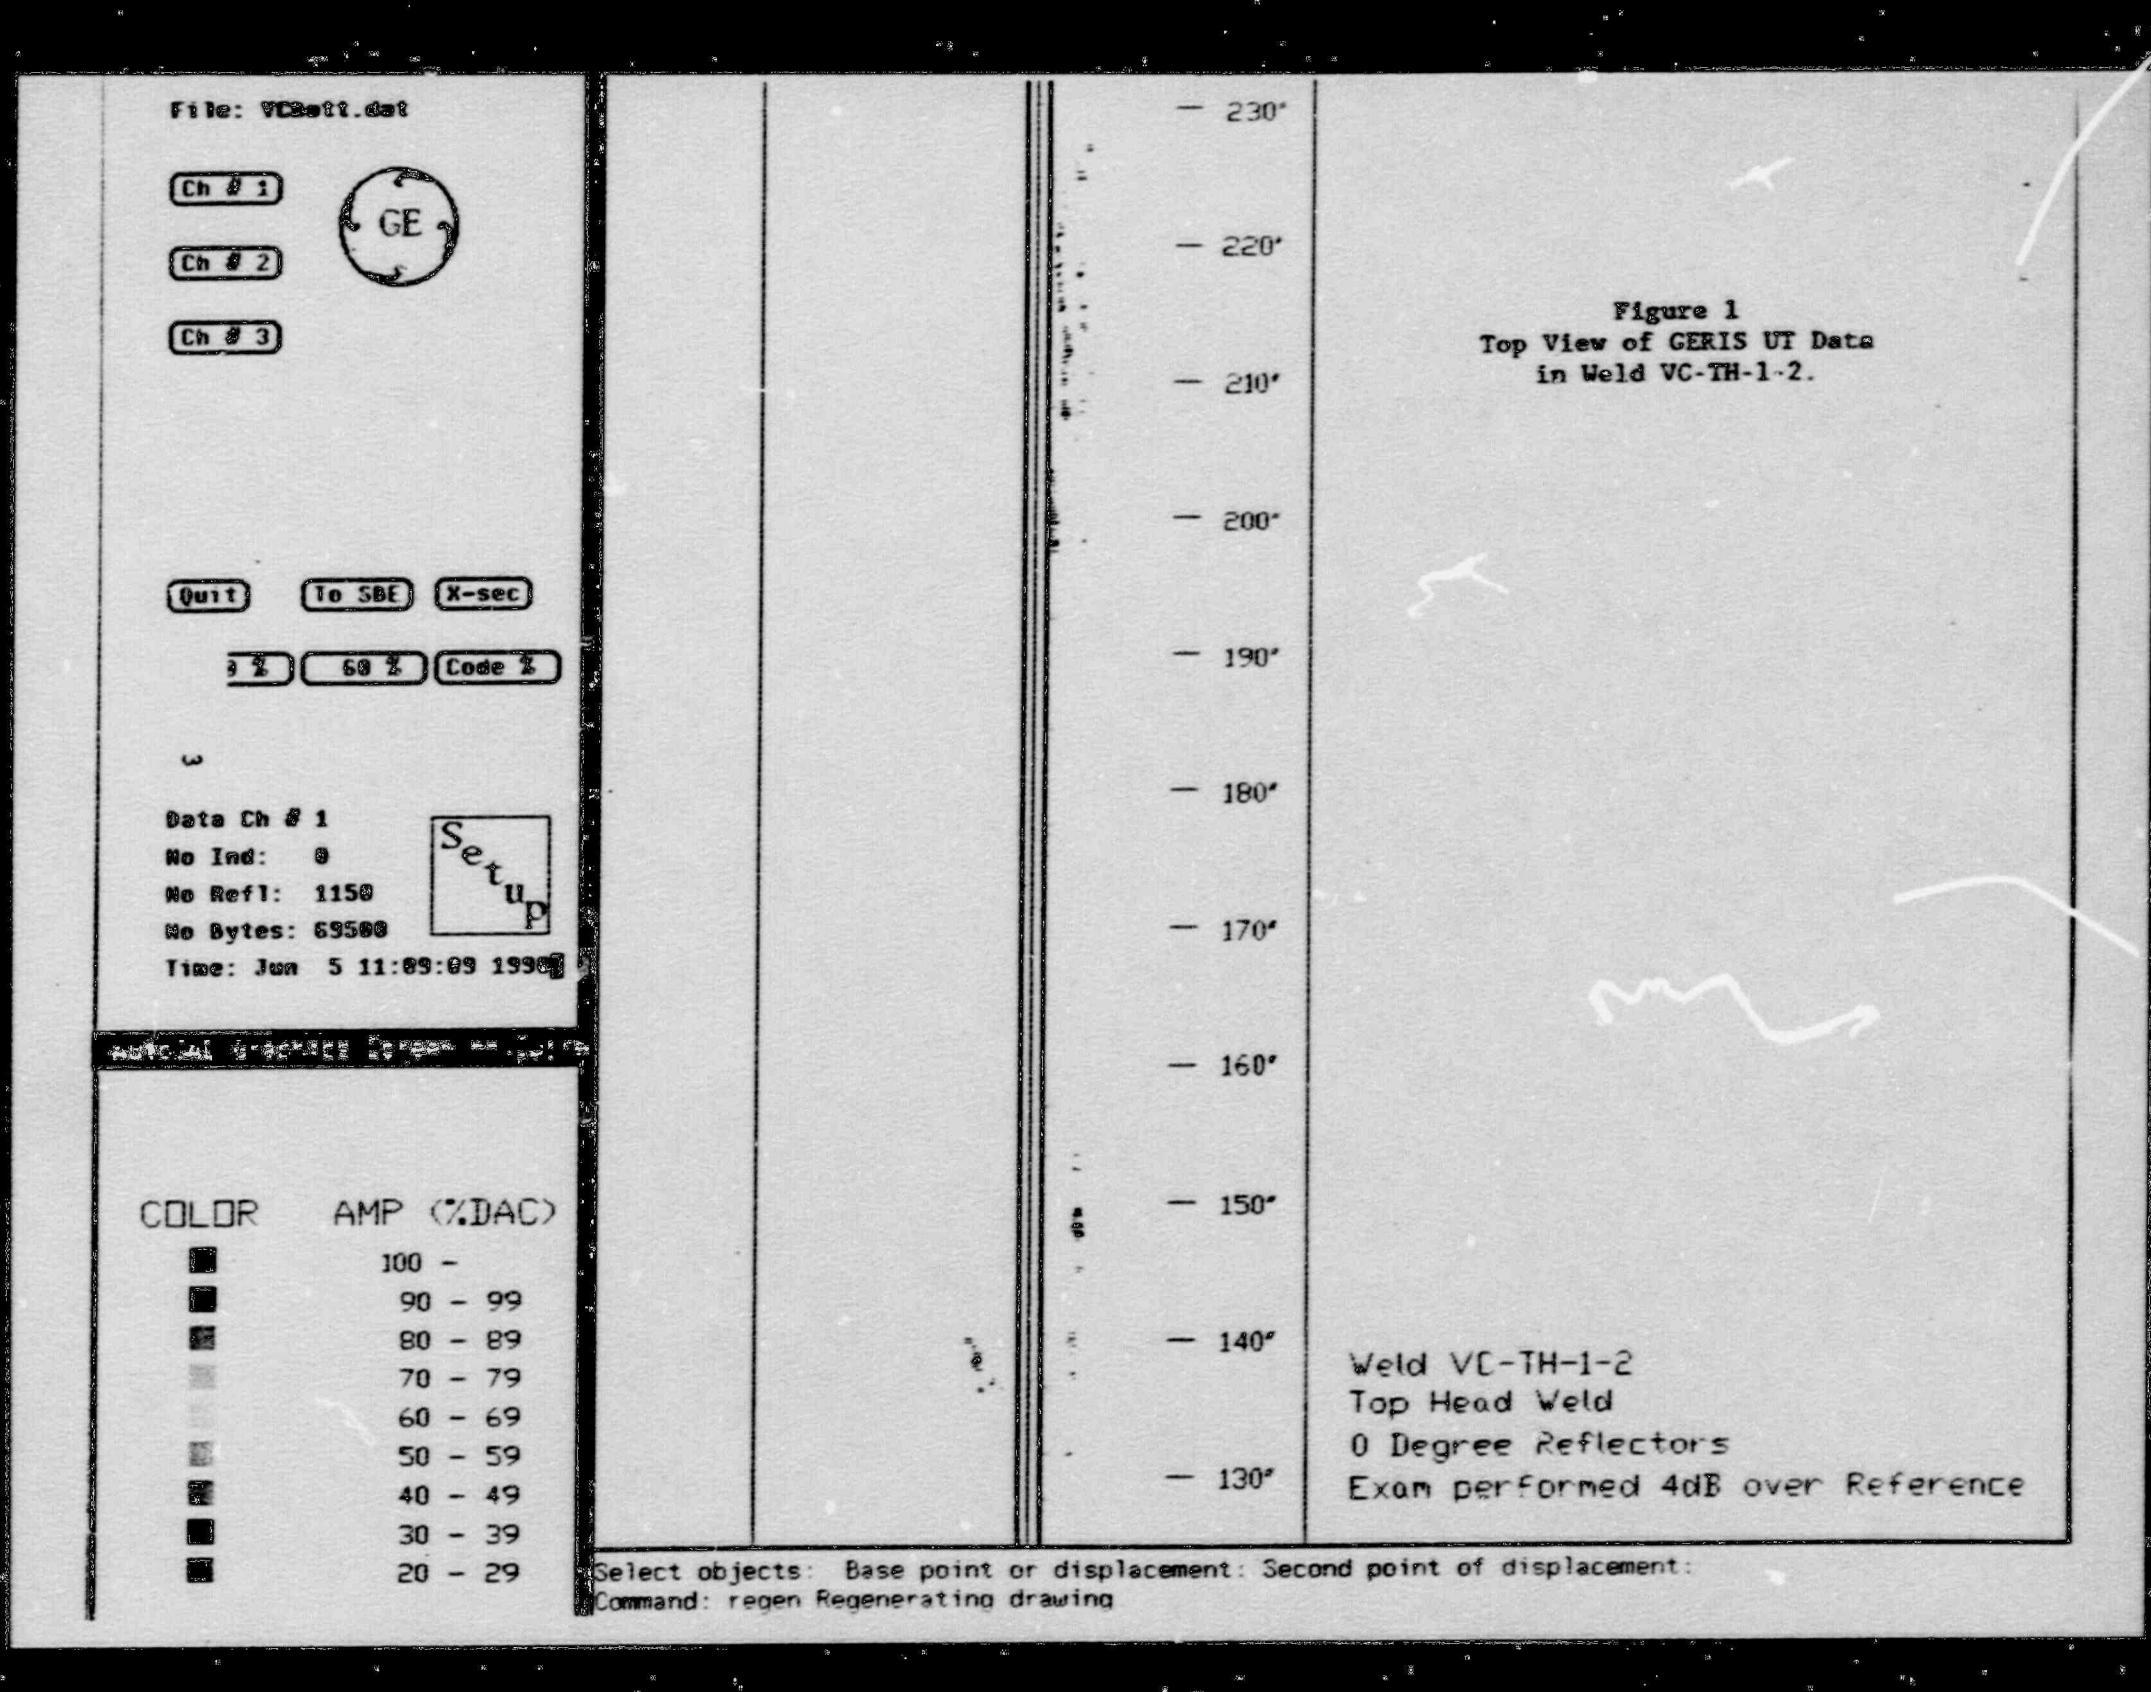
GERIS recorded base material, mid-plate, 0° indications sporadically over the entire area of the scanned area. Figure 1 is a top view (C-scan) of the data recorded with GERIS. The GERIS data does not show the reflectors to be adjacent to the weld where the RL sizing was performed, however, as mentioned before, a supplemental high sensitivity manual 0° examination did. The area where the sizing was performed was from 130" to 155" on Figure 1. Figure 2 illustrates a cross-sectional view of all the 0° GERIS data recorded along 80" of length of top head weld VC-TH-1-2. The base material to the right side of the weld is the dollar plate, and the torus plate is on the left side. The reflectors vary in depth from 0.85 inches to 3.45 inches from the outside surface of the top head.

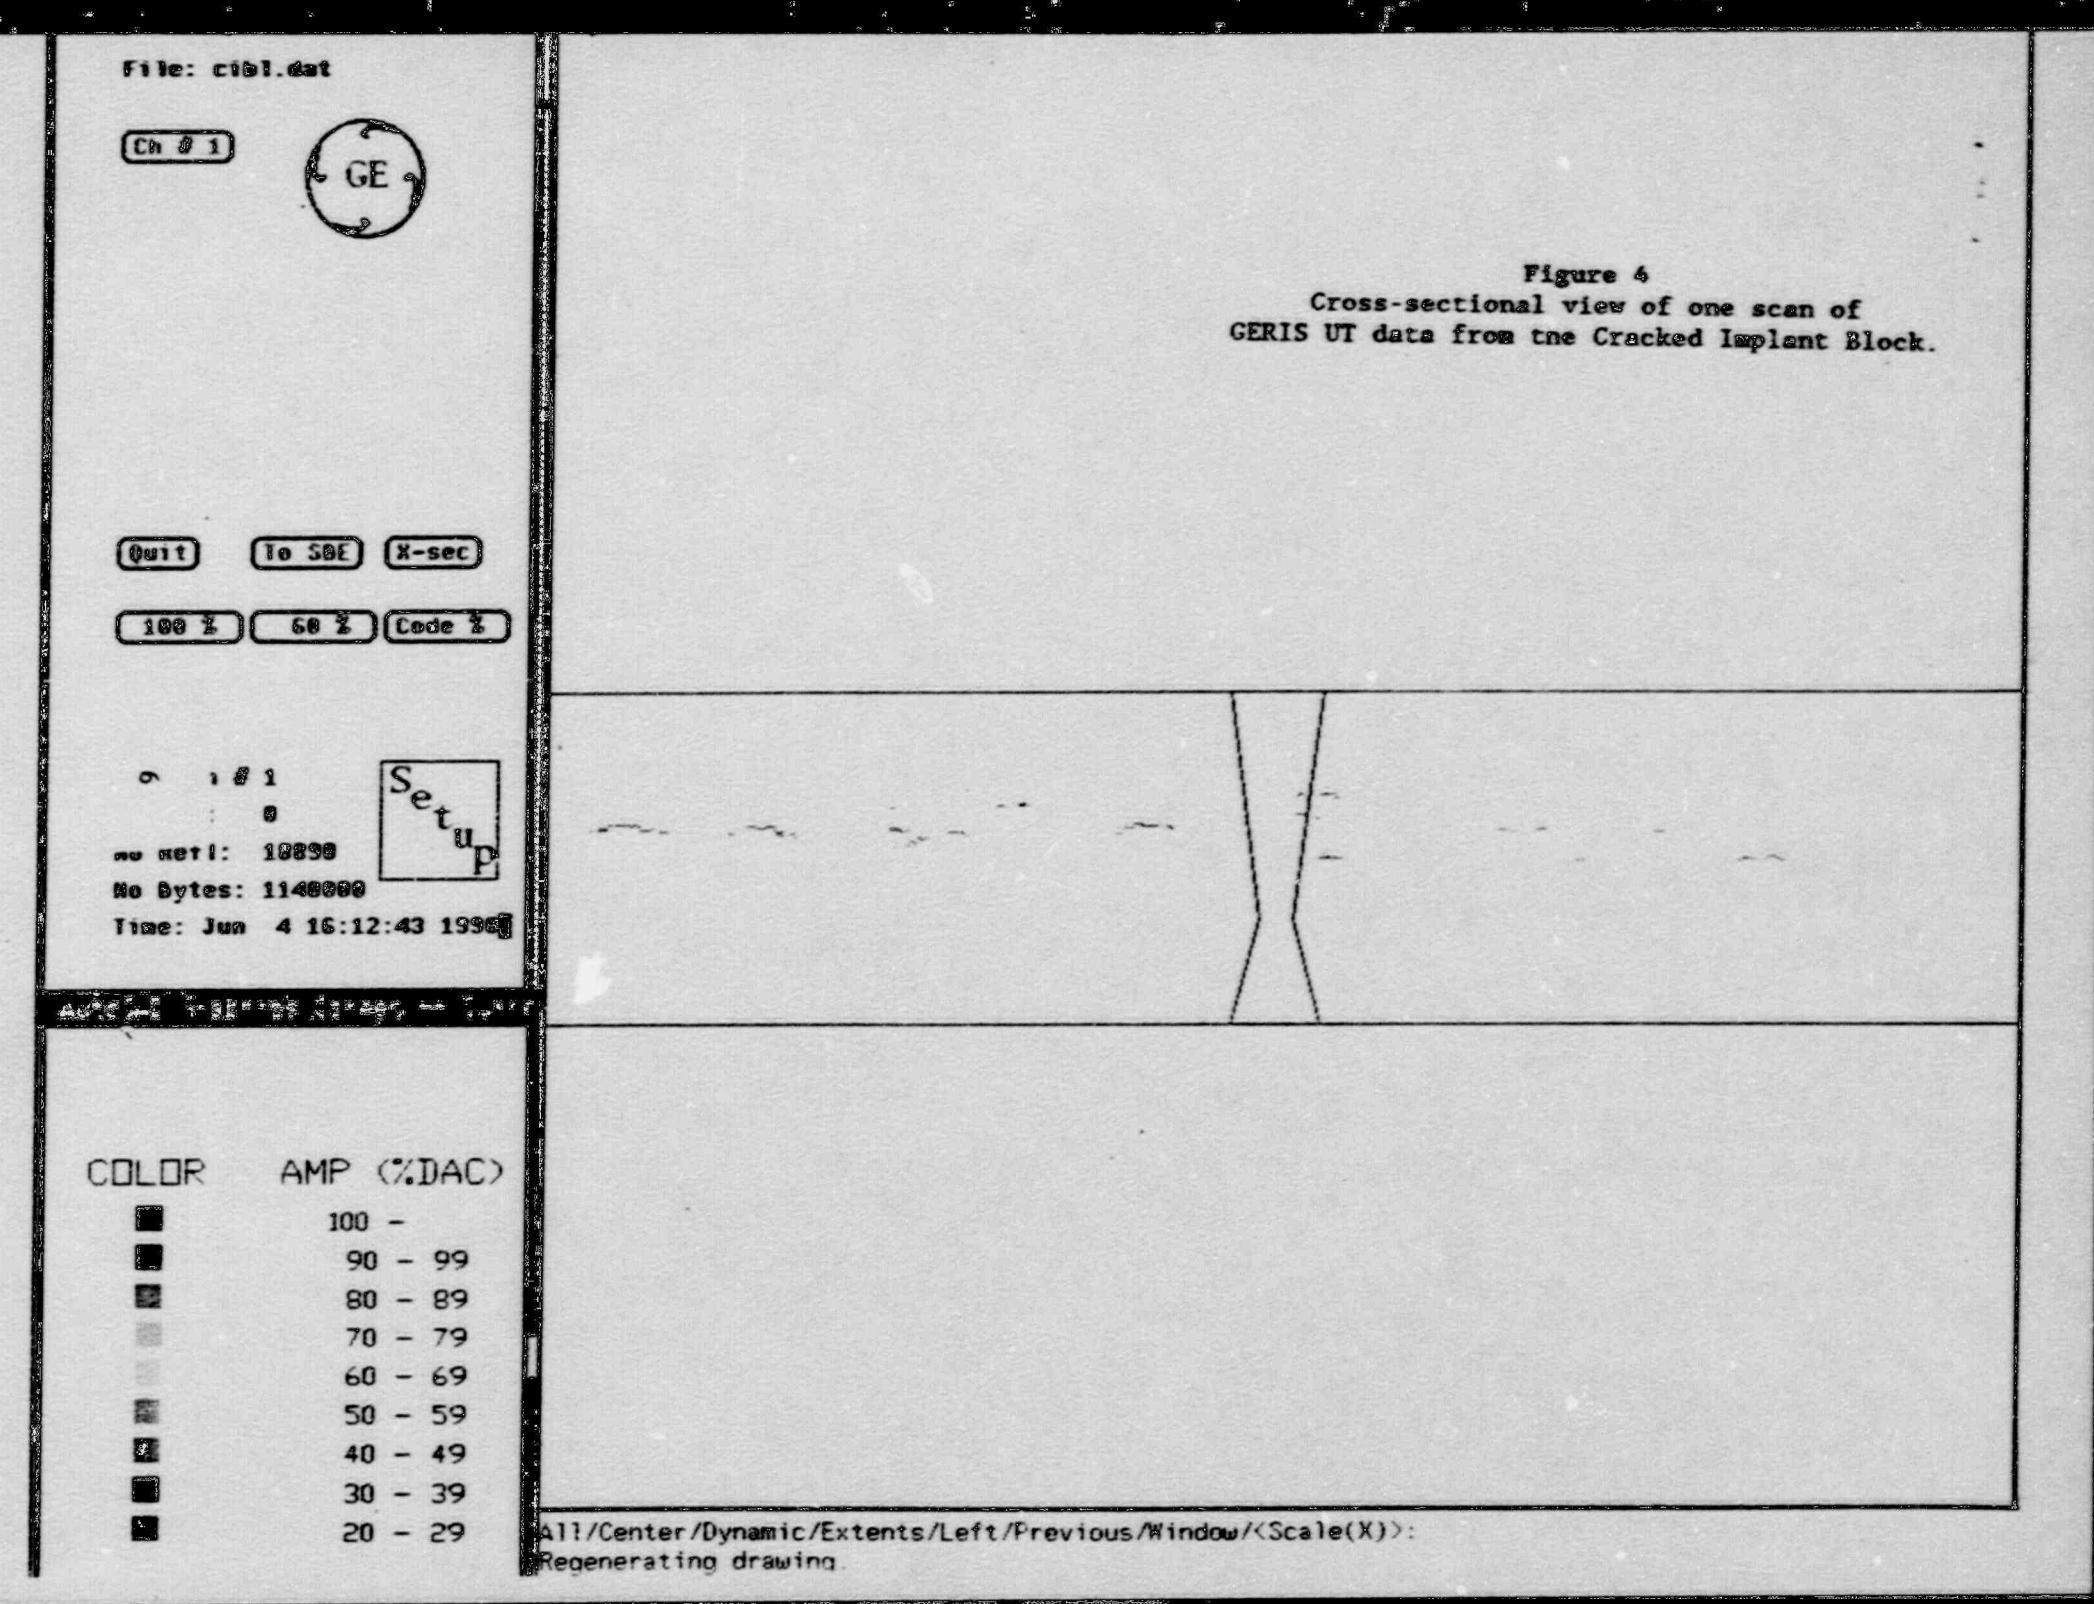
The proximity of the individual reflectors and the distribution of the reflectors of the indications within the volume of material are consistent with plate segregates or small inclusions. To illustrate this fact, Figure 4 is a cross-sectional view of one scan line of data recorded at 20 dB (10 times) above calibration sensitivity. Note that areas exist that consist of densely packed reflectors of varying depths. The ultrasonic data plots of these segregates appear larger than their actual size due to transducer size and ultrasonic beam divergence. Although these segregates do reflect sound due to their metallurgical properties, they also allow some sound to pass through.

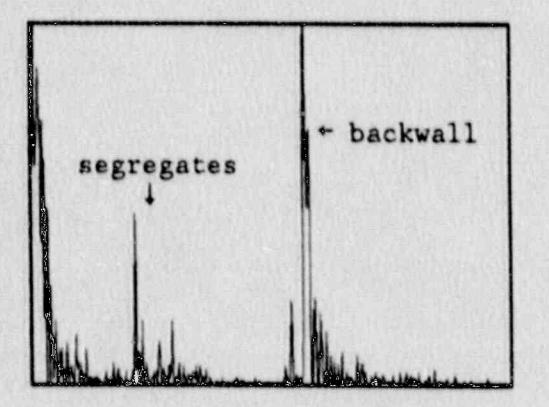
Manual UT data using a 5 MHz, 1" diameter, straight beam transducer, was taken at 3 locations ranging from .3 inches to 1.0", from the right side of the weld centerline. Figures 5 thru 7 are the digitized A-scans taken at these locations. Mid-plate segregates that were detected ranged in depth from 1.5" to 3". The sensitivity for this test was 20 dB over a backwall signal set at 80% FSH where no mid-plate segregates were present. The amplitude of these segregates in this test was less than one half of the amplitude of the backwall and in nc case observed resulted in a complete loss of back reflection. A complete loss of back reflection is a part of the Code basis for rejection of such indications.

Figure 5 0° A-scan .3" from Ref.

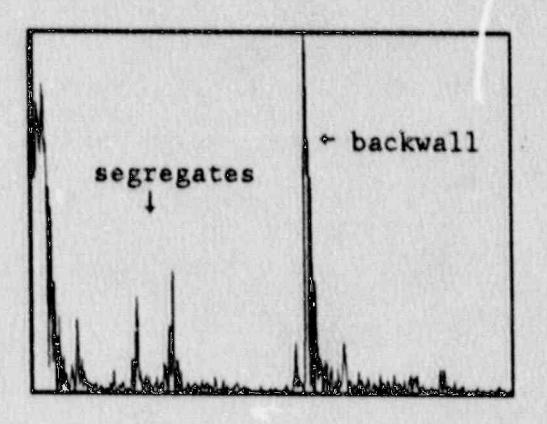
Figure 6 0° A-scan .8" from Ref.

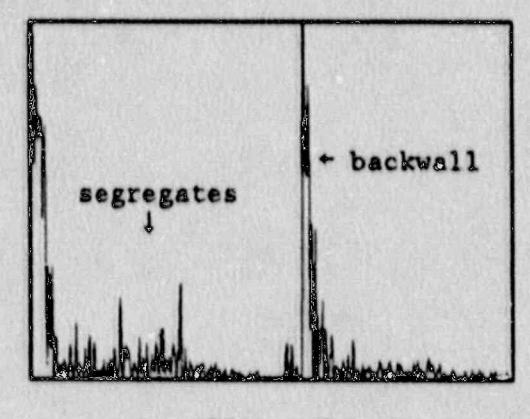
Figure 7 O' A-scan 1.0" from Ref.

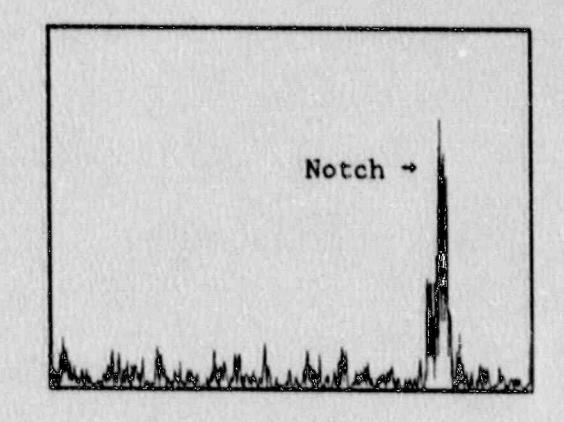
The ultrasonic instrument was then calibrated with a dual element 2 MHz 45° RL transducer. The sweep was set at 5" in depth using the side-drilled holes in a 4" ASME Code calibration block. The sensitivity was set with the 2% of T notch at 80% FSH (full screen height) as shown in Figure 8.

Figure 8 45° RL A-scan of Calibration Block Notch

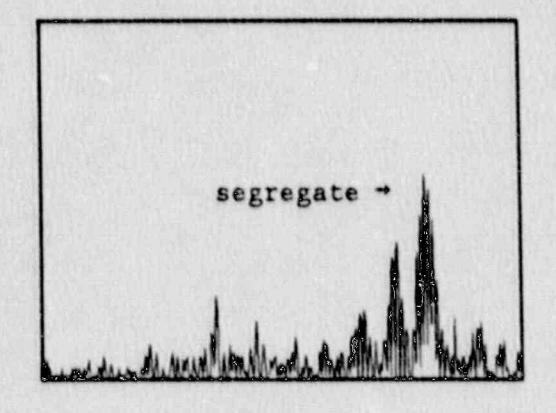
The area, where the 0° manual ultrasonic data (Figures 5 thru 7) was taken, was scanned with the 45° RL. At reference sensitivity a segregate was detected with the transducer at 1.6" from the weld centerline. The sweep position on the CRT screen showed 4" of depth as shown in Figure 9. With a 45° RL transducer a 23° shear wave component exists. The segregate detected was detected by the shear wave component. Since the velocity of longitudinal waves is 1.8 times greater than that of shear waves, and the refracted angle is twice that of the shear wave, the reflector appears to be 4" deep instead of the actual depth of 3". Figure 10 is a cross-sectional plot of the segregates showing longitudinal and shear wave components.

Figure 9 45° RL 1.6" from Ref.

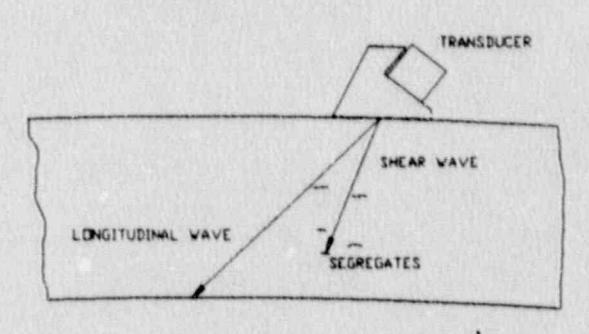
Figure 10 Plot of Figure 9 A-scan using Multiple Beam Components.

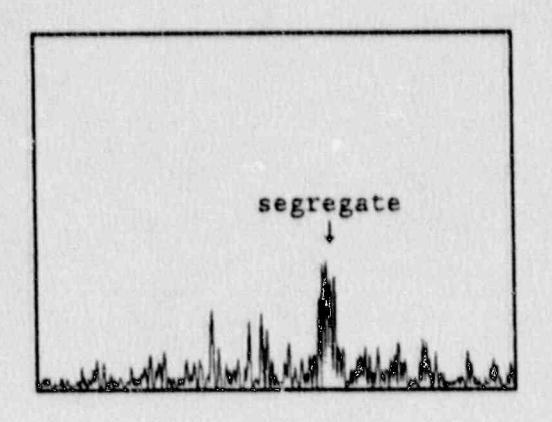
The transducer was moved forward 0.5" to a distance of 1.1" from the weld centerline. The shear wave component then detected a segregate at a different depth as shown on the sweep of the A-scan in Figure 11. The depth of this segregate was at 2.4". Therefore, the assumed depth of this reflector using the 45° RL component was 3" as illustrated in the cross-sectional plot in Figure 12.

Figure 11 45° RL 1.1" from Ref.
