In the Matter of
Public Service Electric and Gas Company
(Atlantic Nuclear Generating Station, Units 1 and 2)
Docket Nos. STN 50-477, STN 50-478

SUBJECT: NRC FIRE PROTECTION RESEARCH TEST

SUBJECT: UL FIRE PROTECTION TESTS

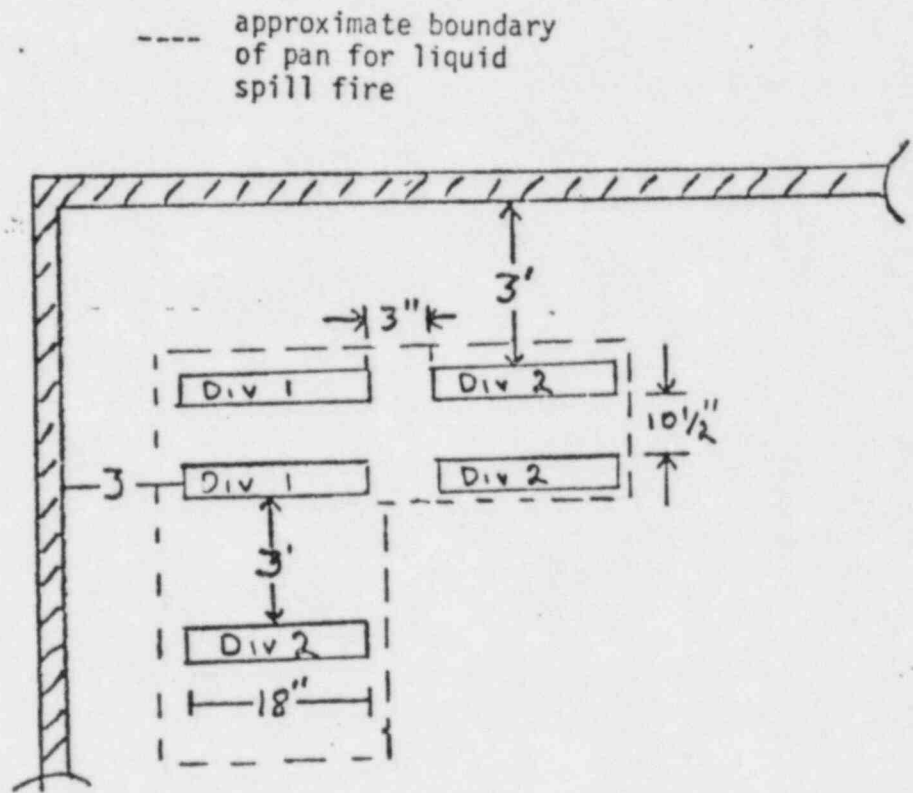
Figure 1

Vertical Tray Corner Test

(2) AUTOMATIC FIRE DETECTORS
