SACRAMENTO MUNICIPAL UTILITY DISTRICT

(Rancho Seco Nuclear Generating Station)

MOTION OF THE NRC STAFF TO FILE ITS
SUPPLEMENTAL RESPONSE ON RADIOGRAPHIC
EXAMINATIONS OF UNMODIFIED HPI NOZZLES BY MARCH 31, 1983

Subject: STATUS OF MAKE-UP NOZZLE CRACKING IN BABCOCK & WILCOX
(B&W) PLANTS

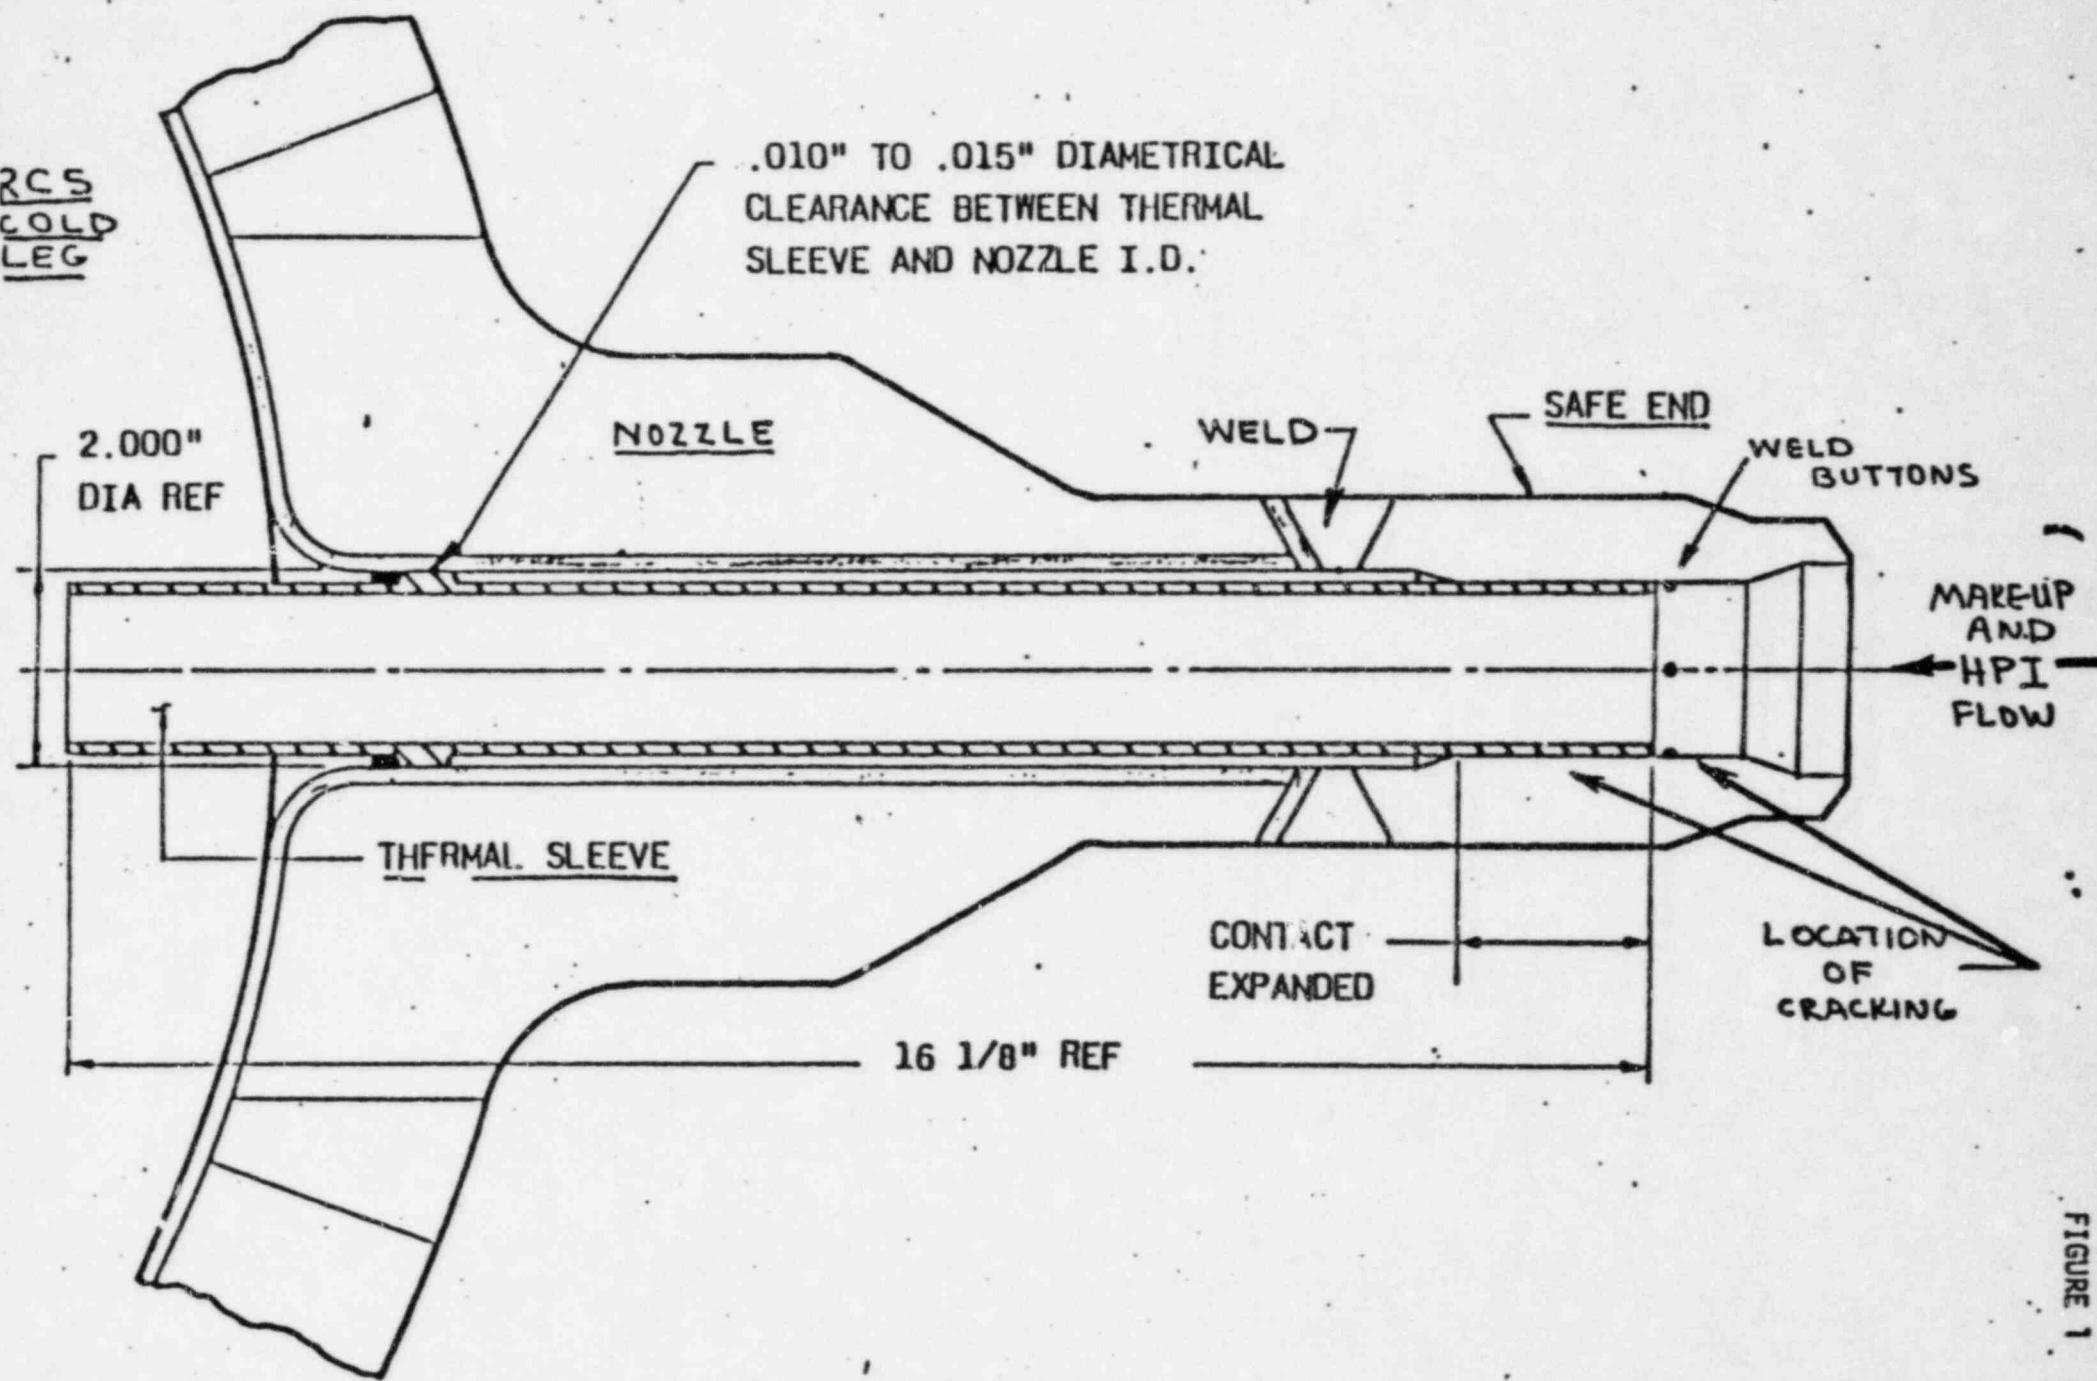
FIGURE 1

For all B&W plants, except Oconee, the normal make-up nozzle
is one of four nozzles to the cold leg of the reactor coolant
system that are used in the event HPI is required. At Oconee,
two of the four lines are used for normal make-up. The make-up
line is a "double-duty" line in that it is used for normal
primary coolant make-up in addition to its HPI function.
Thermal sleeves are installed within all of the HPI/make-up
nozzles to protect the nozzles from the effects of cool water
from the make-up tank or borated water storage tank thermally
shocking the nozzles that are in contact with hot reactor
primary coolant water. A typical thermal sleeve design for
B&W plants is shown in Figure 1.

TYPICAL B+W MAKE-UP/HPI NOZZLE | THERMAL SLEEVE DESIGN
