UNITED STATES  
NUCLEAR REGULATORY COMMISSION  
REGION III  
799 ROOSEVELT ROAD  
GLEN ELLYN, ILLINOIS 60137

MIDLAND NUCLEAR PLANT -  
UNIT NO 1, DOCKET NO 50-329  
UNIT NO 2, DOCKET NO 50-330  
SETTLEMENT OF DIESEL GENERATOR FOUNDATIONS AND BUILDING

Settlement of the diesel generator foundations and building  
INTERIM REPORT # 1

MEMORANDUM FOR: H. D. Thornburg, Director, RCI, IE  
FROM: James G. Keppler, Director, RIII  
SUBJECT: MIDLAND 1 AND 2 - EXCESSIVE SETTLEMENT OF  
DIESEL GENERATOR BUILDING FOUNDATIONS (A/I F30437H1)

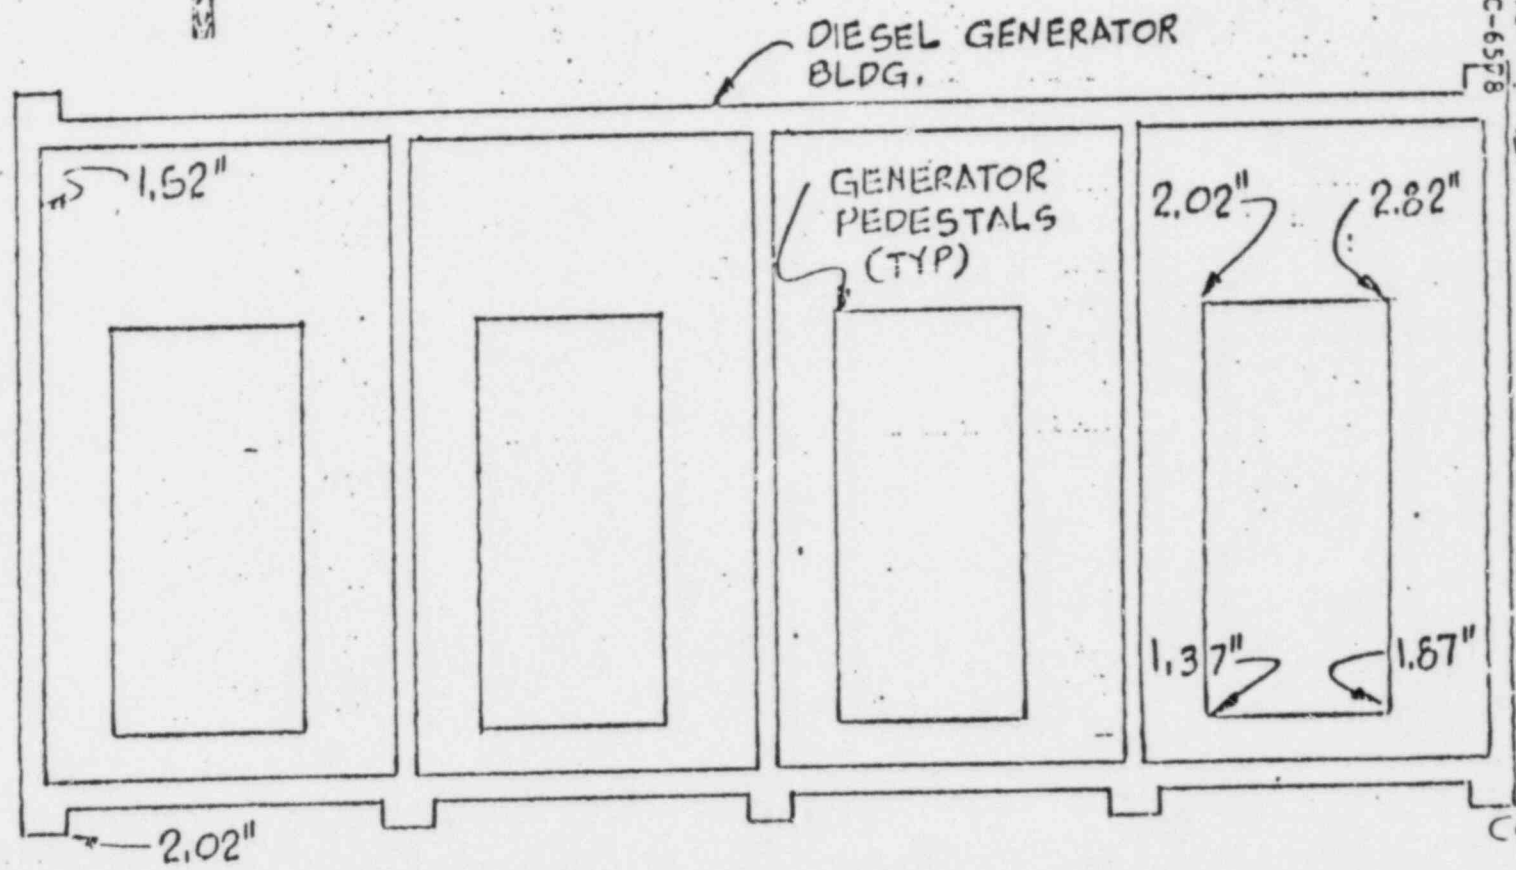
NO.	DATE	REVISIONS	
1	9-22-78	ISSUED FOR INFO. TO MCAR # 24 INTERIM REPORT # 1	
ORIGIN		 CONSUMERS POWER COMPANY MIDLAND PLANTS UNIT 1 AND 2 MCAR # 24	
JOB NO.	REV.	BY	CHKD.
7830			
SPEC. DES. GUIDE NO.	FIGURE 1

The Bechtel Foundation Data Survey Program (Specification 7220-C-76) generated data that indicated the settlement of the diesel generator foundations and building was greater than anticipated. Nonconformance Report 1482 was generated on August 21, 1978, describing the settlements.

The general foundation and building settlements, as of September 19, 1978, are shown on Figure 1 (attached).

Due to the magnitude of the settlements observed, a soils boring program was started. Based on the borings completed to date, the fill under the building has variable strength properties ranging from good to poor.

DIESEL GENERATOR BLDG.  
 SETTLEMENT DATA AS OF 9-19-78  
 (IN INCHES)

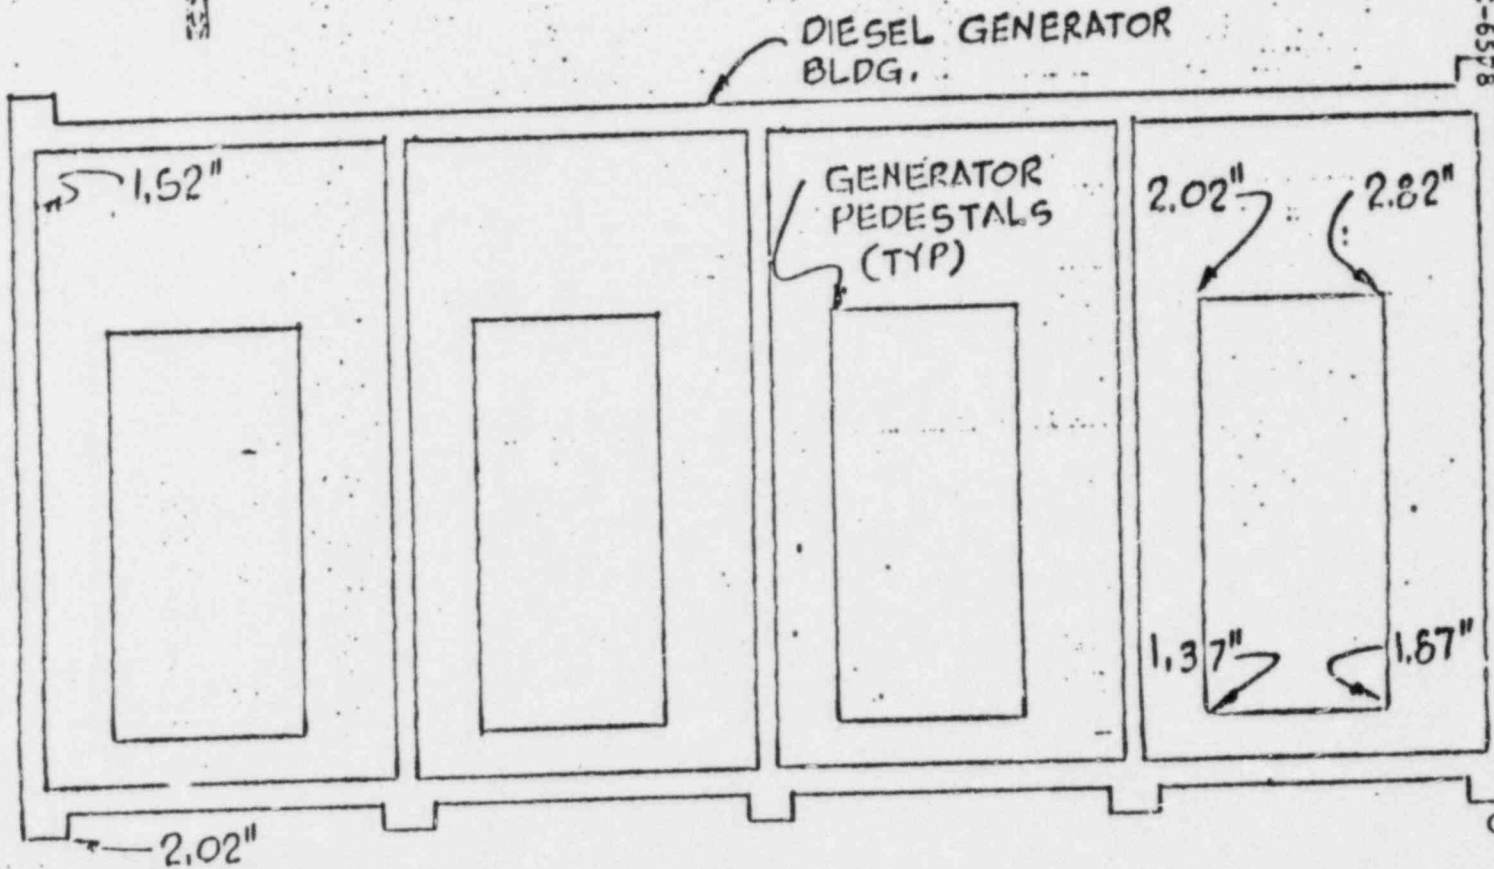
NO.	DATE	REVISIONS	JOB NO.	SPEC. DIS. GUIDE NO.
	5-22-78			
ORIGIN	ISSUED FOR INFO. TO MCR # 24 INTERIM REPORT # 1		BY	CMR
	CONSUMERS POWER COMPANY			
	MIDLAND PLANTS LANDS			
	MCR # 24			
FIGURE 1

The Bechtel Foundation Data Survey Program (Specification 7220-C-76) generated data that indicated the settlement of the diesel generator foundations and building was greater than anticipated. Nonconformance Report 1482 was generated on August 21, 1978, describing the settlements.

The general foundation and building settlements, as of September 19, 1978, are shown on Figure 1 (attached).

Due to the magnitude of the settlements observed, a soils boring program was started. Based on the borings completed to date, the fill under the building has variable strength properties ranging from good to poor.

DIESEL GENERATOR BLDG.  
 SETTLEMENT DATA AS OF 9-19-78  
 (INCHES)

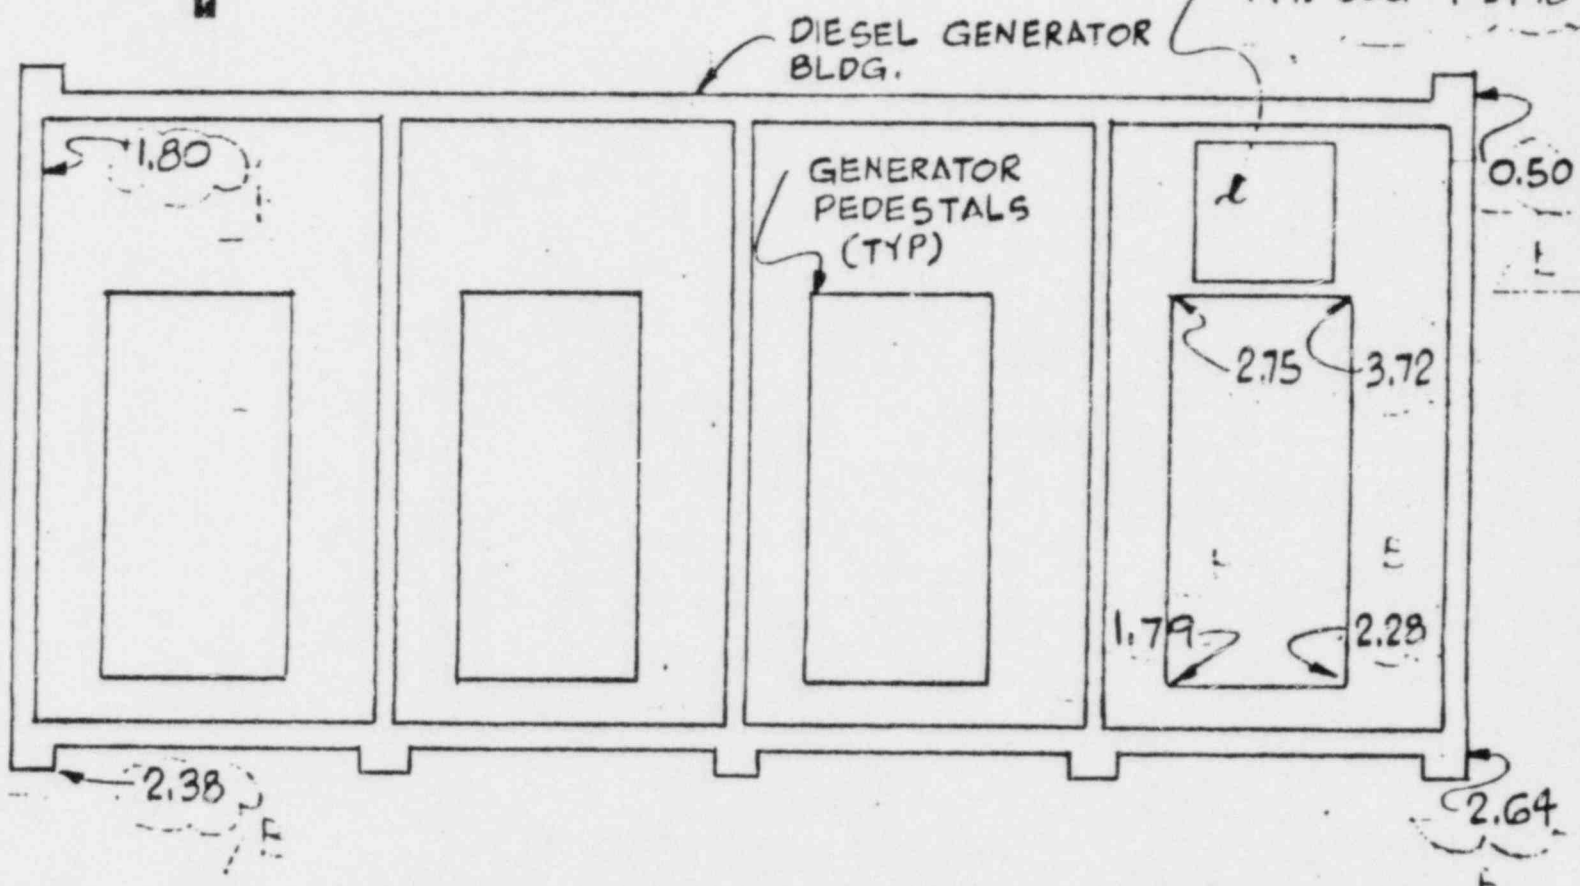
DIESEL GENERATOR BLDG.

BUILDING SETTLEMENT DATA (IN INCHES) AS OF 10-27-78  
 GENERATOR PEDESTAL SETTLEMENT DATA (IN INCHES) AS OF 10-31-78.
