**COLORADO ENGINEERING
EXPERIMENT STATION INC.**

**Air Blast Destructive Testing
of NUKON® Insulation
Simulation of a Pipe Break LOCA**

Tests 1,2,3,4,7 and 8
Final Report

October 22, 1993

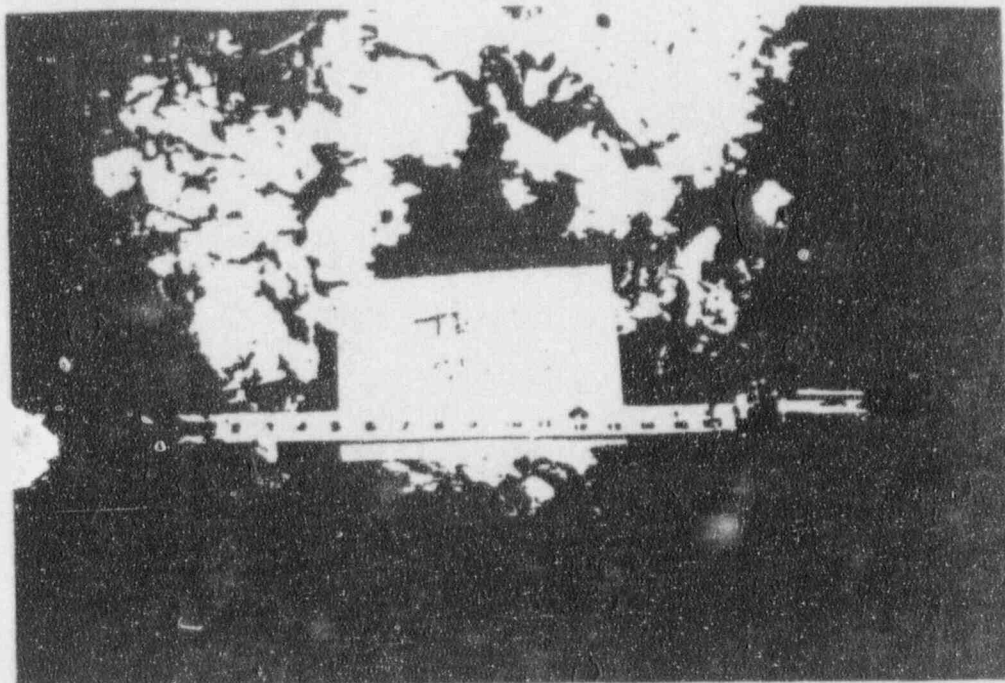
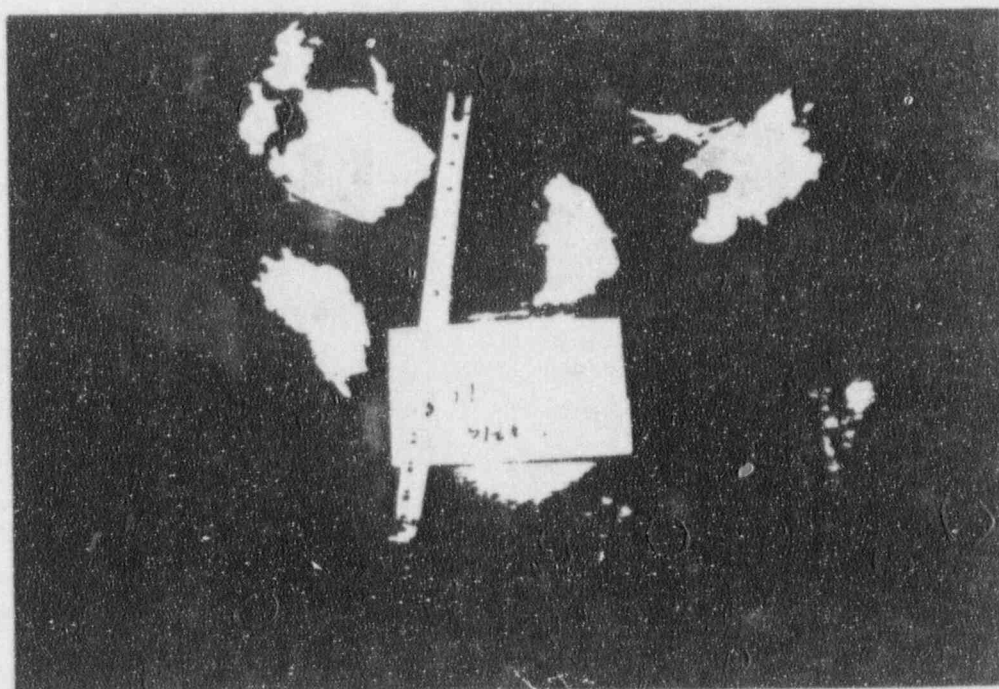
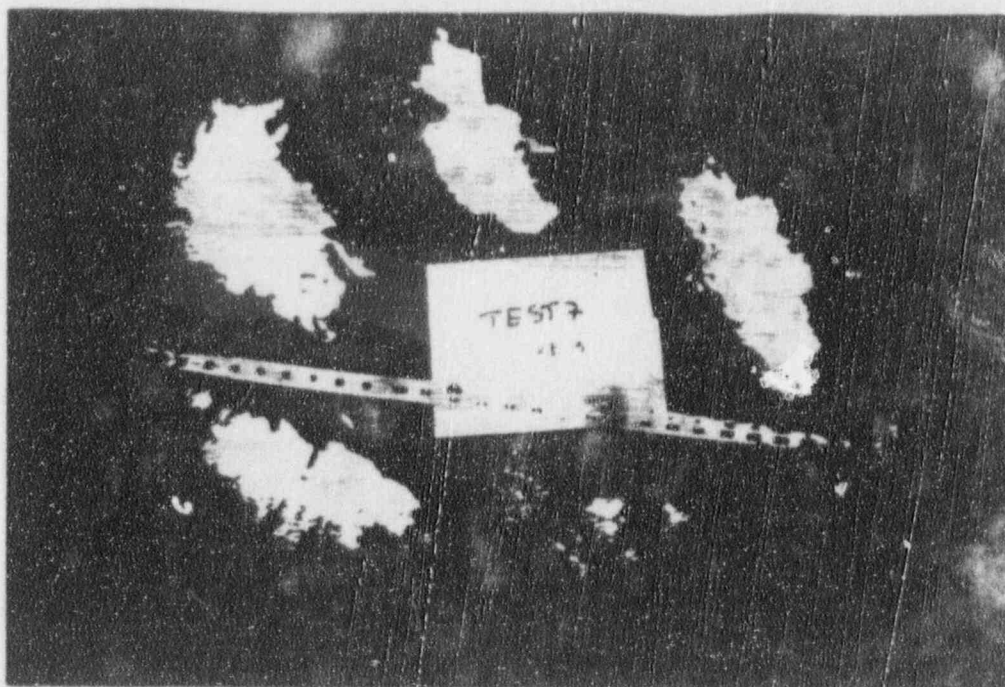
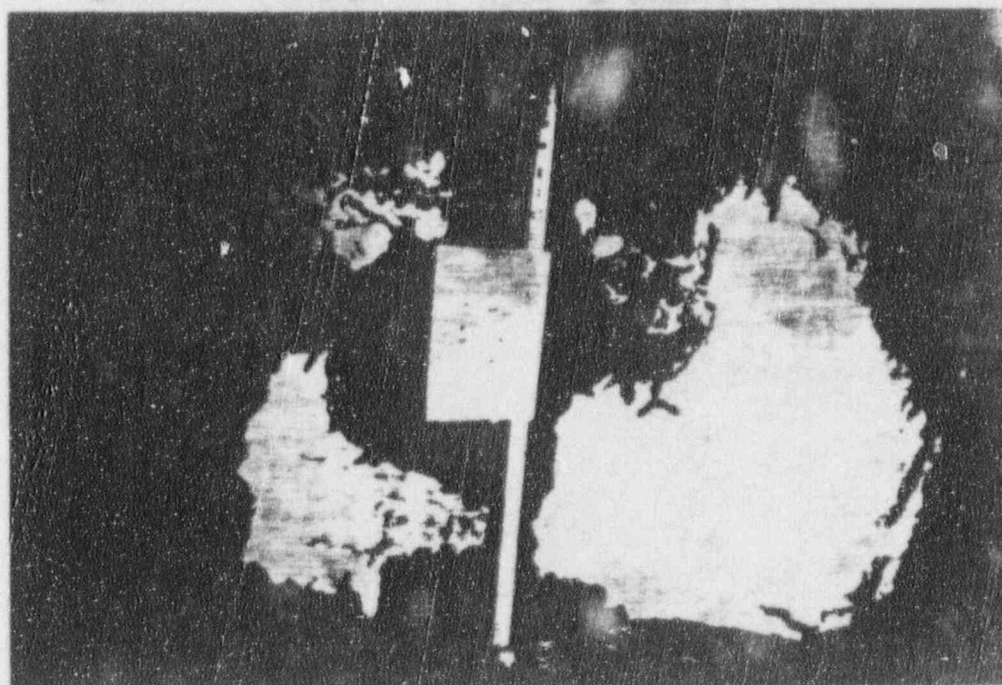
Typical examples of Sizes 1-4 debris are shown in Figures 6 - 9, these are debris that were collected after Test 7. Debris classified as Sizes 2, 3 and 4 still retain the layered structure

present in the original blanket. Size 1 debris is typically composed of clumps of fibers with a few pieces of textile fibers, scrim and individual fibers, this can be seen in Figure 6. The density of debris in Sizes 2, 3 and 4 is typically greater than that of Size 1 debris. It is believed that Size 1 debris results from direct impact by the jet; Sizes 2, 3 and 4 result from indirect impact.

Figure 6: Typical Size 1 Debris

Figure 7: Typical Size 2 Debris

Figure 8: Typical Size 3 Debris

Figure 9: Typical Size 4 Debris

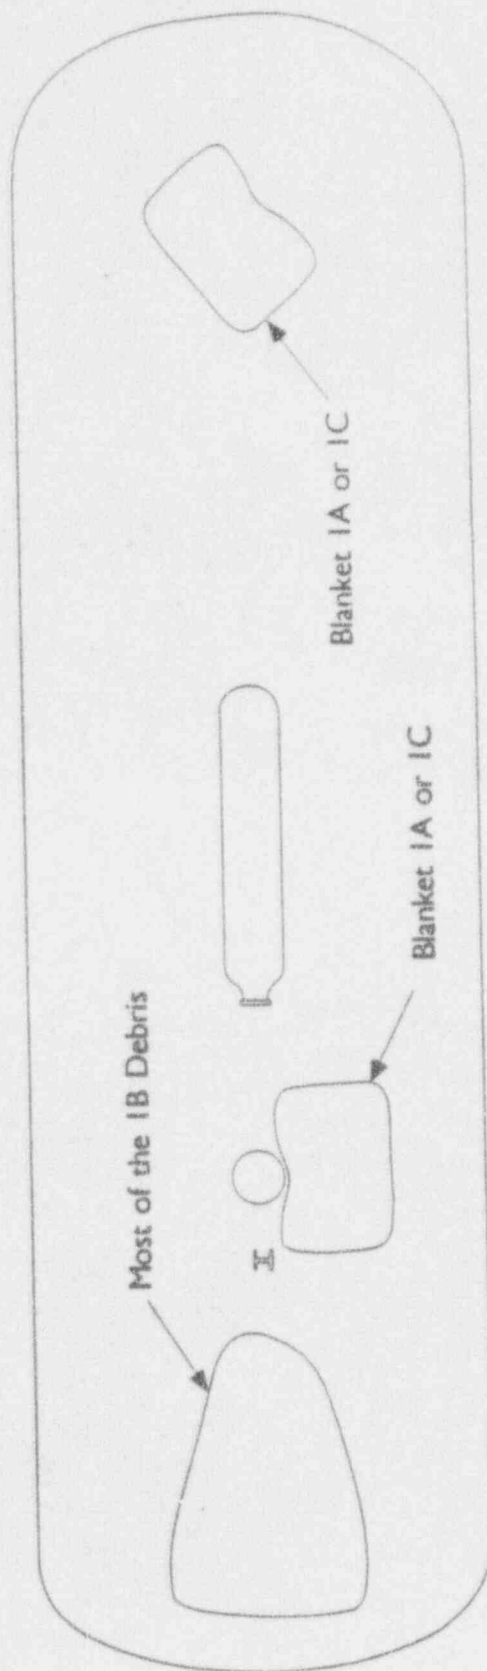
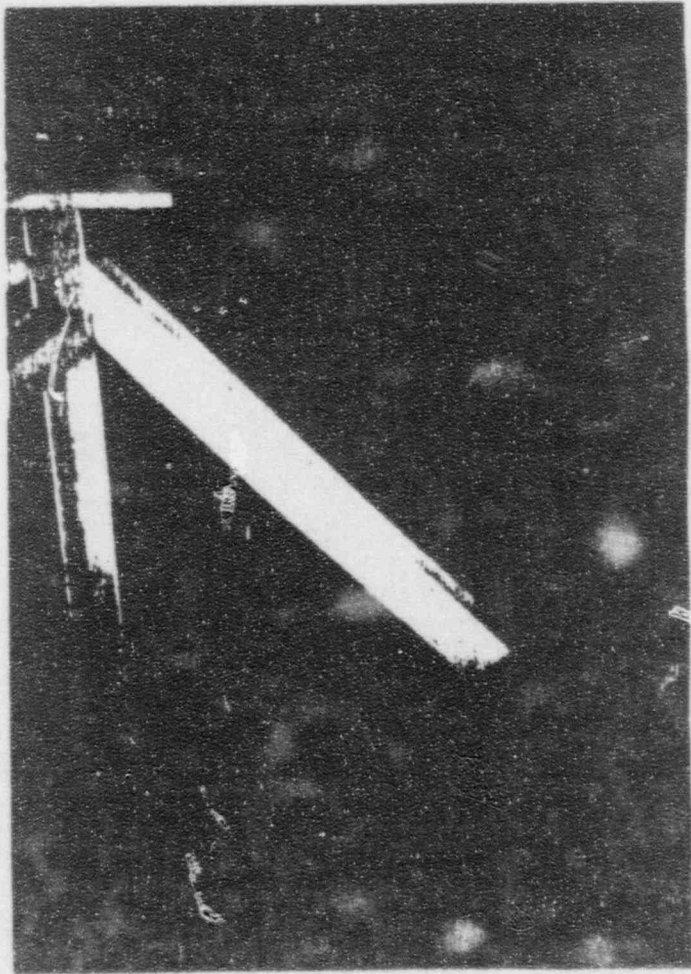
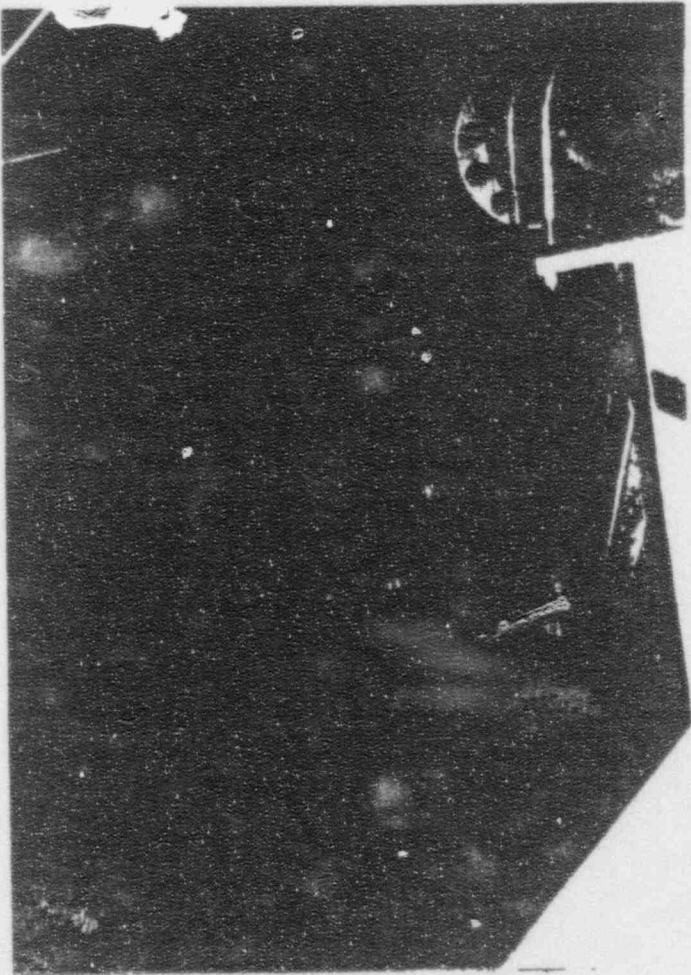
Figure 10: Location of Test 1 Debris

The "after test" conditions are shown in Figures 10 - 12. Blanket 1B was destroyed, most of the larger pieces were located in the south end of the test chamber. Both of the other blankets were dislodged from the pipe but were not damaged. One blanket was located immediately to the left of the mounting pipe. The other blanket was located in the north end of the chamber. It was not noted as to which blanket (1A or 1C) was found in which location.

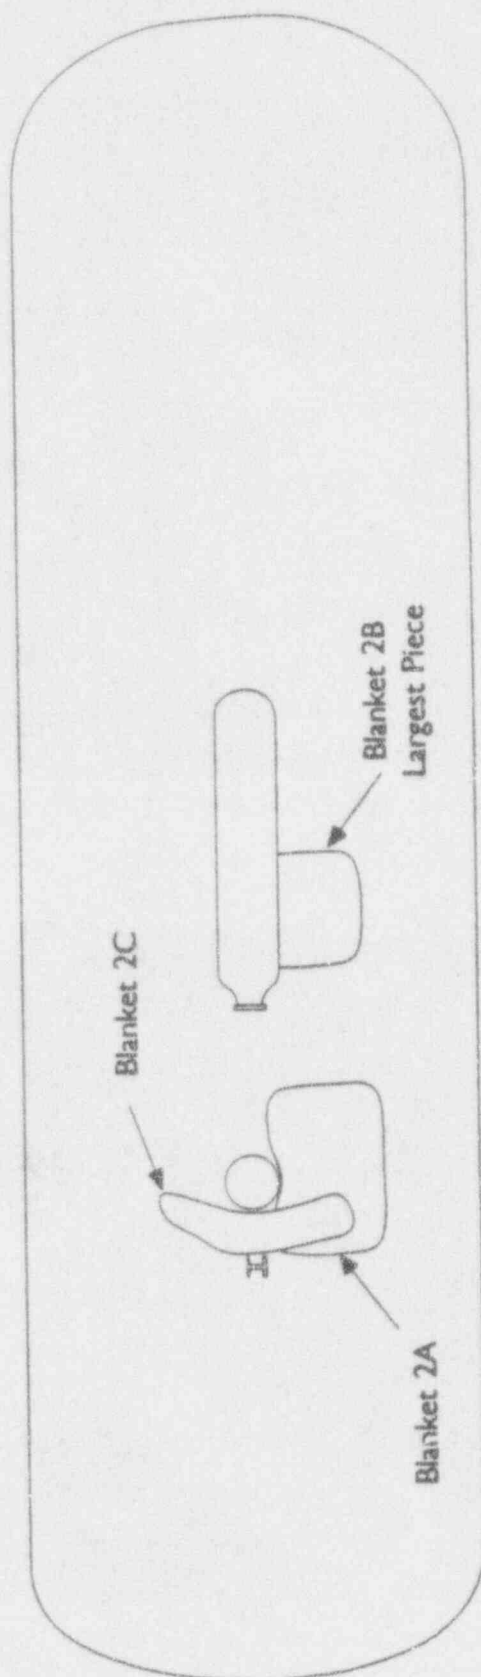
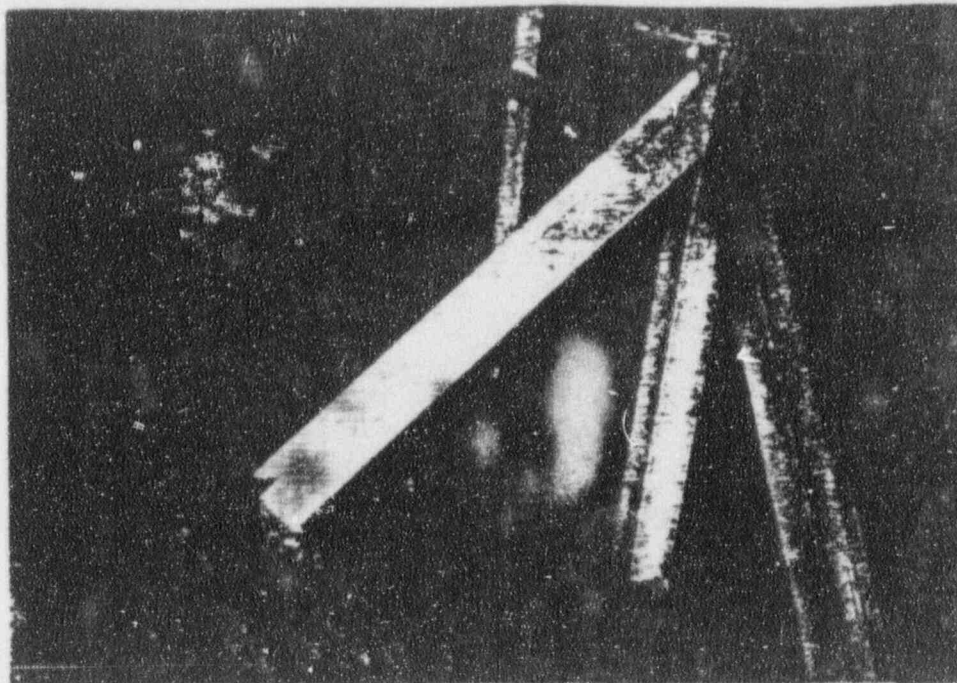
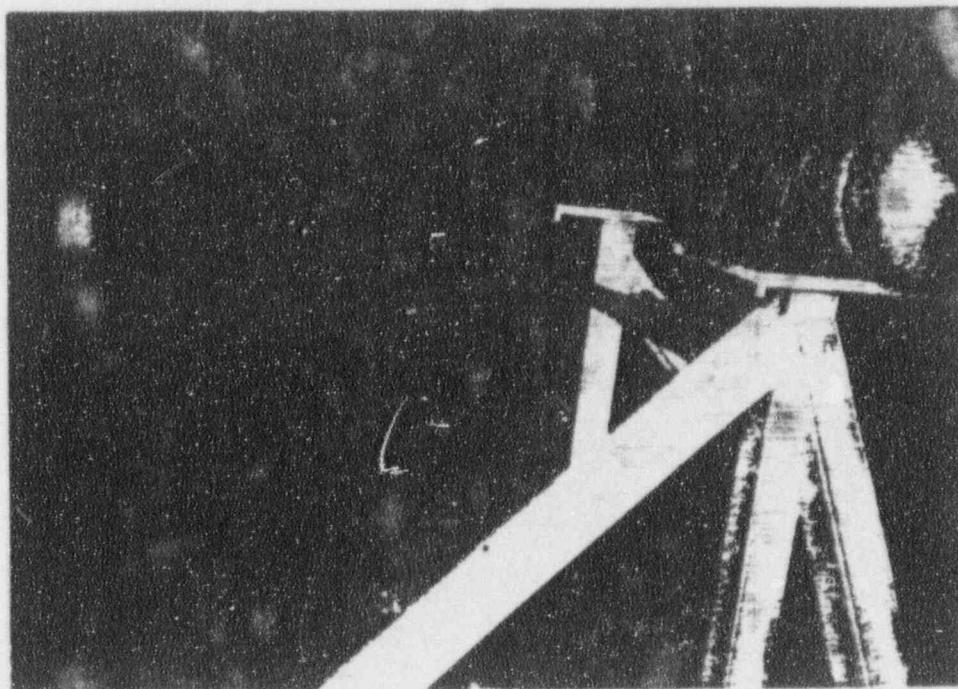
Figure 13: Location of Test 2 Debris

The "after test" conditions are shown in Figures 13 - 15. Blanket 2B was destroyed; the largest piece was located below the burst tank, most of the rest were located in the south end of the test chamber. Most of the woven fabric was found wrapped around the base of the mounting pipe. The other two blankets were dislodged from the pipe but were not damaged. Blanket 2A was located immediately to the left of the mounting pipe. Blanket 2C was found wedged between the mounting pipe and the "T-beam" located immediately behind the mounting pipe.

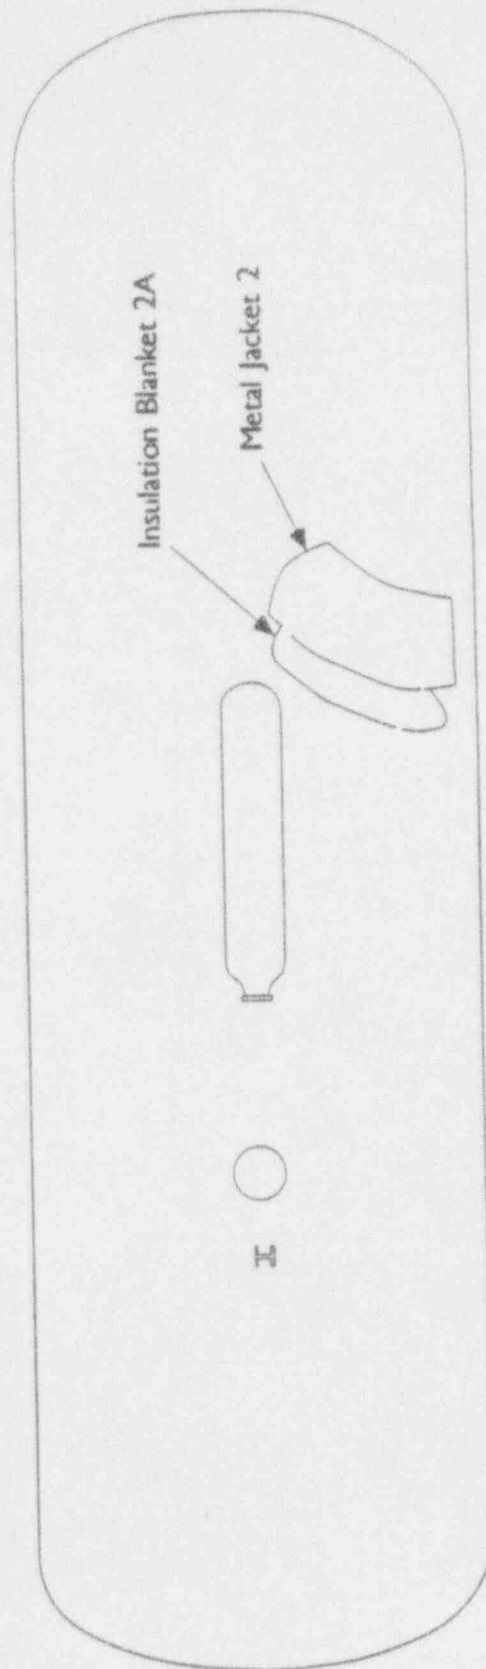
Figure 16: Location of Test 3 Debris

No fibrous debris was found as a result of this test. Blanket 2A and metal section 2 were completely dislodged from the mounting pipe by the air jet. Both were located towards the north end after the test as shown in Figure 16. Blanket 1C and metal section 1 were still mounted on the pipe after the conclusion of the test, all three sets of metal jacket latches and strikes were still fastened. The velcro fasteners of blanket 2C, the middle blanket, were pulled open but the blanket was still held in approximately the original position by metal jacket section 1.

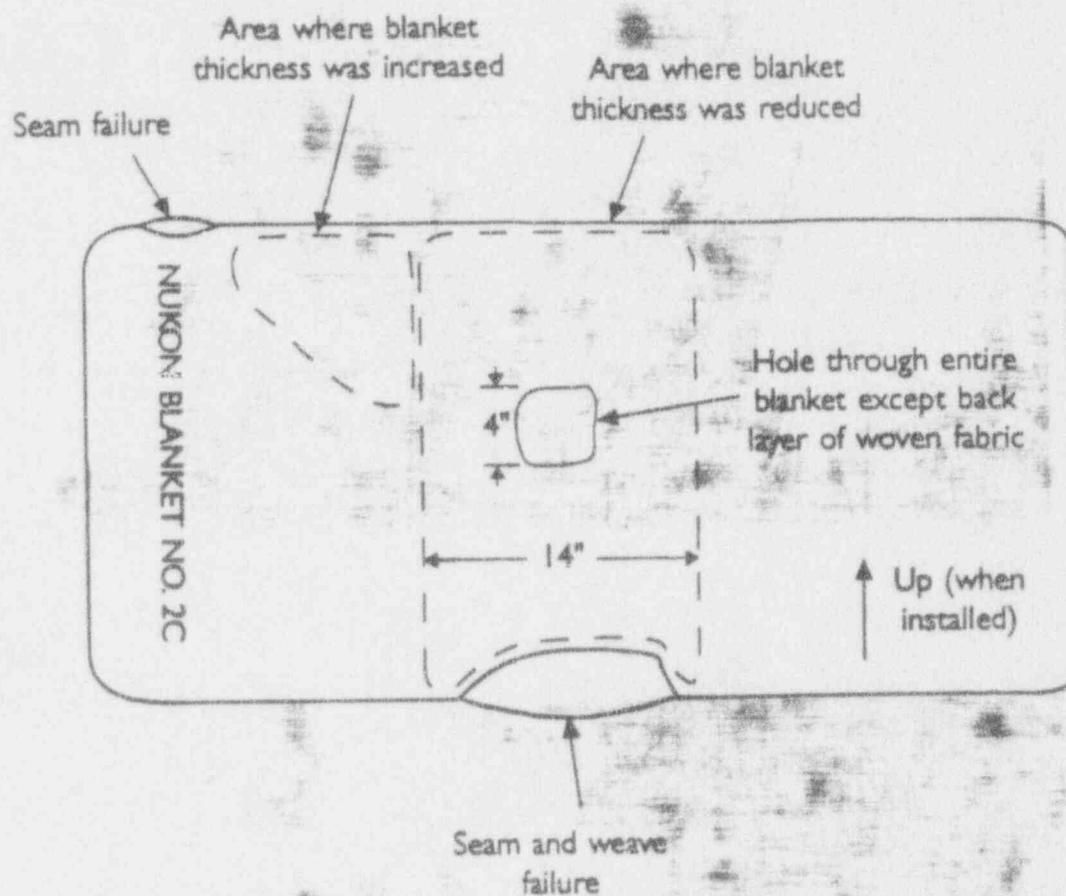
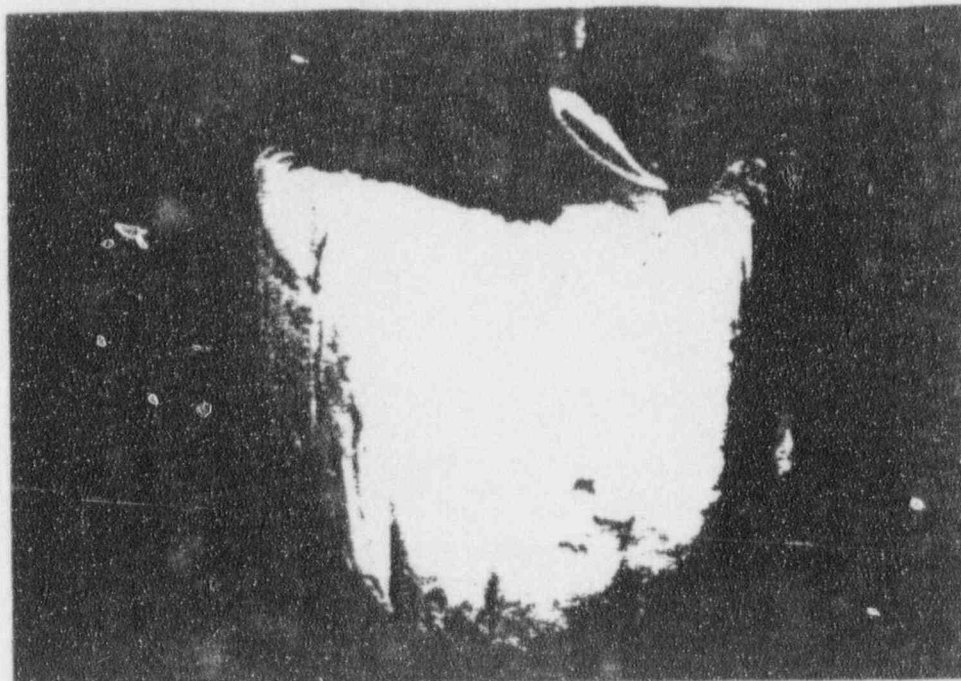
Blankets 2A and 1C sustained no damage. Three observations were made regarding the middle blanket, 2C, they are listed below and shown in Figures 17 and 18:

1. A four inch diameter hole was located at the point of jet impact. This blanket sustained some damage but was not destroyed as was the case in the first two tests. No debris resulted.
2. The woven fabric exhibited some weave and seam failures.
3. The insulation thickness was reduced over a 14 inch wide area at the center of the blanket. The insulation thickness was increased over an area above and to the left of the center.

Figure 17: Blanket 2C after Test 3

Figure 18: Blanket 2C after Test 3

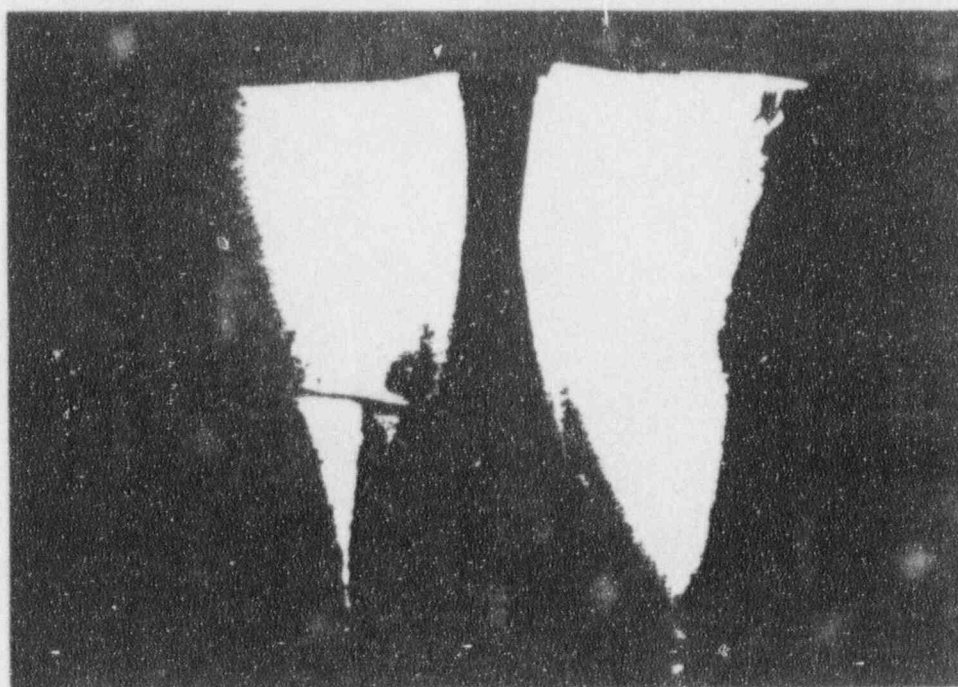
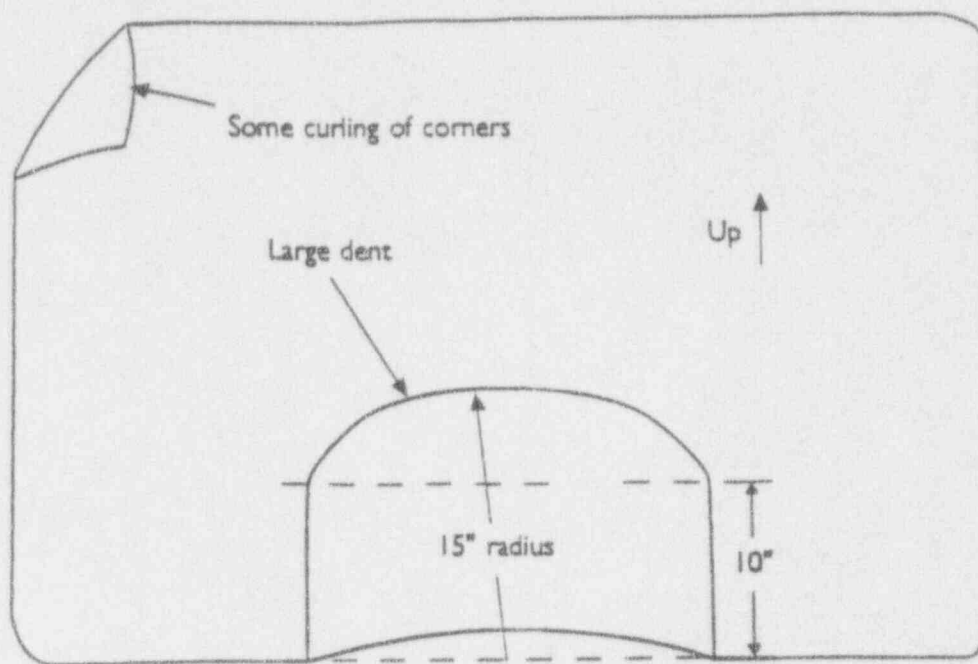
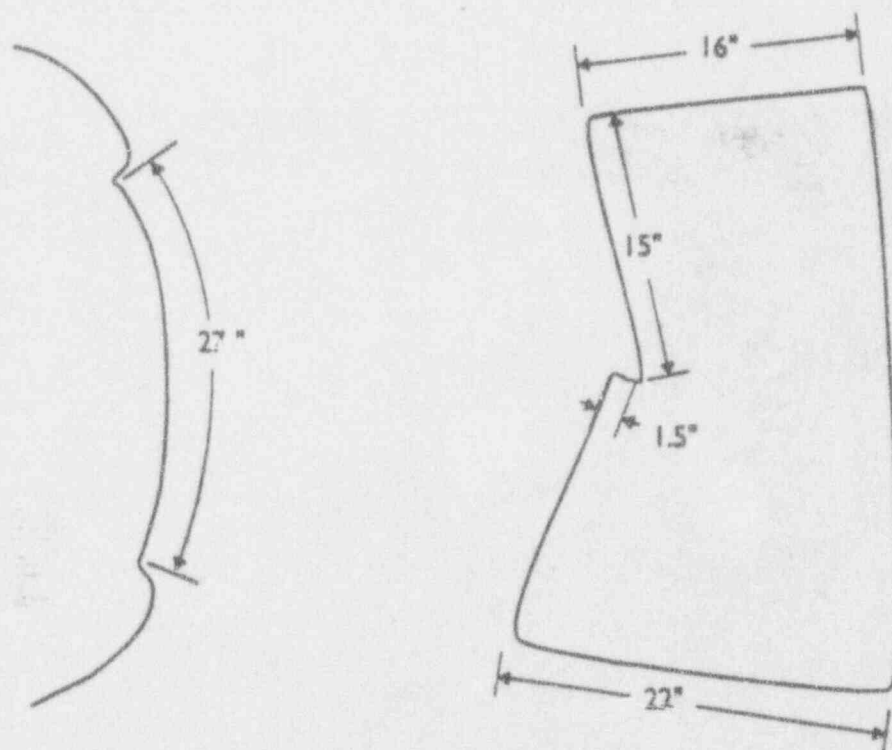
Both metal jackets are shown in Figure 19. Figure 20a shows the front view of the jacket 2 surface. Some curling of the corners and edge damage was sustained. A deep dent was located in the area immediately in front of the jet. Smaller and deeper dents were observed to be concentrated within a radius of 4 inches from the jet impact point. These dents were assumed to be caused by pieces of the rupture disc. Figure 20b shows the top view of metal jacket 2. "flatter" area (of 27 inch width) corresponds to the large dent shown in Figure 20a. A large dent was also observed in jacket 1, the dent pattern was similar to that indicated in Figure 20a. The side view of metal jacket 1 is shown in Figure 20c.

Figure 19: Metal Jacket Sections 1 and 2 after Test 3

Figure 20a: Surface View of Metal Jacket Section 2 after Test 3

Figure 20b: Top View of Metal Jacket Section 2 after Test 3

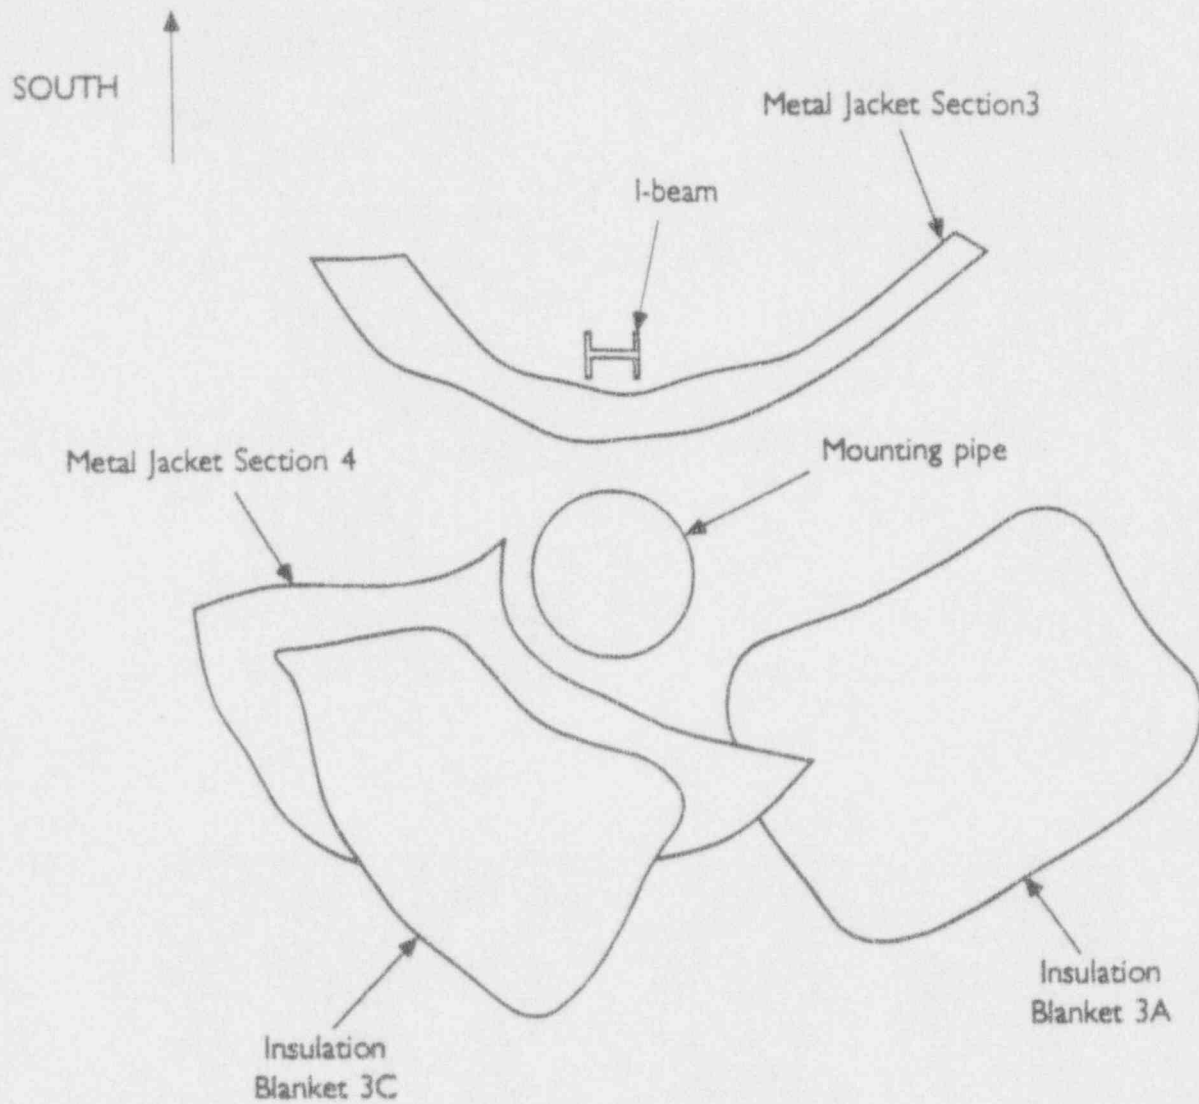
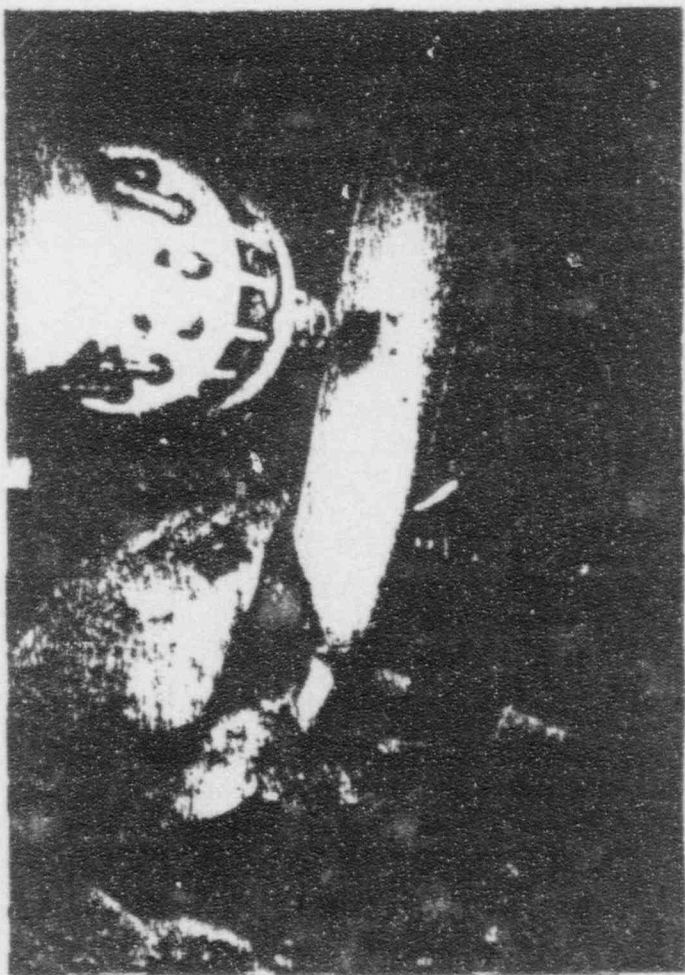
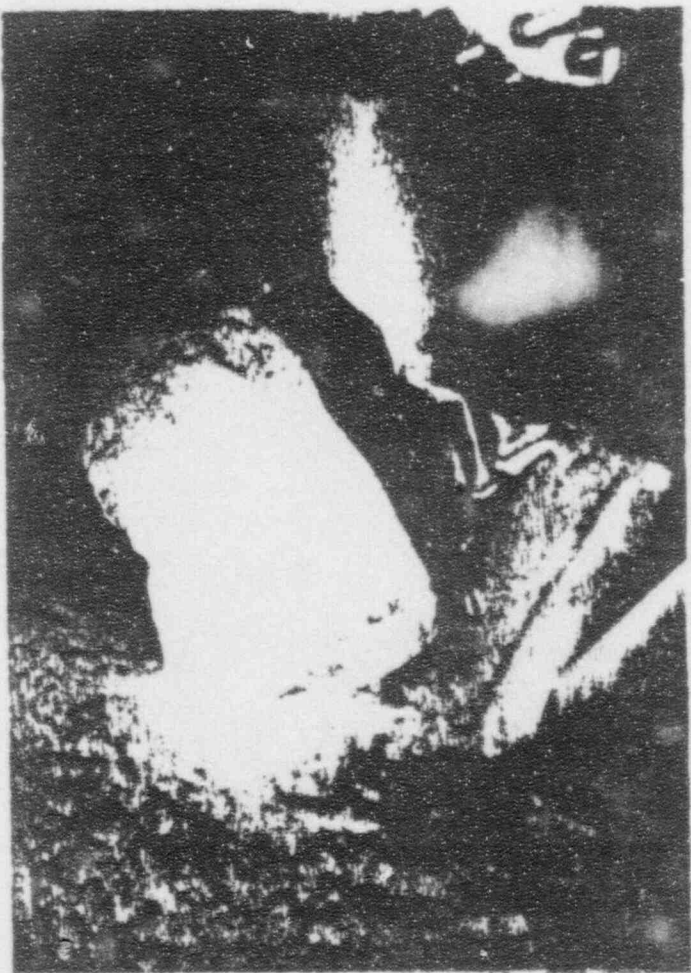
Both sections of metal jacketing and insulation blanket 3B were dislodged and heavily damaged by the air blast; the locations are shown in Figures 21, 22 and 23. Figures 24 and 25 record the condition of the two metal jacket sections. Each figure contains an outside surface view that can be interpreted as a map of the surface condition. The top view in each figure is an attempt to document the distortion from the original circular shape. Each jacket section had been held in position by latches and strikes; the air blast removed some of this hardware. In all cases the rivets had torn through the metal jackets. The condition of the hardware is noted in the figures.

Insulation blankets 3A and 3C were dislodged but not at all damaged by the air blast. Blanket 3B was blown apart by the air blast, most of the larger pieces were located in the south end of the test chamber.

Figure 21: Location of Metal Jackets and Insulation Blankets after Test 4.

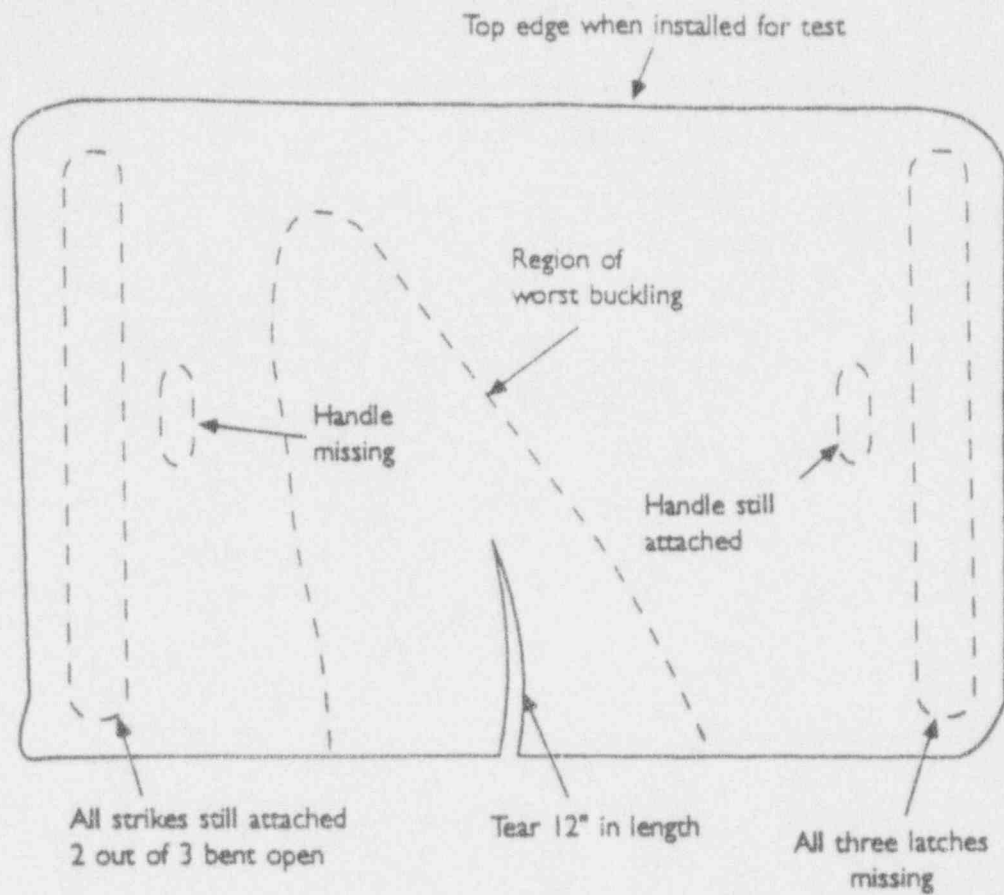
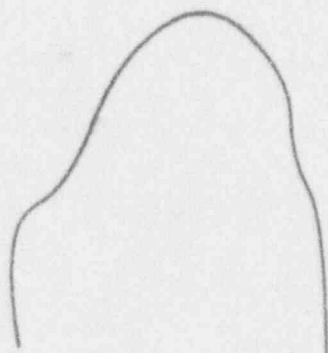
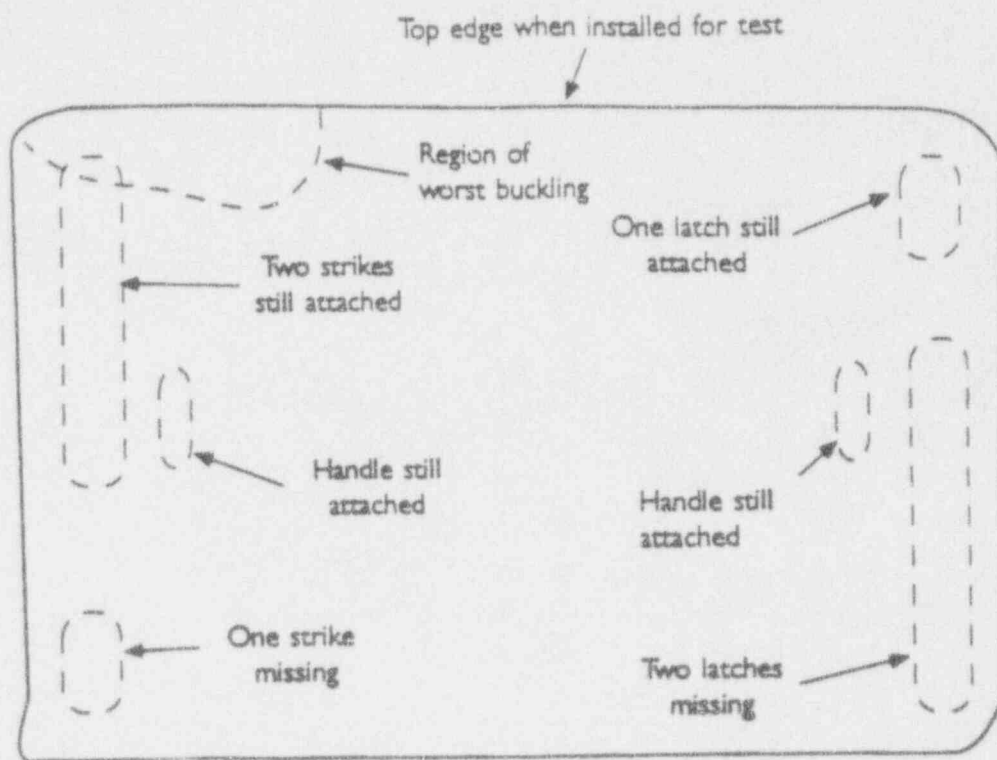
1. Test 4 showed that the particular metal jacket used for these tests will not prevent destruction of the insulation if the jet impacts the latch side. The likely failure mode of the metal jacket is for the rivets that secure the latches to pull free from the sheet metal.

Figure 24: Metal Jacket 3 after Test 4.
Top View (left) and
Outside Surface View (above).

Figure 25: Metal Jacket 4 after Test 4.
Top View (left) and
Outside Surface View (above).

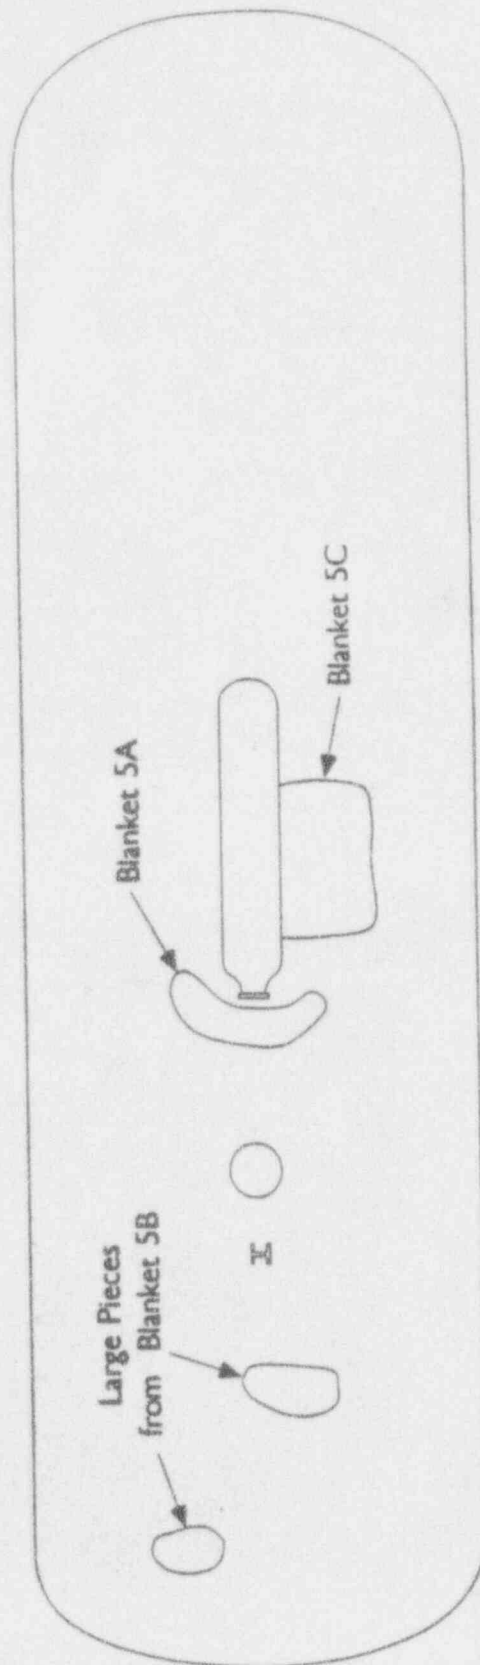
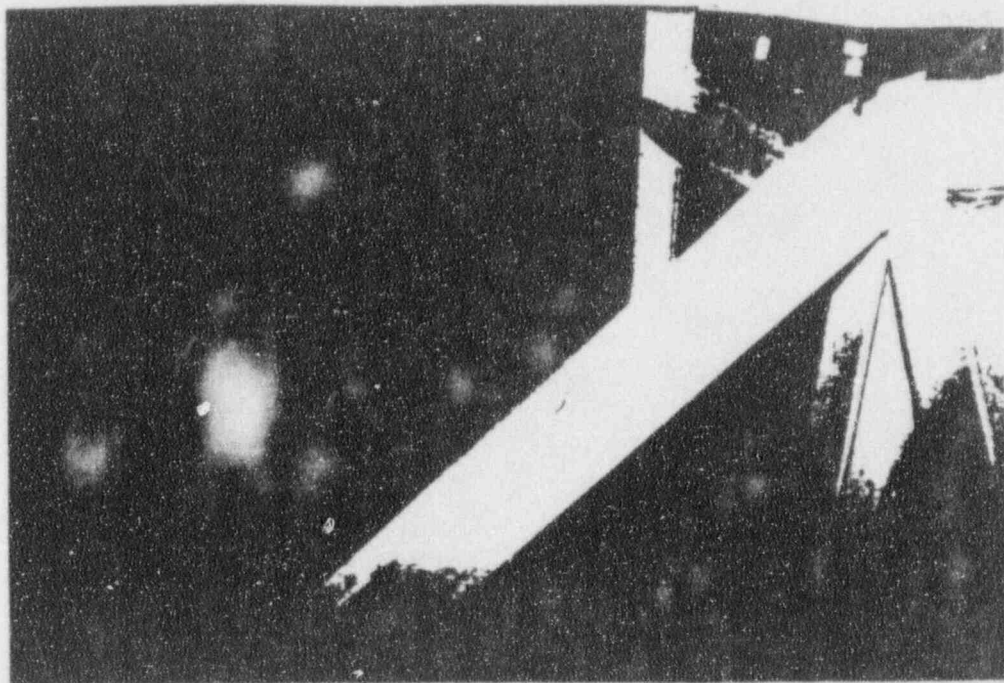
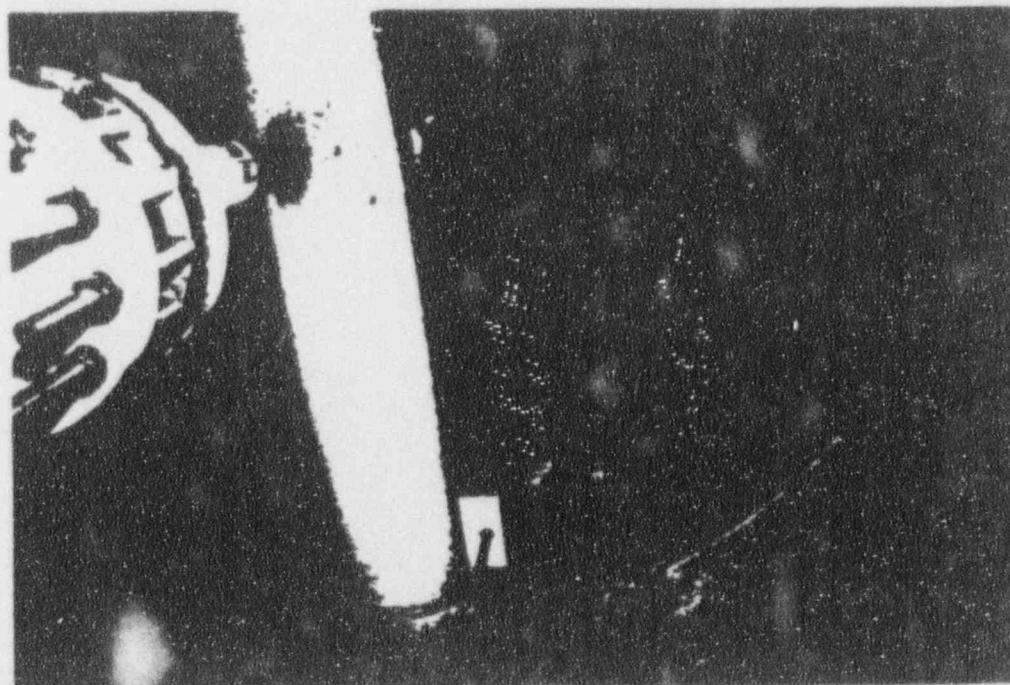
Shown in Figures 26 - 28 are the "post test" conditions; blanket 5B, the middle blanket, was destroyed as in Test 1. Some of the larger pieces from 5B ended up in the South end. Blankets 5A and 5C were undamaged, they both ended up lodged below the burst tank.

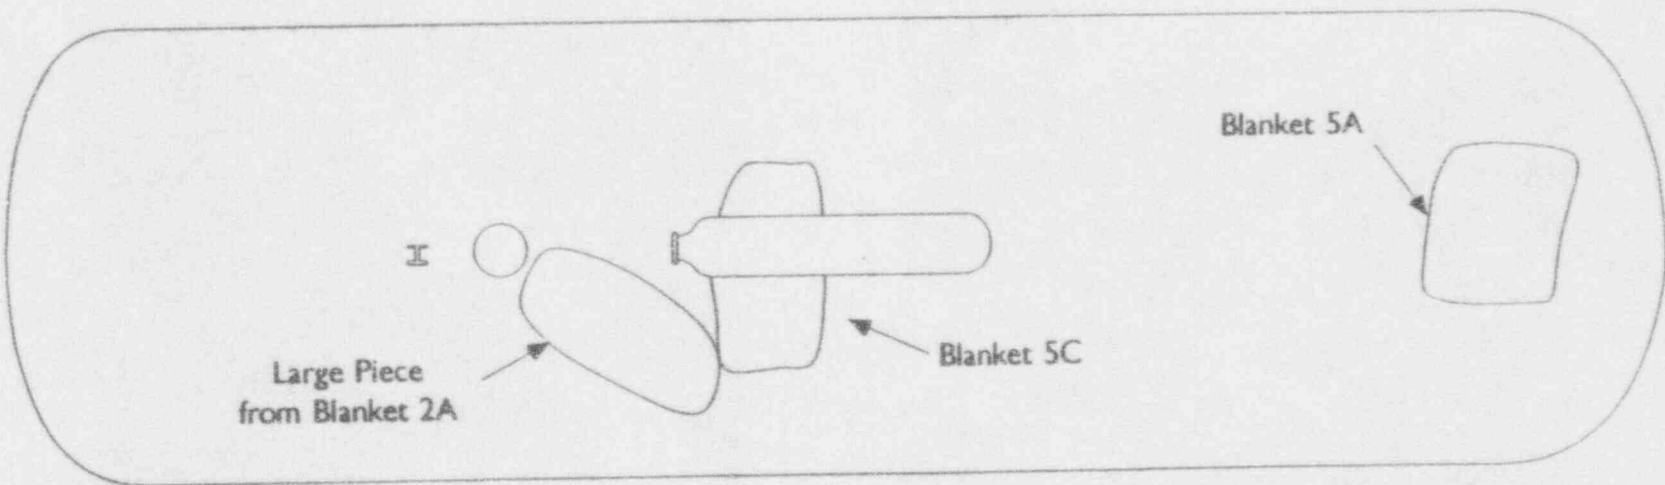
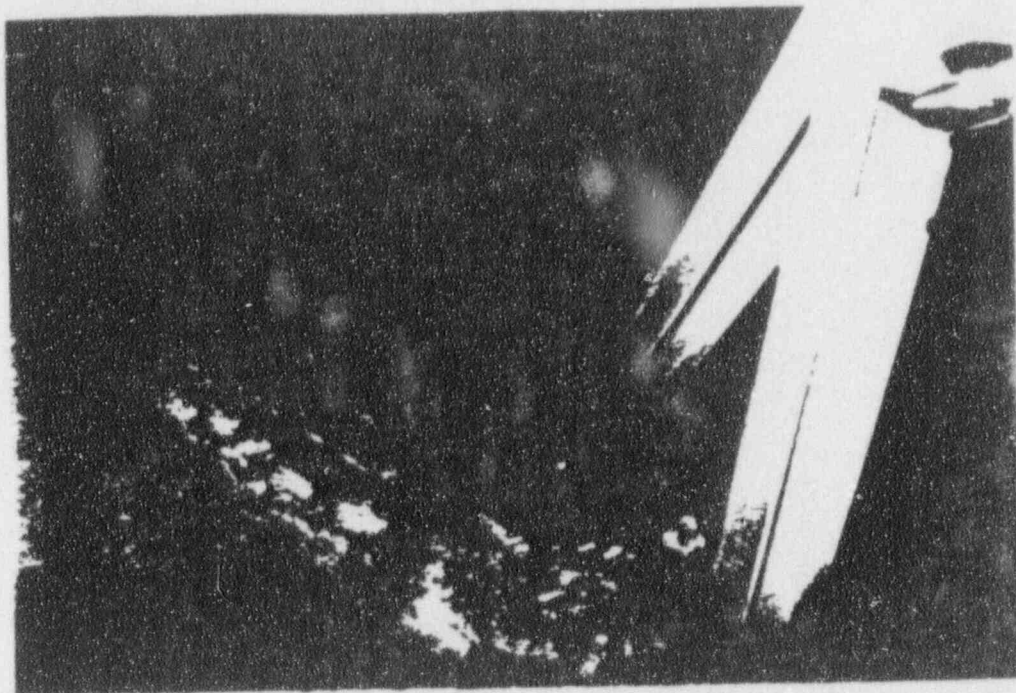
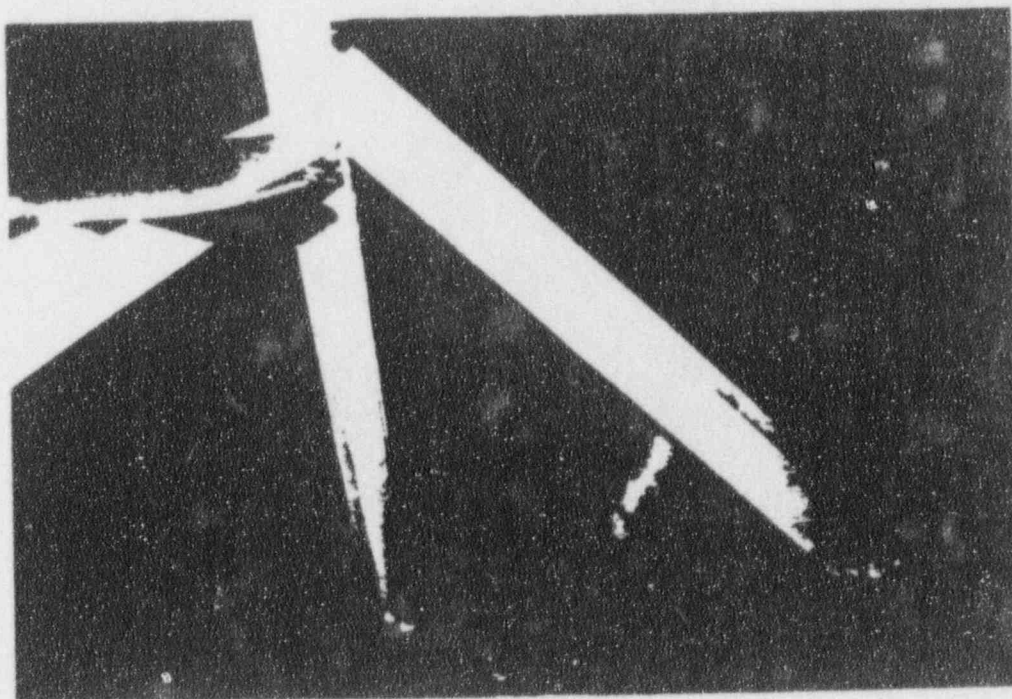
Shown in Figures 29 - 30 are the "post test" conditions. Blanket 2A was destroyed as in the previous tests but there was visibly less debris generated. The larger piece of blanket 2A ended up at the base of the mounting pipe. The other two blankets were undamaged. Blanket 5A ended up in the North end. Blanket 5C ended up lodged below the burst tank.
