**COLORADO ENGINEERING
EXPERIMENT STATION INC.**

**Air Blast Destructive Testing
of NUKON® Insulation
Simulation of a Pipe Break LOCA**

Tests 1,2,3,4,7 and 8
Final Report

October 22, 1993

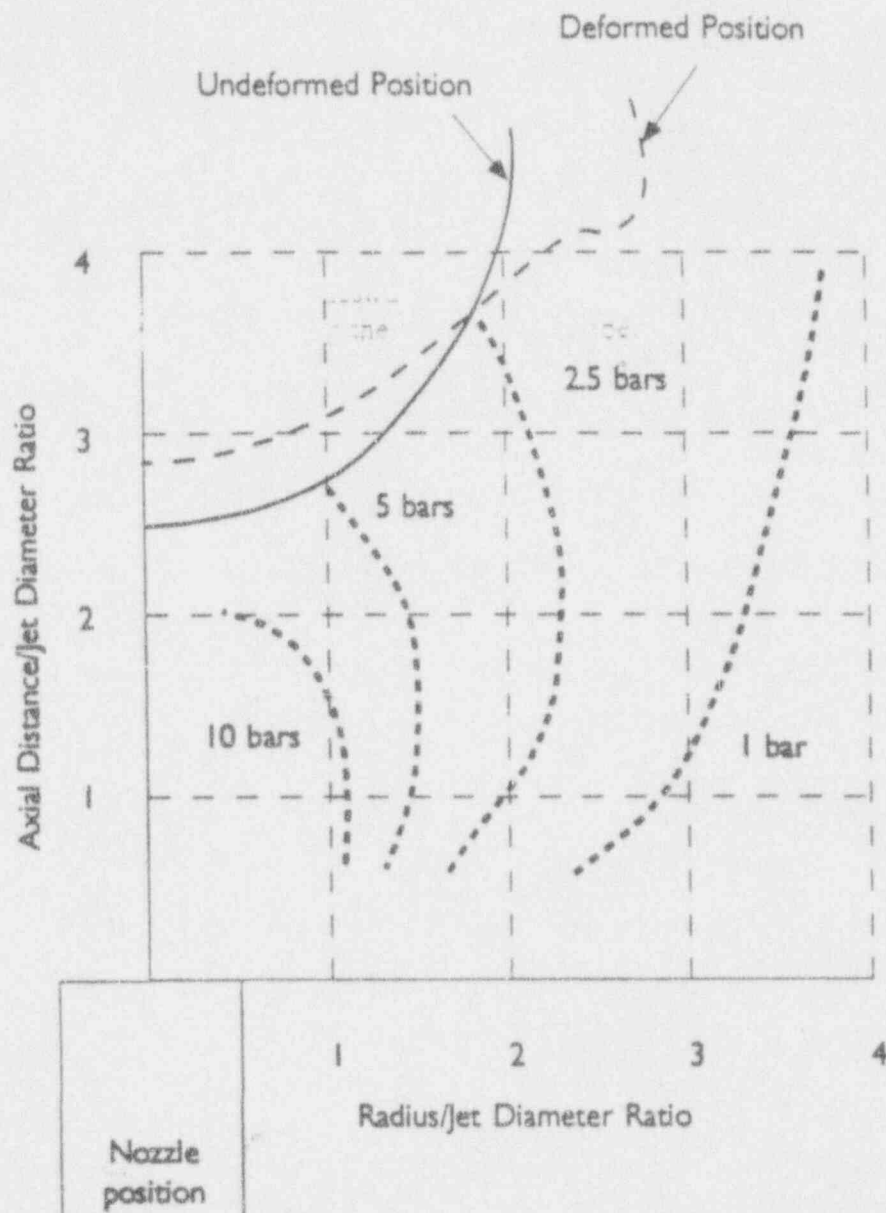
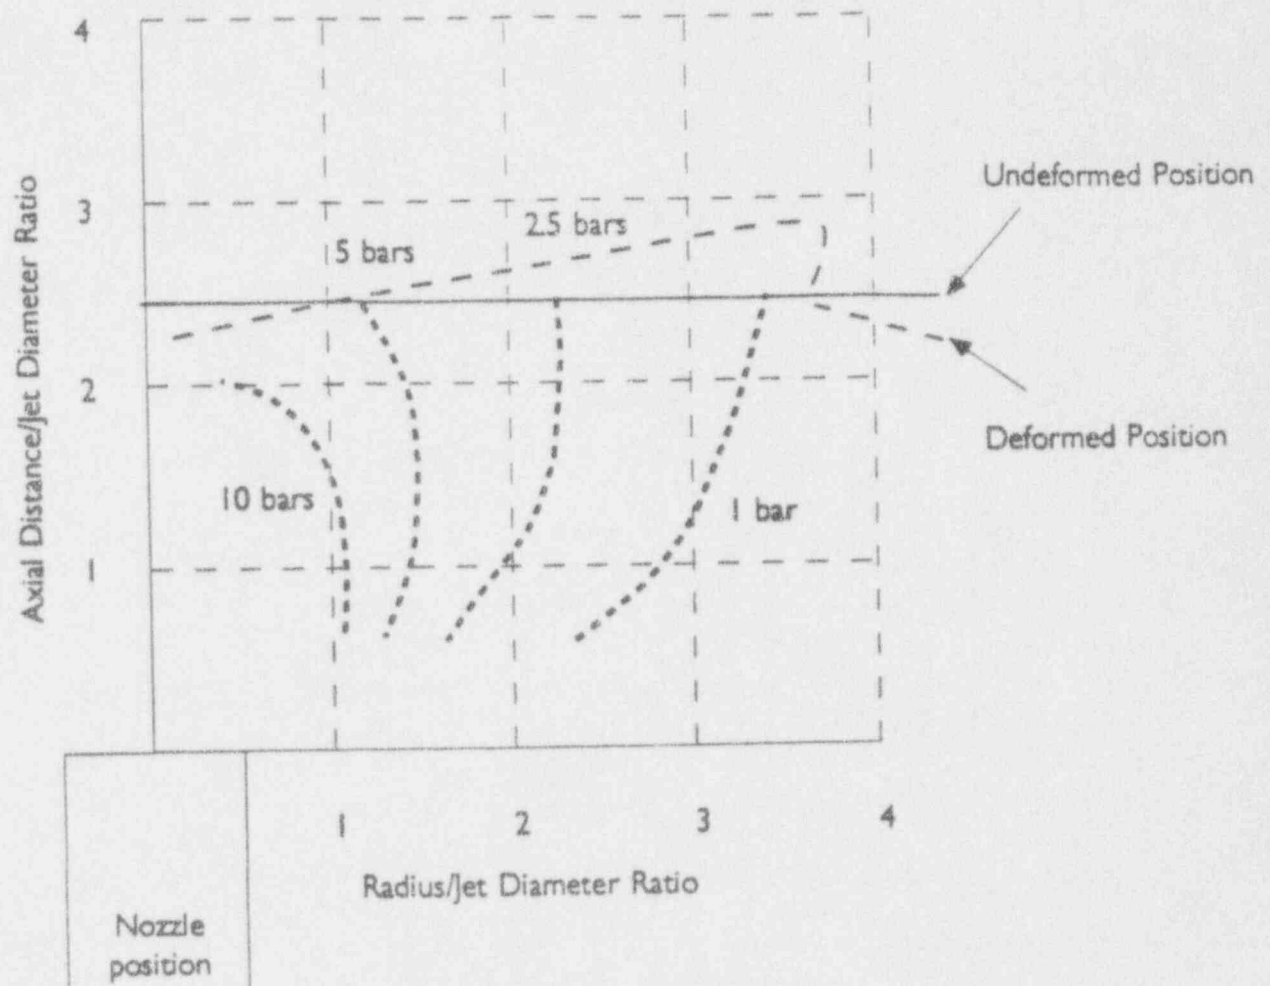
3. The 90° cone of destruction is clearly supported by the damage patterns observed on the metal jackets after Test 3. The 90° cone of destruction is not supported by the Test 8 results because there was no damage to blankets 2A and 2C even though they were located within the 90° cone. The 90° cone of destruction is not supported by the Test 8 results for the same reason. At some distance between 2.2D and 4.0D the jet ceases to continue expanding at a 90° angle.

Figure 32: Deformed and undeformed metal jacket shape (from Test 3) and target pressure contours (from NUREG-0897 figure 3.23). View from the top.

Figure 33: Deformed and undeformed metal jacket shape (from Test 3) and target pressure contours (from NUREG-0897 figure 3.23). View from the side.
