SUBJECT: TRIP REPORT TO NORTH ANNA-2 - FAILURE OF B PHASE
MAIN TRANSFORMER AND SUBSEQUENT FIRE IN THE TRANSFORMER
AREA

SUBJECT: UPDATE ON TRANSFORMER FIRE AT NORTH ANNA POWER STATION,
JULY 3, 1981

SUBJECT: EVENTS AT TMI-2 DURING PREOPERATIONAL
TESTING (SEPTEMBER 5-12, 1977)

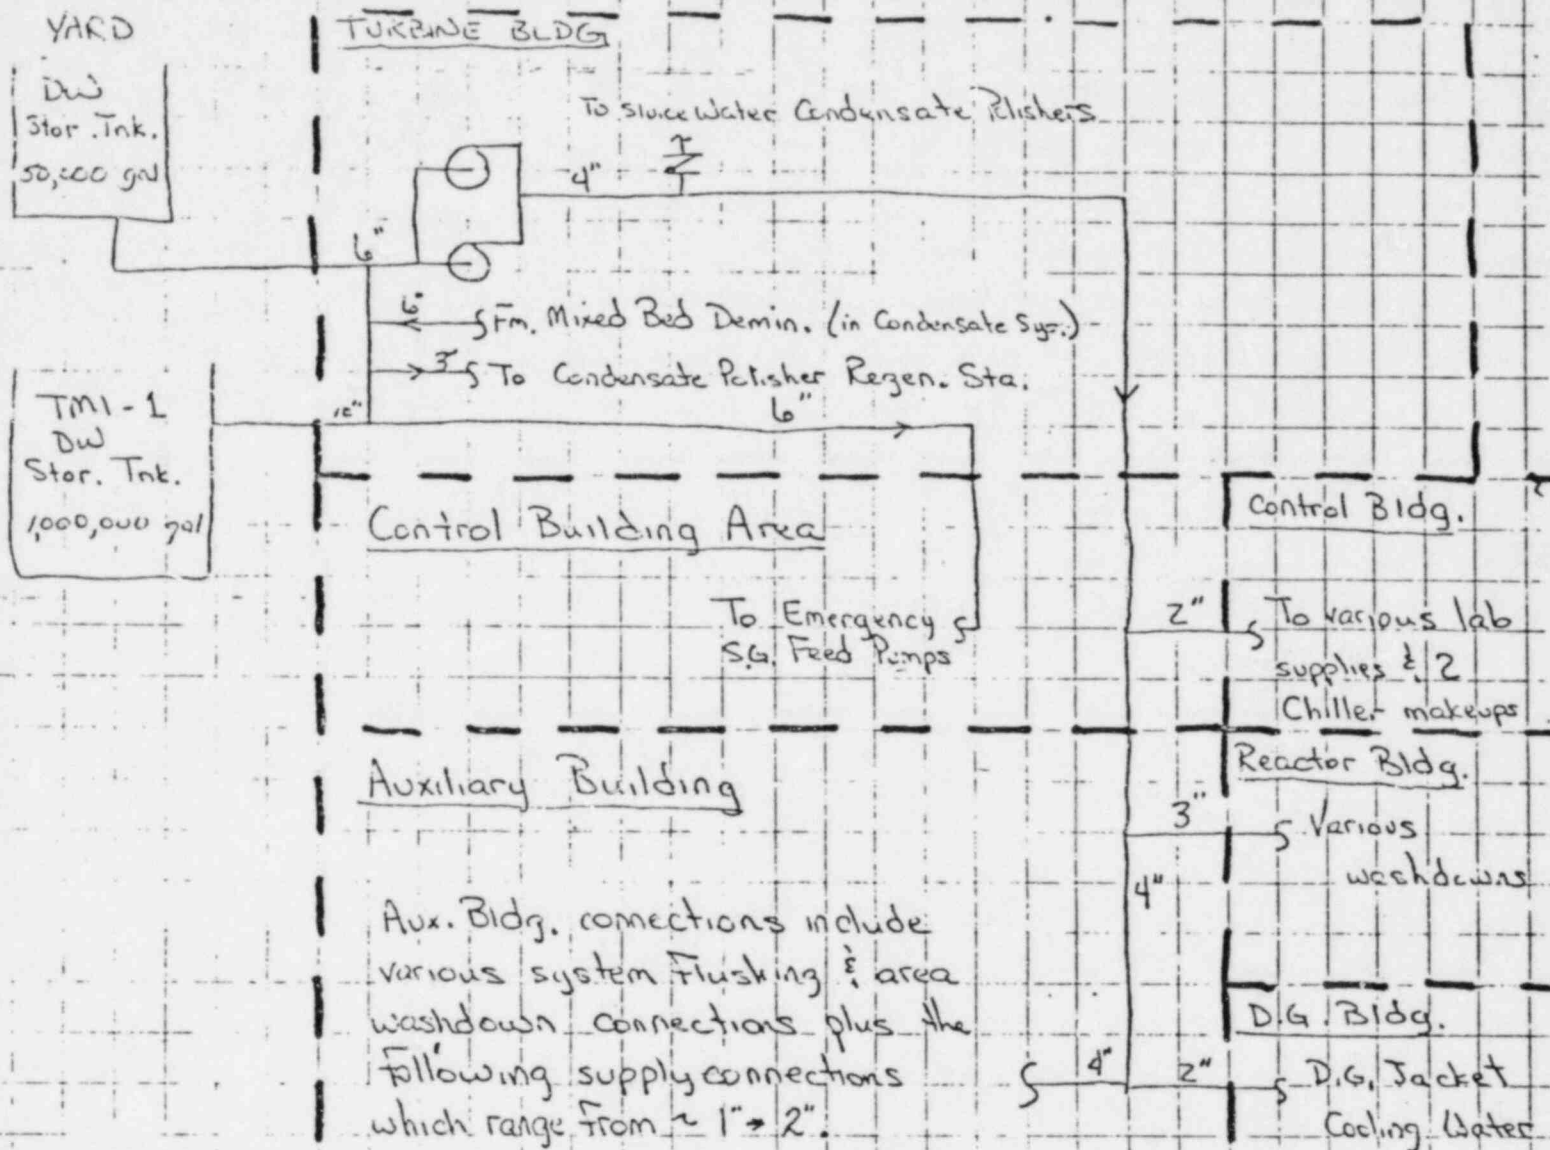
FIGURE 1

1. The polisher malfunction resulted in the introduction of resins into the demineralized water system. The polisher system-interfaces with the demineralized water system so that polisher water can be diverted to the demineralized water system, and demineralized water can be directed to the polisher inlet. It is not clear from the log sheets exactly how the alignment or alignments were such that the resins migrated from the polisher to the demineralized water system, but they did.

2. The logbook indicated (9/7/77, 1st shift) that resin (from the polishers) was found in the demineralized water system in the turbine and auxiliary buildings. The resin clogged the pump suction strainers of all the Nuclear Service Closed Cooling Water (NSCCW) pumps. Figure 1 is a simplified piping diagram of the demineralized water system (based upon TMI FSAR figures 9.2-9 and 10.4-1). As shown in Figure 1, some of the important systems and components in the auxiliary and turbine buildings which connect to the demineralized water system are:

Simplified Piping Diagram for the Demineralized Water System

Note that piping which does not directly relate to polishers or loads have been deleted. Much of the DW system in the turbine bldg. is essentially part of the condensate polishing system

In addition to the obvious recommendations about looking into systems interactions, polishers, demineralized water systems, etc., in retrospect it might be worthwhile to pursue installation of a "reactimeter" in all plants prior to startup testing so that important operational data (potential precursors) may not be lost.
