CONTAINER ASSESSMENT — CORROSION STUDY OF HLW CONTAINER MATERIALS

QUARTERLY PROGRESS REPORT
JANUARY - MARCH 1982

T.M. Ahn and P. Soo

NUCLEAR WASTE MANAGEMENT DIVISION
DEPARTMENT OF NUCLEAR ENERGY, BROOKHAVEN NATIONAL LABORATORY
UPTON, LONG ISLAND, NEW YORK 11973

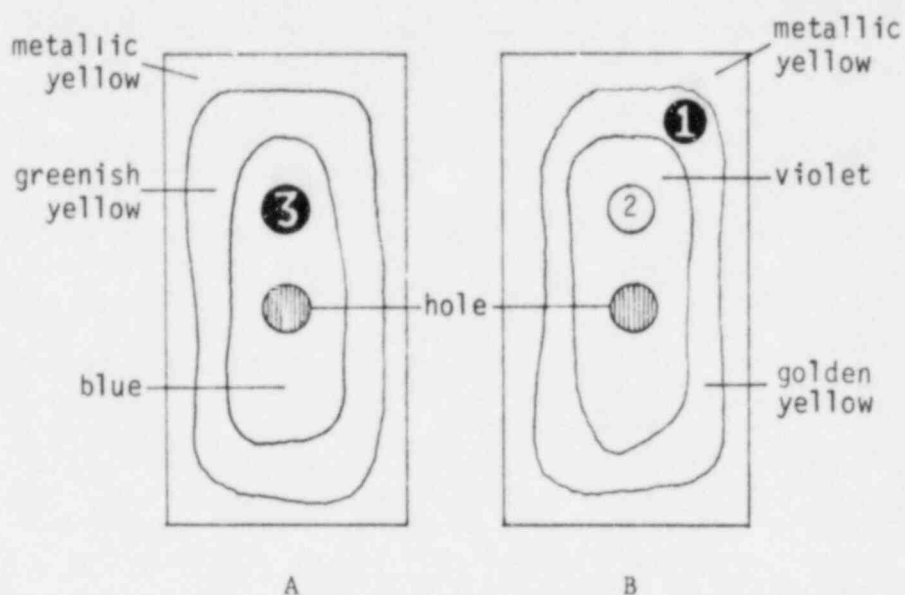
As shown in Figure 1, three samples taken from films with different colors were prepared. The yellow film (position 1, Figure 1) showed crystals with different shapes including pointed and block shaped crystals (Figure 2). All the diffraction rings for the crystals match the peaks for the anatase form of TiO_2 , except one peak at $d = 1.76\text{\AA}$.

Figure 1. TiCode-12 specimens from which TEM samples were prepared. 1, 2, and 3 denote the locations of the areas studied. Surfaces A and B faced each other to form the crevice. The crevice specimen was immersed in Brine A at 150°C for 24 days.

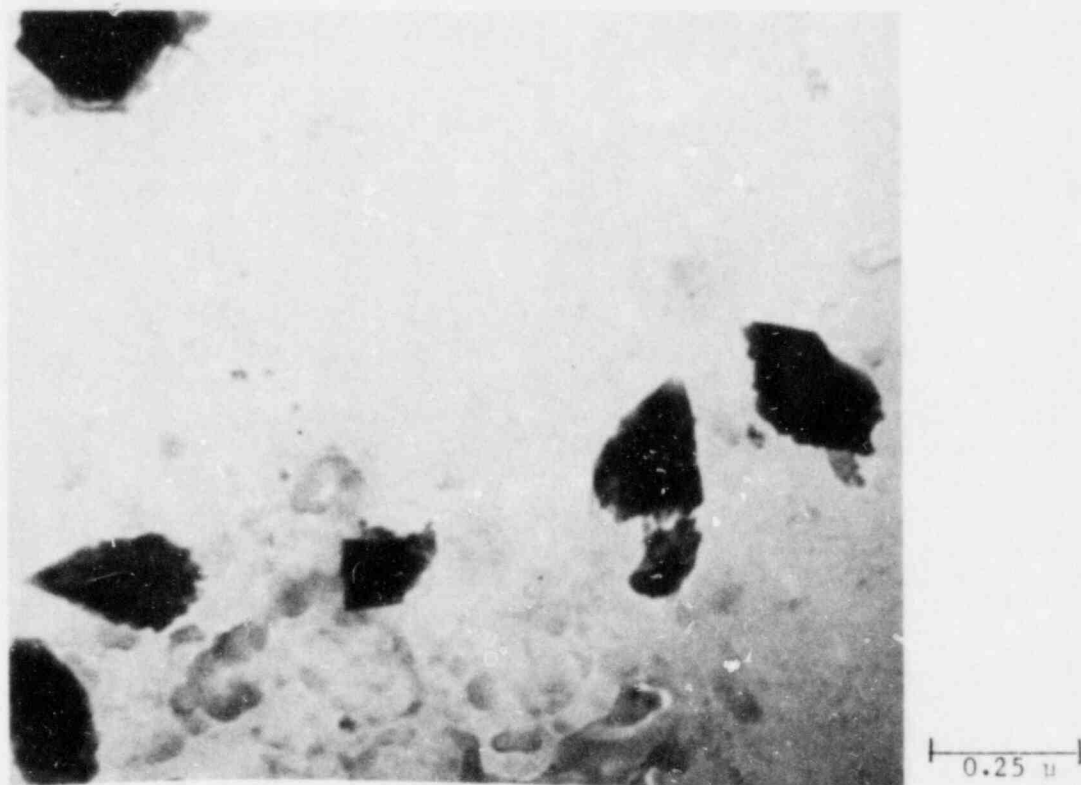
Figure 2. The TEM microstructure of the yellow film formed in position 1 showing pointed and block-shaped crystals.

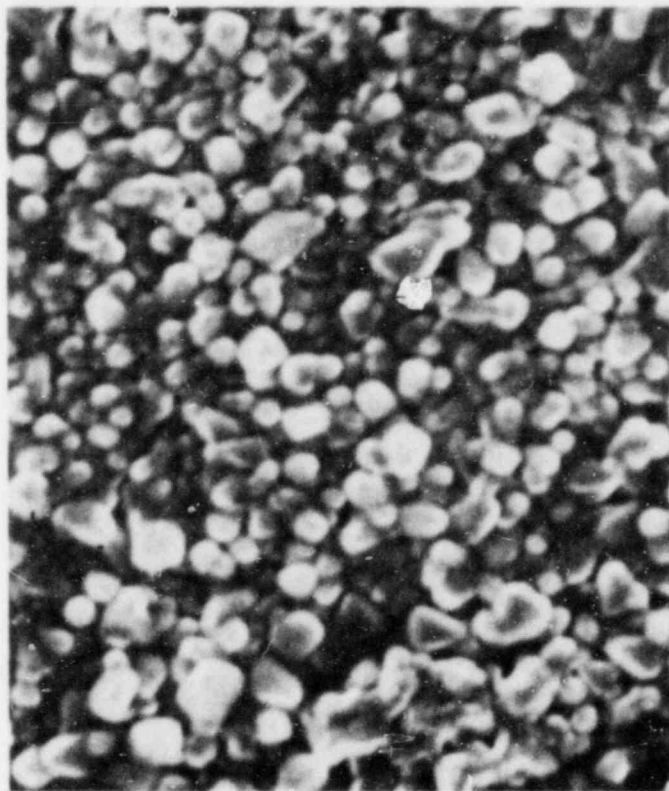
The violet film (position 2, Figure 1) showed mostly block shaped crystals with a few pointed crystals. The diffraction patterns show strong anatase (TiO_2) peaks, with two extra weak peaks at $d \approx 2.13$ and 1.75\AA . Figure 3 is an SEM (Scanning Electron Microscopy) photomicrograph of this violet film.

Figure 3. SEM photomicrograph of the violet film formed inside the crevice of TiCode-12.

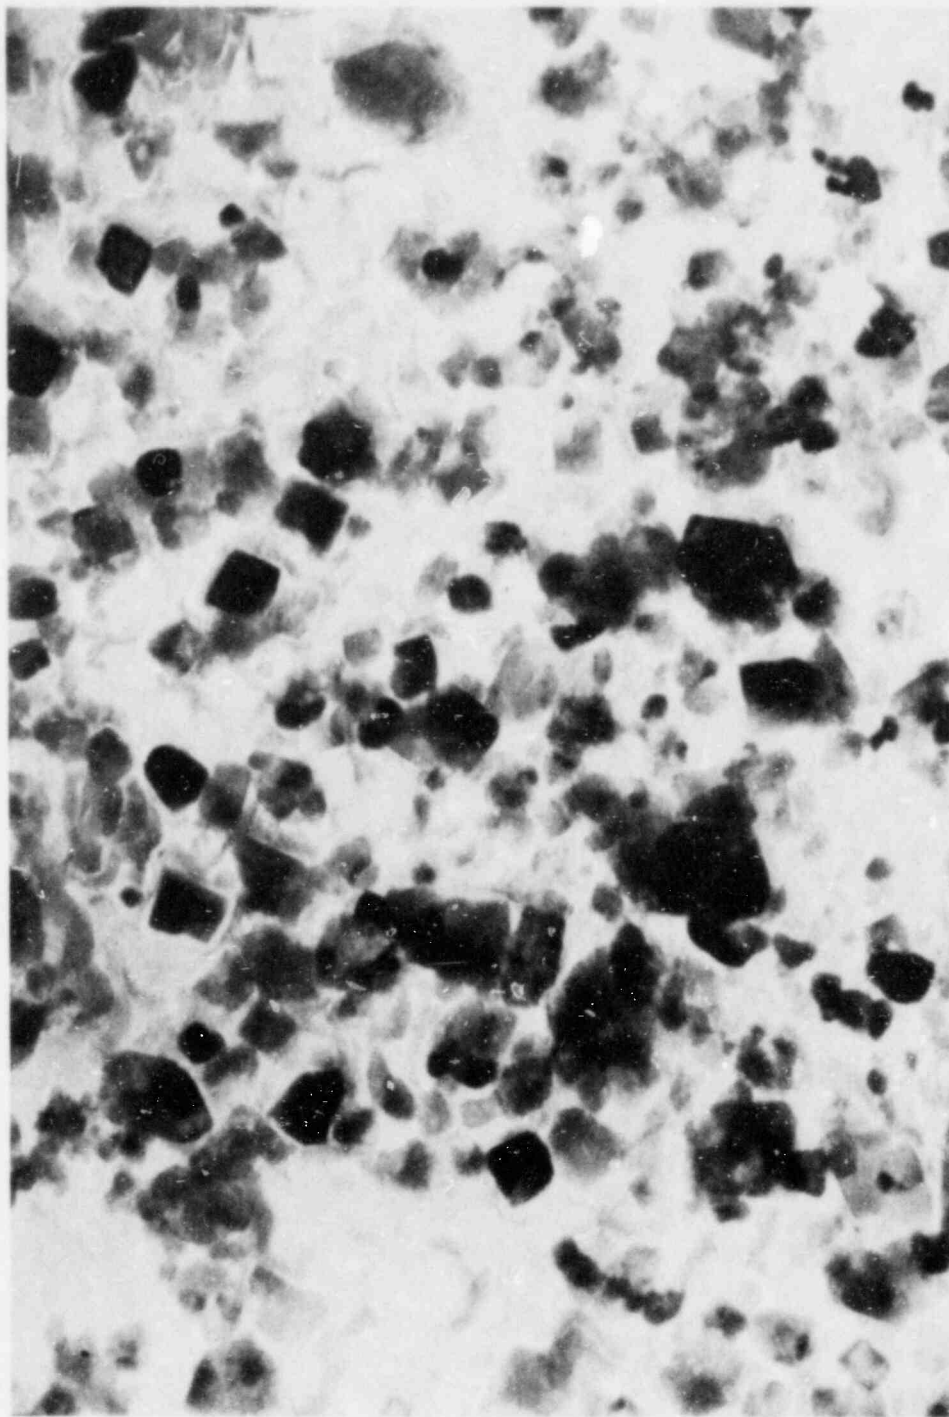
The blue film (position 3, Figure 1) consisted mostly of block shaped crystals with almost no pointed crystals, as shown in Figure 4. All the strong peaks were identified as those from anatase (TiO_2). Additional peaks ($d \approx 2.85, 2.15, 2.03, 1.77, \text{ and } 1.41\text{\AA}$) were observed although they were very weak.

Figure 4. The TEM microstructure of the blue film formed inside the crevice of TiCode-12.

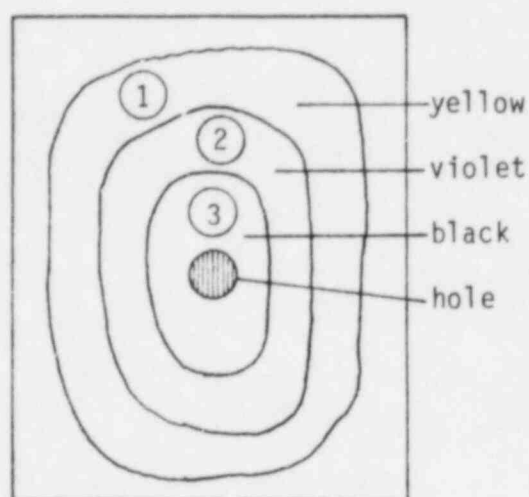
Figure 5. CP titanium crevice corrosion specimen from which TEM samples were prepared. 1, 2, and 3 denote the locations of the areas studied. The crevice specimen was immersed in Brine A at 150°C for 12 weeks.

As shown in Figure 5, three samples with different colors were prepared from crevice regions. The yellow film (position 1, Figure 5) shows all the diffraction peaks of anatase with one very weak peak at $d = 1.75\text{\AA}$. The crystals do not have definite shapes, but are aggregates of small crystallites.

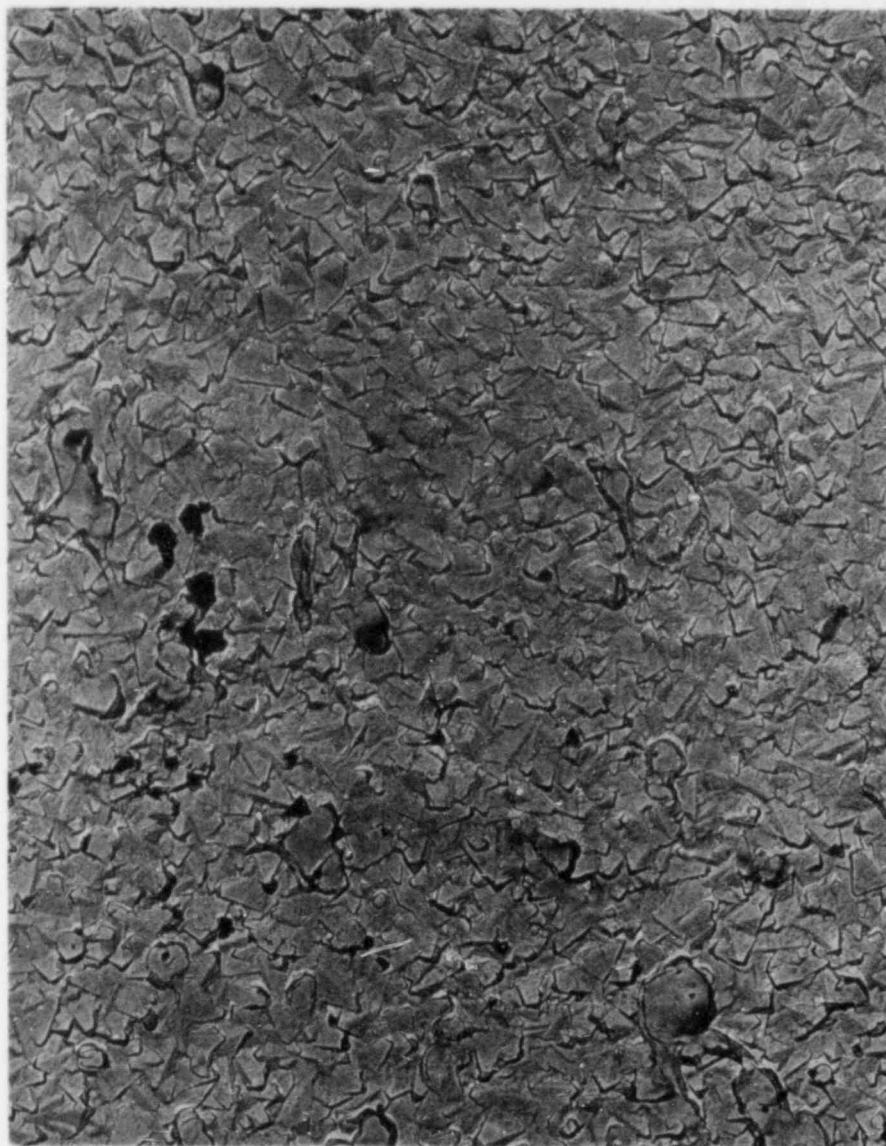
The diffraction pattern of the violet film showed all the peaks expected for anatase. The additional peaks were much stronger than those from TiCode-12 samples, and were more numerous. Figure 6 shows a carbon replica of the anatase crystals.

Figure 6. Carbon replica of an anatase form of TiO_2 formed inside the crevice of CP titanium.

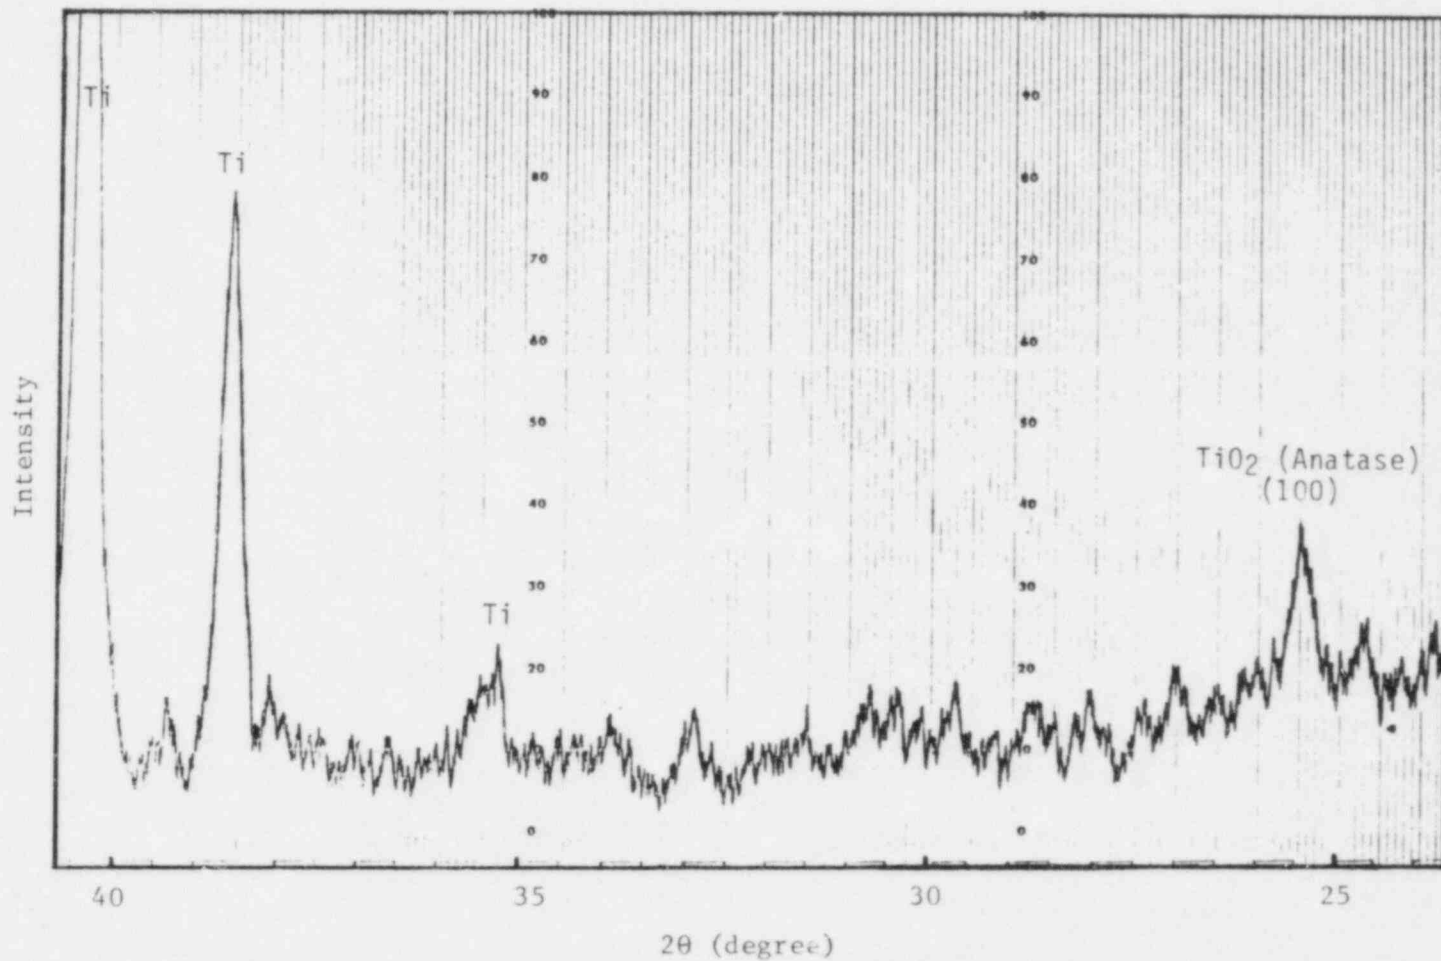
X-ray diffraction was also used to identify the crevice corrosion product. Because of the small amount of the corrosion product, only one peak was obtained as shown in Figure 8. However, this clearly matches the major peak of the anatase form of TiO_2 ($d = 3.52\text{\AA}$).

Figure 8. X-ray diffraction pattern of the crevice corrosion product of CP titanium.

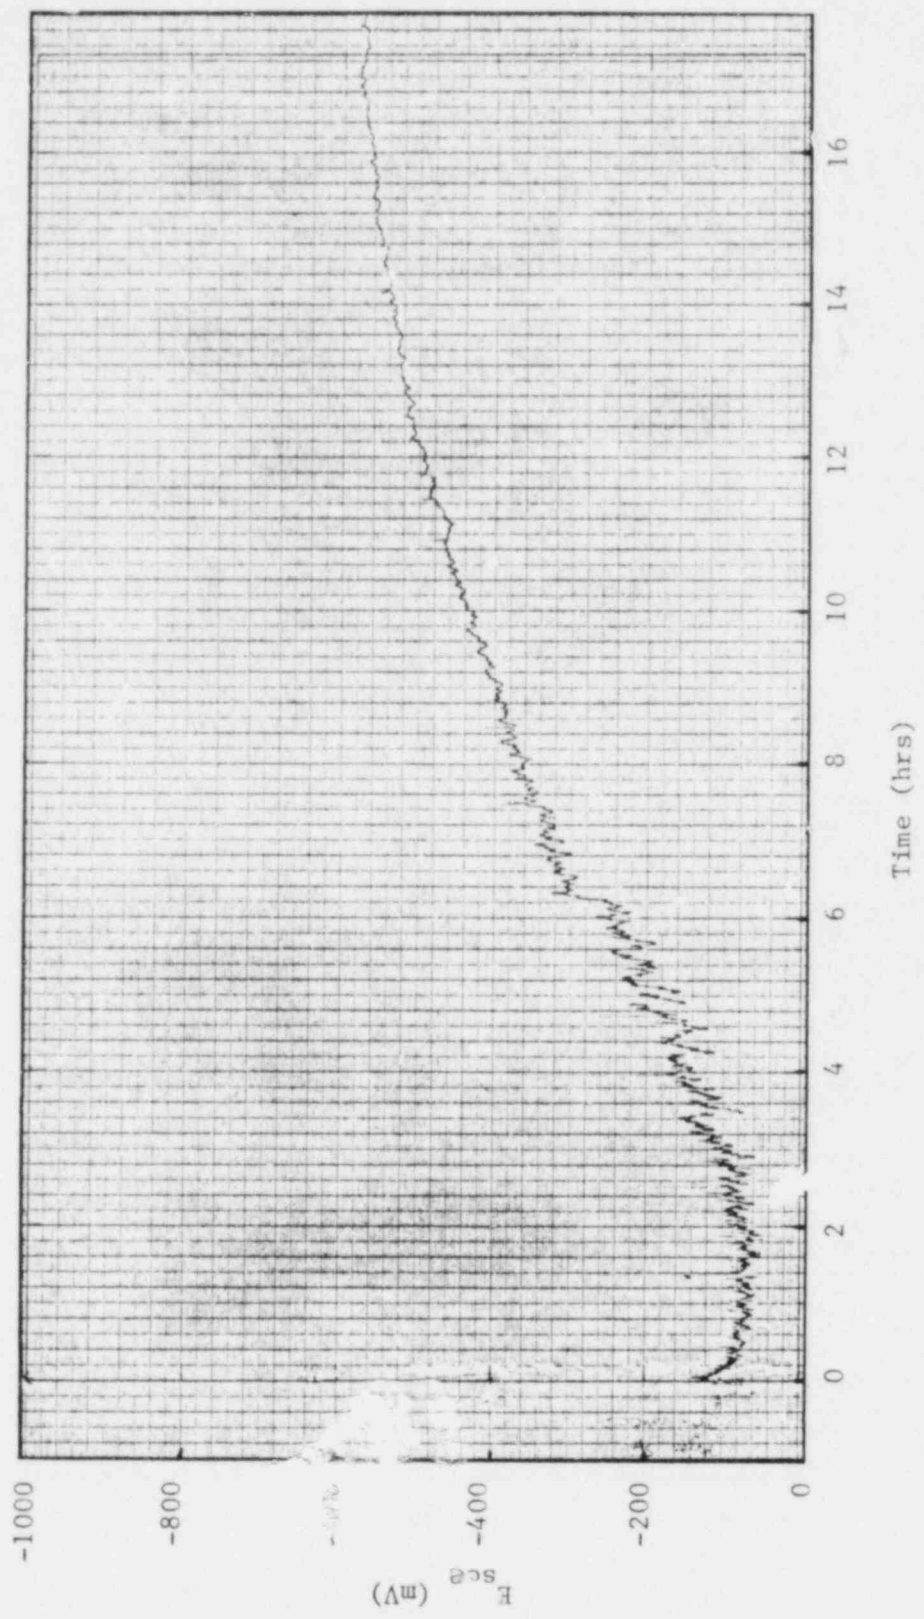
Figure 9. Open-circuit corrosion potential of CP titanium in acidified Brine A at 80°C.

The free corrosion potential of CP titanium suggests that it was initially in a passive state ($E \sim -120$ mV sce, Figure 9) whereas TiCode-12 was not ($E \sim -340$ mV sce, Figure 10). After approximately two-hours' immersion the passive behavior of the CP titanium surface appears to change in that the potential became more cathodic and fluctuated until E was ~ -300 mV sce (Figure 9). The fluctuations probably indicate the ability of bulk impurities in the metal (e.g., Fe) surface to maintain passivation, but which are themselves cyclically depleted and enriched in the surface by dissolution. As film breakdown continues, the facility with which the bulk impurities can maintain passivation is reduced and the potential continues to fall until $E \sim -300$ mV sce. In this potential range, the oxide film is reduced to a monolayer, according to Kelly.⁶ The rapid decrease in potential at this point reported for high purity titanium ($\text{pH} = 0$, $[\text{Cl}^-] = 1$ M) by Kelly⁶ is not observed here and may be due to the continued influence of the bulk impurities.

With continued immersion, the potential decreased linearly at an approximate rate of 34 mV per hour. After about 17 hours, it reached a "steady state" value of $E \sim -620$ mV sce. This potential is similar to the open circuit potential attained by CP titanium under similar conditions following mechanical removal of the oxide (allowing for the difference in $[\text{Cl}^-]$).¹ In fact, this potential ~ -620 mV sce is very close to the potential shown by both Griess⁴ and Kelly⁶ at $\text{pH} = 1$ and $[\text{Cl}^-] = 1$ M to be that associated with the maximum corrosion rate and is independent of temperature.

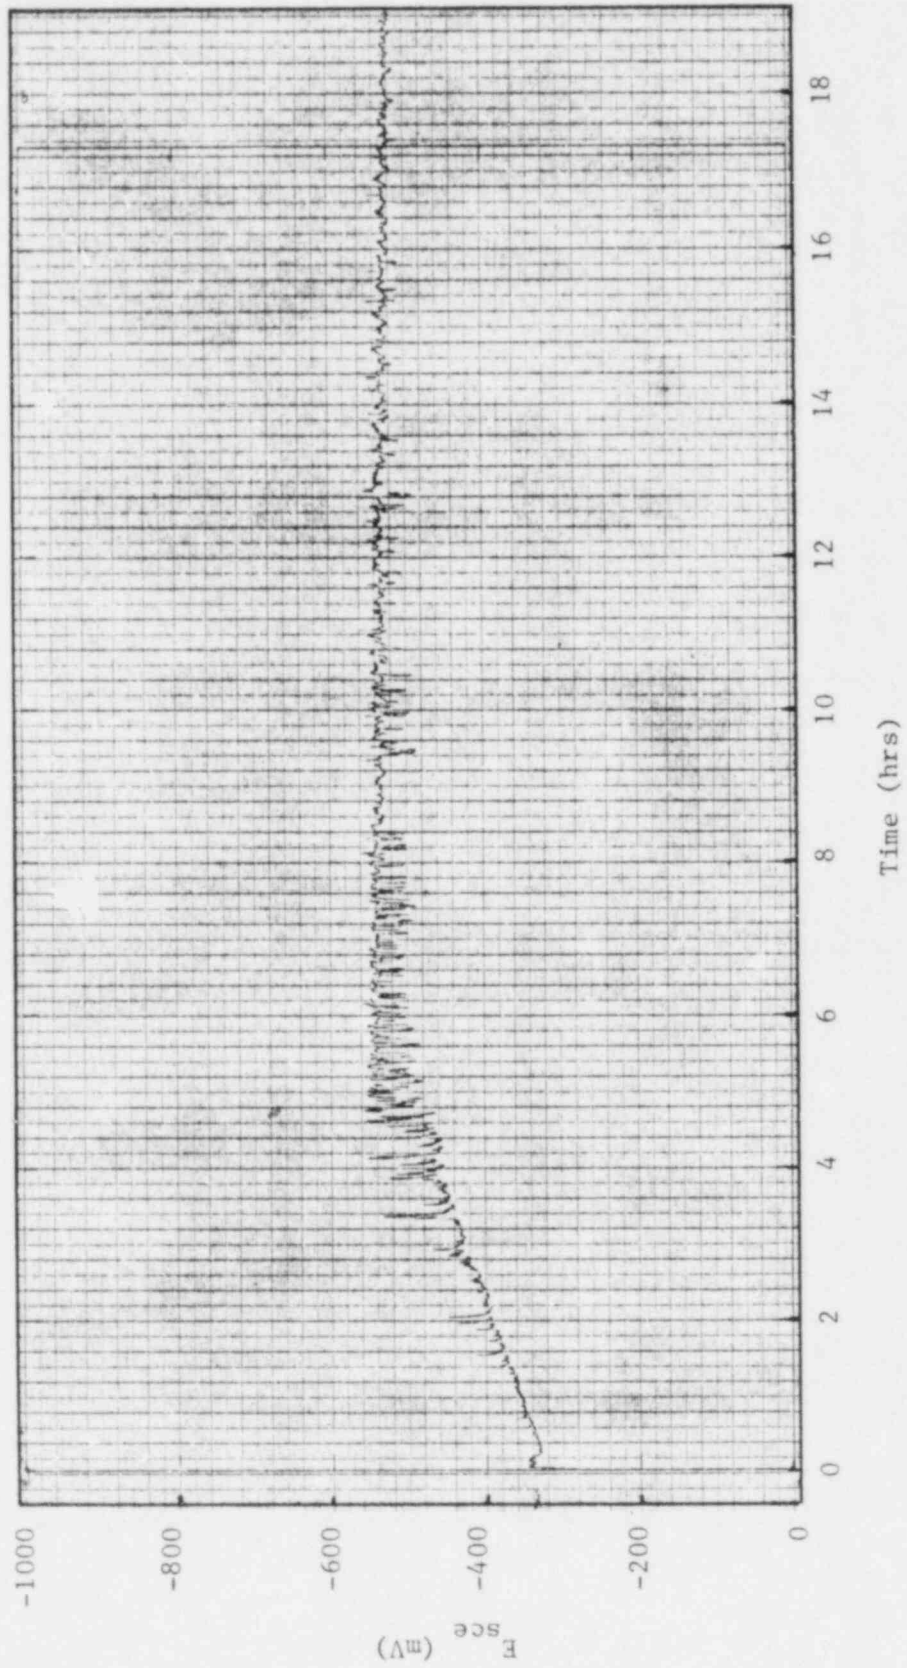
Figure 10. Open-circuit corrosion potential of TiCode-12 in acidified Brine A at 80°C.

The observations for TiCode-12 require further analysis. Previously it was reported that for similar conditions but lower Cl^- concentration ($[\text{Cl}^-] = 1$ M) an abraded TiCode-12 surface attained a potential of approximately -400 mV sce after approximately 83 minutes.¹ After the same time the o/c potential of TiCode-12 in acidified brine reaches approximately the same potential but at this point fluctuations in the potential are noted (Figure 10). It is not considered that these fluctuations are due to the same source (i.e., bulk impurities such as Fe) as in the case of CP titanium since the potential is considerably more cathodic and the fluctuations are much more rapid. Reference to work by Griess⁴ reveals that a Ti-1% Ni-1% Mo alloy also exhibited essentially similar potential cycling over a time period of approximately 20 minutes. In this work, the time period was an order of magnitude shorter. Also, the fluctuation ranges from -315 mV sce to -470 mV sce in Griess'⁴ work while the present study shows the average fluctuations varied from -550 mV sce to -480 mV sce, i.e., remaining more or less active. Reference to thermodynamic data allows some pertinent comments to be made regarding this fluctuation behavior of TiCode-12. In the potential range covered by the fluctuations, dissolution of Mo could be expected to be appreciably less than in the case of Ni, after considering the Pourbaix diagrams for Ni and Mo.⁷ Further, in the case of stainless steel containing Mo, the mechanism of crevice corrosion inhibition in acidic chloride environments is

most probably associated with the formation of insoluble MoO_2 which reduces active dissolution.⁸ Hence, it is highly likely that the observed oscillatory potential behavior is a result of varying concentrations of Ni at the surface as a result of the dissolution. After some time, there should be an appreciable buildup of Mo on the surface, reducing the influence of the Ni concentration on the surface behavior. This is illustrated in Figure 10, which shows much smaller potential fluctuations, ~ 15 mV, after approximately eight hours. A buildup of Mo in the surface film would then be responsible for the "steady state" corrosion potential observed after ~ 18 hours.

These results are preliminary. Nevertheless, it can be concluded that the breakdown of the passive film on TiCode-12 in the presence of acidified Brine A is most probably due to the dissolution of Ni as a result of the high halide concentrations used. Continuing efforts will be made to explore this behavior further at higher temperatures and with various halides and oxidant ion concentrations.

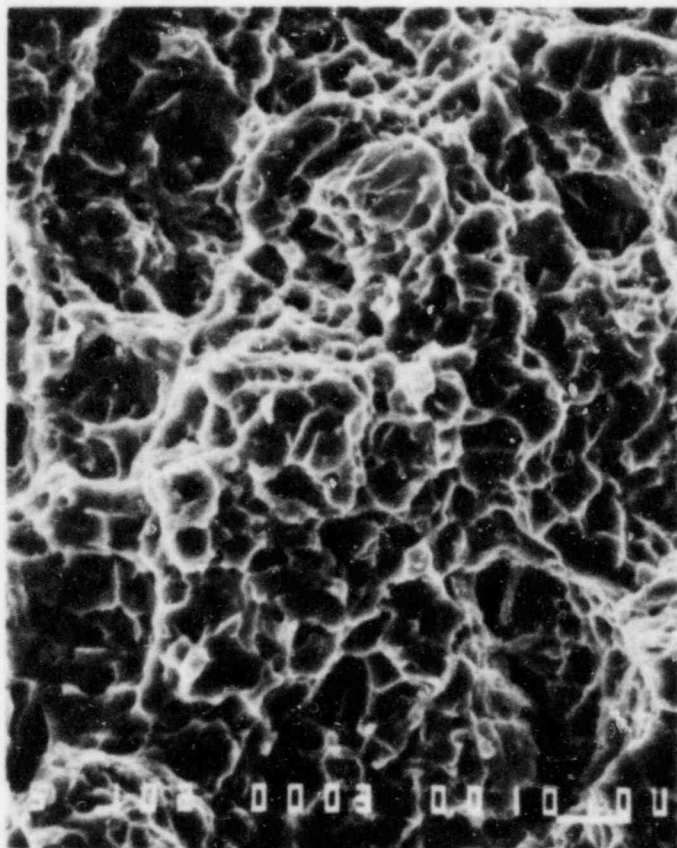
Table 1 shows the approximate K_Q values and hydrogen concentration levels of the tested samples. At a 100-ppm hydrogen concentration, the sample was very ductile with a slanted fracture surface¹¹ suggesting that plane strain conditions had not been achieved for this thickness. The fracture surface is very ductile with dimples as shown in Figure 11.

Figure 11. Ductile fracture of TiCode-12 with a hydrogen concentration of 100 ppm.

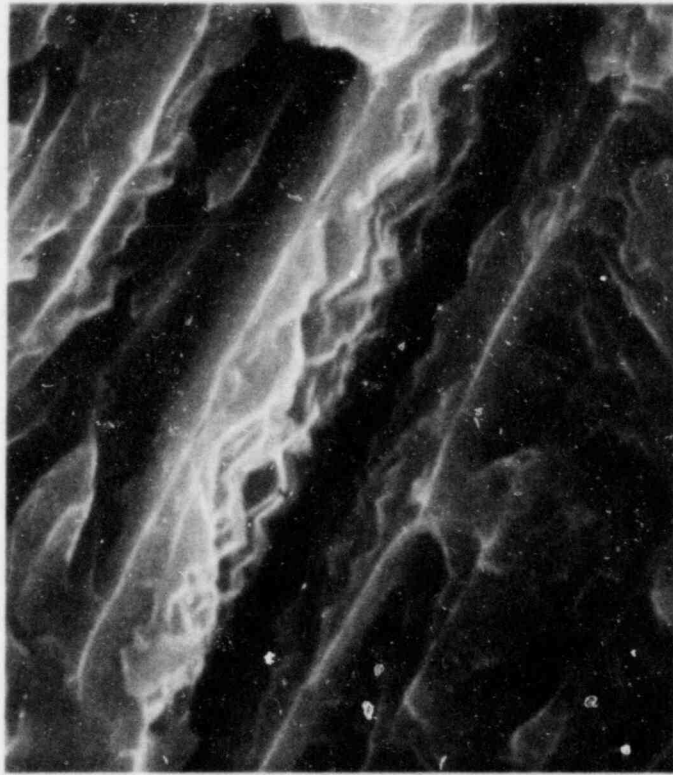
The fractographs obtained for high hydrogen concentrations show both alpha phase cleavage and interface cracking. Figure 12 shows a typical example of an interface crack showing surface facets. When the sample is rotated, the facets may be examined more easily as shown in Figure 13. This figure is quite similar to the fractographs observed in other near-alpha titanium alloys.¹³ Figure 14 shows intermittent crack propagation in a grain and a secondary interface crack developed in the center of the micro-crack. The grain size is much smaller than the figure size indicating that the fracture mode is alpha phase cleavage. The direction of intermittent crack propagation changes depending on the grain orientation. Also, at least two different orientations of crack propagation in one grain are observed. This suggests crystallographic fracture in the alpha grain as discussed by other authors.¹⁴ Figures 15 and 16 show quite clearly this crystallographic fracture. Meyn has identified this feature as the cleavage of alpha phase on or near the (0001) basal plane in Ti-6Al-4V.¹⁵ Meyn,¹⁶ and Blackburn and Williams¹⁷ have found the cleavage-like facets lie approximately 14 degrees from (0001). Figure 17 shows another feature of crystallographic fracture. However, in this case, there is a possibility that the cleavage might be from interface cracking since the interface also has crystallographic features.¹³ Currently, this crystallographic behavior is being investigated using Laue back-reflection techniques to determine the cleavage surface orientation.

As mentioned above, the fractographic observations in comparison to other near-alpha titanium alloys suggest that hydride formation is probably responsible for the hydrogen embrittlement of TiCode-12 at least at hydrogen concentrations above 5000 ppm. The mechanism may be:

Figure 12. Hydrogen induced interface facets formed by brittle interface cracking of TiCode-12 with hydrogen above 5000-ppm.

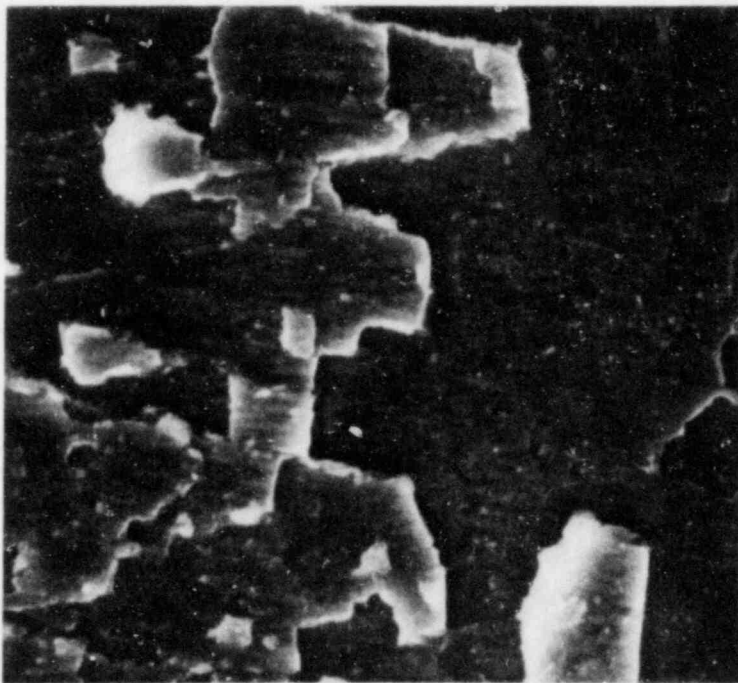
Figure 13. Hydrogen induced interface facets observed after rotation of the sample position in Figure 12.

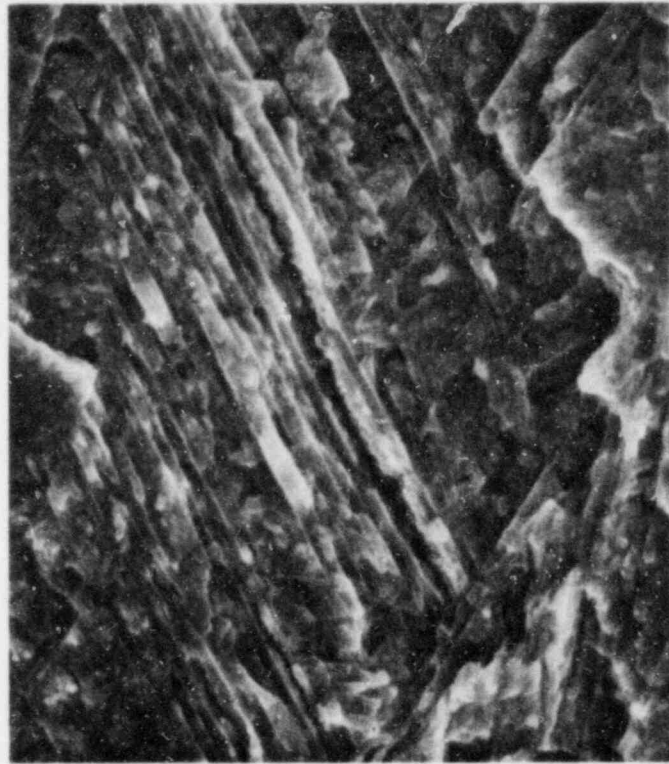
Figure 14. Hydrogen induced intermittent brittle crack propagation in a grain of TiCode-12 with hydrogen concentration above 5000 ppm. Note secondary interface cracking in the center.

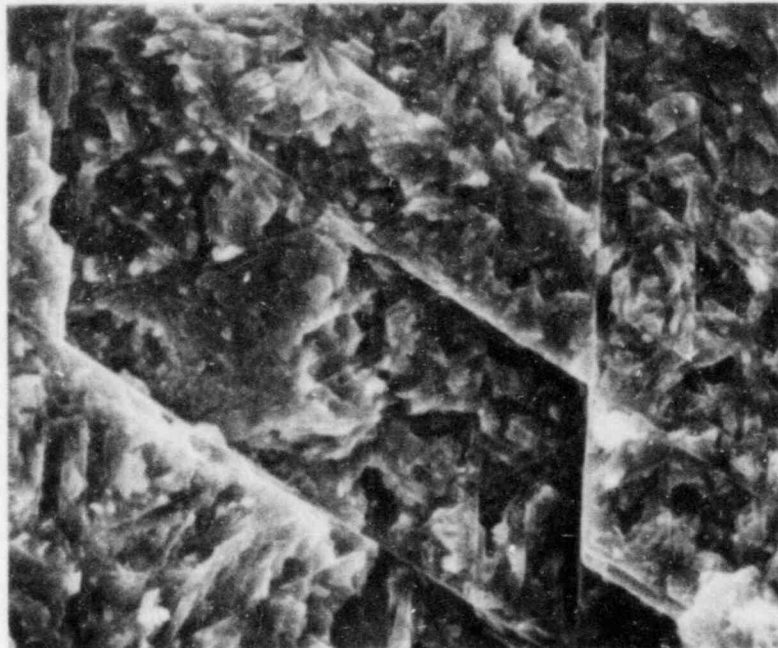
Figure 15. Fracture surface of TiCode-12 with hydrogen concentration above 5000 ppm showing crystallographic fracture, magnification 2000X.

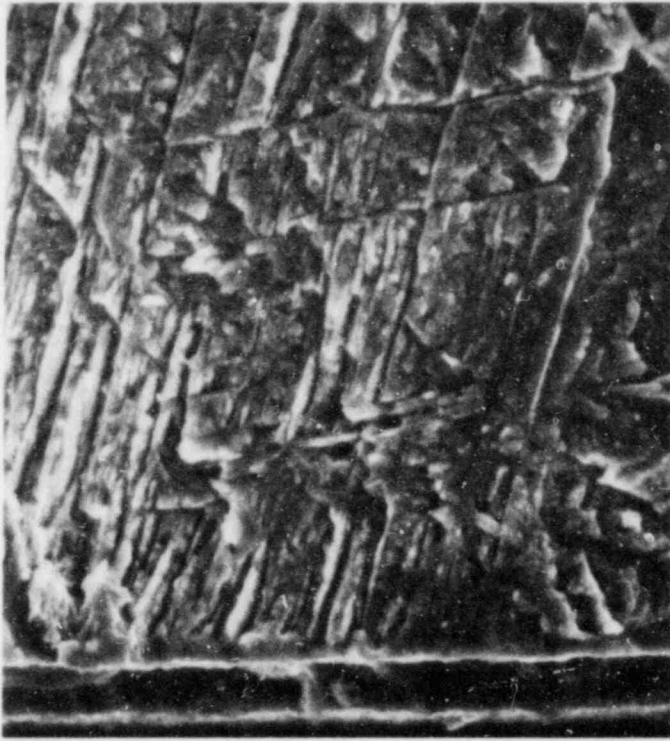
Figure 16. Fracture surface of TiCode-12 with hydrogen concentration above 5000 ppm showing crystallographic fracture, magnification 1000X.

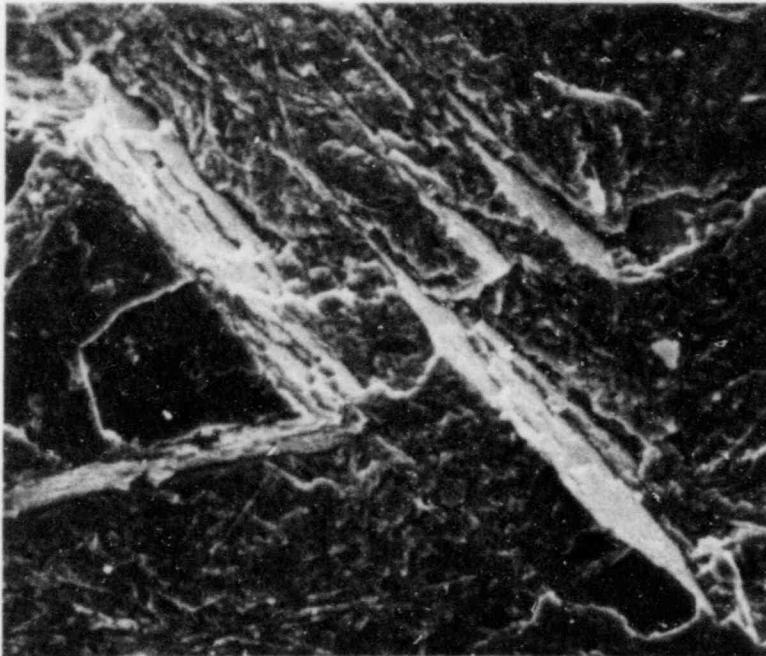
Figure 17. Fracture surface of TiCode-12 with hydrogen concentration above 5000 ppm showing crystallographic fracture, magnification 500X.
