UNITED STATES
NUCLEAR REGULATORY COMMISSION
WASHINGTON, D.C. 20555

OFFICE OF THE
INSPECTOR GENERAL

As you know, the Office of the Inspector General is conducting an investigation which involves welding issues at Seabrook Nuclear Power Station. On November 1, 1990, Special Agent Frank Forgione of this office spoke with Mr. Neal Pillsbury, New Hampshire Yankee (NHY), Director of Quality Programs. Mr. Forgione has indicated that this conversation concerned the NRC Independent Review Team report NUREG-1425 and the need for additional information from NHY by the Office of the Inspector General (OIG).

In order to more clearly understand the Yankee Atomic Electric Company's (YAEC) 100% review of Pullman Higgins weld radiographs, additional documentation is needed. The table compiled by NHY in NUREG-1425 page 14-2, indicates for the year 1982, 537 film packages were reviewed and two film-quality rejects/discrepancies and three administrative-type rejects/discrepancies were identified. The table provided no reject data for the period from 1979 through 1981 when the table lists 636 film packages were reviewed.

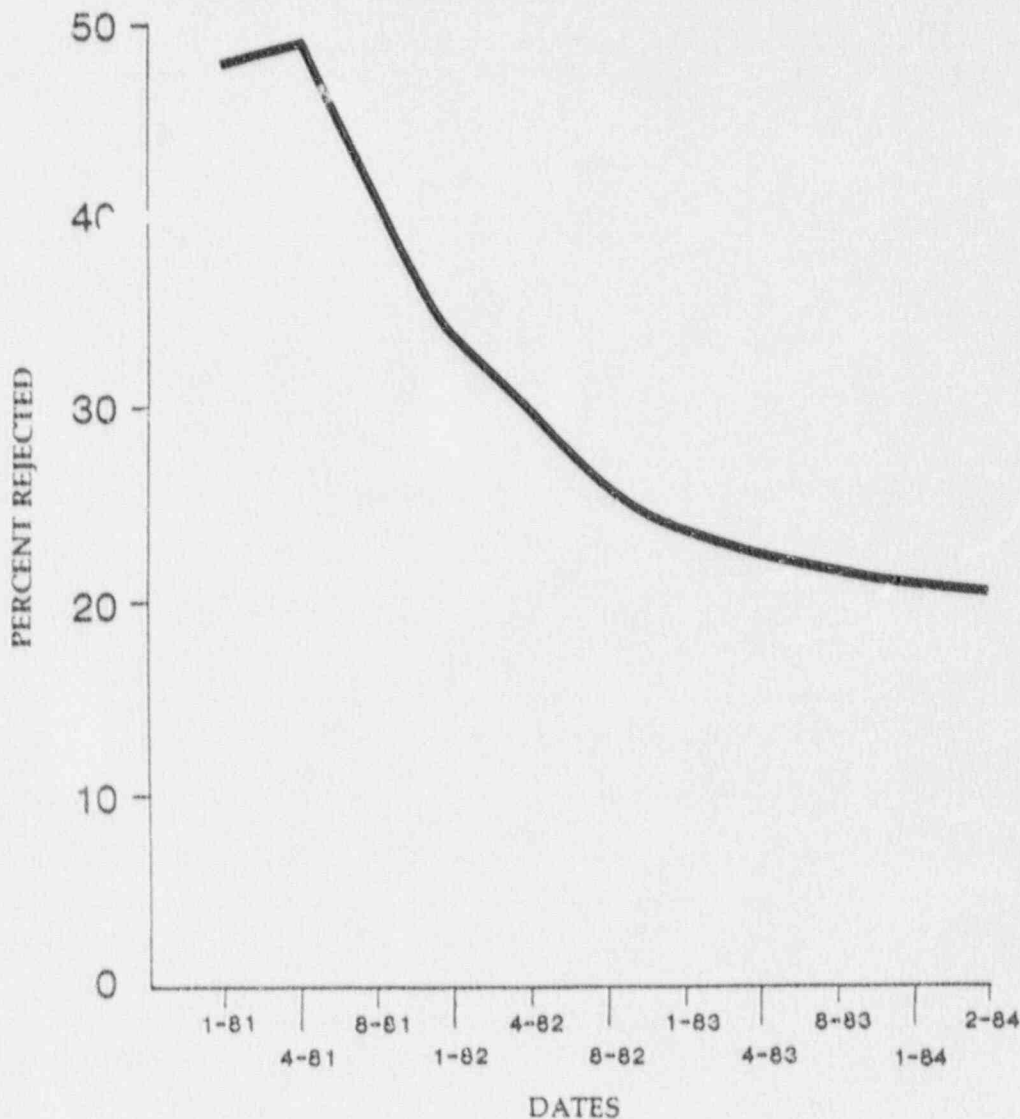
LARGE WELD REJECTION RATE

EXHIBIT VI-49
