Department of Energy

Enclosed for your information is a Class III Project Interface Document (PID) No. 03-S-41 for the Durango, Colorado, Uranium Nill Tailings Remedial Action site. The PID involves a change for the completion date in Specification 01010-1.8.A. In addition, a copy of the previously sent Class II PID 93-S-30 is enclosed per the request of Dawn Jacoby of your staff.

UMTRA PROJECT OFFICE PROJECT INTERFACE DOCUMENT

Site Durango	Date8/09/90	PID No. 03-S-3	Site No. 03	Vic Pro	No.
Originator and location M. L. Wesely, SF	Phone 415/442-751	Organization MKES	Answer By:	Referen	
Subject Redesign of the Di Along Ditch No. 2			inage Outlet		ract Ho:
Description of Problem and Recommend	ed Solution	3 Clarific	tion	Change Change	
PROBLEM 1: A drill locations in the region area are shown in Fig Ditch No. 1 is much de competent bedrock was observation wells (see embankment which contareservoir for water en SOLUTION 1: Revise thend of Ditch No. 1 on Drawing DUR-DS-10-0340	pure 1 and 2, reper than original implemented, the location of we ins the discharging the ditcher outlet struct Drawing DUR-DS	No. 1 outfall. respectively. nally anticip ne excavation lls in Figure ge water of

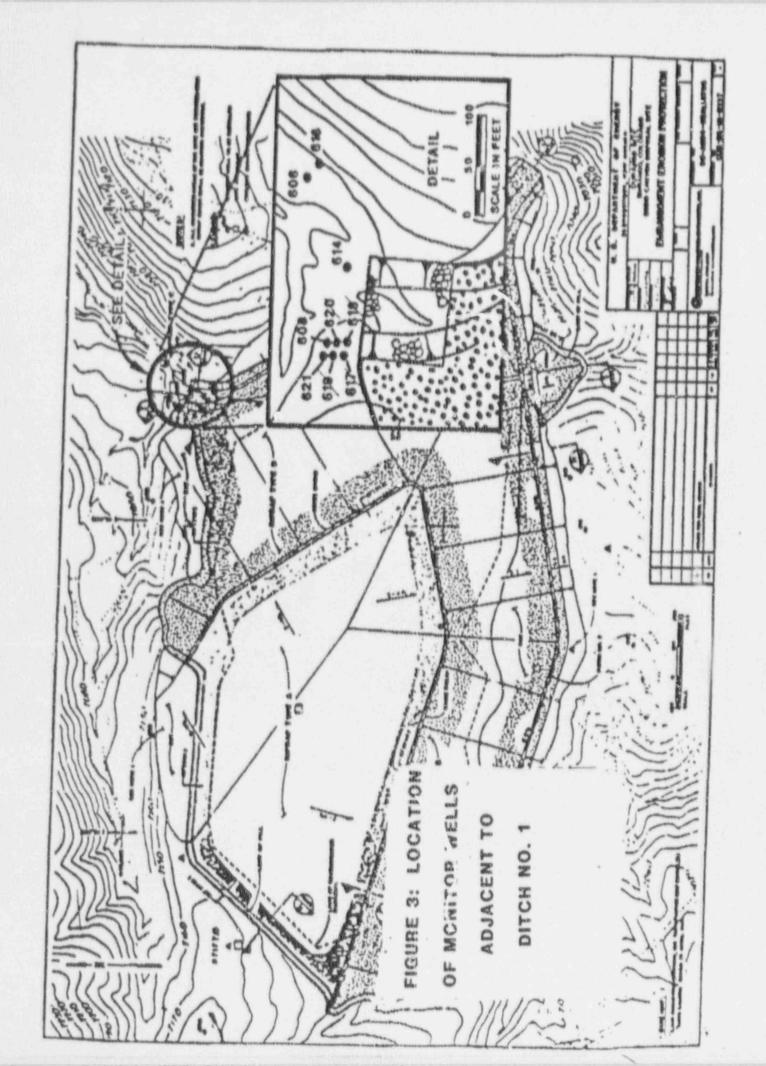
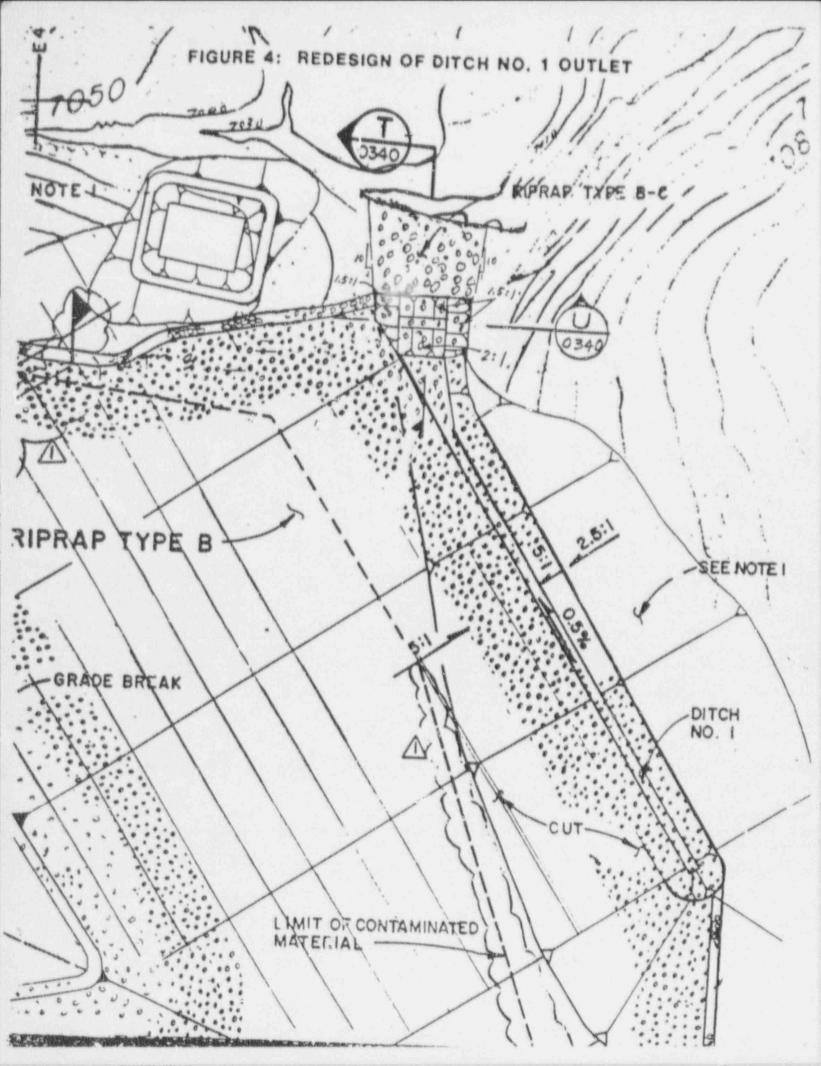
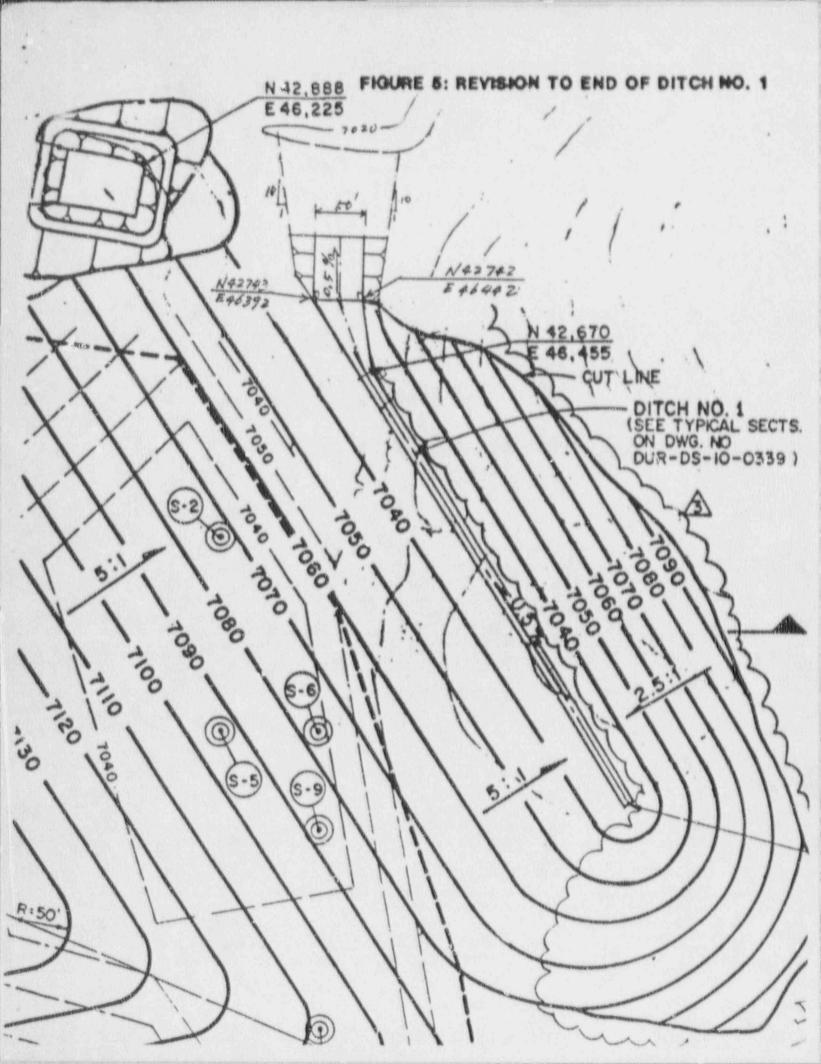
Design of the outlet structure was reevaluated to determine what volume and size of rock would be required to maintain erosion protection for water discharging from Ditch No. 1. The attached drawings (Figures 4, 5, and 6) and supporting calculations present the proposed revisions. Changes include:

o Removal of the words "key into bedrock",

o Slope from ditch into outlet box steepened to 2:1 and subsequent shift of outlet further away from the northern drainage channel.

Addition of a rock apron from the far edge of the outlet to the northern drainage

channel to prevent gully initiation from water exiting the outlet box,

Regrade slope of natural ground towards northern drainage channel to approximately 8:1, and

o Continue 1 foot of Type B riprap from ditch across top of outlet box.
