UNITED STATES
NUCLEAR REGULATORY COMMISSION
REGION IV
URANIUM RECOVERY FIELD OFFICE
BOX 26326
DENVER, COLORADO 80226

JAN 22 1991

MEMORANDUM FOR: Docket File 40-8907
FROM: Joel P. Grimm, Project Manager
SUBJECT: REVIEW OF GEOLOGIC AND GEOMORPHIC ASPECTS OF THE
UNC-CHURCH ROCK RECLAMATION PLAN

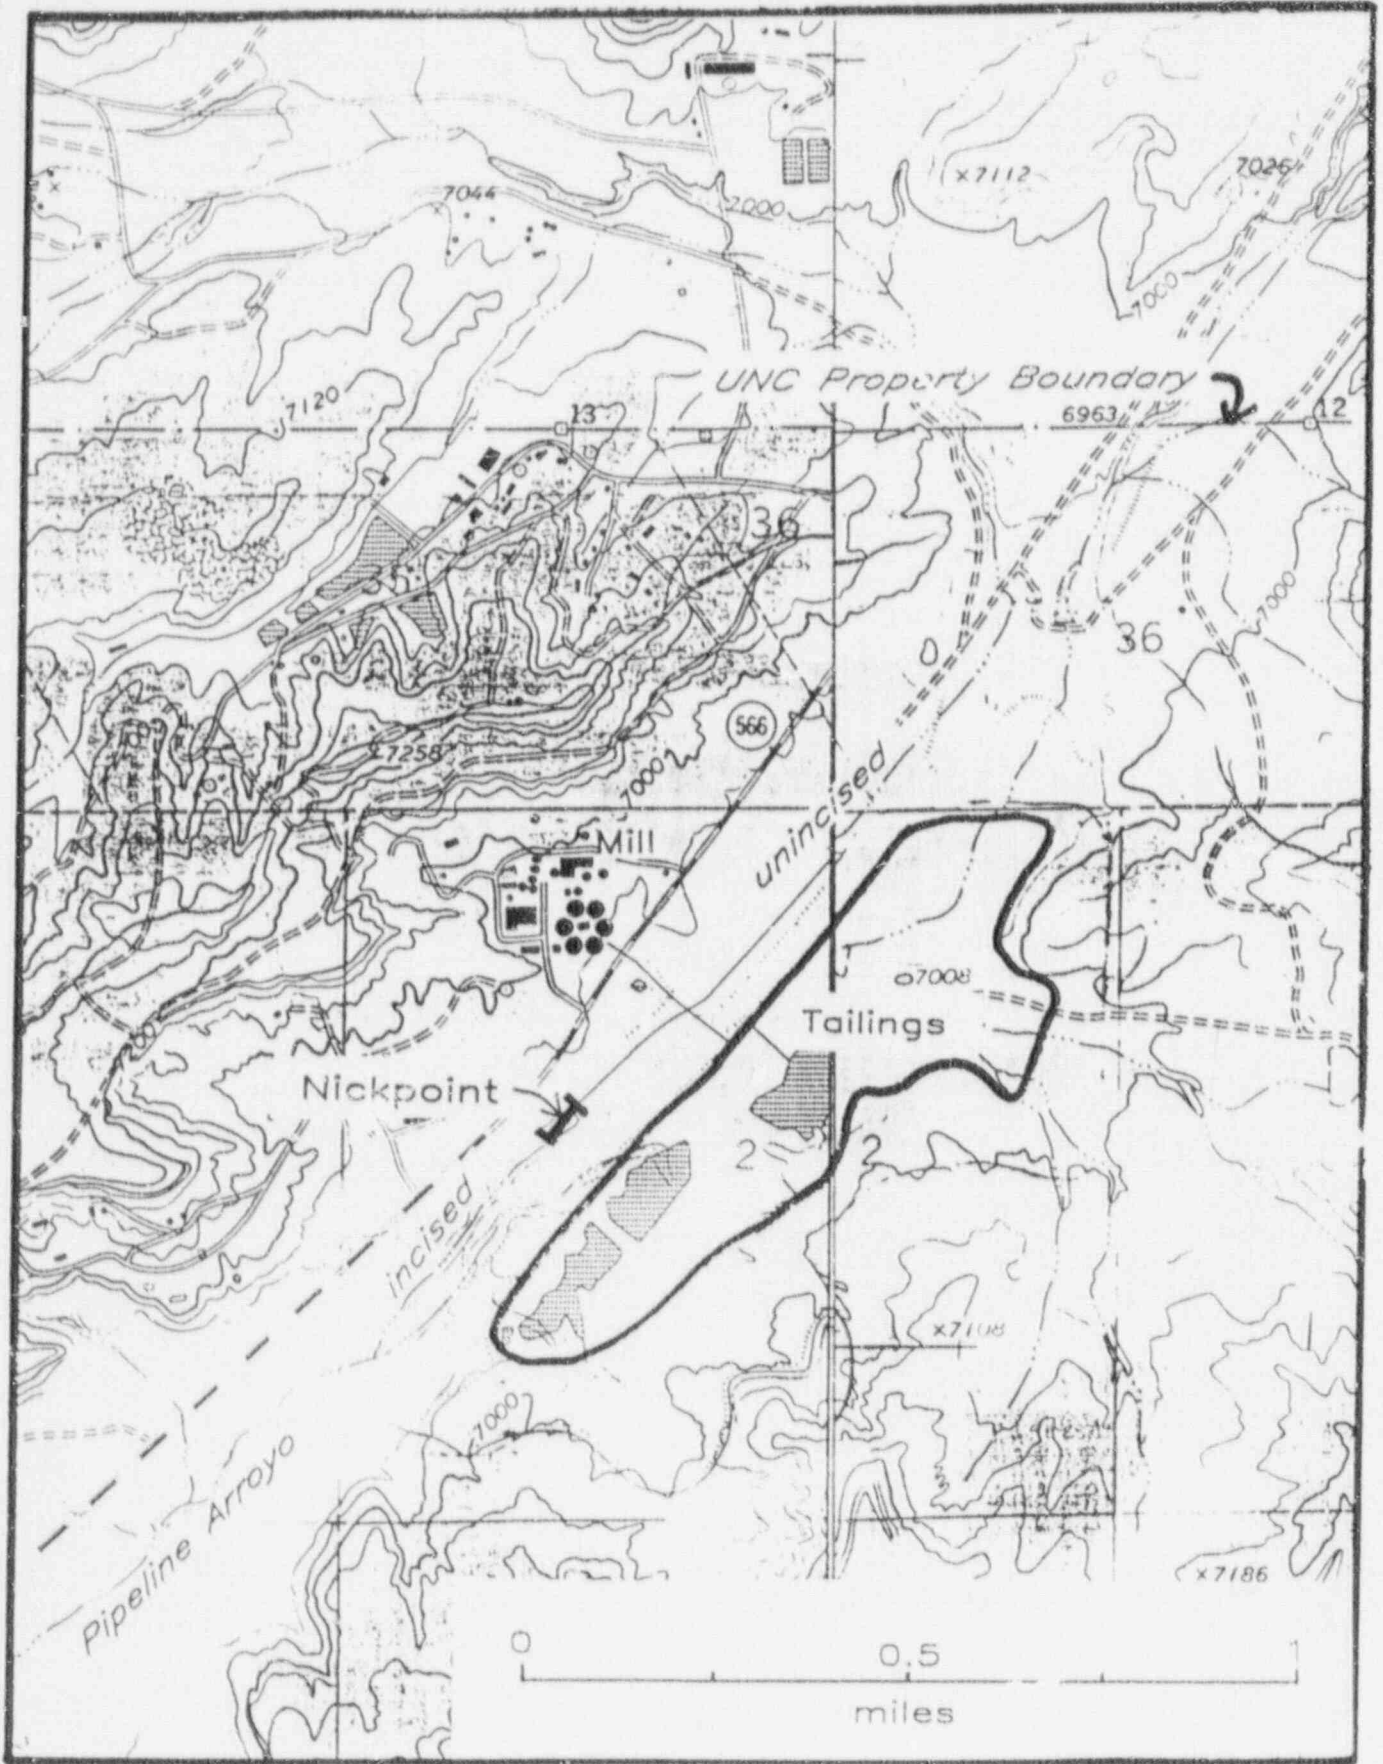
Figure 2: Detailed topographic map of the approximate tailings disposal area and its relationship to Pipeline Arroyo.

Pipeline Arroyo is a channel incised in excess of 10 meters adjacent to the pile (fig. 2). The arroyo's vertical banks are subject to mass wasting and erosion, as revealed by aerial photographs and field observations. The channel gradient in the deeply incised area is approximately 0.018. The arroyo has headcut upstream from the Rio fuerco. Approximately one-third of the way northward along the tailings pile, Pipeline Arroyo encounters resistant sandstone bedrock in its channel. The channel rises steeply in a short distance, resulting in a nickpoint that comes to nearly the same elevation as the valley floor. The arroyo no longer occurs upstream, and the channel is unincised on a wide valley floor (fig. 2). The unincised area is a sediment storage area, maintaining a very low channel gradient of only 0.002 (Table 1).

The applicant's goal is stabilization of the pile for the required 1000 years, using a PMF as the design basis. The applicant originally proposed to excavate through the nickpoint, creating one continuous, straight, and deep channel from the northern property boundary (fig. 2) to beyond the southern end of the tailings pile. The design included lowering the channel in excess of 8 meters at the nickpoint, creating 2:1 sideslopes in the bedrock reach, knocking down the vertical gully walls in alluvial reaches to 3:1 sideslopes, and steepening the channel gradient upstream to about 0.008, and downstream up to 0.025. The goal of this design was to contain the PMF within the excavated channel, preventing high-velocity flow along the tailings embankment. The entire reach of Pipeline Arroyo along the tailings and up-valley would be channelized, and would mostly occur in alluvium. Most importantly, the tailings embankment is adjacent to the channel for a distance exceeding 400 meters, with no intervening buffer area.

Considering the site characteristics and geomorphic concepts discussed above, it is concluded that geomorphic conditions downstream of the nickpoint are unstable, and the southern one-third of the tailings pile is in jeopardy of becoming involved in arroyo widening. In addition, removal of the nickpoint and channelization of the northern area will result in destabilization of that area, including the area where no buffer area occurs between the embankment and channel. Specifically, the unincised area's valley gradient is probably as steep as is stable. If a gradient steeper than 0.002 were stable, excess sediment would have been deposited upstream to raise valley slope. Thus, the northern part of the site will become susceptible to basin rejuvenation if altered. Without considerable engineered enhancements to this design, it is concluded that the proposal is not likely to provide stabilization of the

- 1) Changing the proposal to excavate the northern channel. Instead, the existing channel will be altered only to provide a low-flow channel 30 feet wide from the northern property line to the nickpoint. Erosion of the tailings embankment during extreme events will be minimized by construction of an erosion resistant berm along the embankment interceptor ditch at the calculated level of the PMF.

- 2) Abandoning the proposal to remove the nickpoint by excavation. Instead, the nickpoint will be reinforced with a buried riprap jetty from the exposed bedrock, through the subsurface, to the tailings embankment. This proposal will provide stable base level for the drainage basin north of the nickpoint.

- 3) Leaving the arroyo south of the nickpoint relatively unaltered. The area known as the sacrificial slope will be regraded to promote sheet flow of direct runoff. In addition, the base of the tailings embankment will be ringed by an interceptor ditch, and runoff from the embankment will be diverted to a controlled structure.

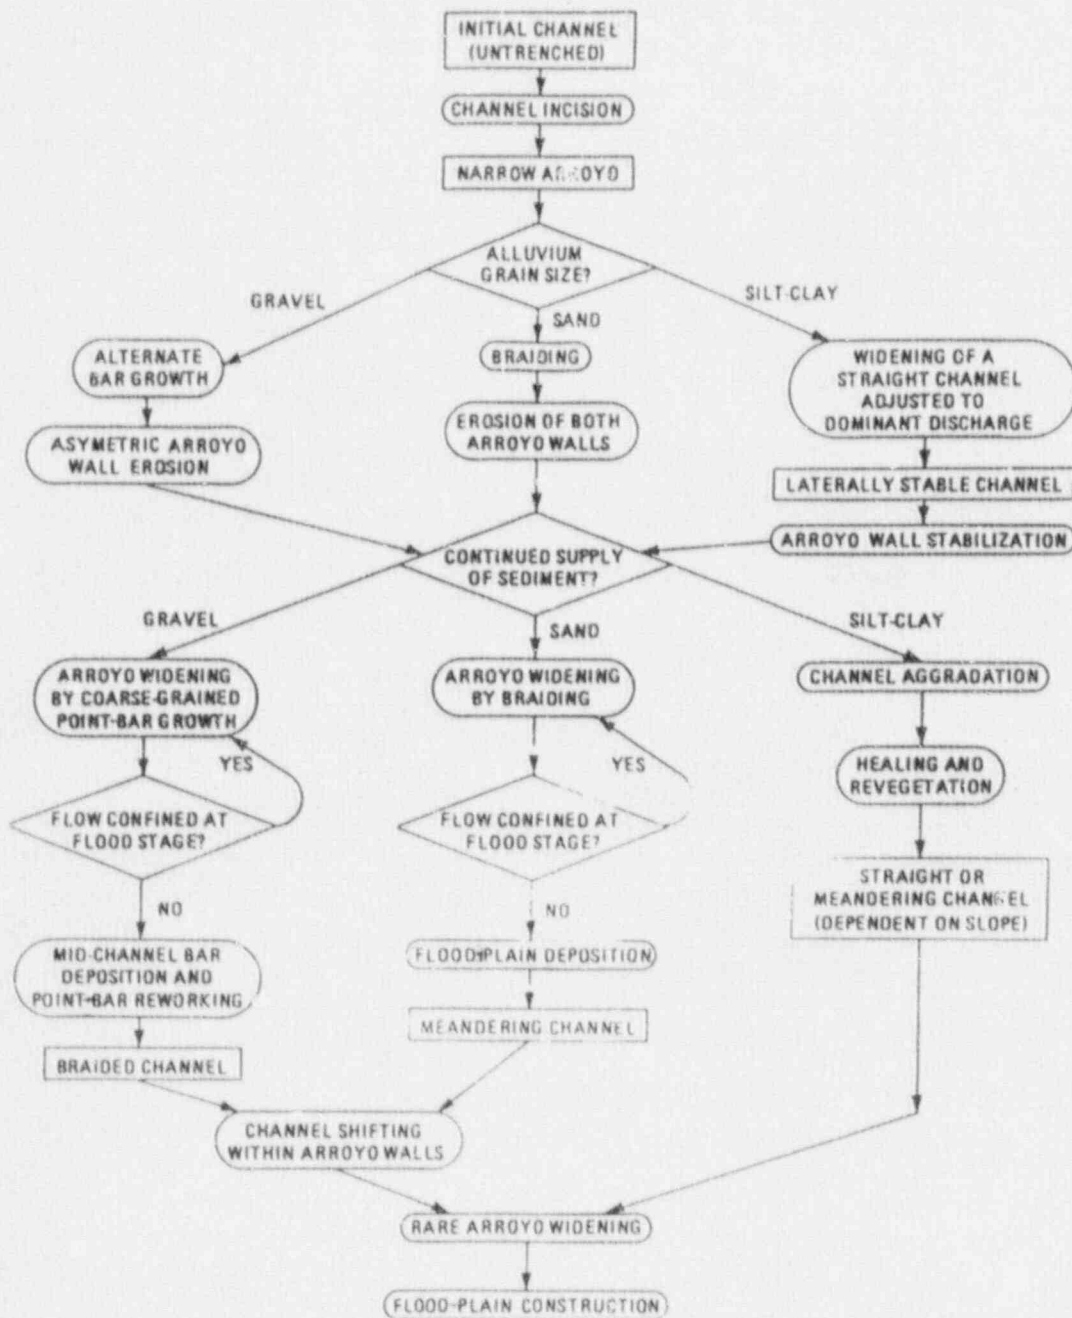
Figure 3: Model of arroyo development in different sediment, based on field studies and laboratory simulations. Pipeline Arroyo conditions are similar to those in the central column (from Meyer, 1989; Figure 37).

braided bars and the active channel occupies the entire arroyo floor (Meyer, 1989). Both arroyo walls are nearly vertical, and the arroyo experiences large amounts of widening by bank failure and erosion (fig. 3). These findings resemble existing conditions in Pipeline Arroyo. Unstable conditions continue for extended periods of time, and stability is not achieved until large volumes of sediment are removed, and sediment production upstream abates (Meyer, 1989).
