REVISION	1
RESPONSIBLE SECTION	PRA
SERIAL NUMBER	C2-517-1073-RE
PLANT (UNIT)	CY
PAGE 1 OF	11
REVISION PAGES	-
ATTACHMENT PAGES	-
APPENDIX PAGES	13c
TOTAL PAGES	147
BLDG/SYS/COMP	SG/E08
NPRF DATE/CTP DATE	
QUALITY SOFTWARE USED	CAFTA 2.2c

TITLE: Evaluation on Existing Versus Proposed ABT Transfer Scheme on MCC 5 Reliability

TITLE: EVALUATION OF EXISTING VERSUS PROPOSED ABT TRANSFER SCHEMES
ON MCL-5 RELIABILITY

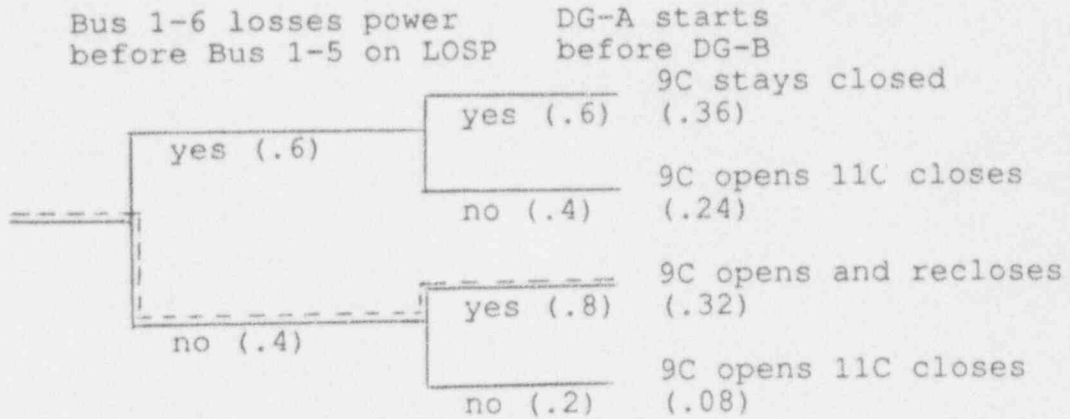
Assuming a loss of power only on Bus 1-5, ABT breaker 9C would open and breaker 11C would close to energize MCC-5 from Bus 1-6.

Assuming that both 9C and 11C fail closed and both Buses 1-5 and 1-6 are being supplied by the DGs no fault (phase miss-match) would be able to propagate and result in one or both of the DGs tripping. Voltage protection between MCC-5 and the DGs would have to fail. This coupled with both breakers failing closed would be a minimum three order cutset and an extremely low probability occurrence. Thus, this type of an event is not considered credible.

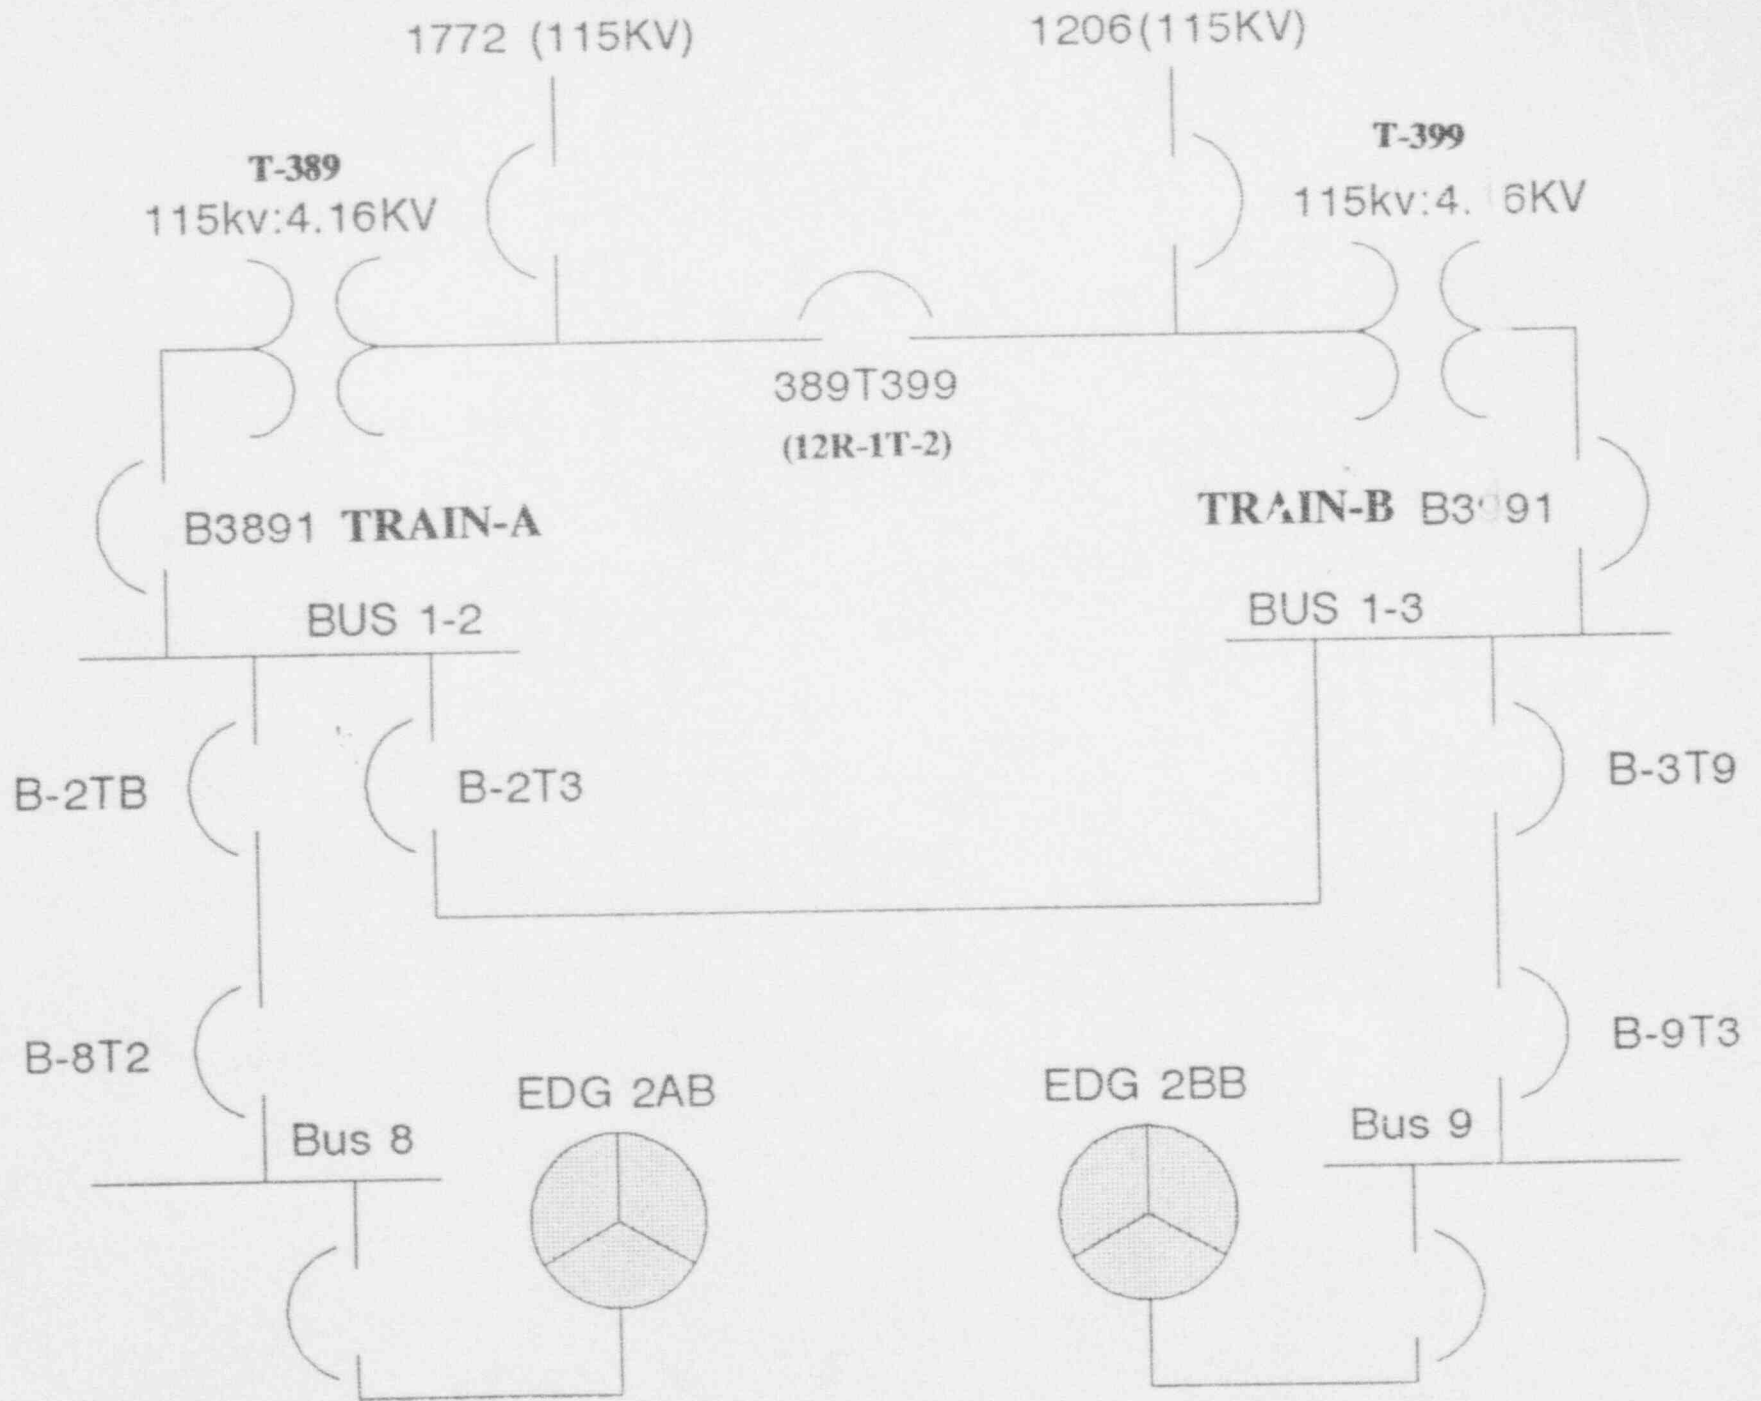
FIGURE 1

SIMPLIFIED ELECTRICAL SYSTEM DIAGRAM

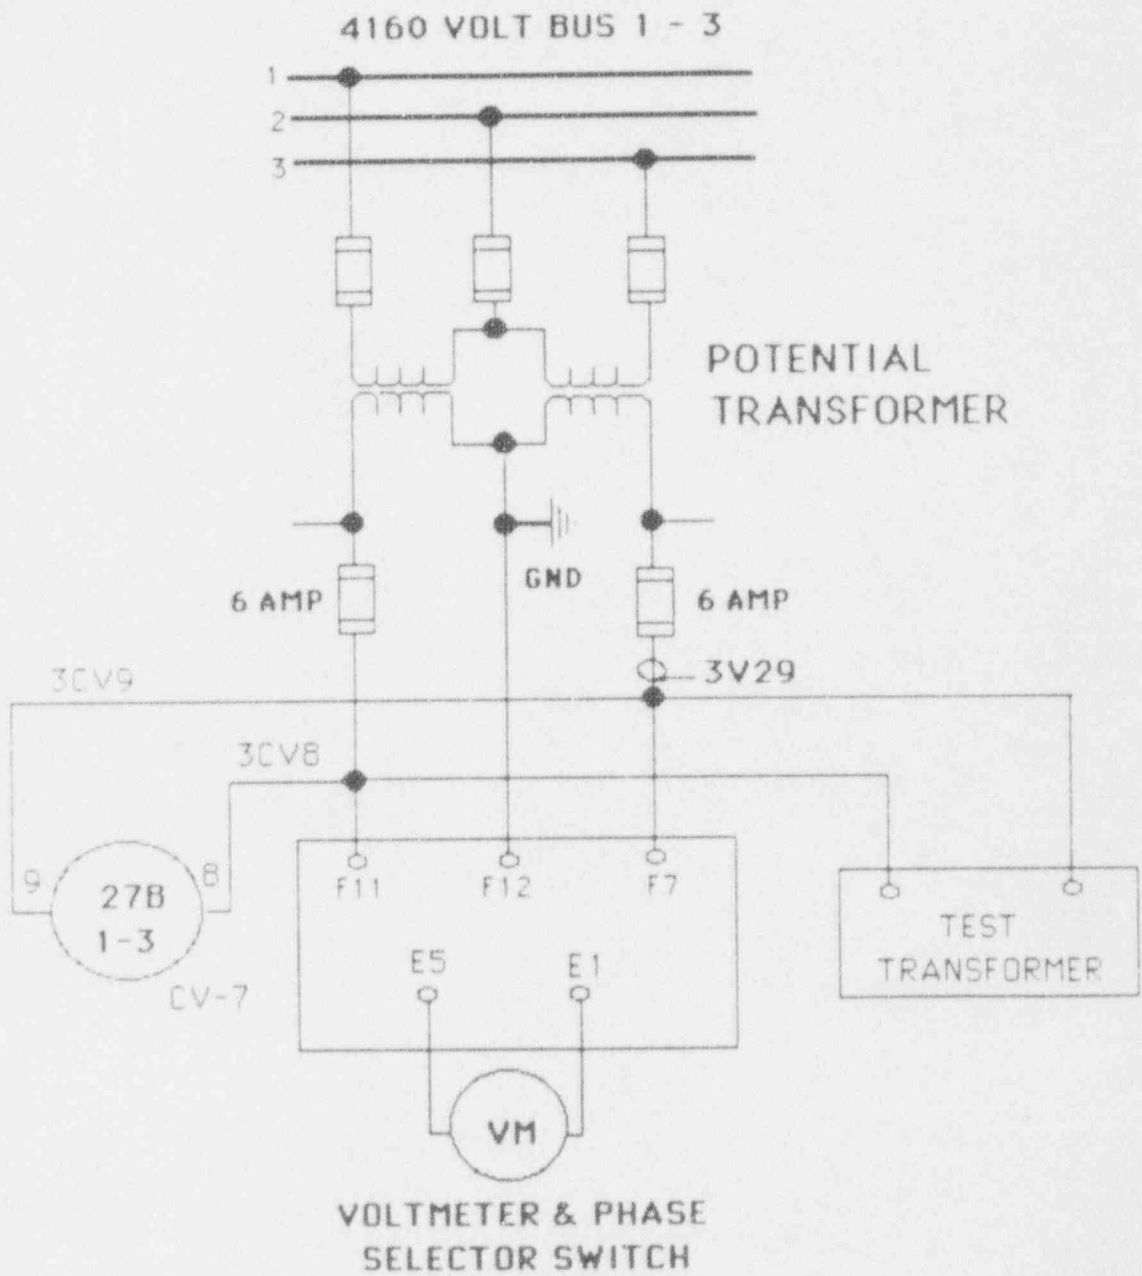
FIGURE 2

BUS 1-3 PT CIRCUIT & UNDERVOLTAGE TRIP SCHEME

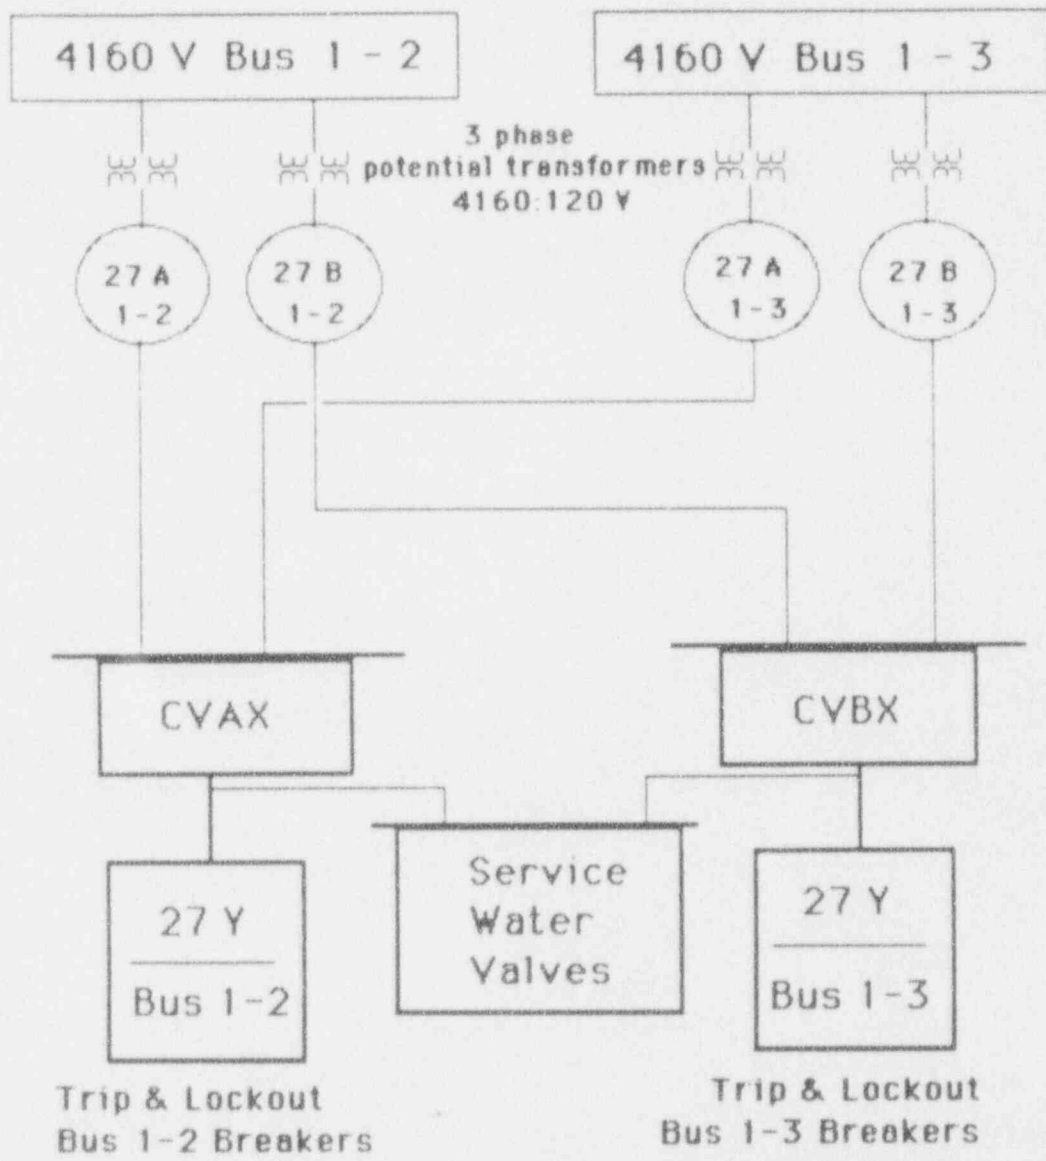
FIGURE 3

BUS 1-2/1-3 UNDERVOLTAGE LOGIC

JUNE 26 LOSS OF POWER EVENT

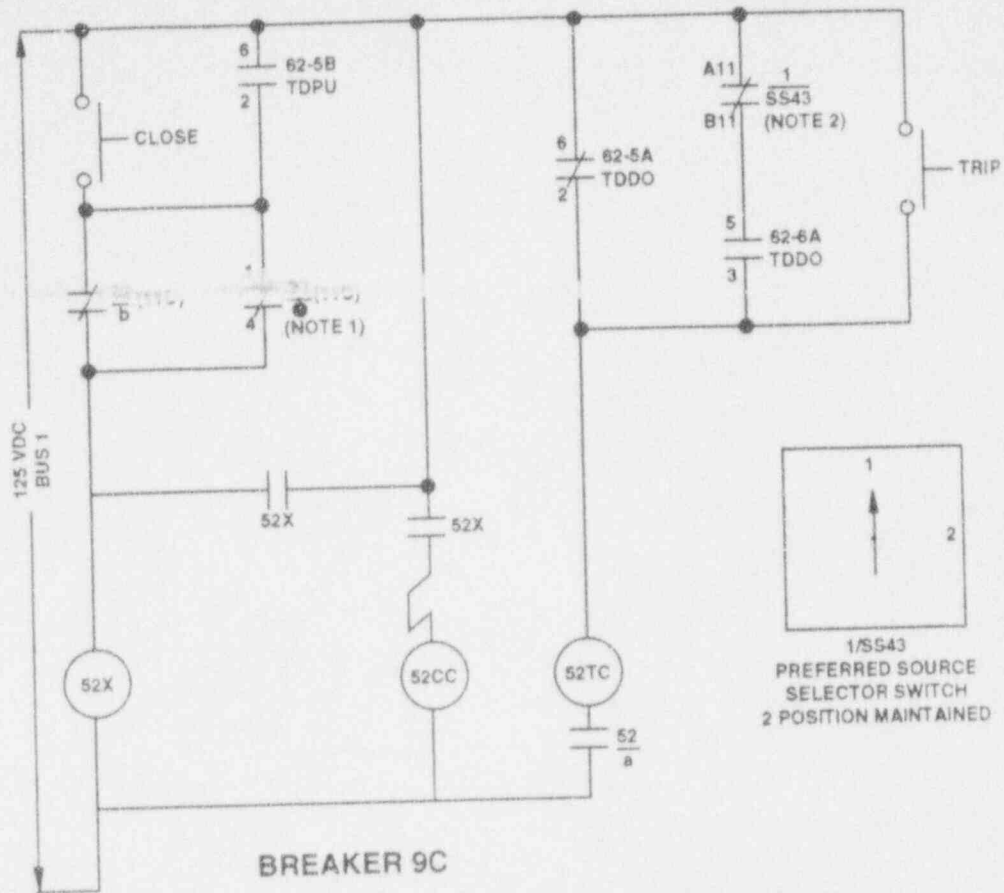
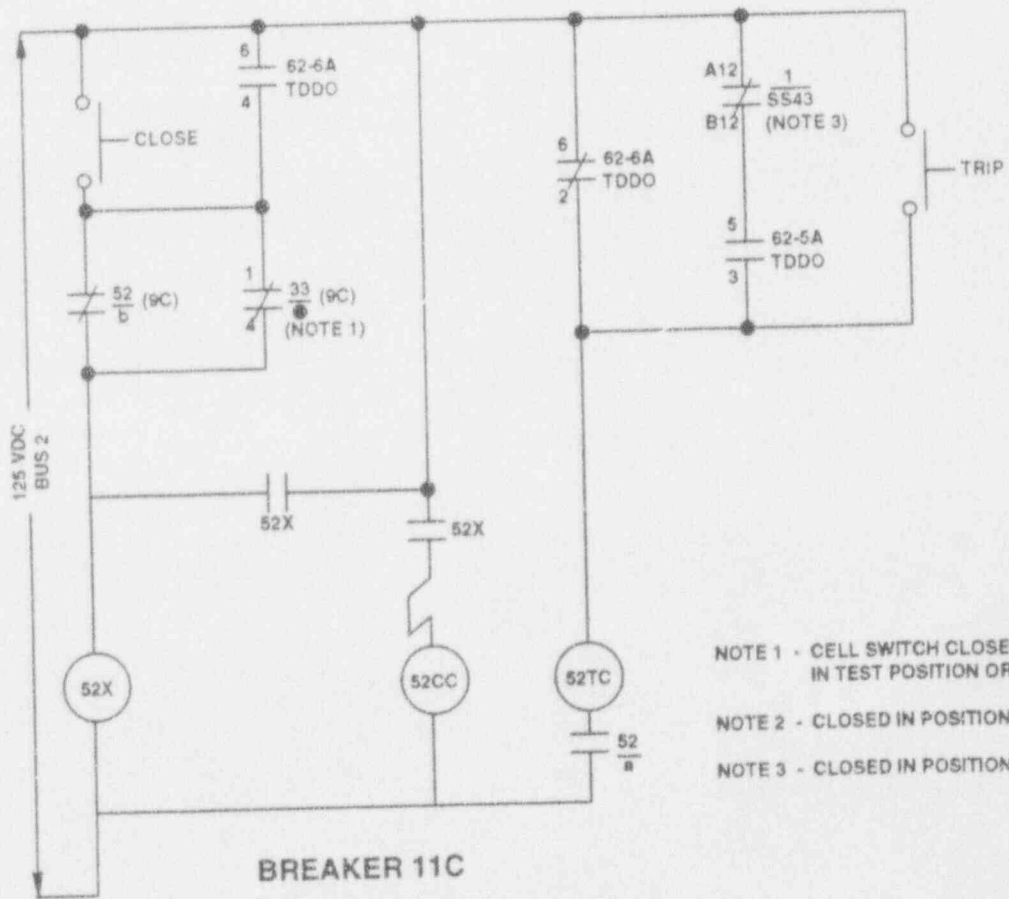
FIGURE 5

ABT LOGIC DIAGRAM
