Florida Power Crystel River Unit 3 Docket No. 50-302

July 8, 1994 3F0794-03

Subject:Intermediate Building High Energy Line Break<br/>Inspection of Welds Associated With Valves MSV-55 & MSV-56Reference:1)FPC to NRC letter, 3F1193-02, dated November 10, 1993

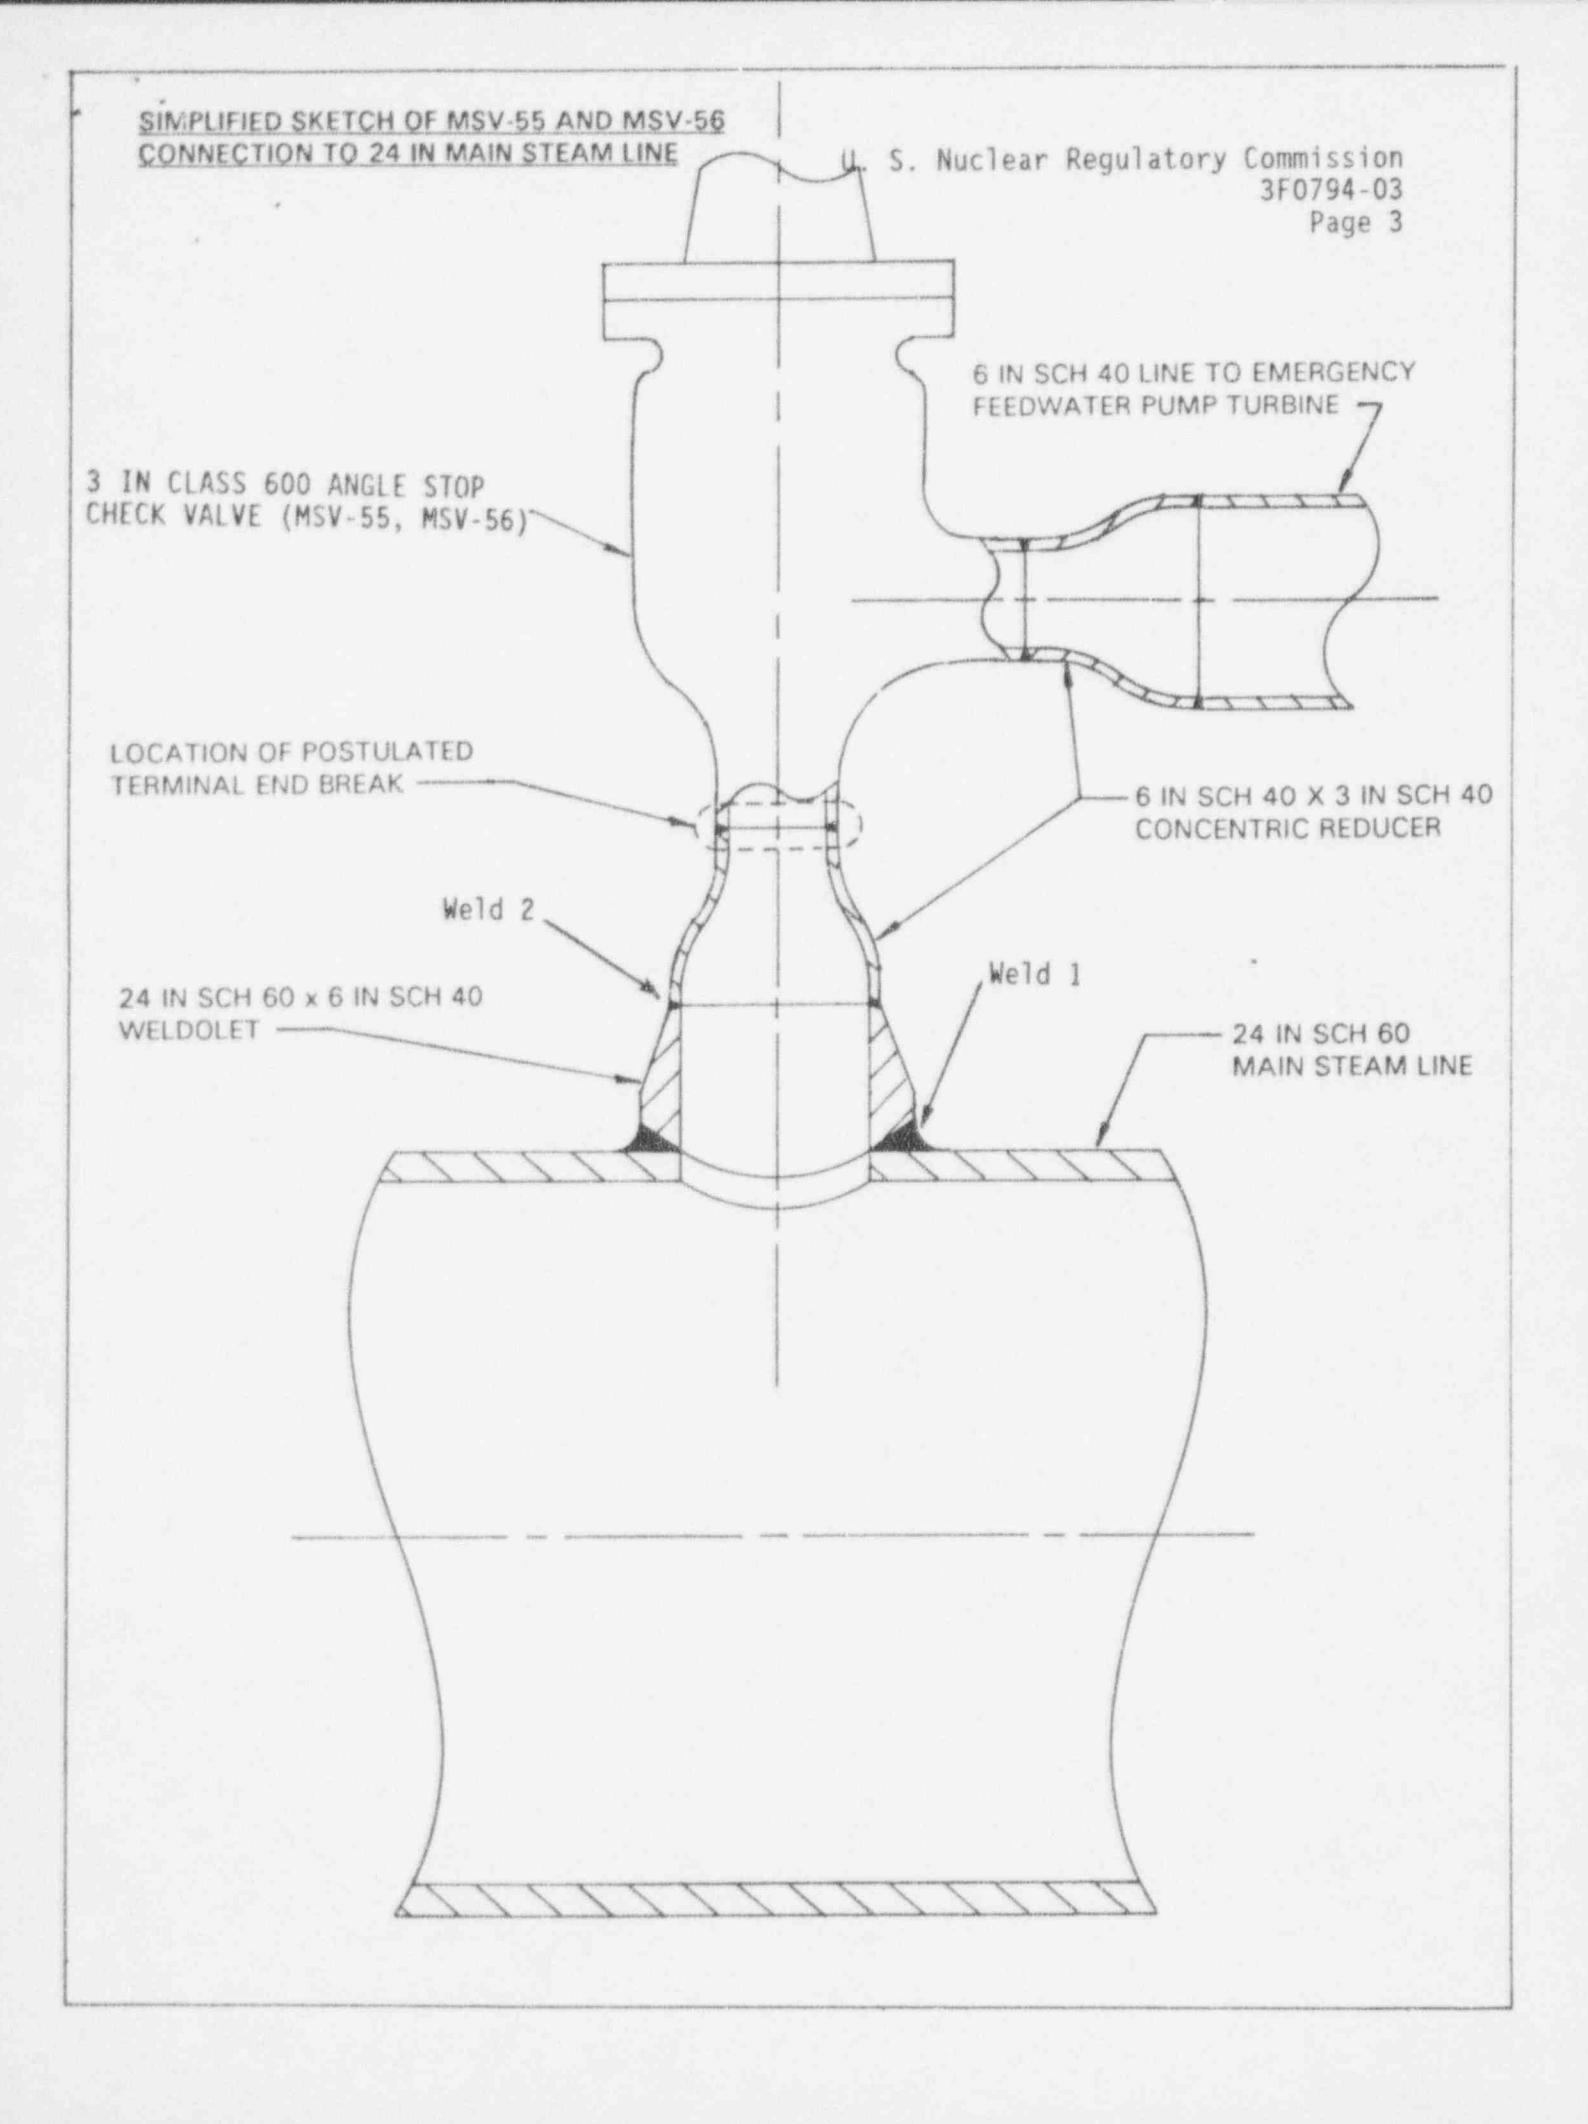
- Weld 1: 24 in Sch 60 x 6 in sch 40 weldolet to 24 in Sch 60 main steam line and
- Weld 2: 24 in Sch 60 x 6 in Sch 40 weldolet to 6 in Sch 40 x 3 in Sch 40 concentric reducer.

The first surface examination method inspection for MSV-56 using magnetic particle revealed two indications at Weld 1. Both indications were removed and re-examination was performed. The weld was found to be acceptable.

The first volumetric examination inspection for MSV-56 using ultrasonic techniques at Weld 1 revealed that a meaningful examination could not be conducted because of the weld joint configuration.

Weld 1 associated with MSV-55 was examined by surface examination using the magnetic particle method and was found to be acceptable. As stated earlier, Weld 1 at MSV-56 was found acceptable by magnetic particle examination after removing the indications.

Weld 2 at MSV-55 and MSV-56 were examined by the surface examination method using magnetic particle and found to be acceptable. Weld 2 at MSV-55 and MSV-56 were examined by the volumetric examination method using radiographic technique and were found to be acceptable.
