NORTHEAST UTILITIES

Millstone Nuclear Power Station, Unit No. 3 Modification to Pipe 3SWP*PIC Relief Request from ASME Code Section XI Requirements

Details Pertaining to Relief From ASME Section XI Requirements

Technical Evaluation

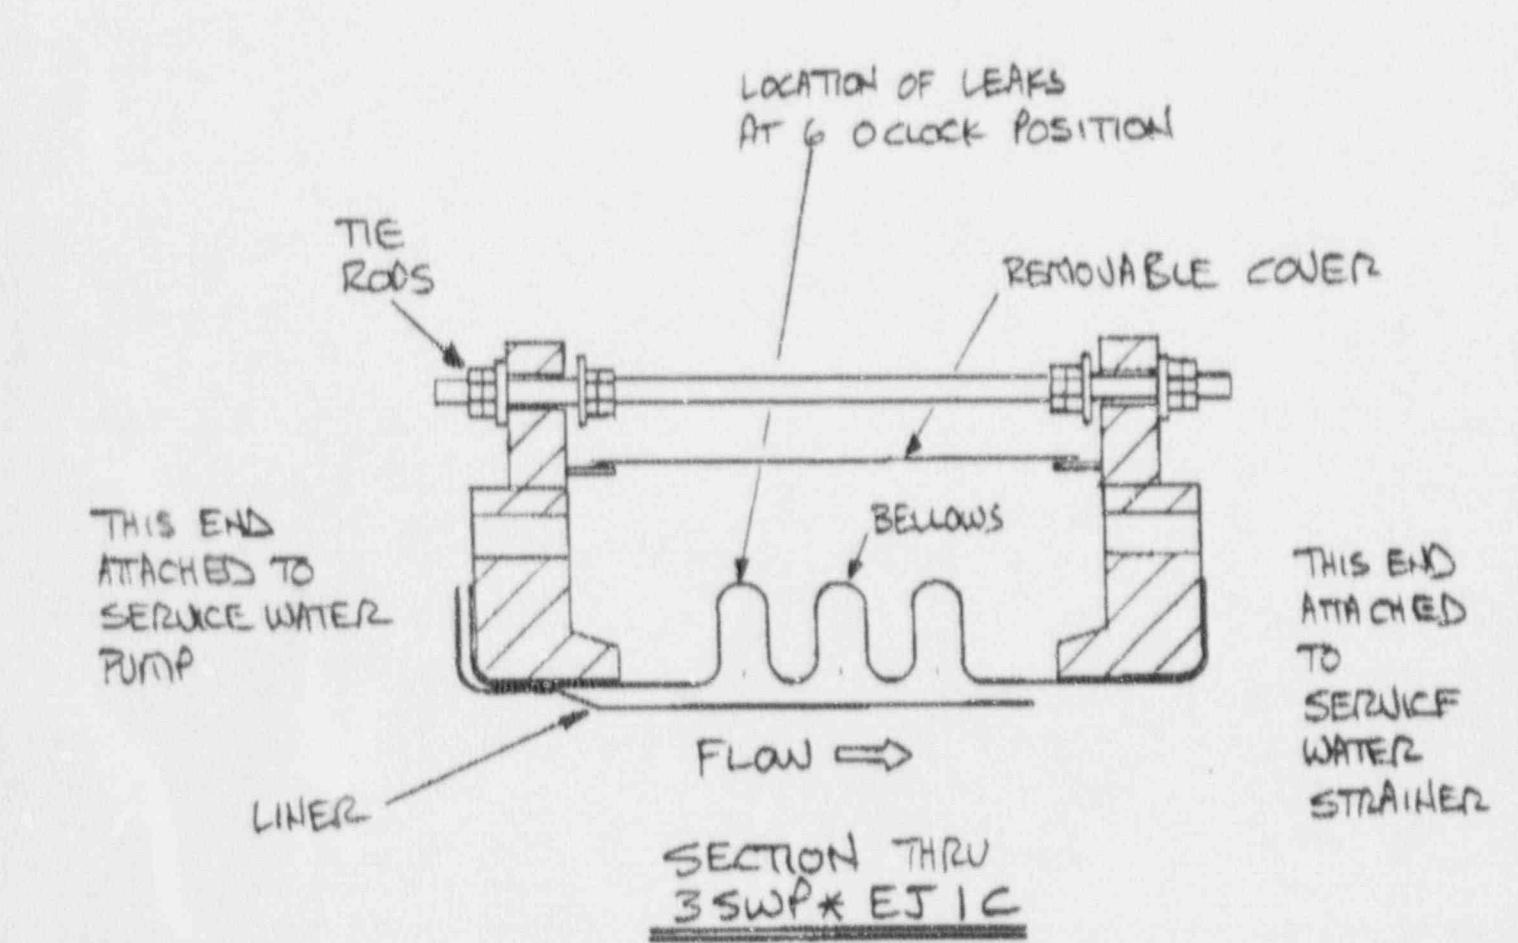
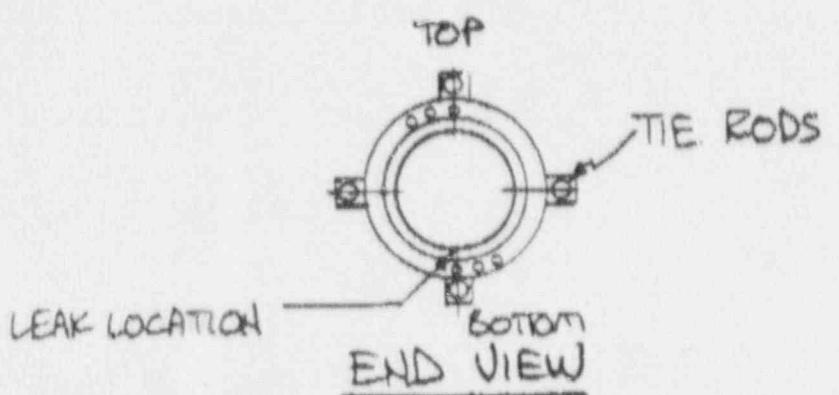
3 SWP * EJ IZ

See the attached drawing. There are two holes, one approximately 1/16" diameter and one 1/16" wide and 1/8" long that are located on the bottom of the first full convolution from the pump end of the expansion joint. The remainder of the joint was visually inspected. The hole is caused by localized pitting and is not characteristic of overall degradation.

Flaw Type: Thru-wall

Root Cause Description: Holes caused by pitting of Monel due to stagnant conditions between bellows and liner and the accumulation of bio-matter in the convolutions. Some minor general area wall loss, but this is not significant at this time.

The pin holes will be plugged with a rubberized sealant (RTV) from both sides. It is impractical to wrap the expansion joint from outside due to circumference of joint and location of hole. Weld repair was examined. Due to the long-term exposure of the joint to saltwater, the location of the flaws, and the thickness of the material, a welded repair is not possible. A major ASME III expansion joint manufacturer was contacted on the possibility of them performing a repair. They would not recommend or give any type of guarantee on this type of repair.
