Report Required by 10 CFR Part 50, Section 50.73

MONTICELLO NUCLEAR GENERATING PLANT Docket No. 50-263 License No. DPR-22

Revision 1 to LER 94-008, Structual Beam Connections Associated With the Cable Spreading Room Floor Found to be Different Than Design

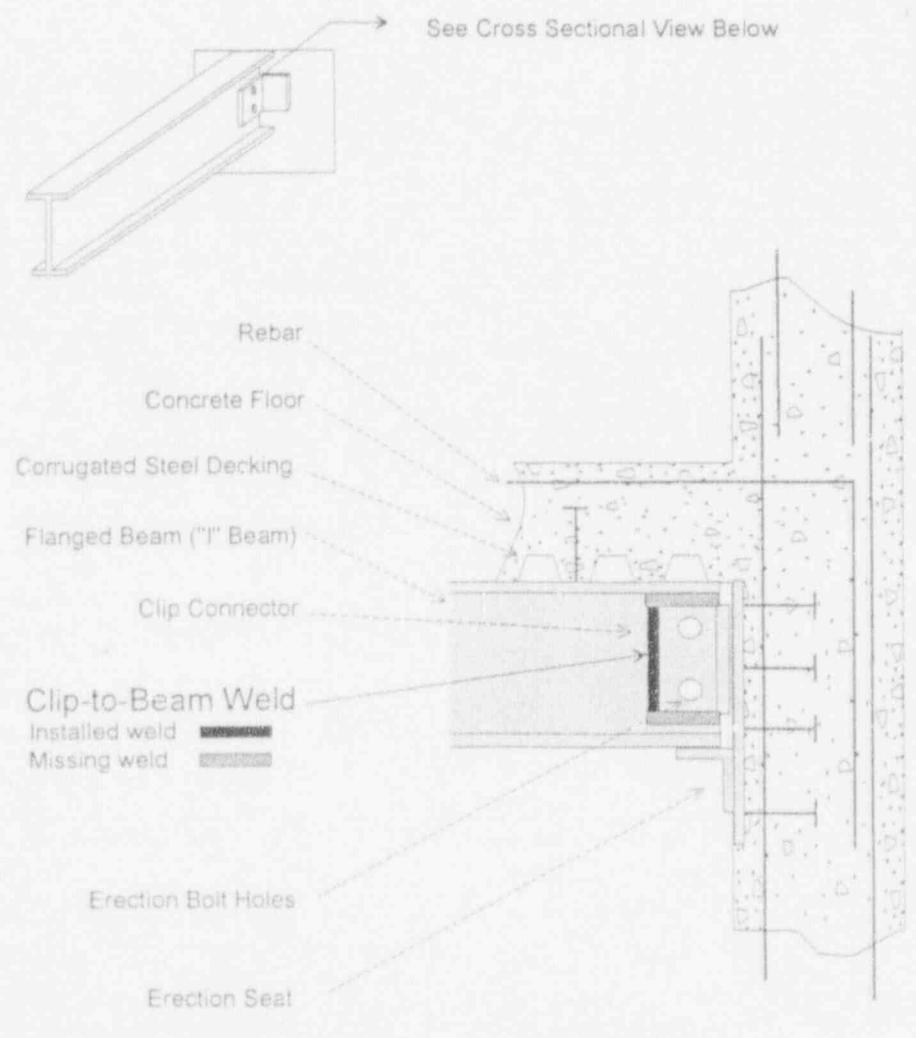
TYPICAL CABLE SPREADING ROOM FLOOR FIELD WELDED BEAM CONNECTIONS

This type of connection is shown in Figure 1. The original design specified a full weld between the clip and the beam, e.g., a vertical weld and a top and bottom weld. The engineer identified several beams in the Cable Spreading Room floor that did not have the top and bottom horizontal weld (only the vertical weld). Discussions with an individual on the original construction team indicated that documentation approving this variance may exist. A review of the original plant Field Change Requests and Design Change Requests did not locate any documentation of this variance.

During original construction (1968), the construction workers that welded the clips to the beams and girders did not install the clips in accordance with the specified design.

2 At the same time the additional analysis was being conducted, high strength bolts (A325) were purchased to be placed in the erection bolt holes (See

Figure). These bolts were added to five of the higher stressed connections to increase their load carrying capacity by developing friction type connections. It was later determined that the connections did not require the high strength bolts to be operable.
