BROOKHAVEN NATIONAL LABORATORY  
ASSOCIATED UNIVERSITIES, INC.

SUBJECT: Generic Issue, Current Transformer (CT) Protection.

Attachment 2

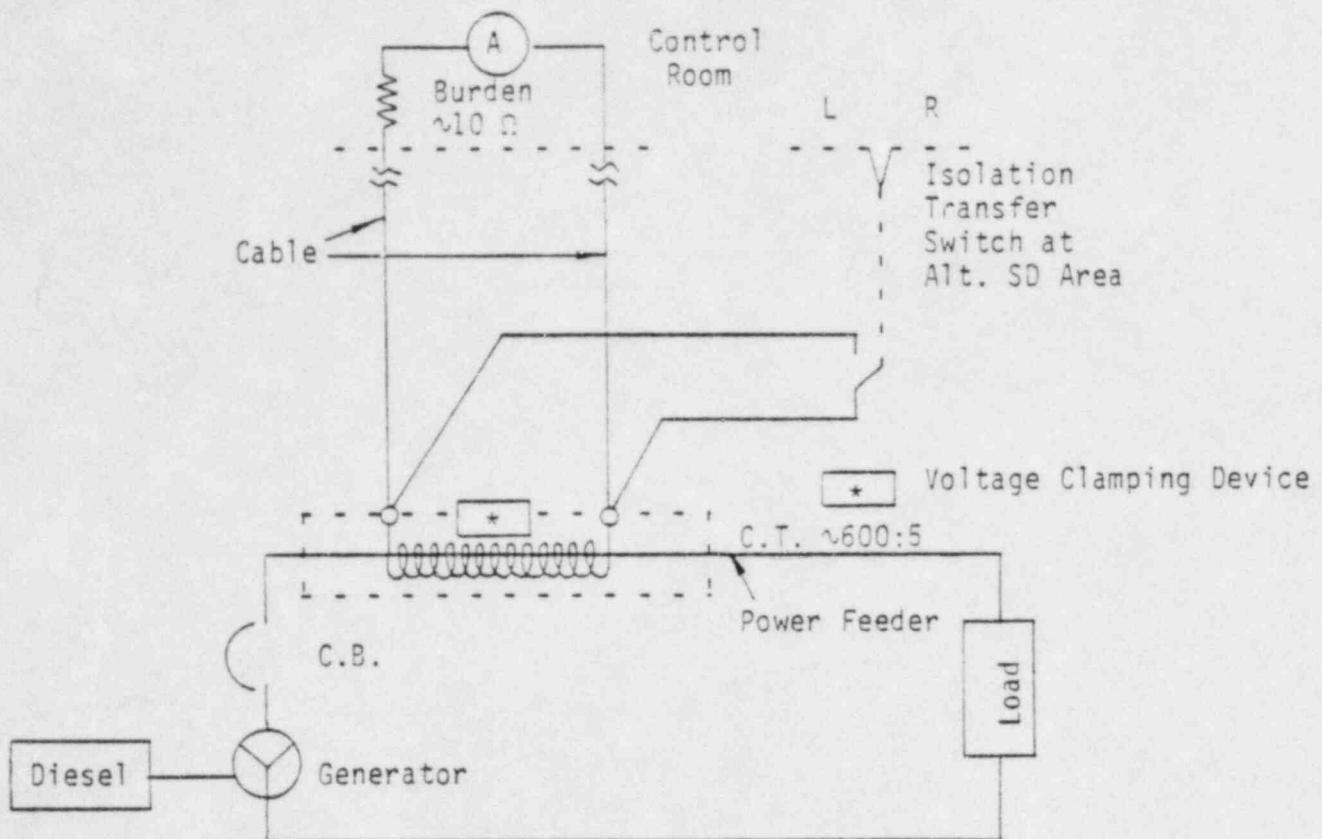
Figure 1.

**Problem:** Current Transformer (CT) secondary leads routed in cable through cable spreading room to control room. Fire damage could cause secondary circuit to open and the resulting transient could trip circuit breaker if CT does not first destroy itself. Furthermore, it could destroy breaker contacts and break down power feeder insulation, causing second fire. CT will probably destroy itself sooner or later. All of this could happen before an operator can reach isolation switch whose contact shorts secondary.

**Background:** If diesel generator is loaded to approximately full load (555-600 amps for Oyster Creek), secondary circuit will carry 4.6-5 amps due to law of equal amp-turns. If burden impedance is approximately  $10\Omega$ , maximum secondary voltage will be  $10 \times 5 = 50$  V rms. Given a typical transformer ratio of 600:5 (120:1), the maximum primary (power feeder) voltage due to the transformer is then  $50/120 = 0.42$  V rms

which is negligible compared to generator voltage of 4160 V. However, if the secondary circuit opens, the circuit load can go to  $10^8 \Omega$   $\pm$ , driving the secondary voltage toward  $5 \times 10^8$  V, and the reflected primary voltage toward  $4.2 \times 10^6$  V. This is because primary (power feeder) current still flows. The reflected voltage appears between the power feeder and ground.

**Damage Analysis:** Unless the secondary is shorted within 1 cycle (approximately 16 ms), or unless there exists a voltage clamping device at the secondary terminals, the current transformer will ultimately self-destruct. However, a current transformer for a 4160 V system could have insulation rated for at least 11 kV, and industrial insulation usually has very large safety margins. Thus, it will take a few seconds to be destroyed by short circuit.

With the onset of the transient, the breaker's OV protection circuit starts to act. If this succeeds in tripping the breaker before the CT self-shorts, the breaker contacts will open at the transient voltage level present. This could severely damage or destroy the contact material due to the high voltage arc (the breaker, too, is rated for 4160 V service).

The diesel generator winding and the load will also see the transient, and either or both could be damaged depending upon their sensitivity and the time necessary for breaker trip and/or CT self-short. The isolation switch contact will also see the secondary transient and could break over--ultimate damage unknown.

**Results:** An unclamped or unshorted (external) CT circuit opened by fire damage could cause the following:

1. Self-destruction of the CT--a second fire may be part of this.
2. Destruction of the circuit breaker supplying the generator or other critical load with a resultant loss in that load.

3. Opening of a circuit breaker on a needed power circuit.
4. Power feeder breakdown--possible second fire.
5. Destruction of other sections of the secondary cable (upstream towards the CT) due to voltage breakdown.
