# EXAMINATION OF CRYSTAL RIVER-3 PULLED STEAM GENERATOR TUBES

## Submitted by: Florida Power Corporation

November 30, 1994

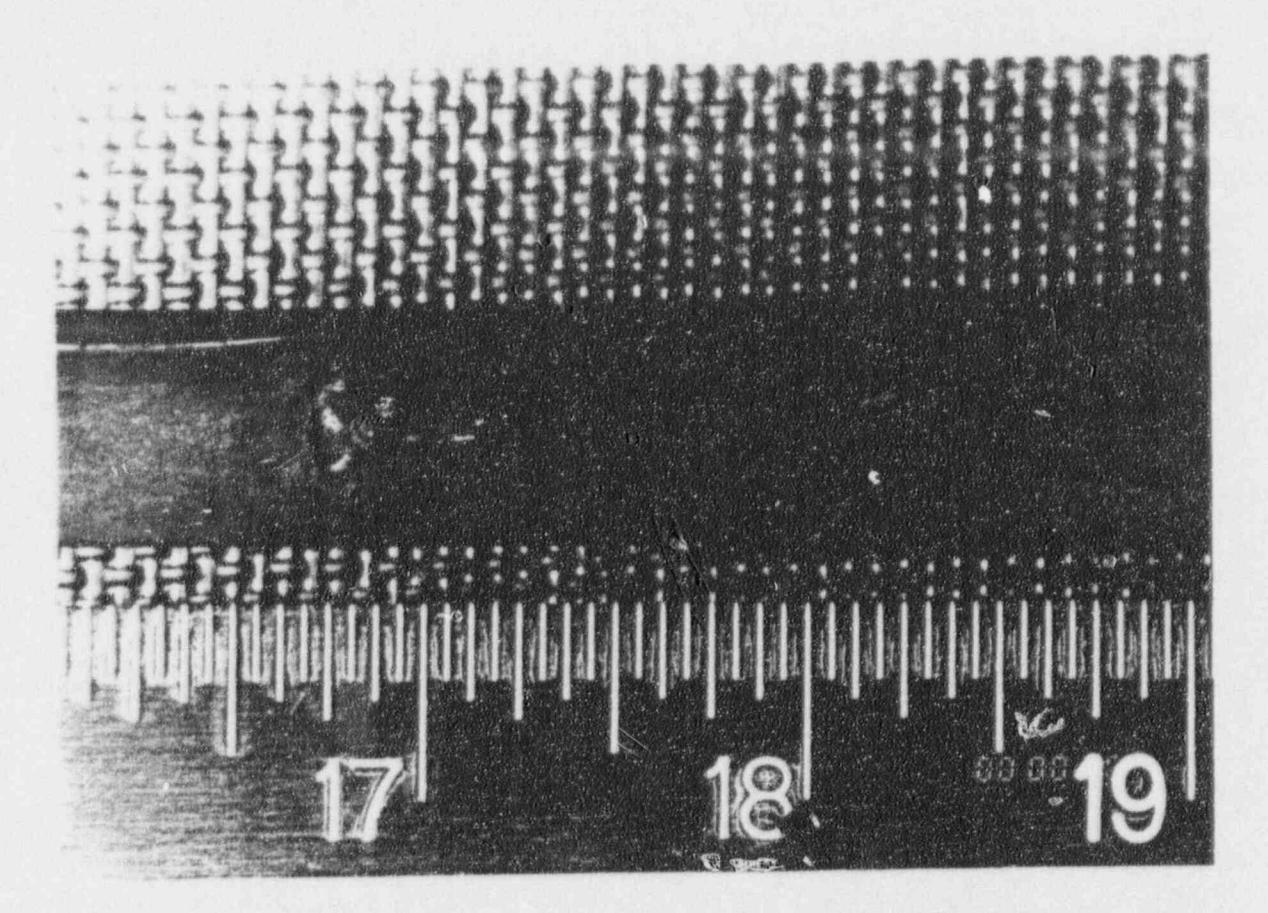
- At the 7th TSP, circular or "D"-shaped wear marks were observed at the bottom edge of the lands on all four pulled tubes. Figure 2-1 is an example of this type of defect.

PIT-LIKE INDICATION ("30% TW) AT 7TH TSP (TUBE 136-26)

There were two types of defects observed at the tube-to-TSP land contacts: at the 7th TSP and 3rd TSP, oval or "D" shaped wear marks were found at the lower edge of a tube support land; at the 9th TSP, tapered wear marks were found at both the upper and lower edges of the support plates. Tapered wear has been observed in tubes pulled previously from other OTSGs (Reference 7). The oval or "D" shaped wear was not observed in previously pulled OTSG tubes, but has been observed in recirculating steam generators as described in Appendix B.

No conclusive evidence of corrosion was found in the wear marks. Therefore, it is concluded that the degradation was the result of mechanical wear from the tube rubbing against the tube support plate land, or against oxides or other debris wedged between the tube and TSP land (abrasive wear). Appendix B includes a description of wear observed in nuclear steam generators and a discussion of industry experience with the detection of wear.

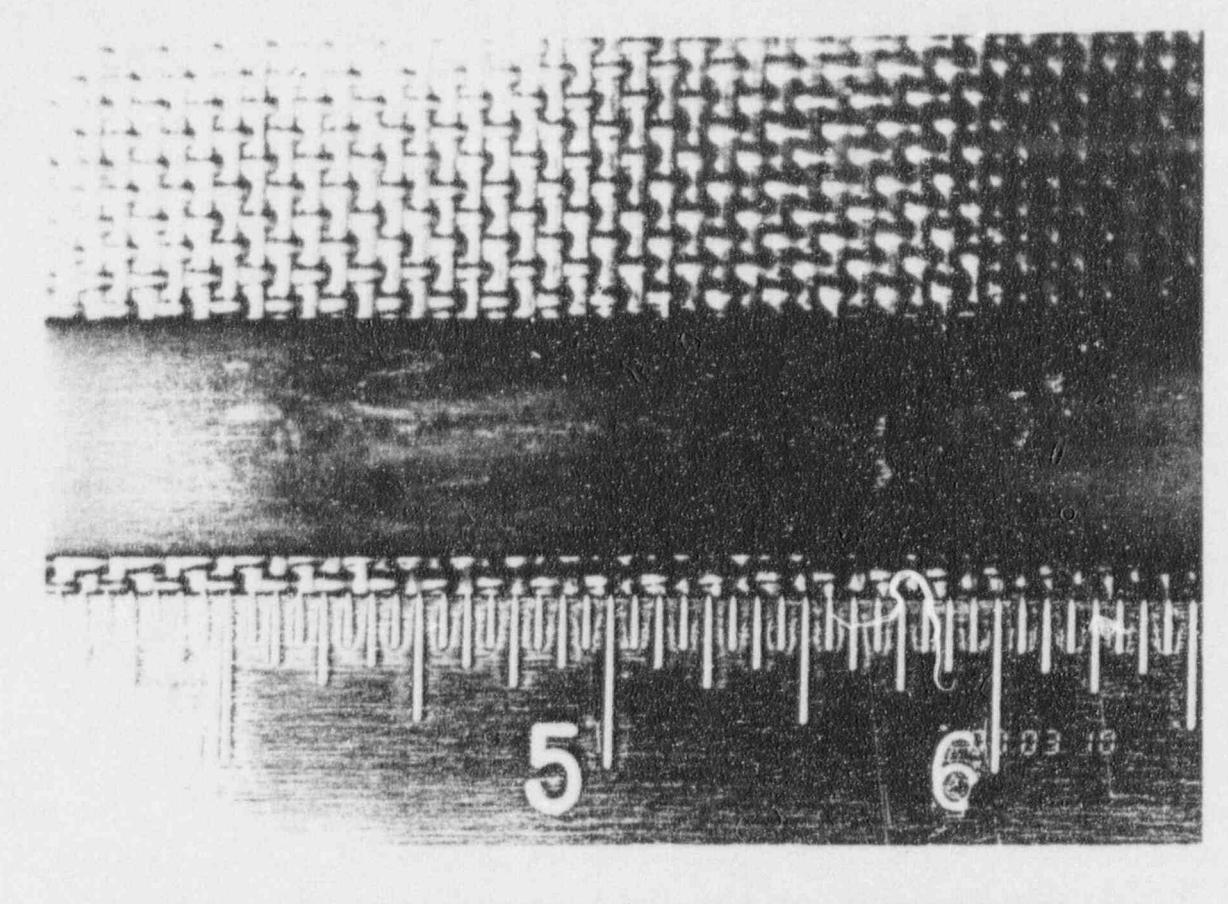
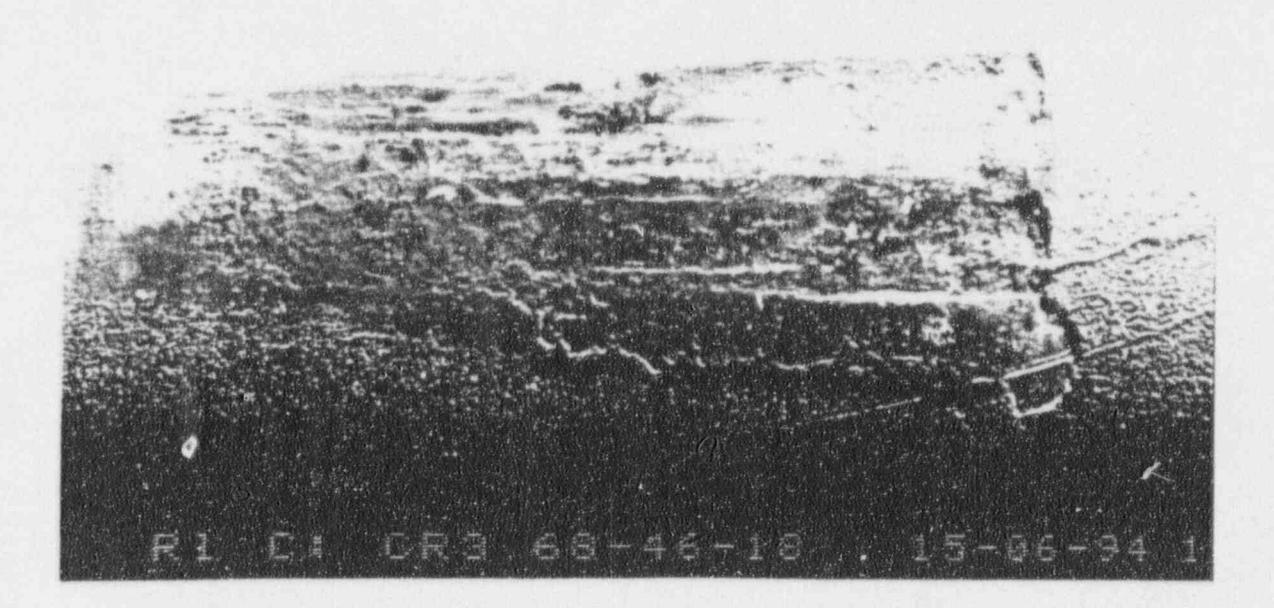
Figure 2-2

- At the 9th TSP, "tapered" wear marks (see Figure 2-2) were observed at the top edge of one TSP land <u>and</u> the bottom edge of a second, adjacent TSP land. These marks were axial in orientation and deepest at the edge of the support plates.

# TAPERED WEAR MARK AT 9TH TSP (TUBE 68-46)

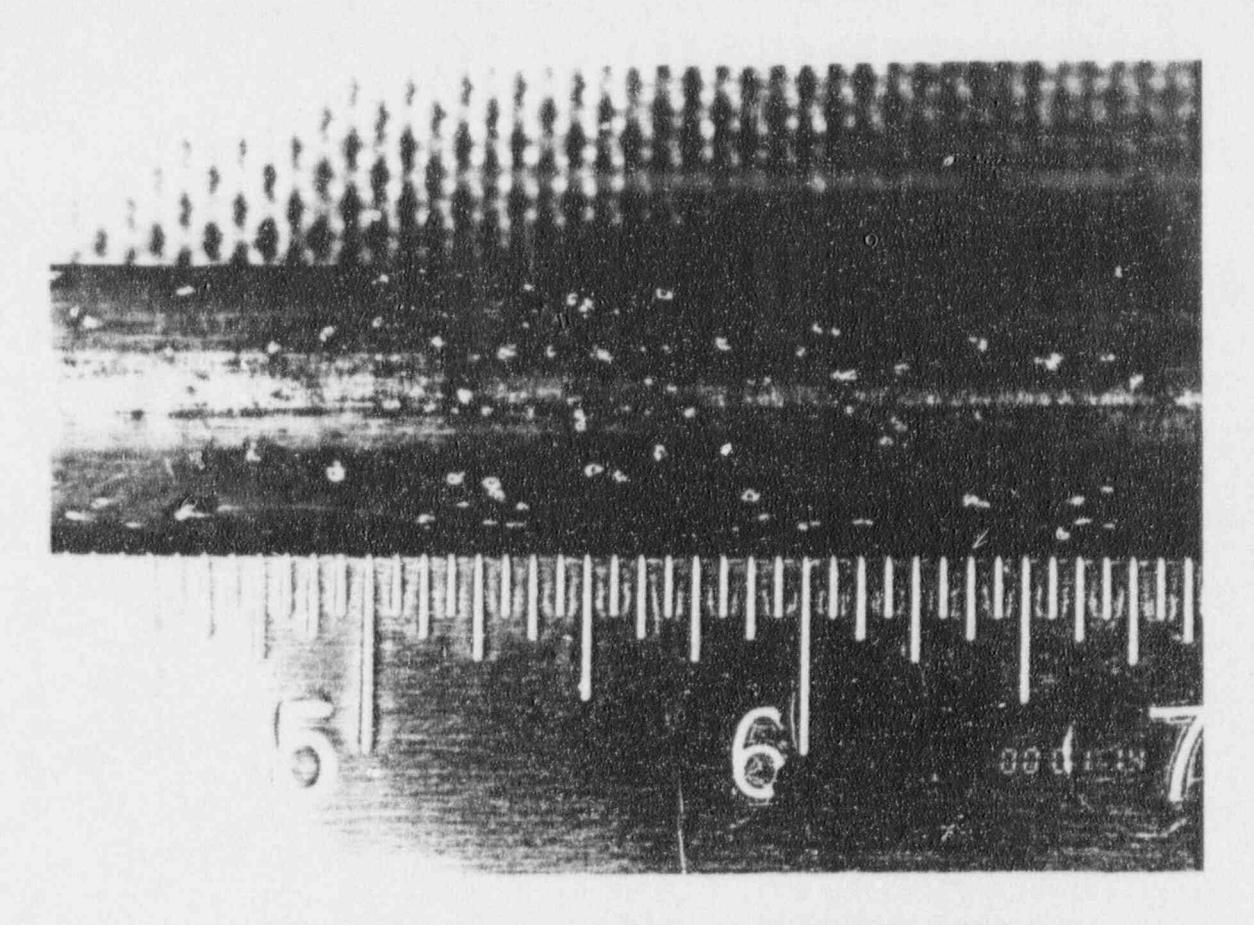
Figure 2-3

- 4. Spots of yellow deposit "nodules", as shown in Figure 2-3, were observed, most predominantly within the lower tubesheet crevice regions and first (lowermost) tube span of tubes 68-46 and 72-49. Streaks of white deposit were also observed in the upper elevations (Figure 2-4) on all four 1994 pulled tubes.

In the lower tubesheet crevice regions, which are relatively free of deposit, yellow deposit nodules (Figure 2-3) were observed. EDS/WDS analysis confirmed that this deposit is elemental sulfur.

YELLOW DEPOSIT IN LOWER TUBESHEET CREVICE

The elemental sulfur deposits observed in the first tube span and within the lower tubesheet crevices may or may not be associated with the intergranular defects. Elemental sulfur is not in the right oxidation state to initiate IGA; although changing environmental conditions during startup, shutdown, and layup could create conditions which could make the sulfur aggressive. Since there is not a direct correlation of the IGA patches with the spots of yellow deposit, it is concluded that the yellow sulfur deposits do not pose a significant corrosion risk.

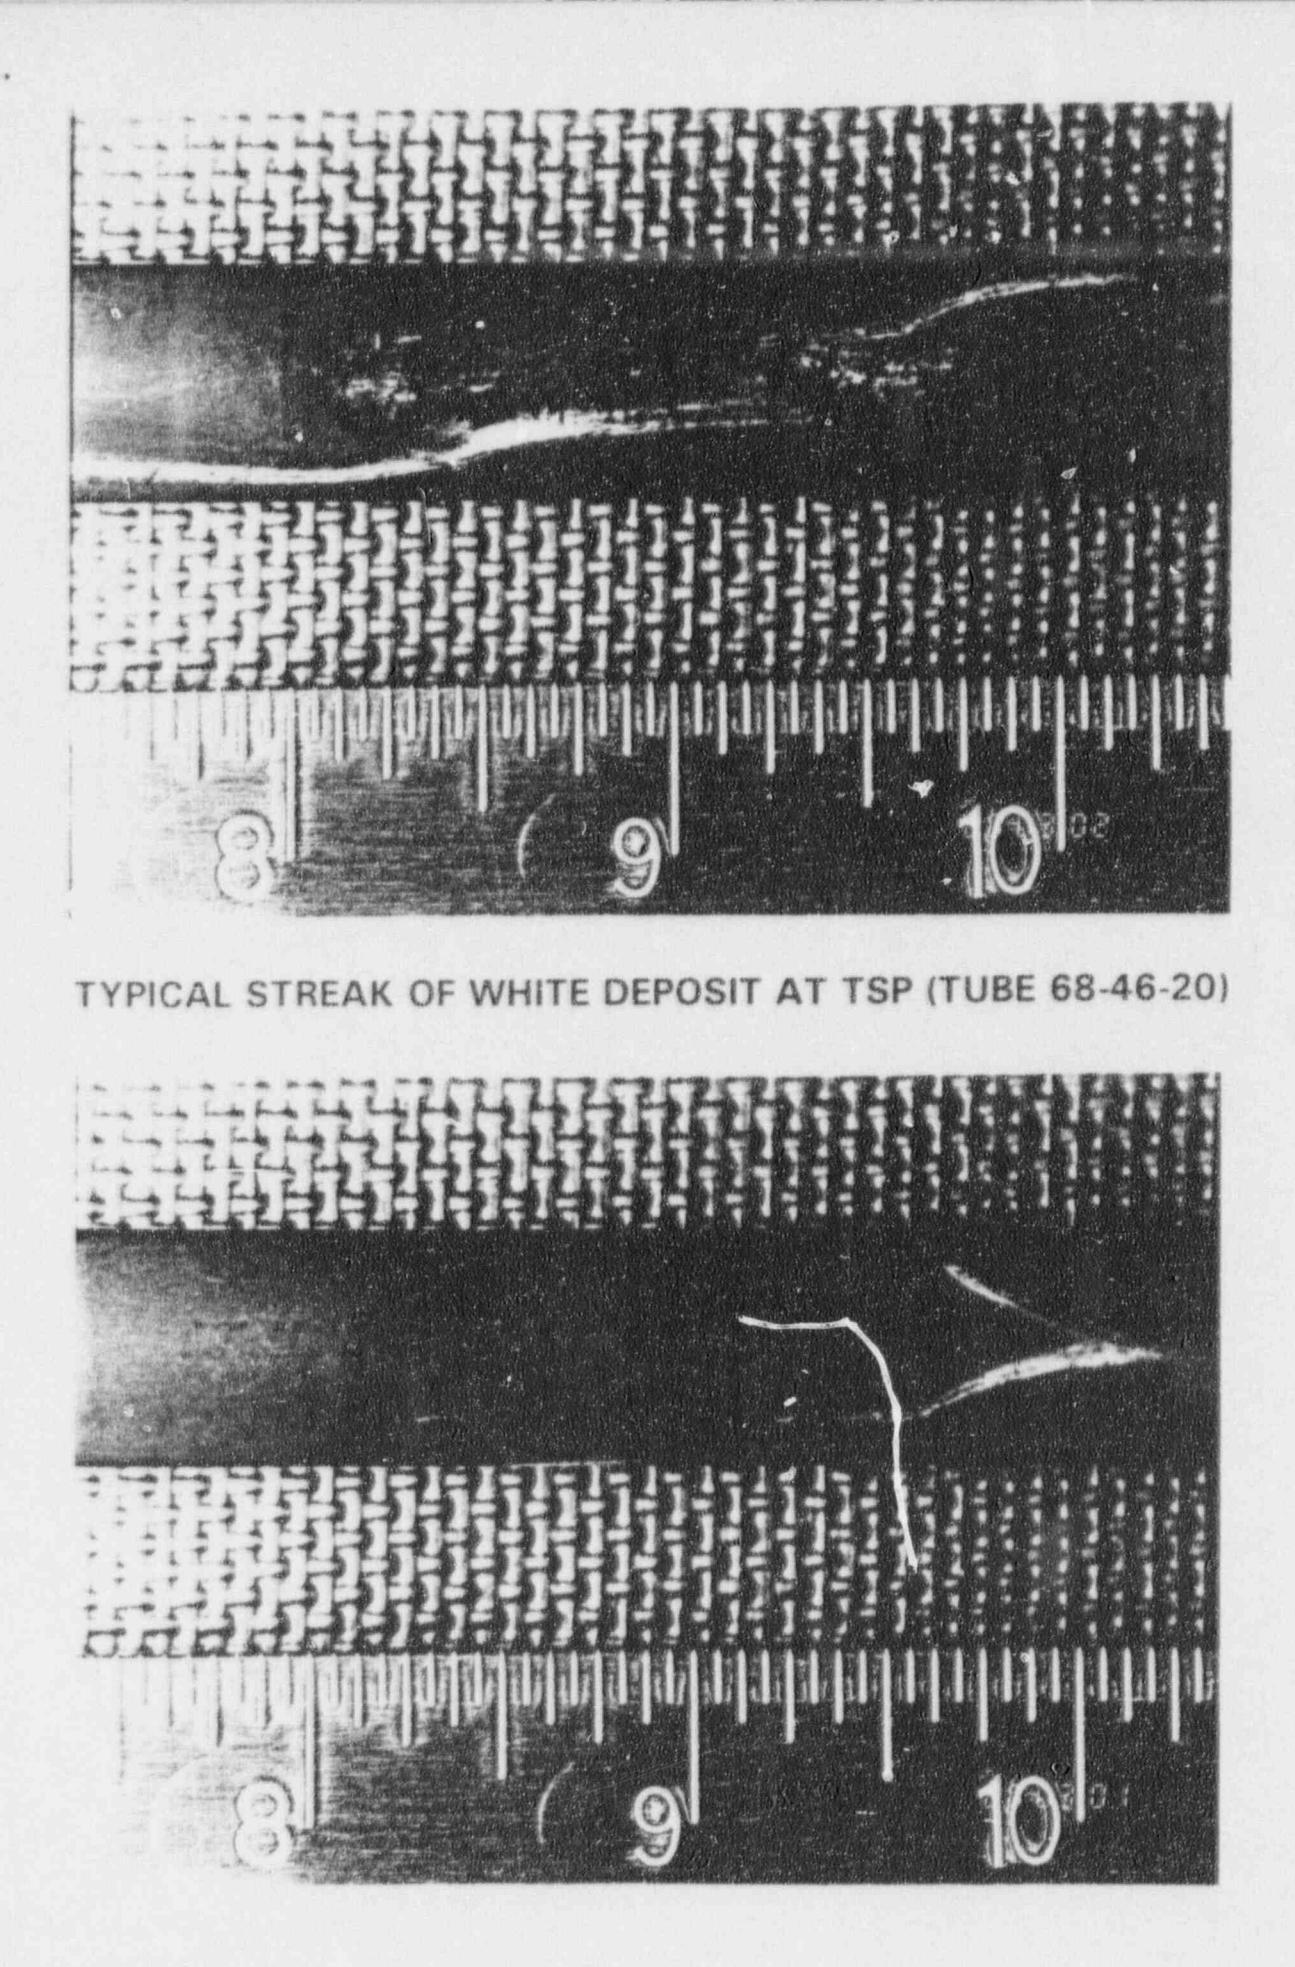
Figure 2-4

In the upper elevations, white streaks of deposit were observed. Scanning electron microscope (SEM)/EDS/WDS analysis suggests that this deposit is thin, relatively fine-grained and rich in manganese and other hardness contaminants. The thin streaks are deposited on top of the magnetite deposits on the tube.
