ACRS FLUID DYNAMICS SUBCOMMITTEE
MEETING MINUTES
DECEMBER 8, 1983
WASHINGTON, DC

Purpose: The purpose of the meeting was to discuss the recent flow-related incidents at the Palo Verde Unit 1, St. Lucie, Unit 1, and Millstone Unit 2 reactors that resulted in equipment damage to the plants' primary systems.

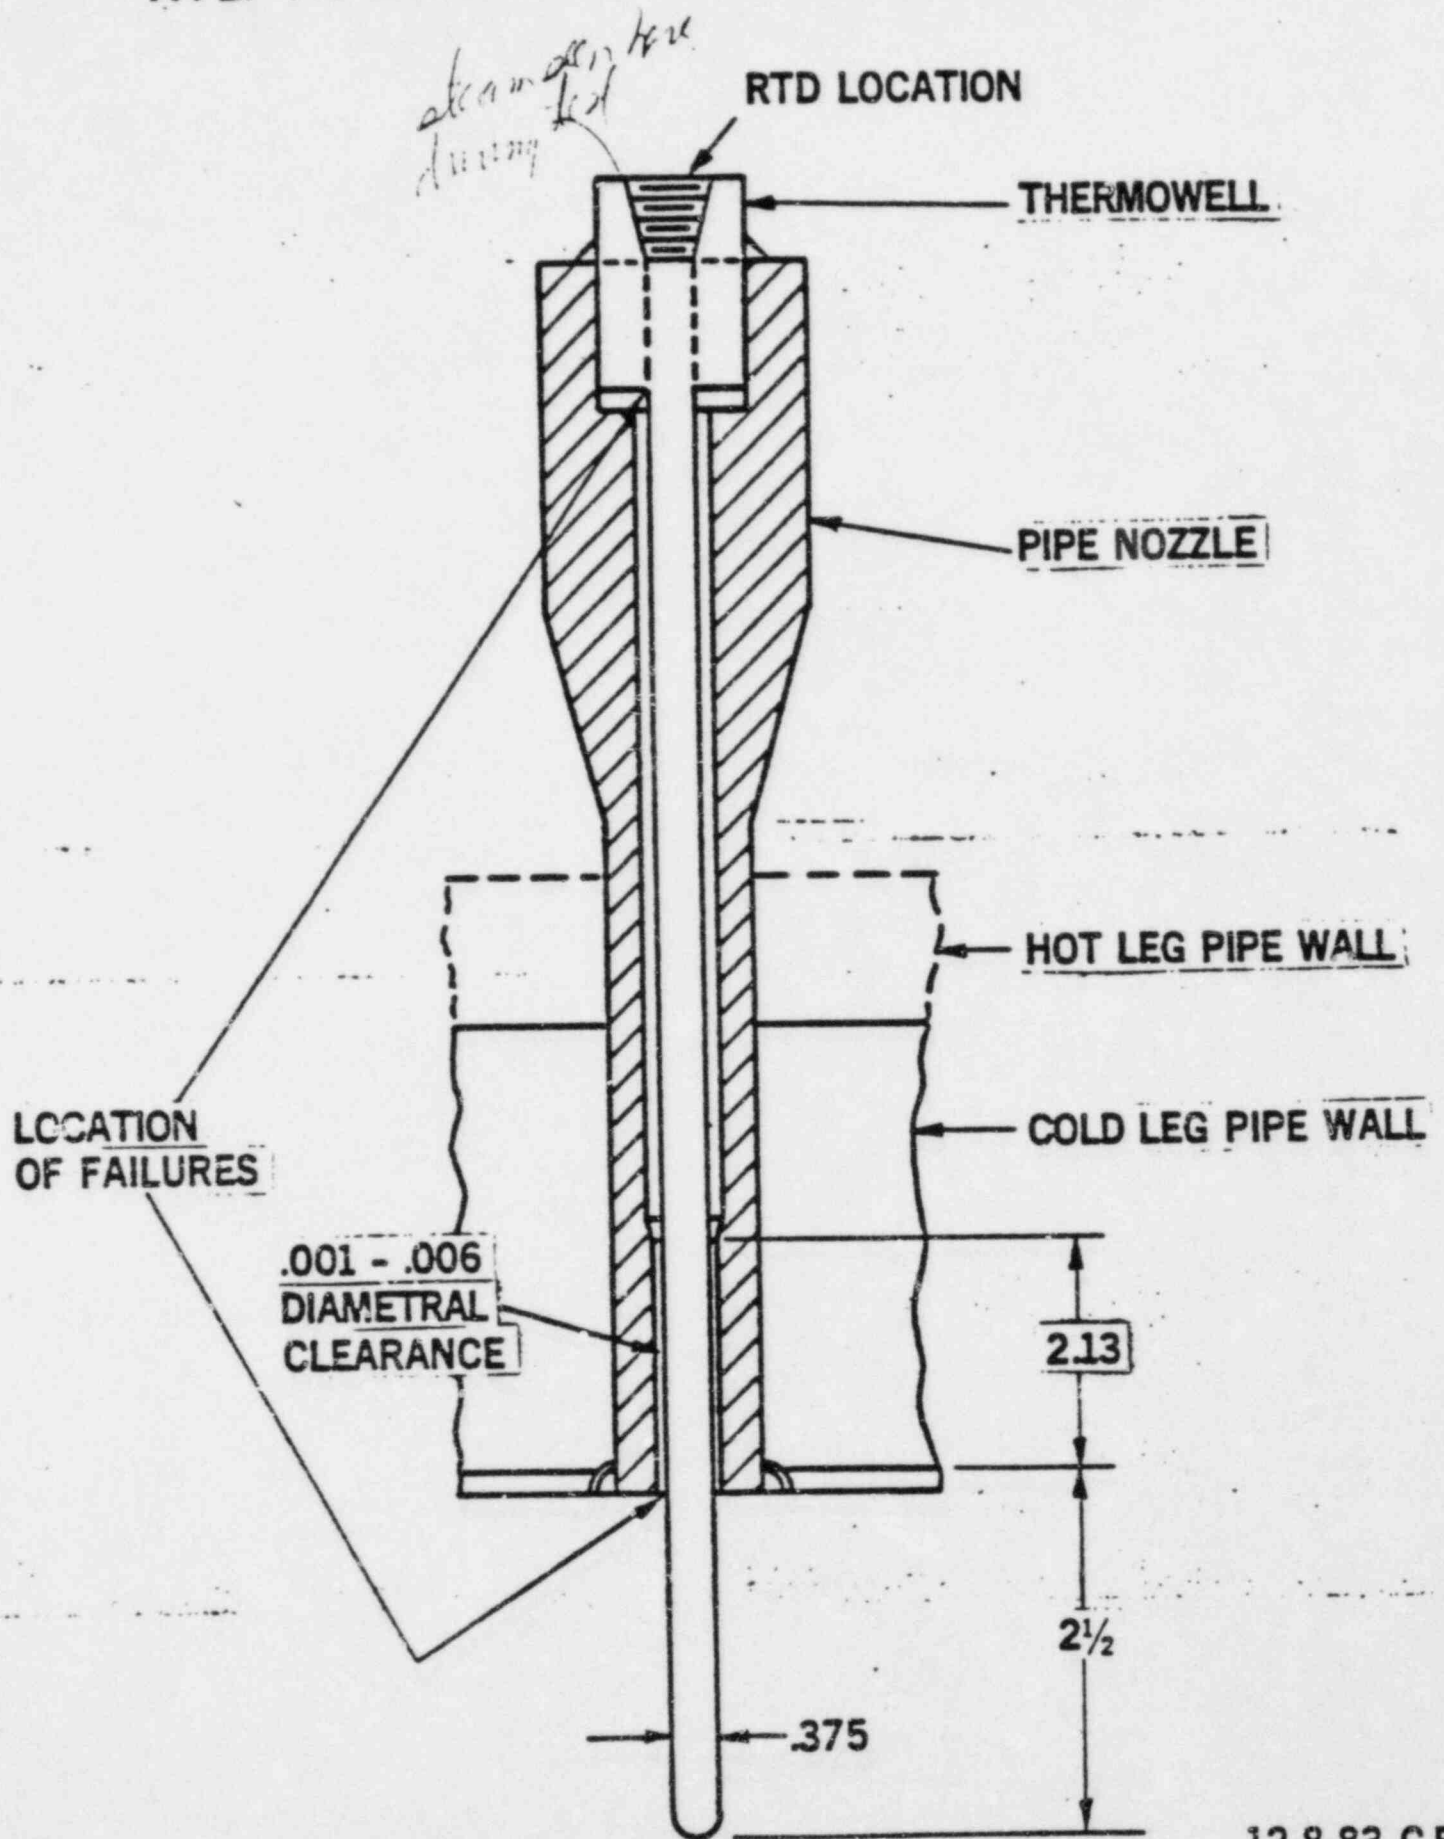
Fig. 1

The original RTD installation with the failure locations is shown on Figure 1. These failures showed up during the pre-core hot functional tests. The failure mode is as follows: (1) the thermowells experienced high cycle vibration, (2) the vibrations were in a plane perpendicular to the flow direction, indicative of vortex shedding, (3) failure was initiated by fatigue, and (4) extensive wearing was found on the thermowell at the annular interface between the inconel thermowell and the inconel pipe nozzle. All failures were seen in the cold leg RTDs. Figure 2 shows the redesigned RTD thermowell. The redesign increased the natural frequency from 1000 to 2800 cps, putting it well out of the region of potential excitation from plant operating conditions. Figure 3 shows the modified pipe nozzle fitting.

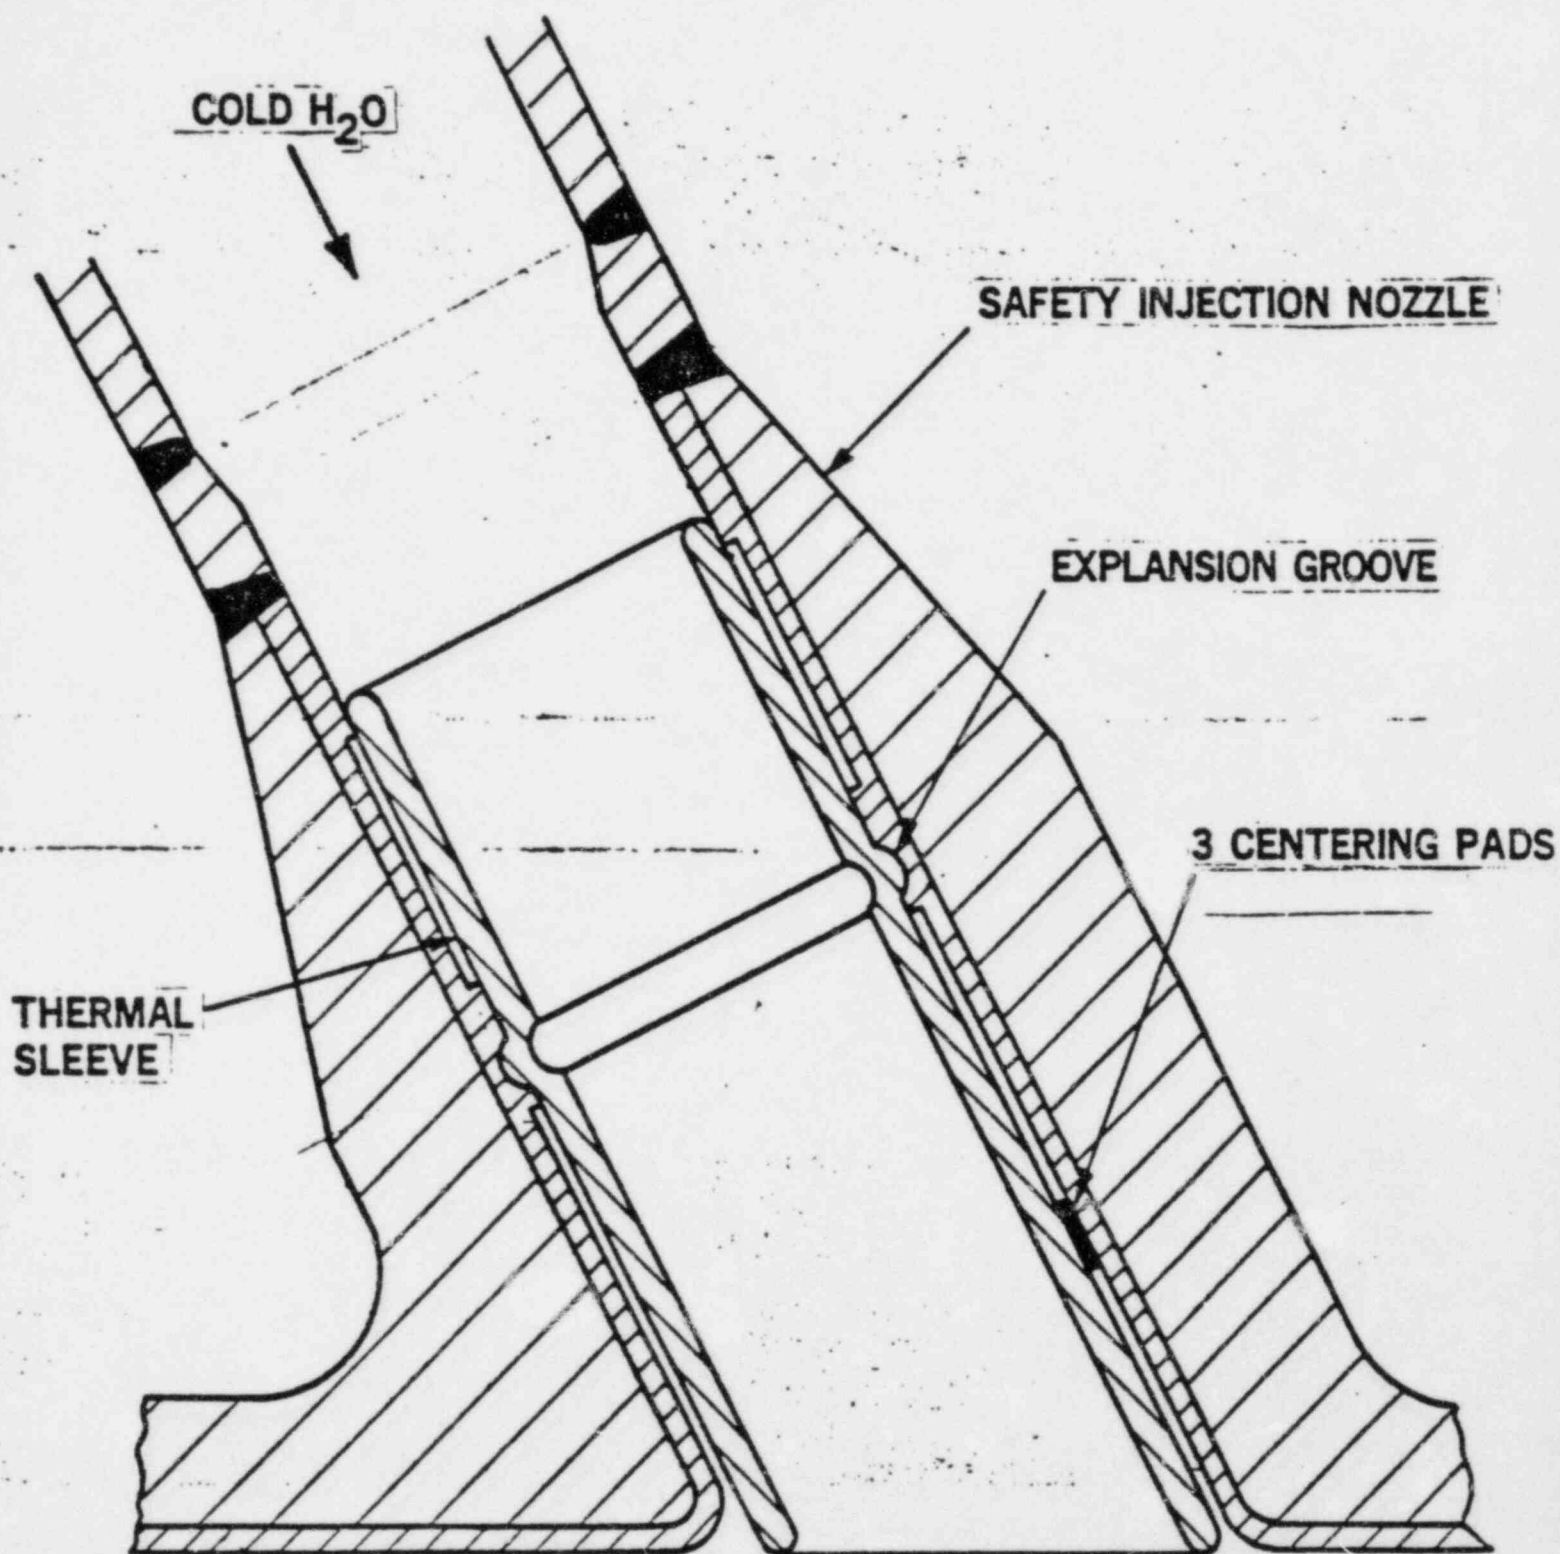
FIG. 5

CE discussed the failure mode for the thermal sleeves located in the cold-leg ECCS injection nozzles (Figure 5). One of the four sleeves was ejected into the cold-leg pipe and another one was partially dislodged from its normal position. Failure was vibration initiated causing the sleeve to loosen, twist, and dislodge from the nozzle. The source of vibration was RC pump flow velocity and mechanical vibration. A possible contributing factor was the design reduction of the expansion* groove depth from 0.125 in. to 0.100 in. for this size thermal sleeve. In response to Mr. Michelson, CE said the vibration that caused the thermowell failures also affected the thermal sleeves. CE has elected to remove the sleeves. Analysis indicated that the thermal fatigue usage factor for the injection nozzle will not be significantly affected by sleeve removal. In response to Mr. Ward, Mr. Ferguson indicated that the usage factor analysis is quite conservative. In response to Mr. Michelson, CE indicated that they have not felt it necessary to advise its customers to inspect their operating plants for loose or missing sleeves.

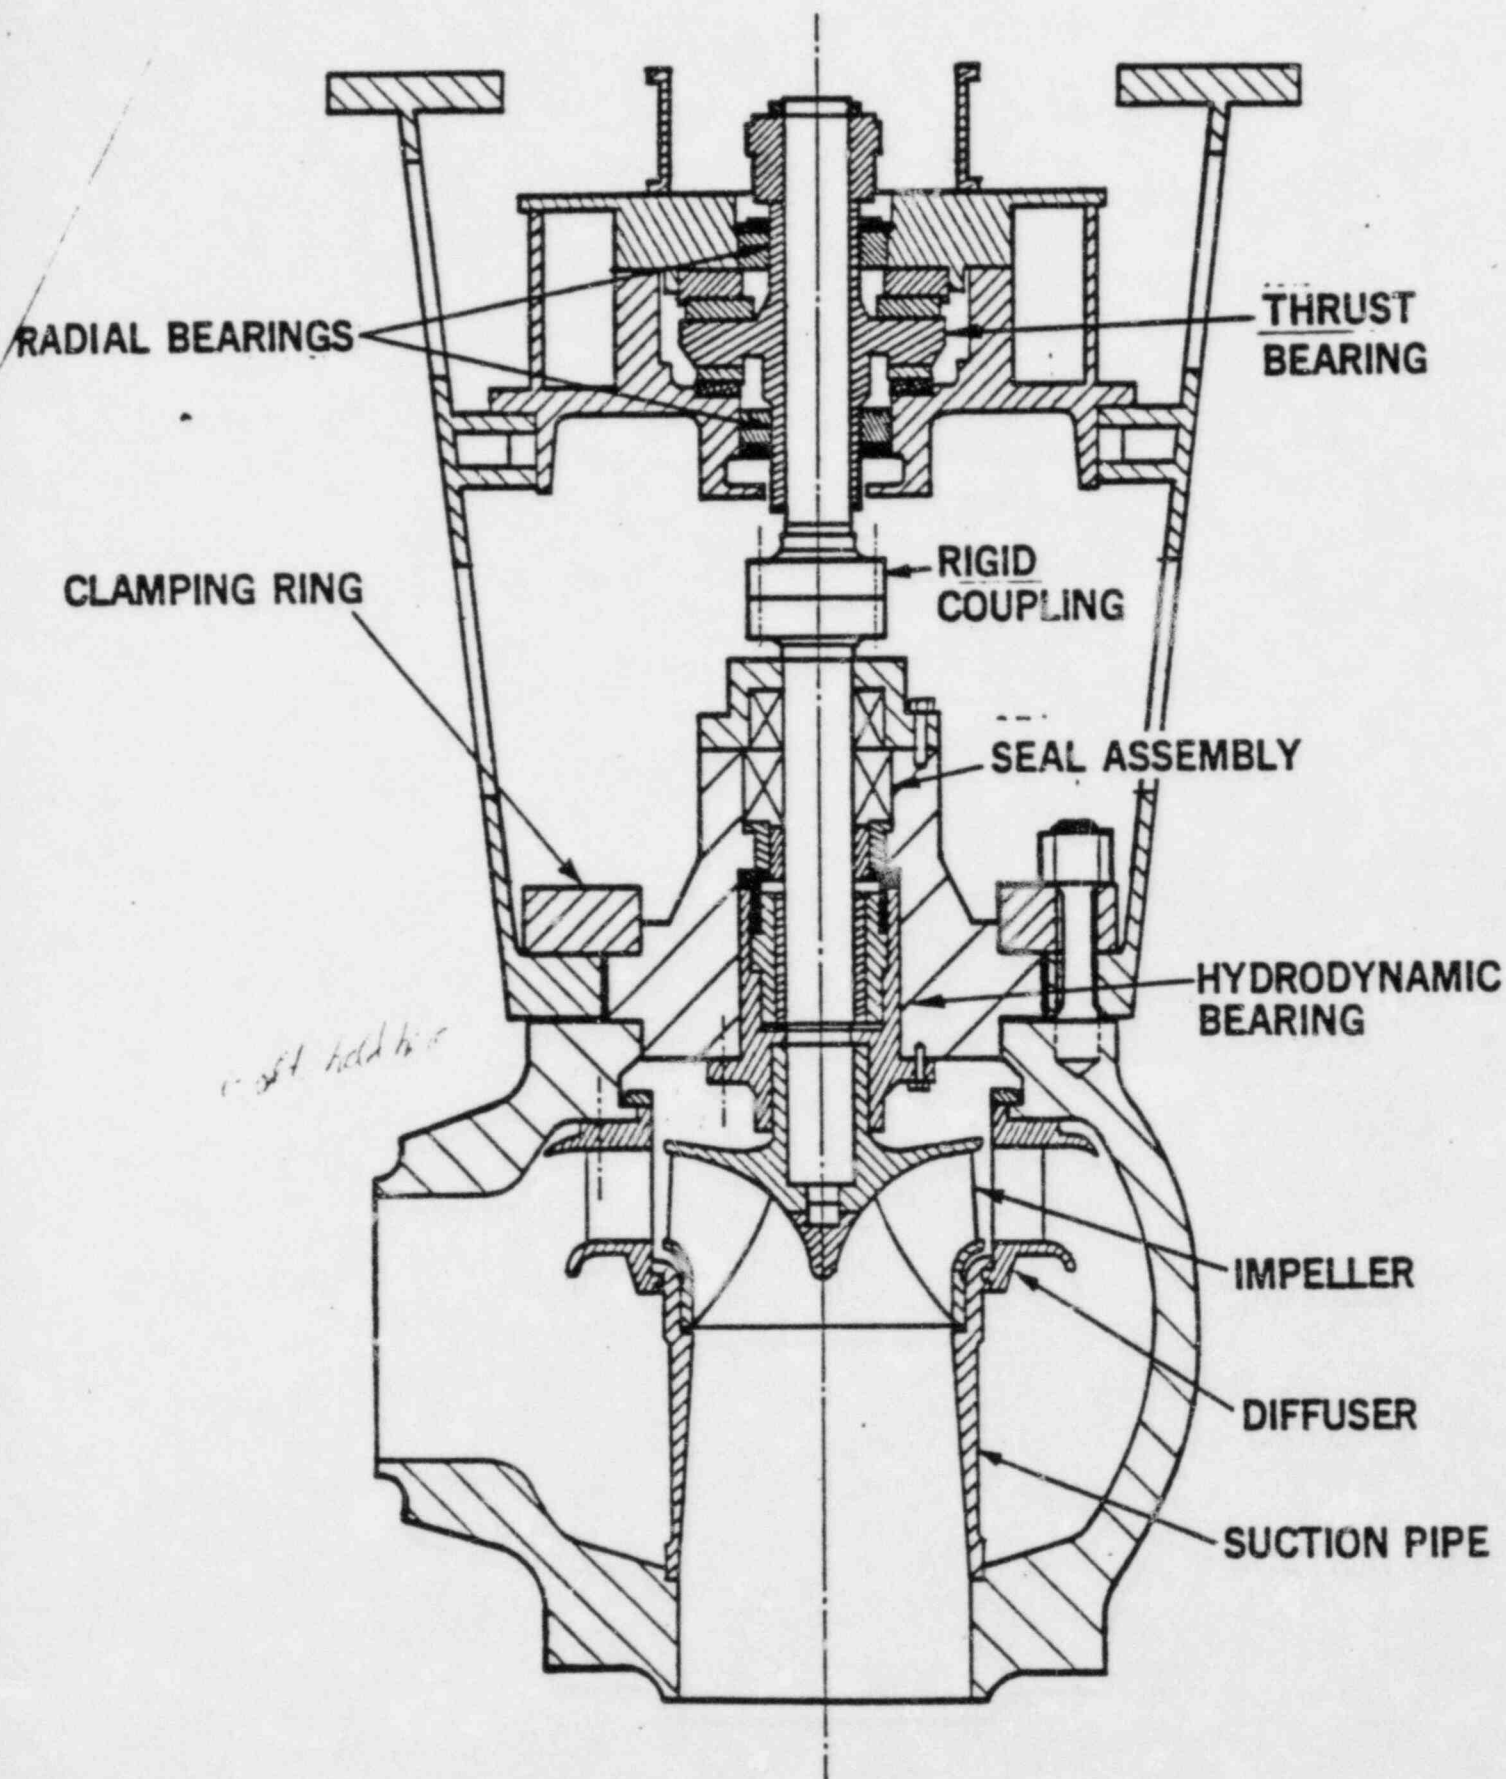
C-E - KSB PUMP DESIGN

Mr. Ferguson detailed the damage to the RC pumps (Figure 6) and the modifications made to resolve the problem. The pumps are of German design and are "first-of-a-kind" components. There was damage seen

to the pump internals (broken diffuser bolts, broken and cracked diffuser vanes) found upon inspection after the hot functional test. Mr. Michelson asked if the loose parts monitor (LPM) was able to detect anything. CE said it was in an on-again, off-again mode and the failures occurred rather quickly, with no parts continually moving around the RCS. APS is analyzing the LPM data they do have, vis-a-vis this event, to help baseline this system. In response to Mr. Michelson, Mr. Scherer (CE) said the LPM is not a cure-all for problems of this kind.

As a result of a series of tests on the pump, the cause of the damage was found to be due to flow pulsations. The fix elected was to increase the clearance between the impeller and diffuser from 2.3% to 6.0% by cutting back the diffuser vanes, without resulting in significant hydraulic impact. Head losses due to increased gap, removal of suction pipe rings, and cutting back the leading edges of impeller were recovered by backfiling the impeller. Radial hydraulic forces on the diffuser were reduced by a factor of 3.3 by increasing the gap to 6.0 percent. The measured stress levels on the impeller and diffuser vanes were at acceptable levels. Metallurgical tests show the cause of the RCP damage was due to flow pulsations. Metallurgical tests show the cracking mode for the impeller is fatigue. There was no evidence of corrosion. Similar examination of the diffuser bolts again indicated fatigue was the most likely failure mode and no evidence of corrosion or hydrogen embrittlement was seen. Details of the diffuser modifications were also noted.

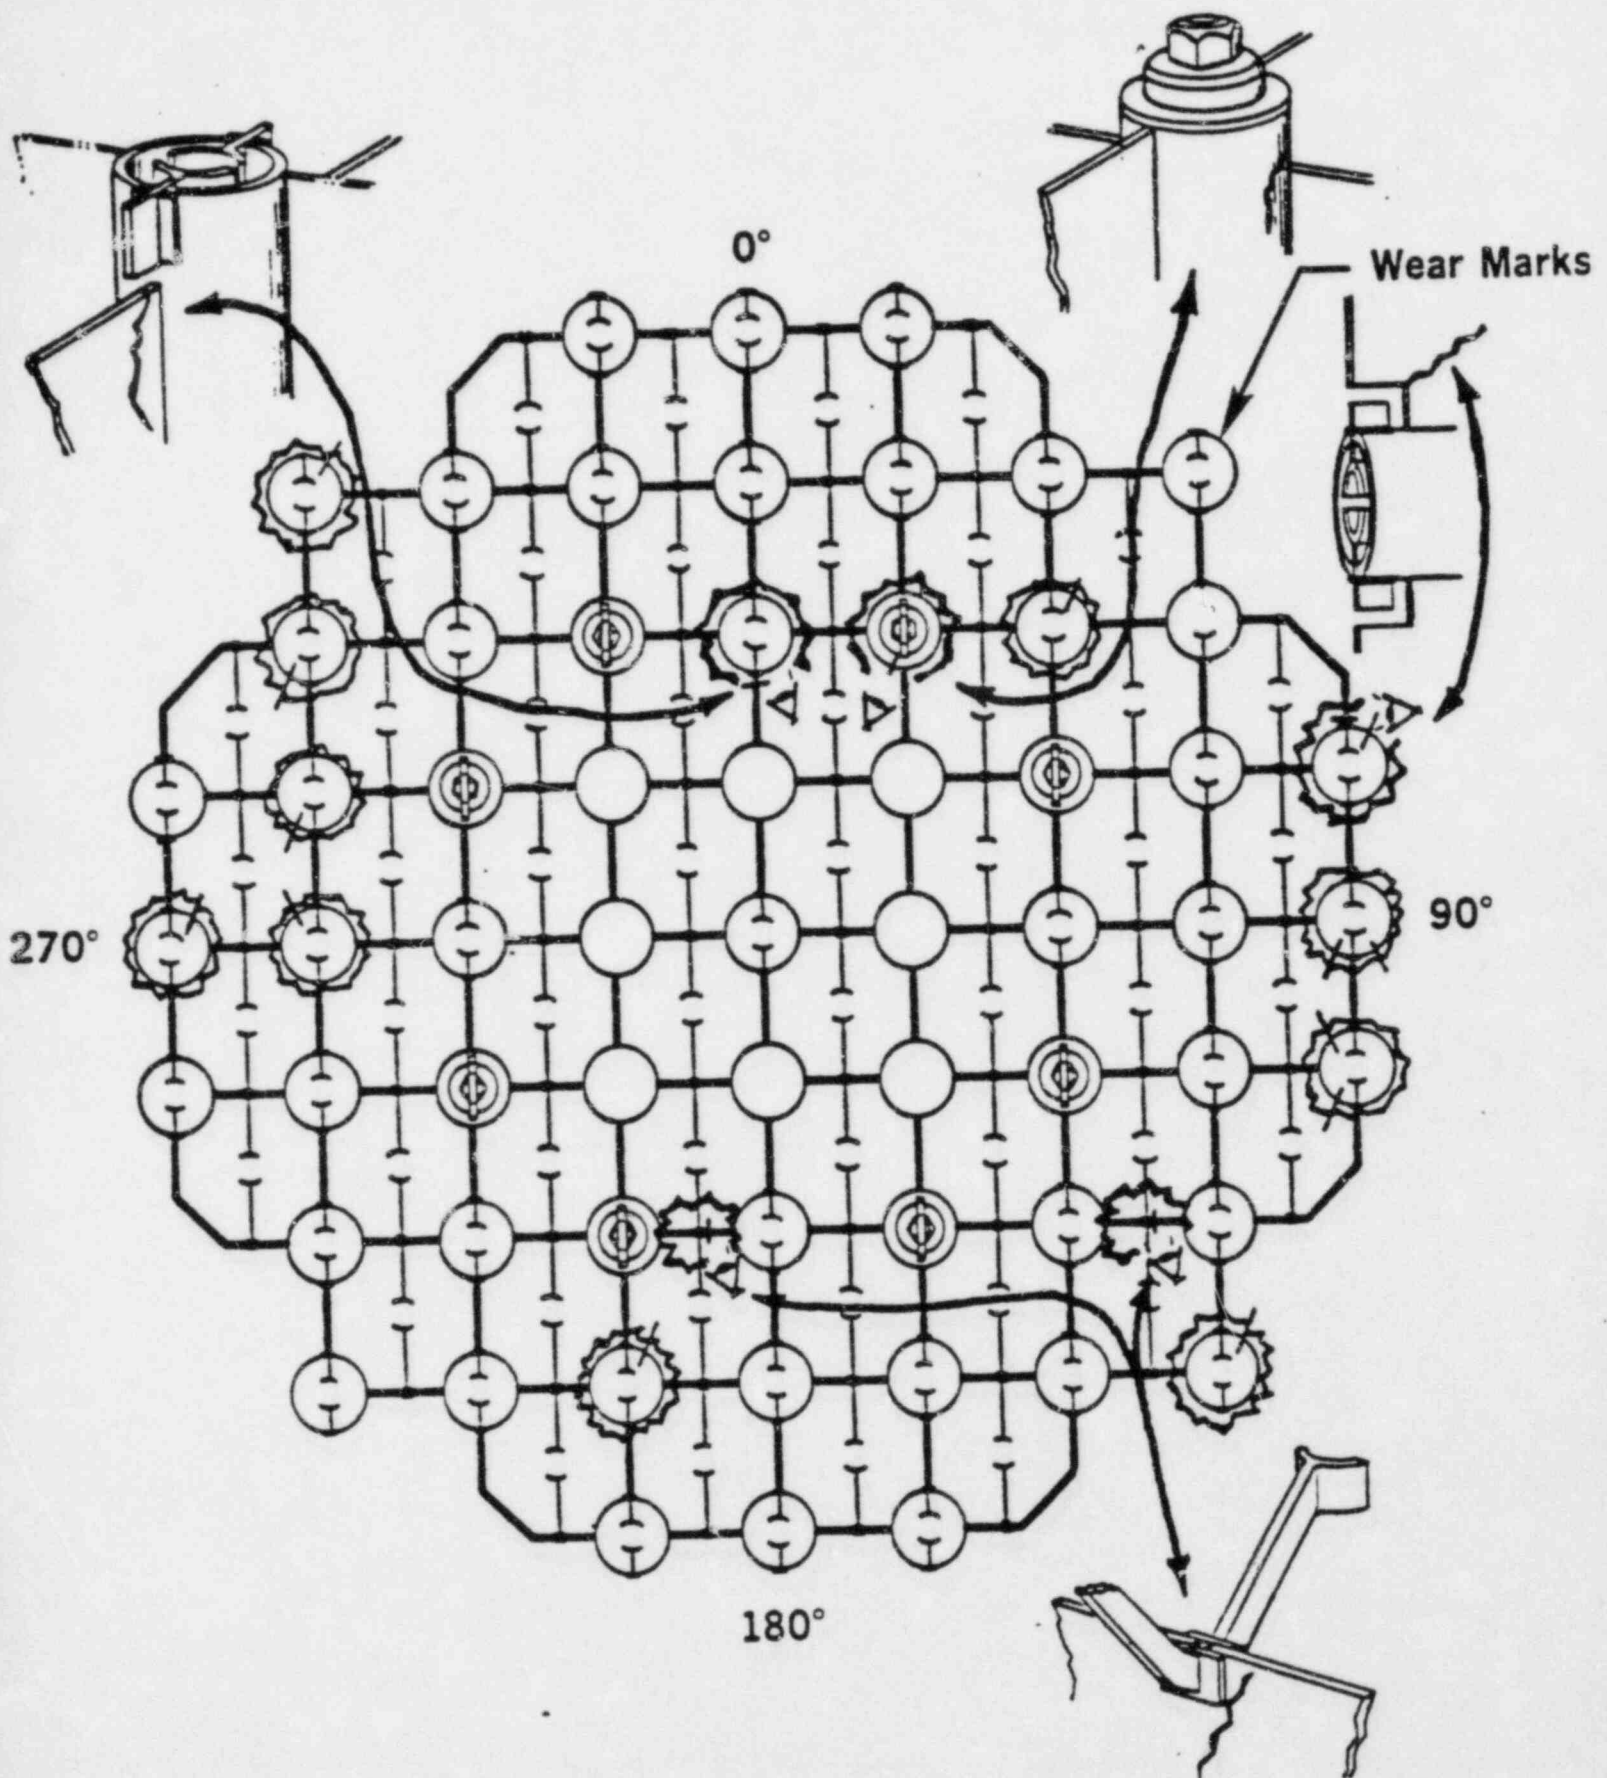
FIG. 9

CE discussed the cracking seen in the upper region of the CEA shroud assembly. Figure 8 shows the shroud and the upper guide structure and Figure 9 shows the location of the cracking in the upper structure

region. Most of the cracking was in this location. The failure mode was by high cycle fatigue. In response to Mr. Dillon, BE said there was no evidence of corrosion seen. Further questions brought out the fact that the CEA shroud design is first-of-a-kind for Palo Verde. Vibration and excitation tests have been done since the damage was observed. These tests showed that there was a problem with vibration induced cracking.
