SUBJECT: MEETING MINUTES - RESPONSE TO VENT HEADER CRACKING IN MARK I CONTAINMENTS - FEBRUARY 23, 1984

SUBJECT: Plant Survey for Nitrogen Injection into Drywell and Wetwell

SIL No. 402 Category 1

#### WETWELL/DRYWELL INERTING

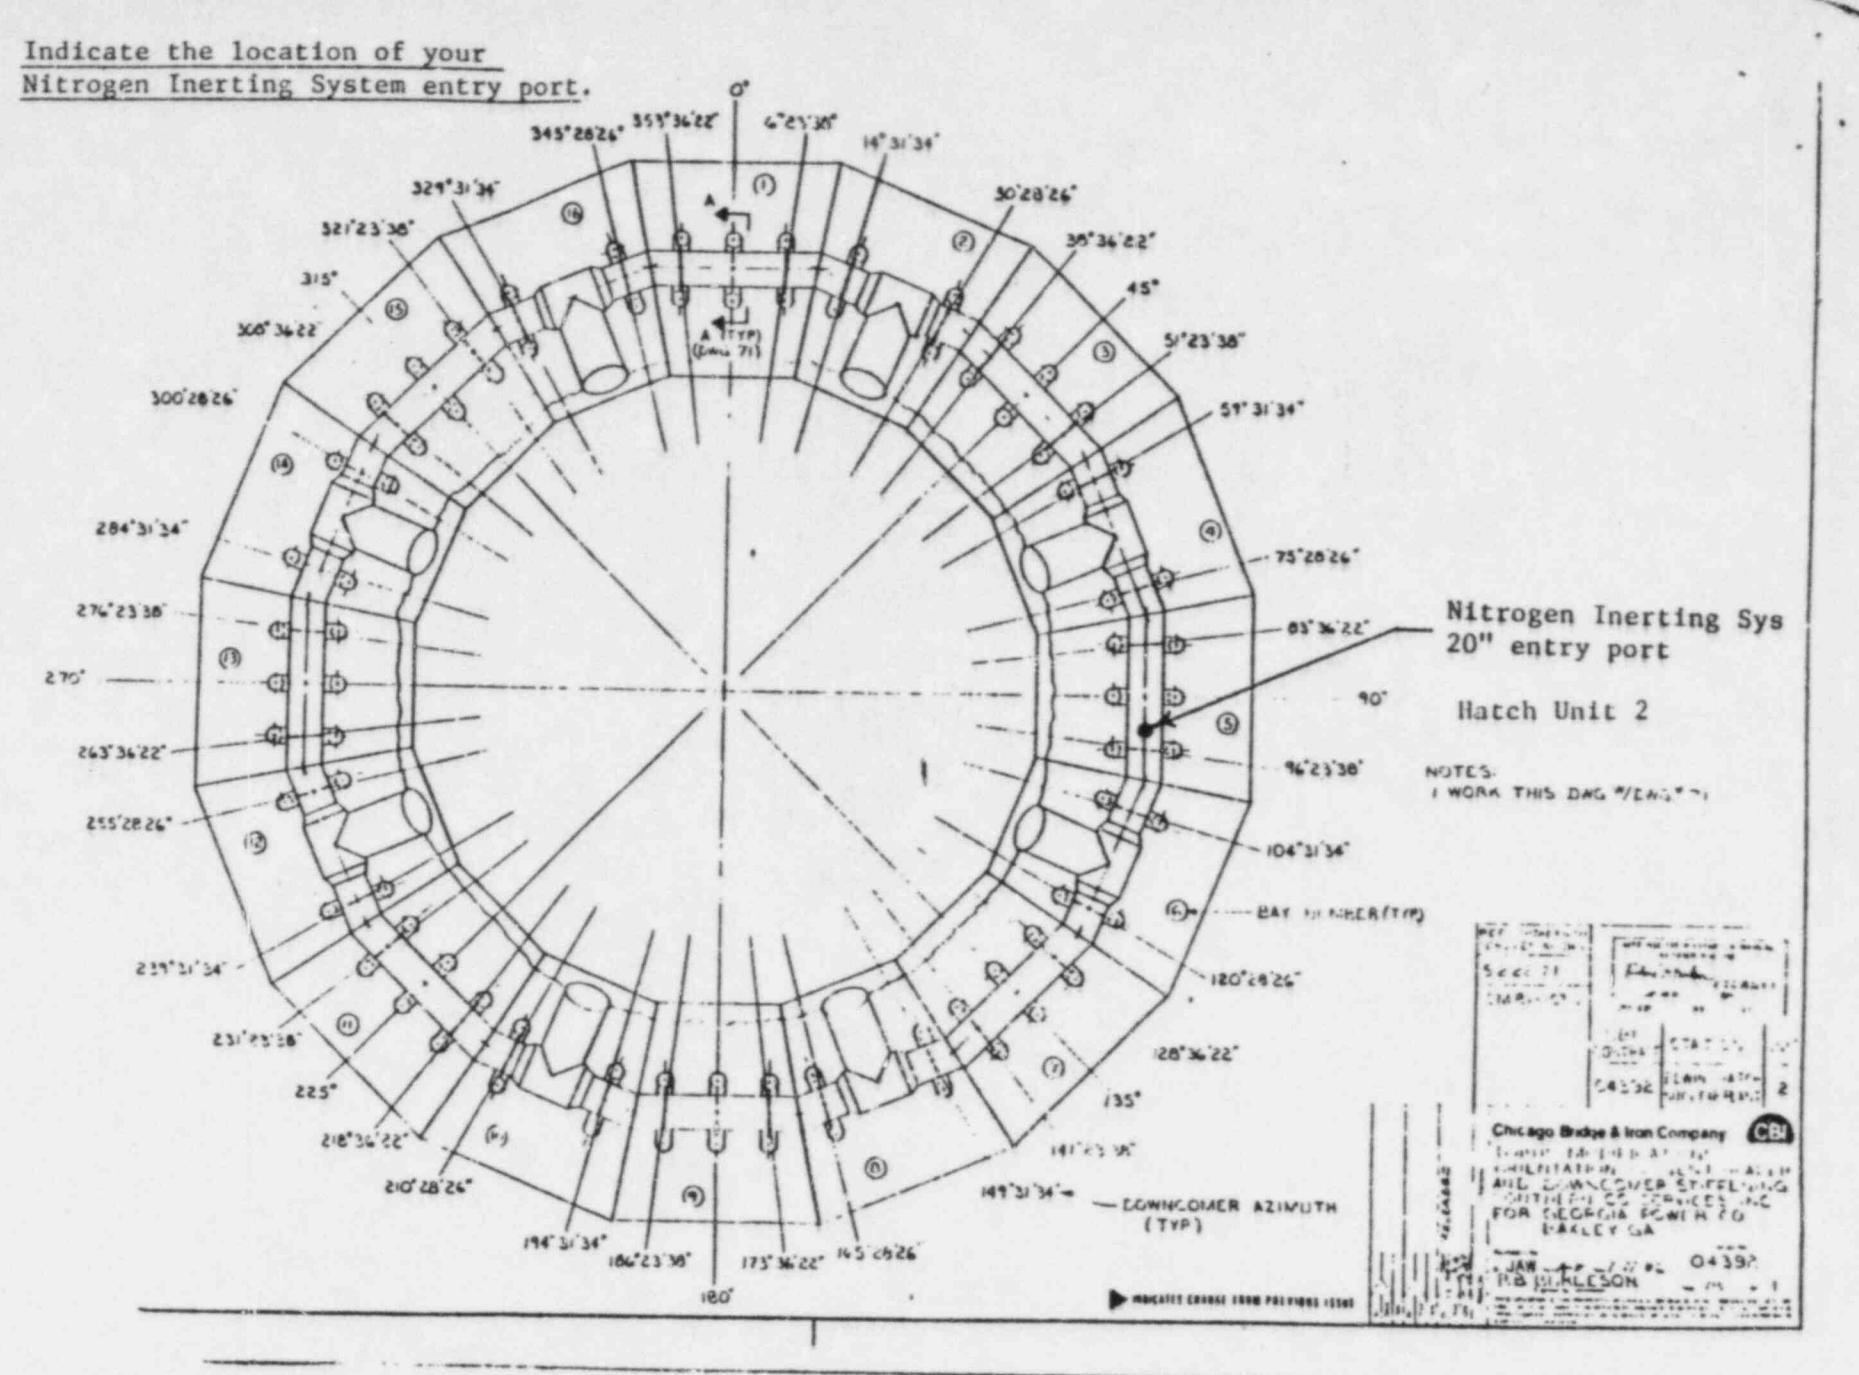
At the reference meeting, the details of the Hatch Unit 2 nitrogen inerting injection port were presented to NRC by the RRG, Georgia Power, and GE. The attached plan and elevation sketches show the Hatch Unit 2 details.

Indicate the location of your Nitrogen Inerting System entry Port.
