April 16, 1984

SUBJECT: Waterford 3 Steam Electric Station Docket No. 50-382 Construction Adequacy of WSES-3 Basemat

ATTACHMENT "A"

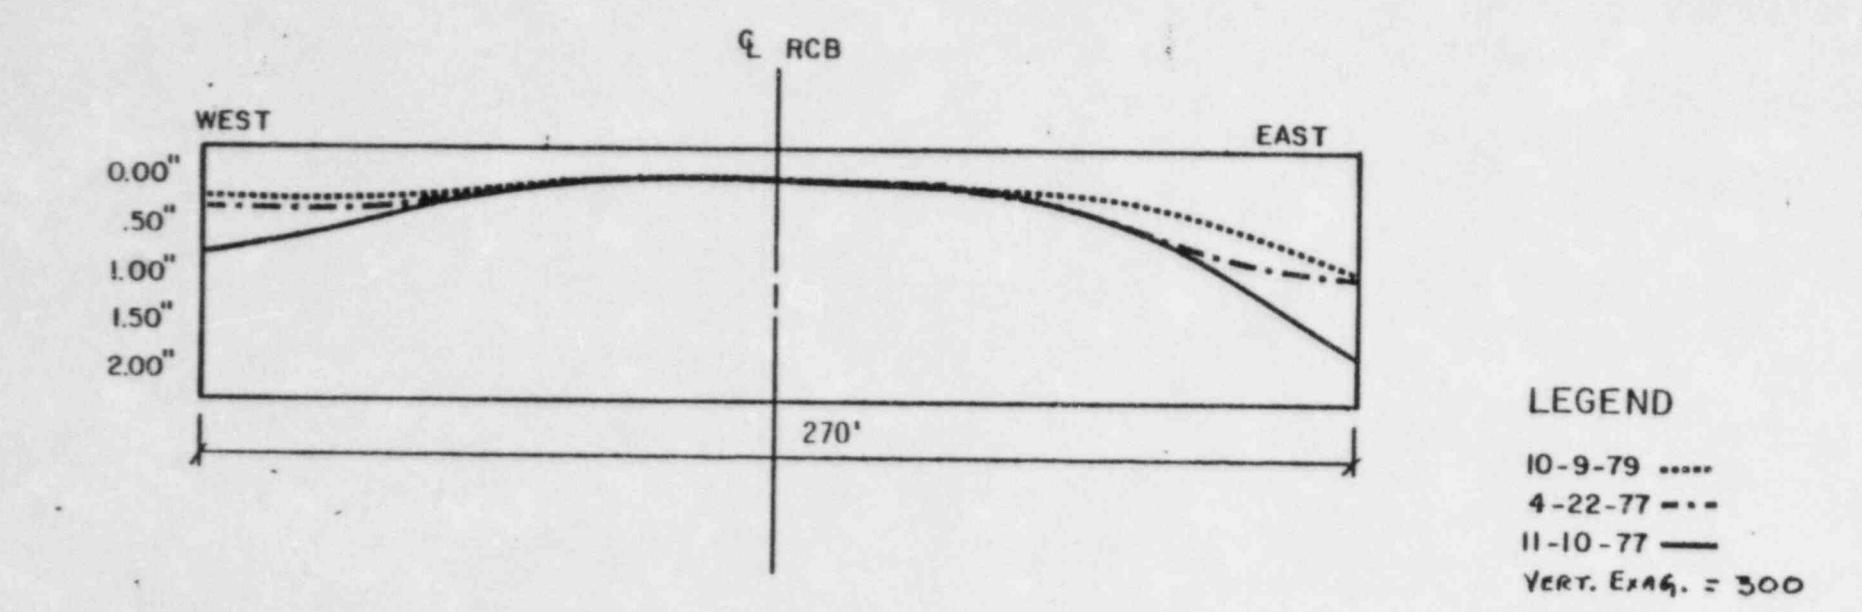
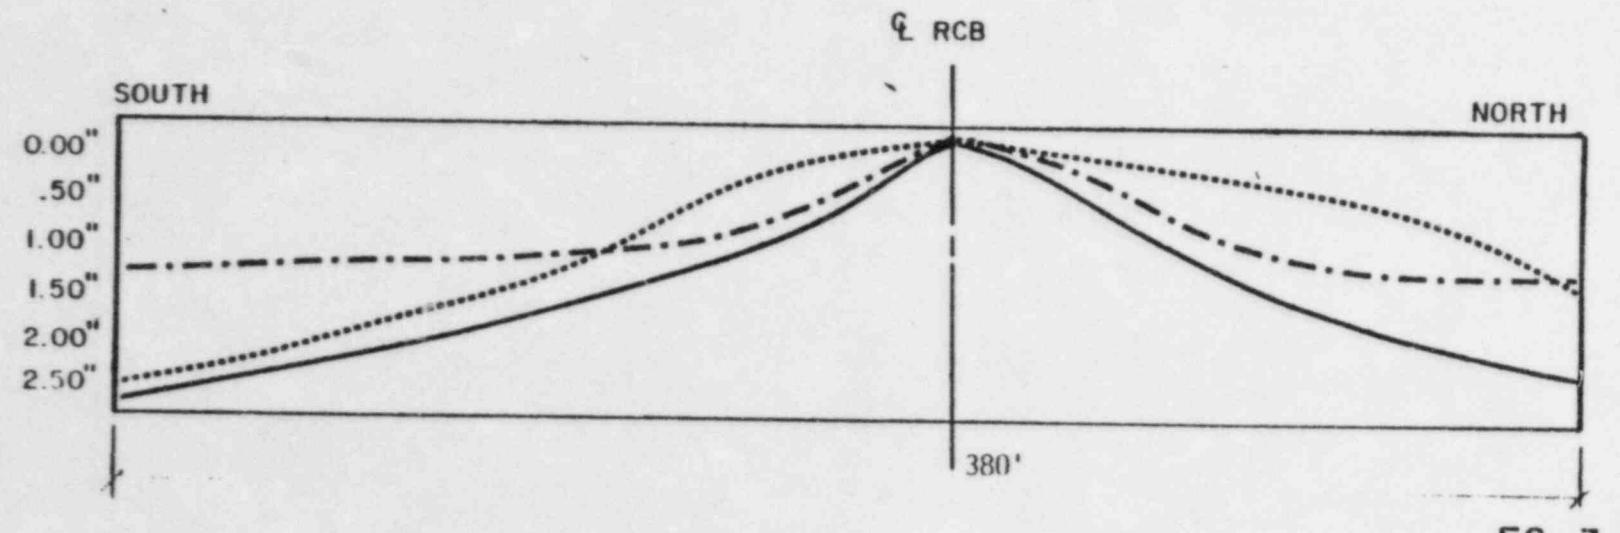
Attached is a graph (Figure ES-3) reflecting the contours obtained from the maps generated on April 22, 1977, November 10, 1977, and October 9, 1979. These curves reflect a before mat (ring wall) loading, after ring wall placement and a majority of concrete construction complete. These contours do reflect a convex mat with maximum differential of two inches (2").

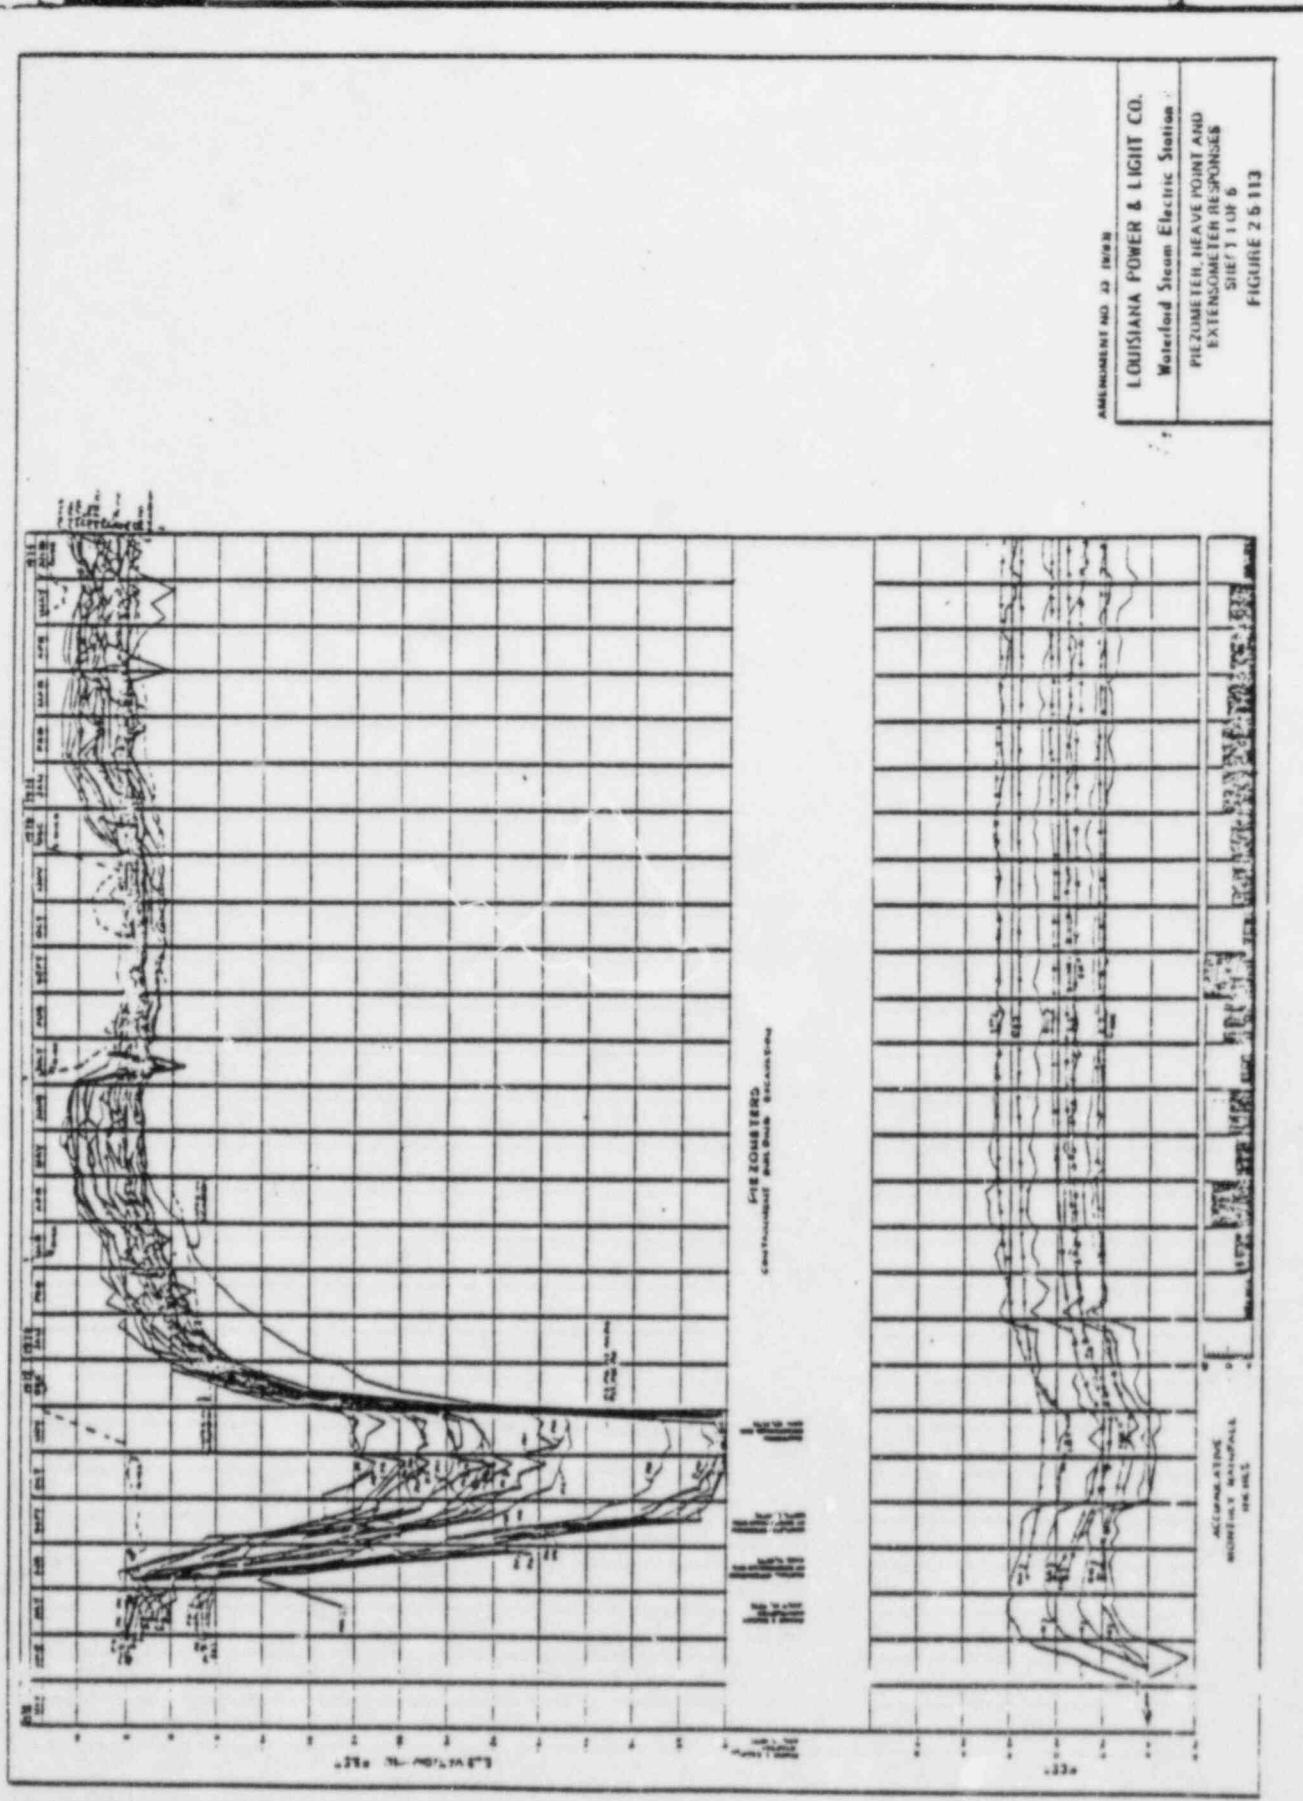
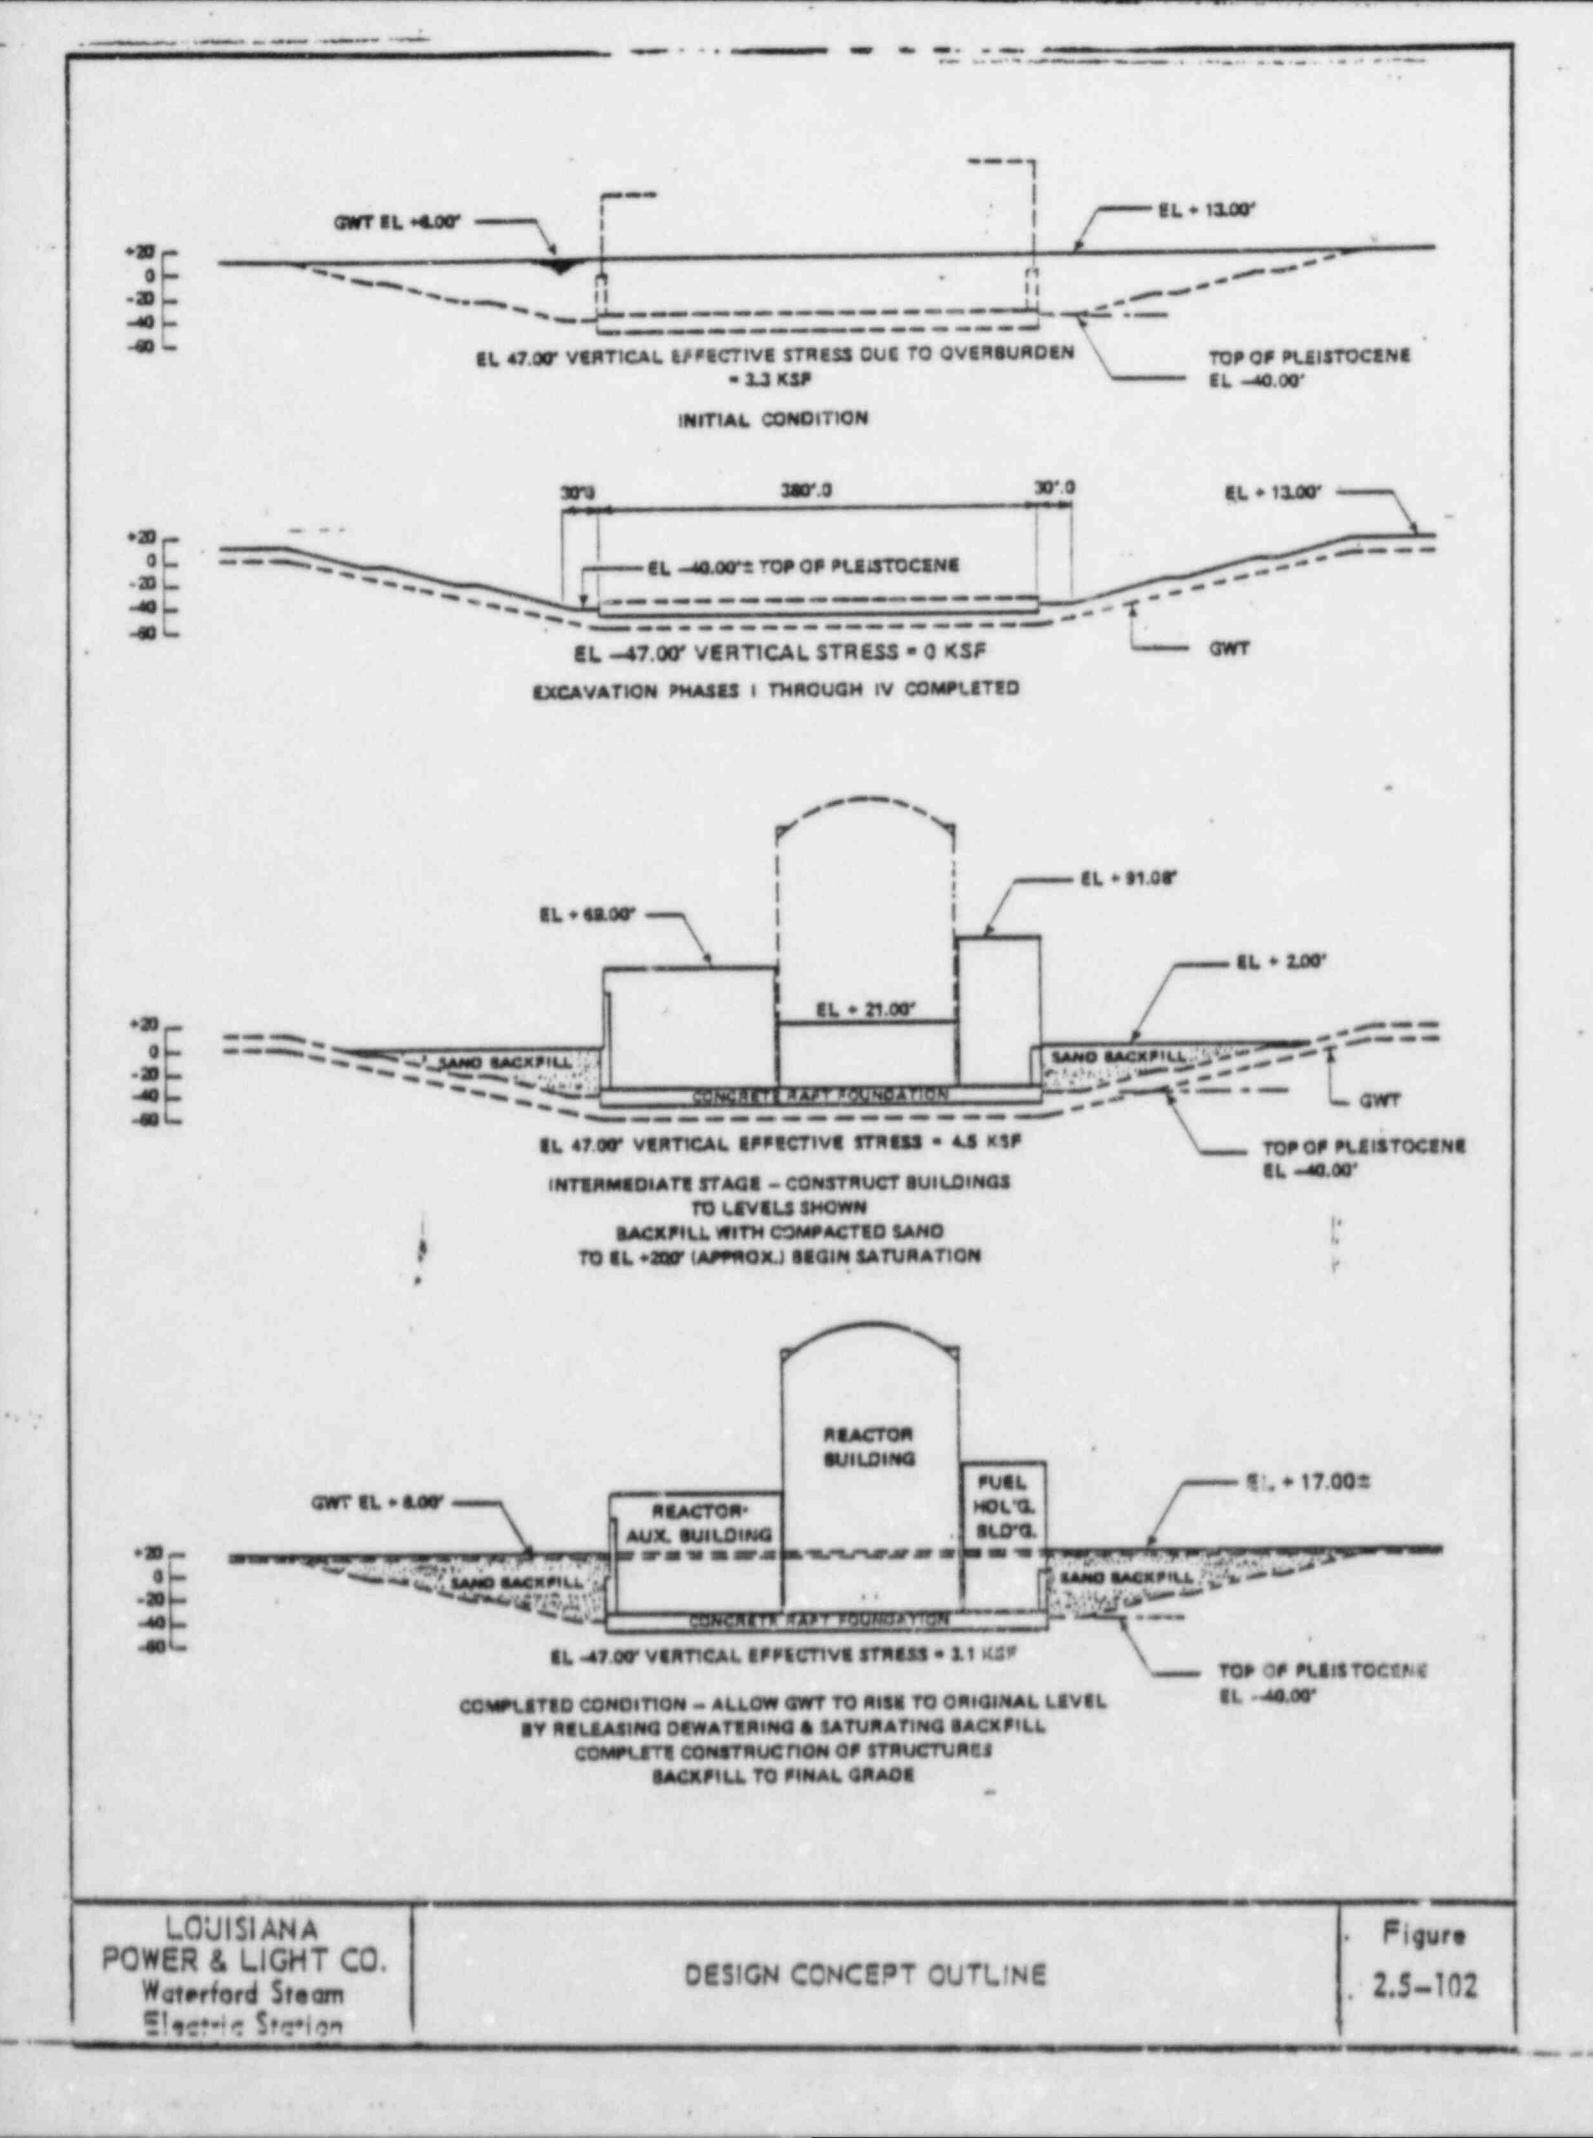
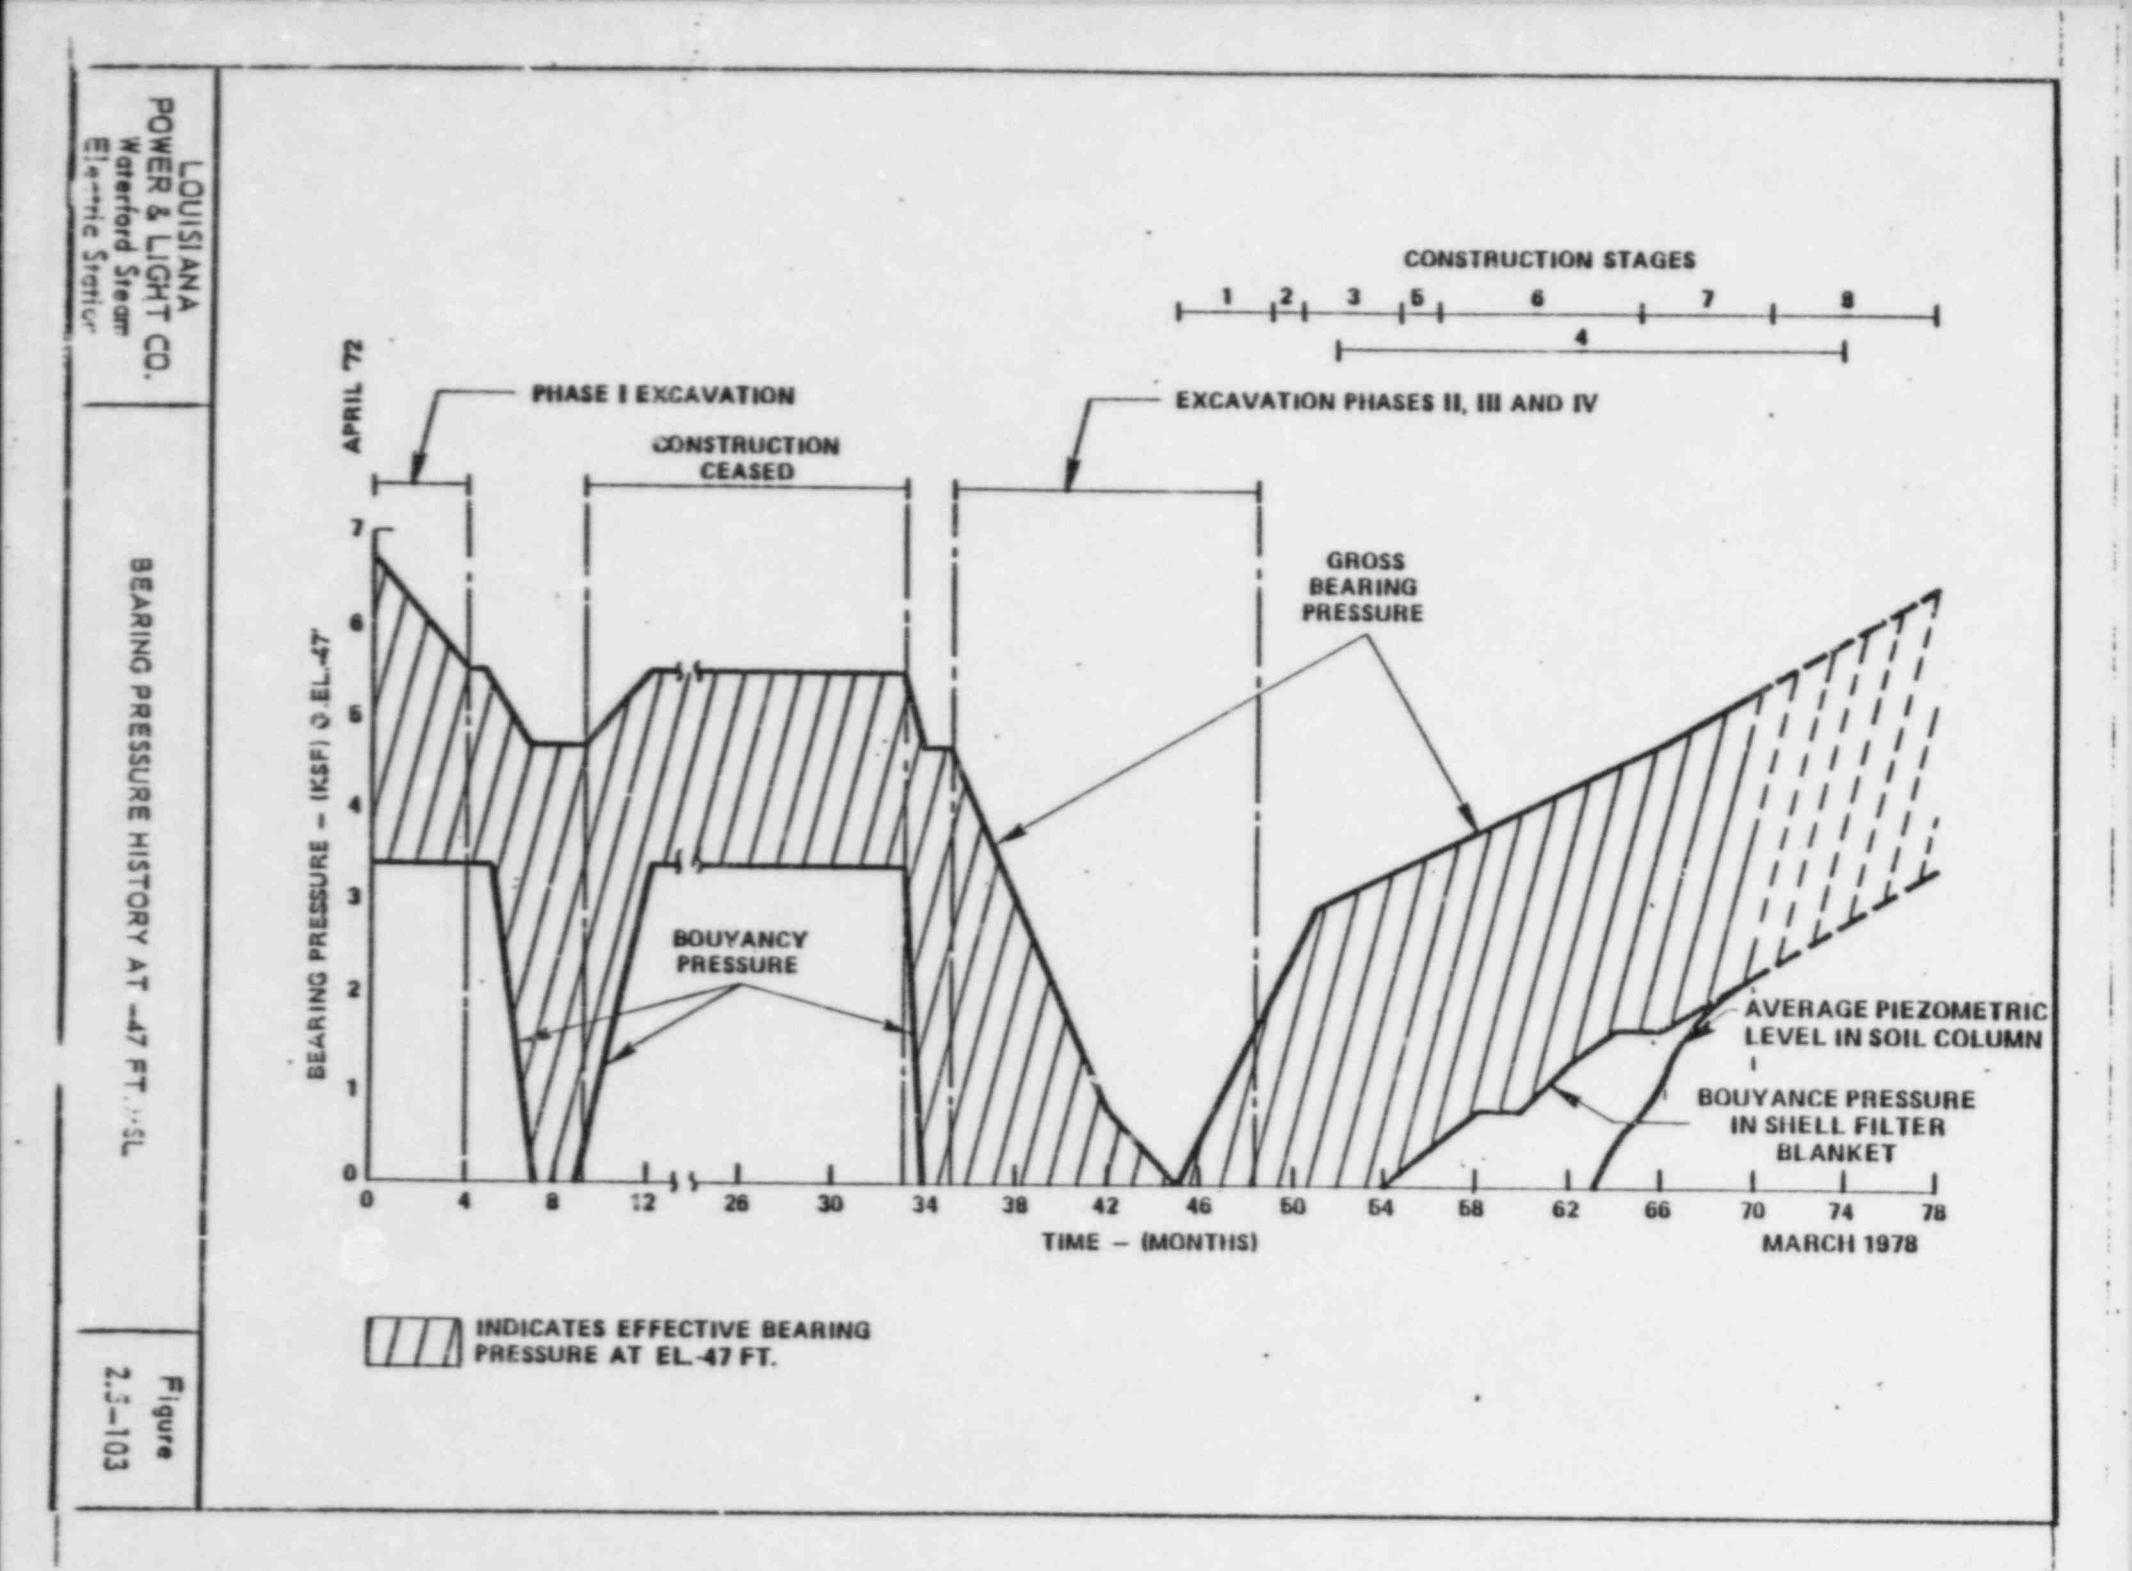
Groundwater control and foundation heave from the start of dewatering until recent time are exhibited in FSAR Fig. 2.5-113 (sheets 1/5 to 5/5).
