April 16, 1984

SUBJECT: Waterford 3 Steam Electric Station Docket No. 50-382 Construction Adequacy of WSES-3 Basemat

ATTACHMENT "A"

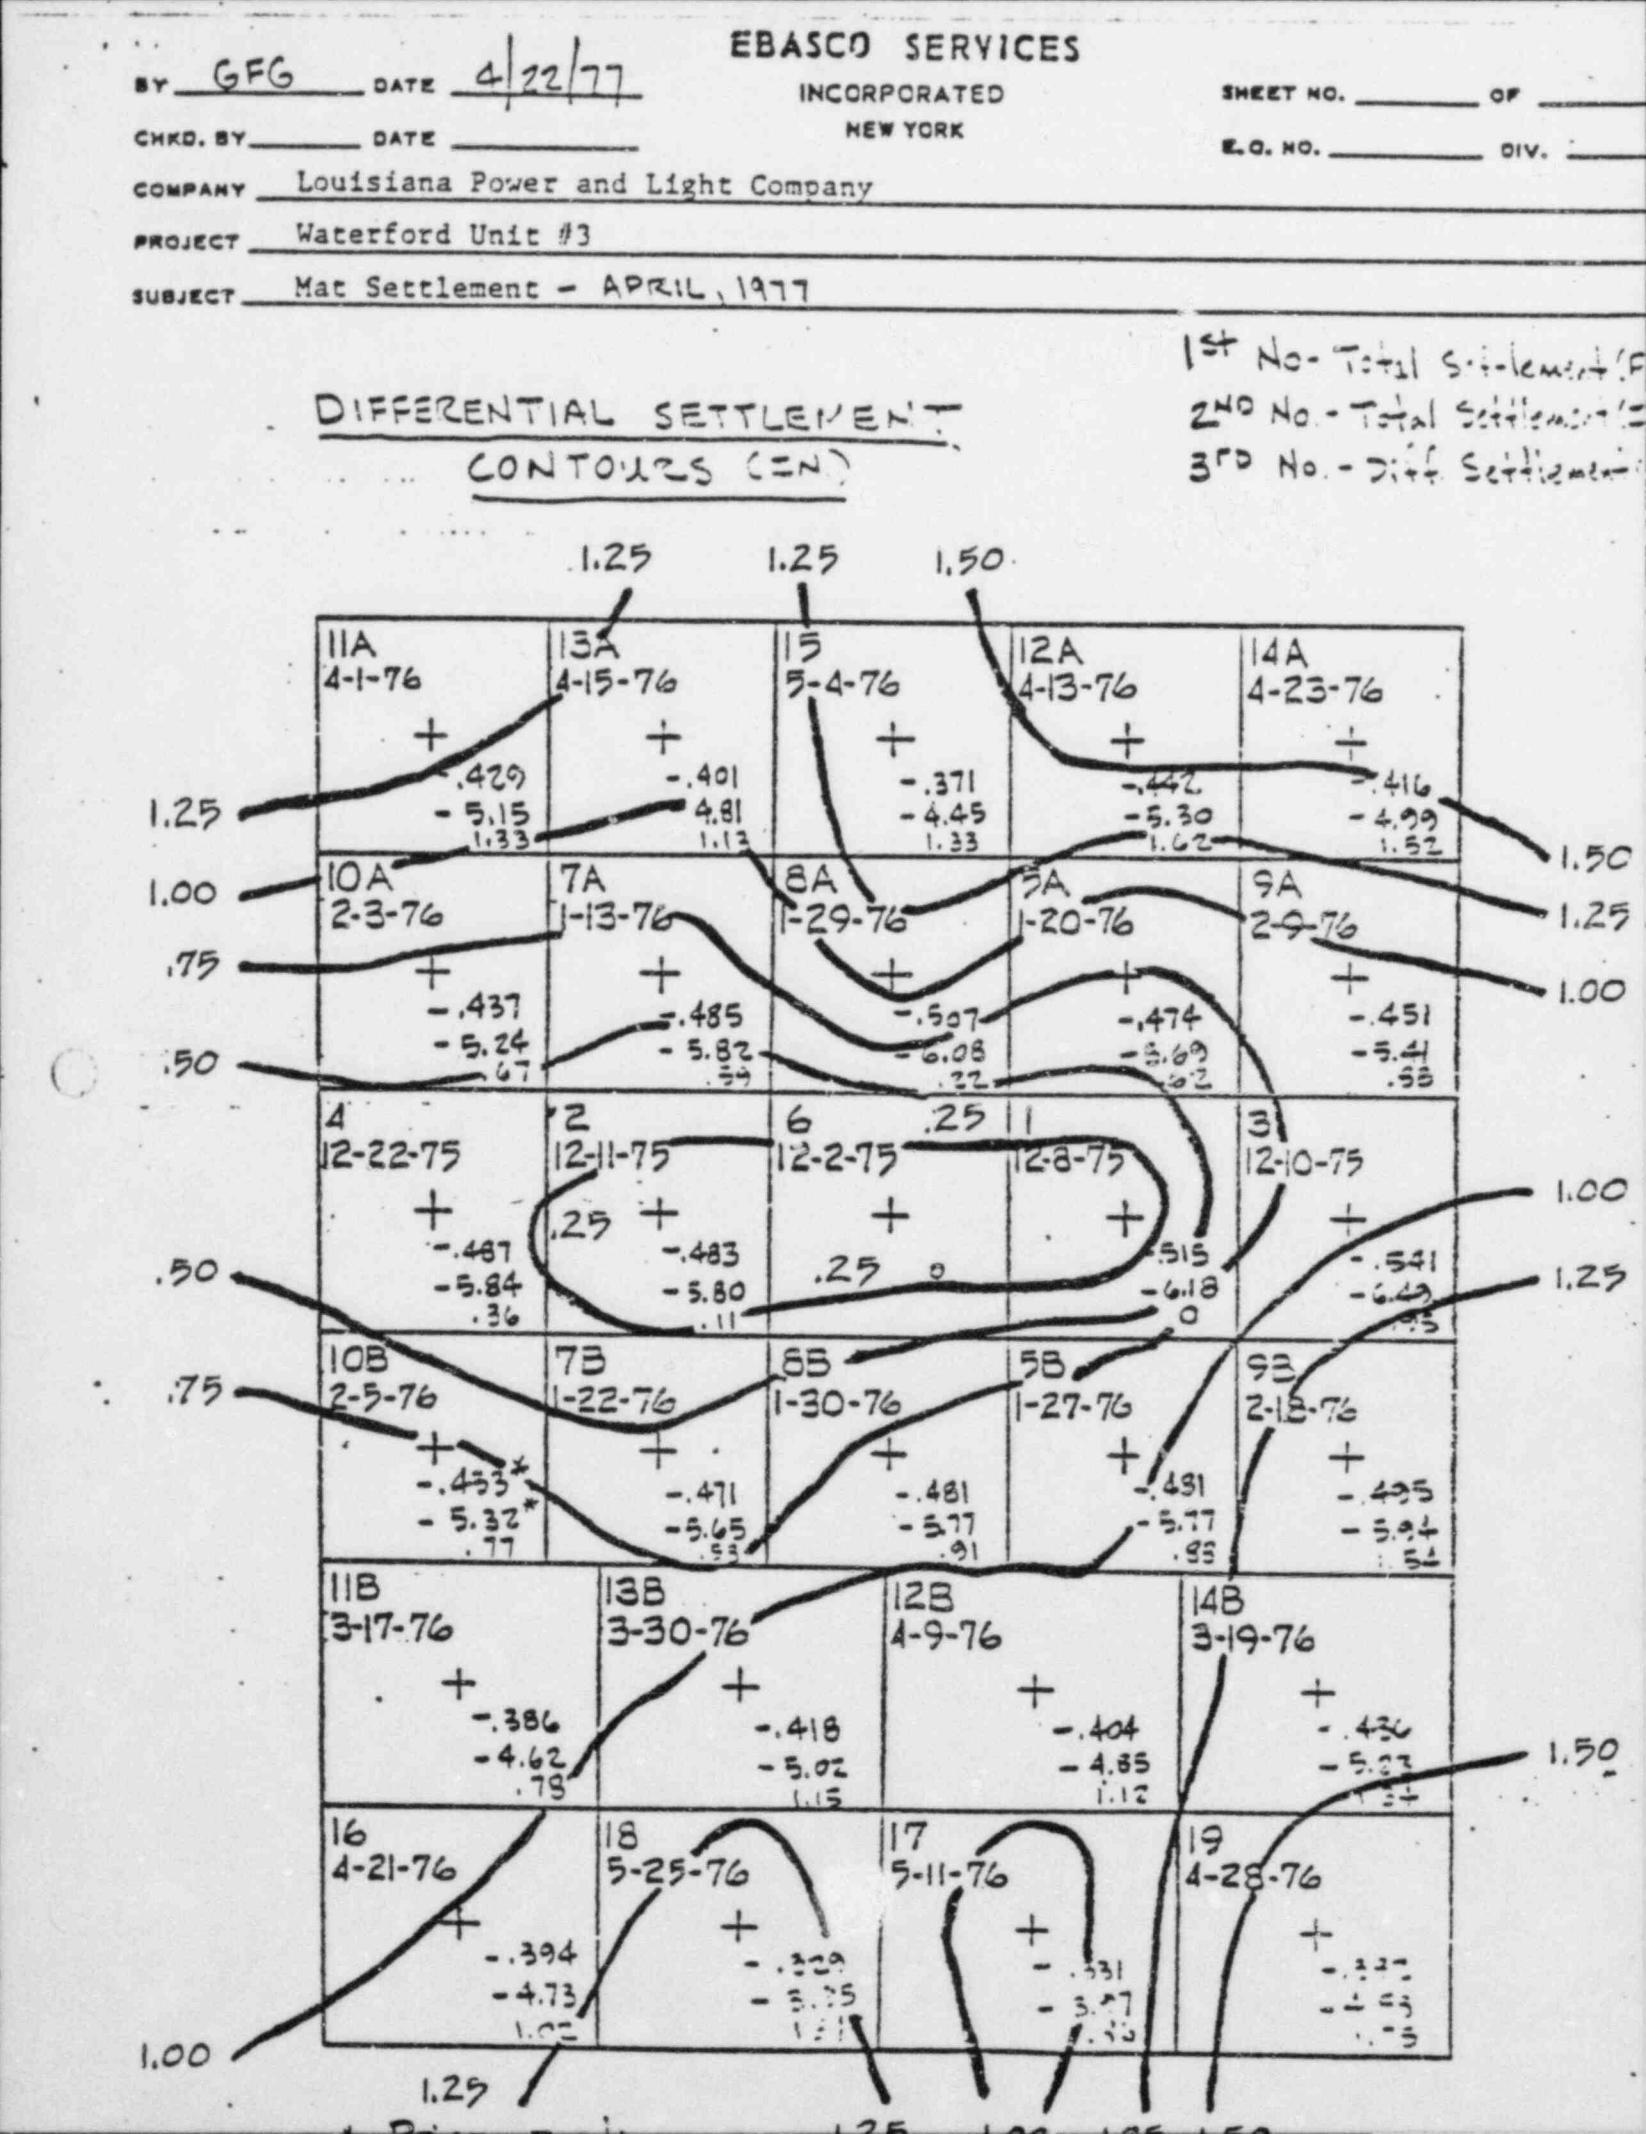
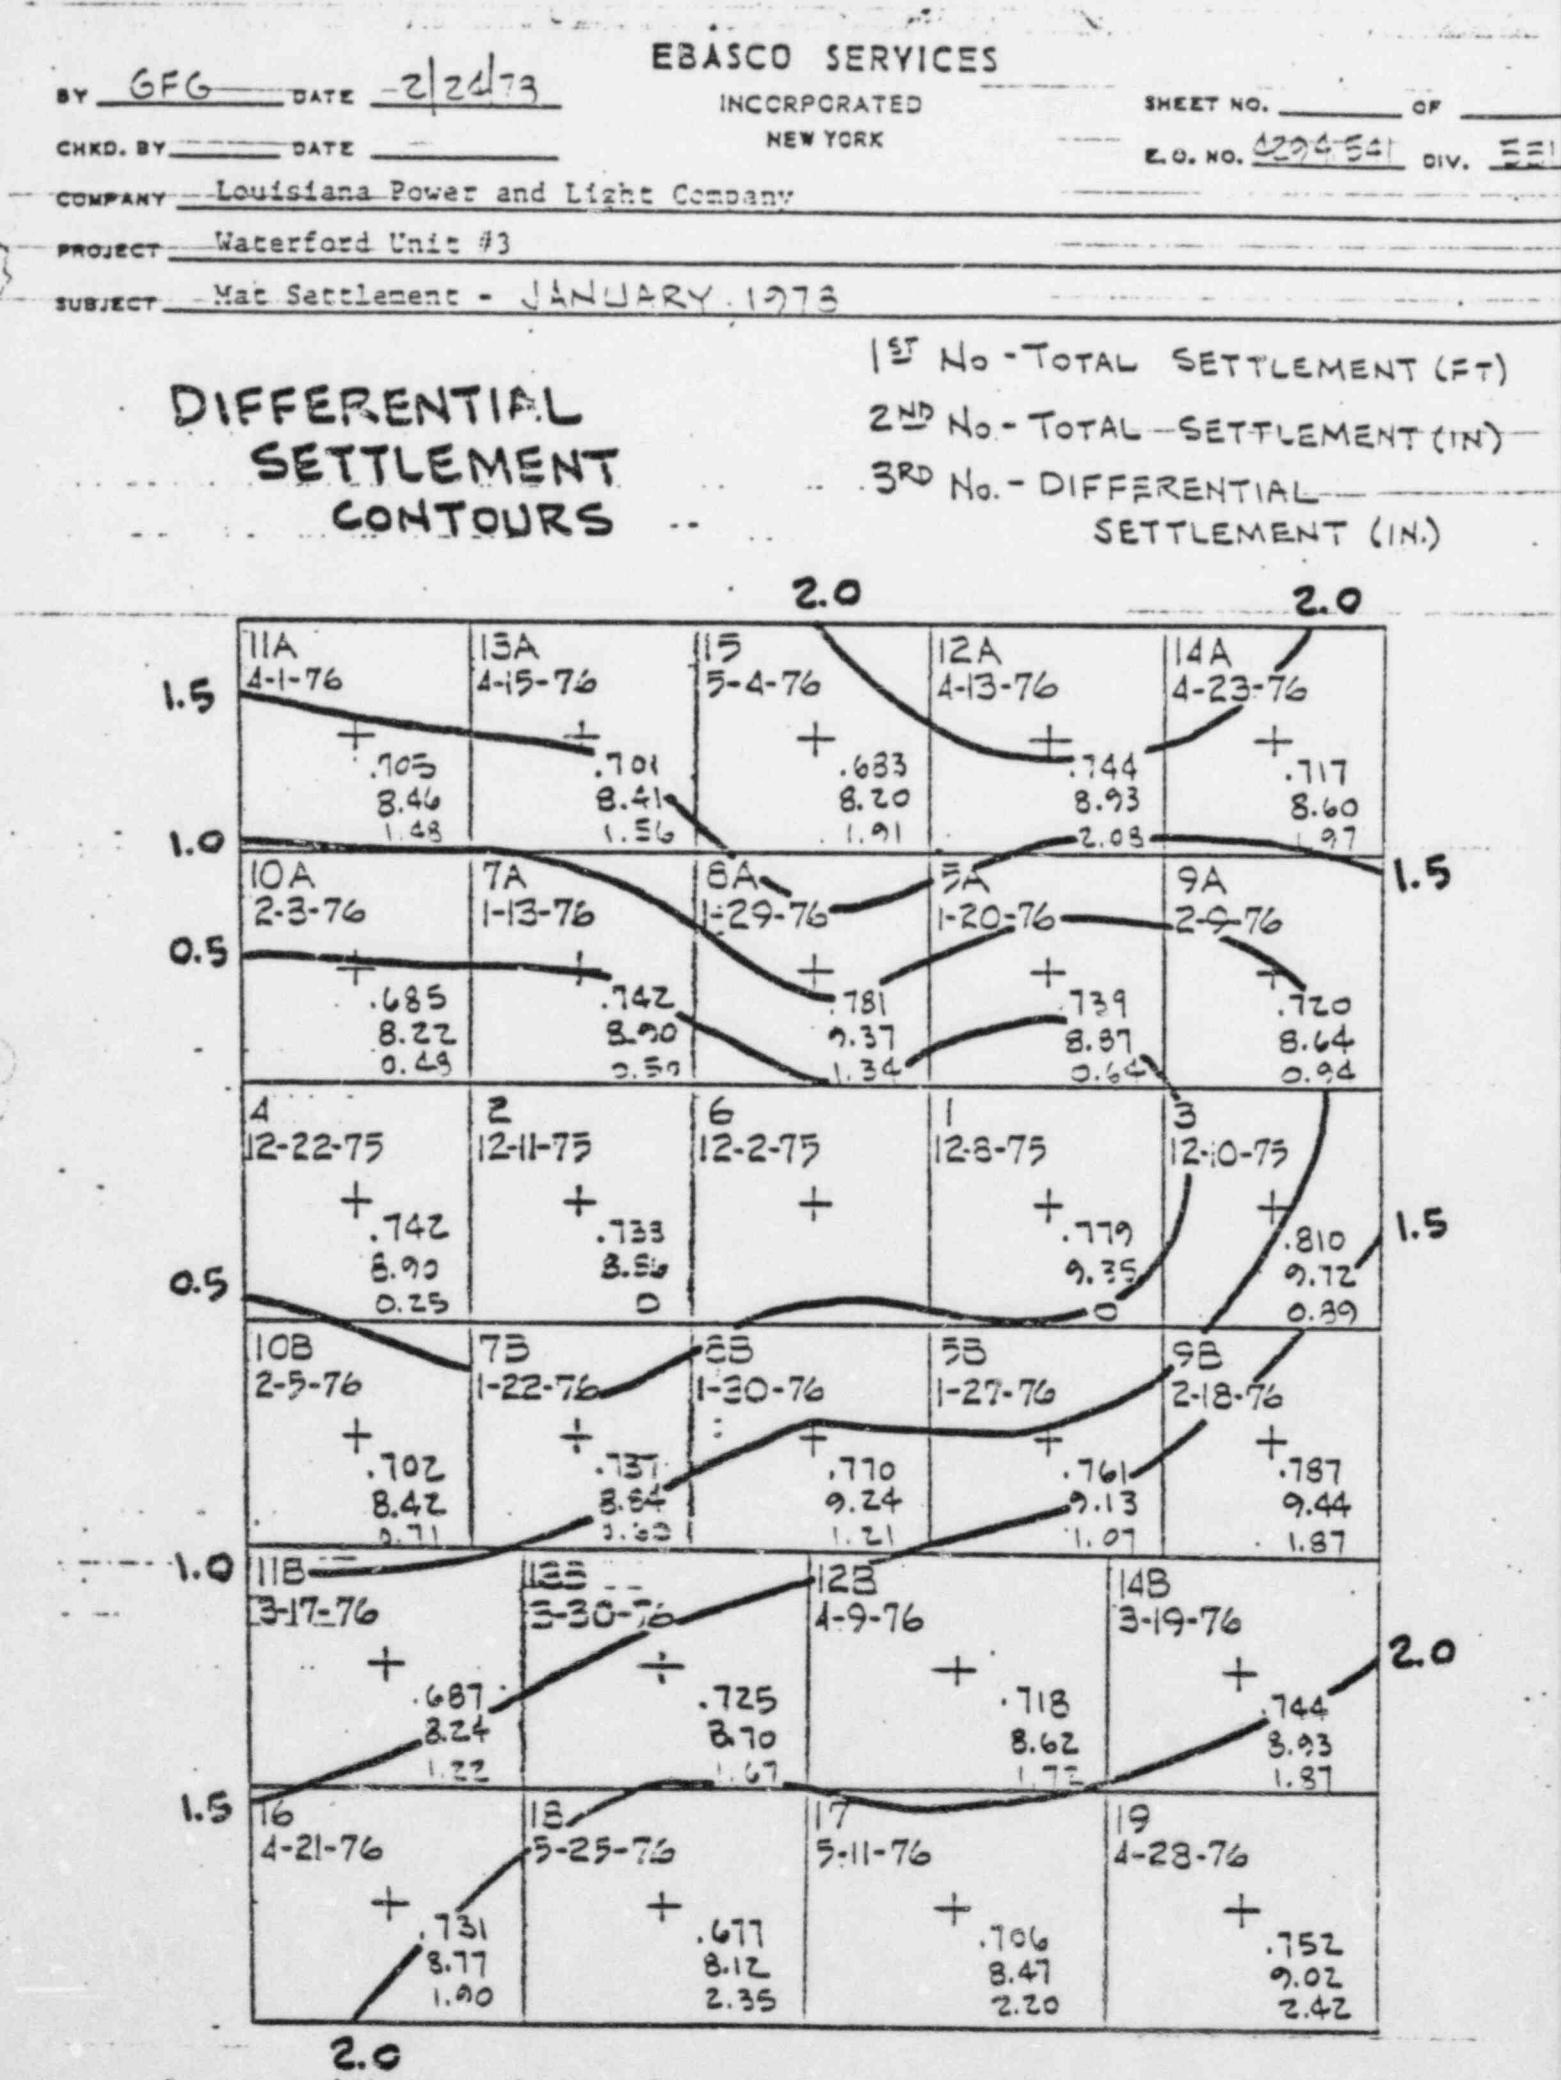
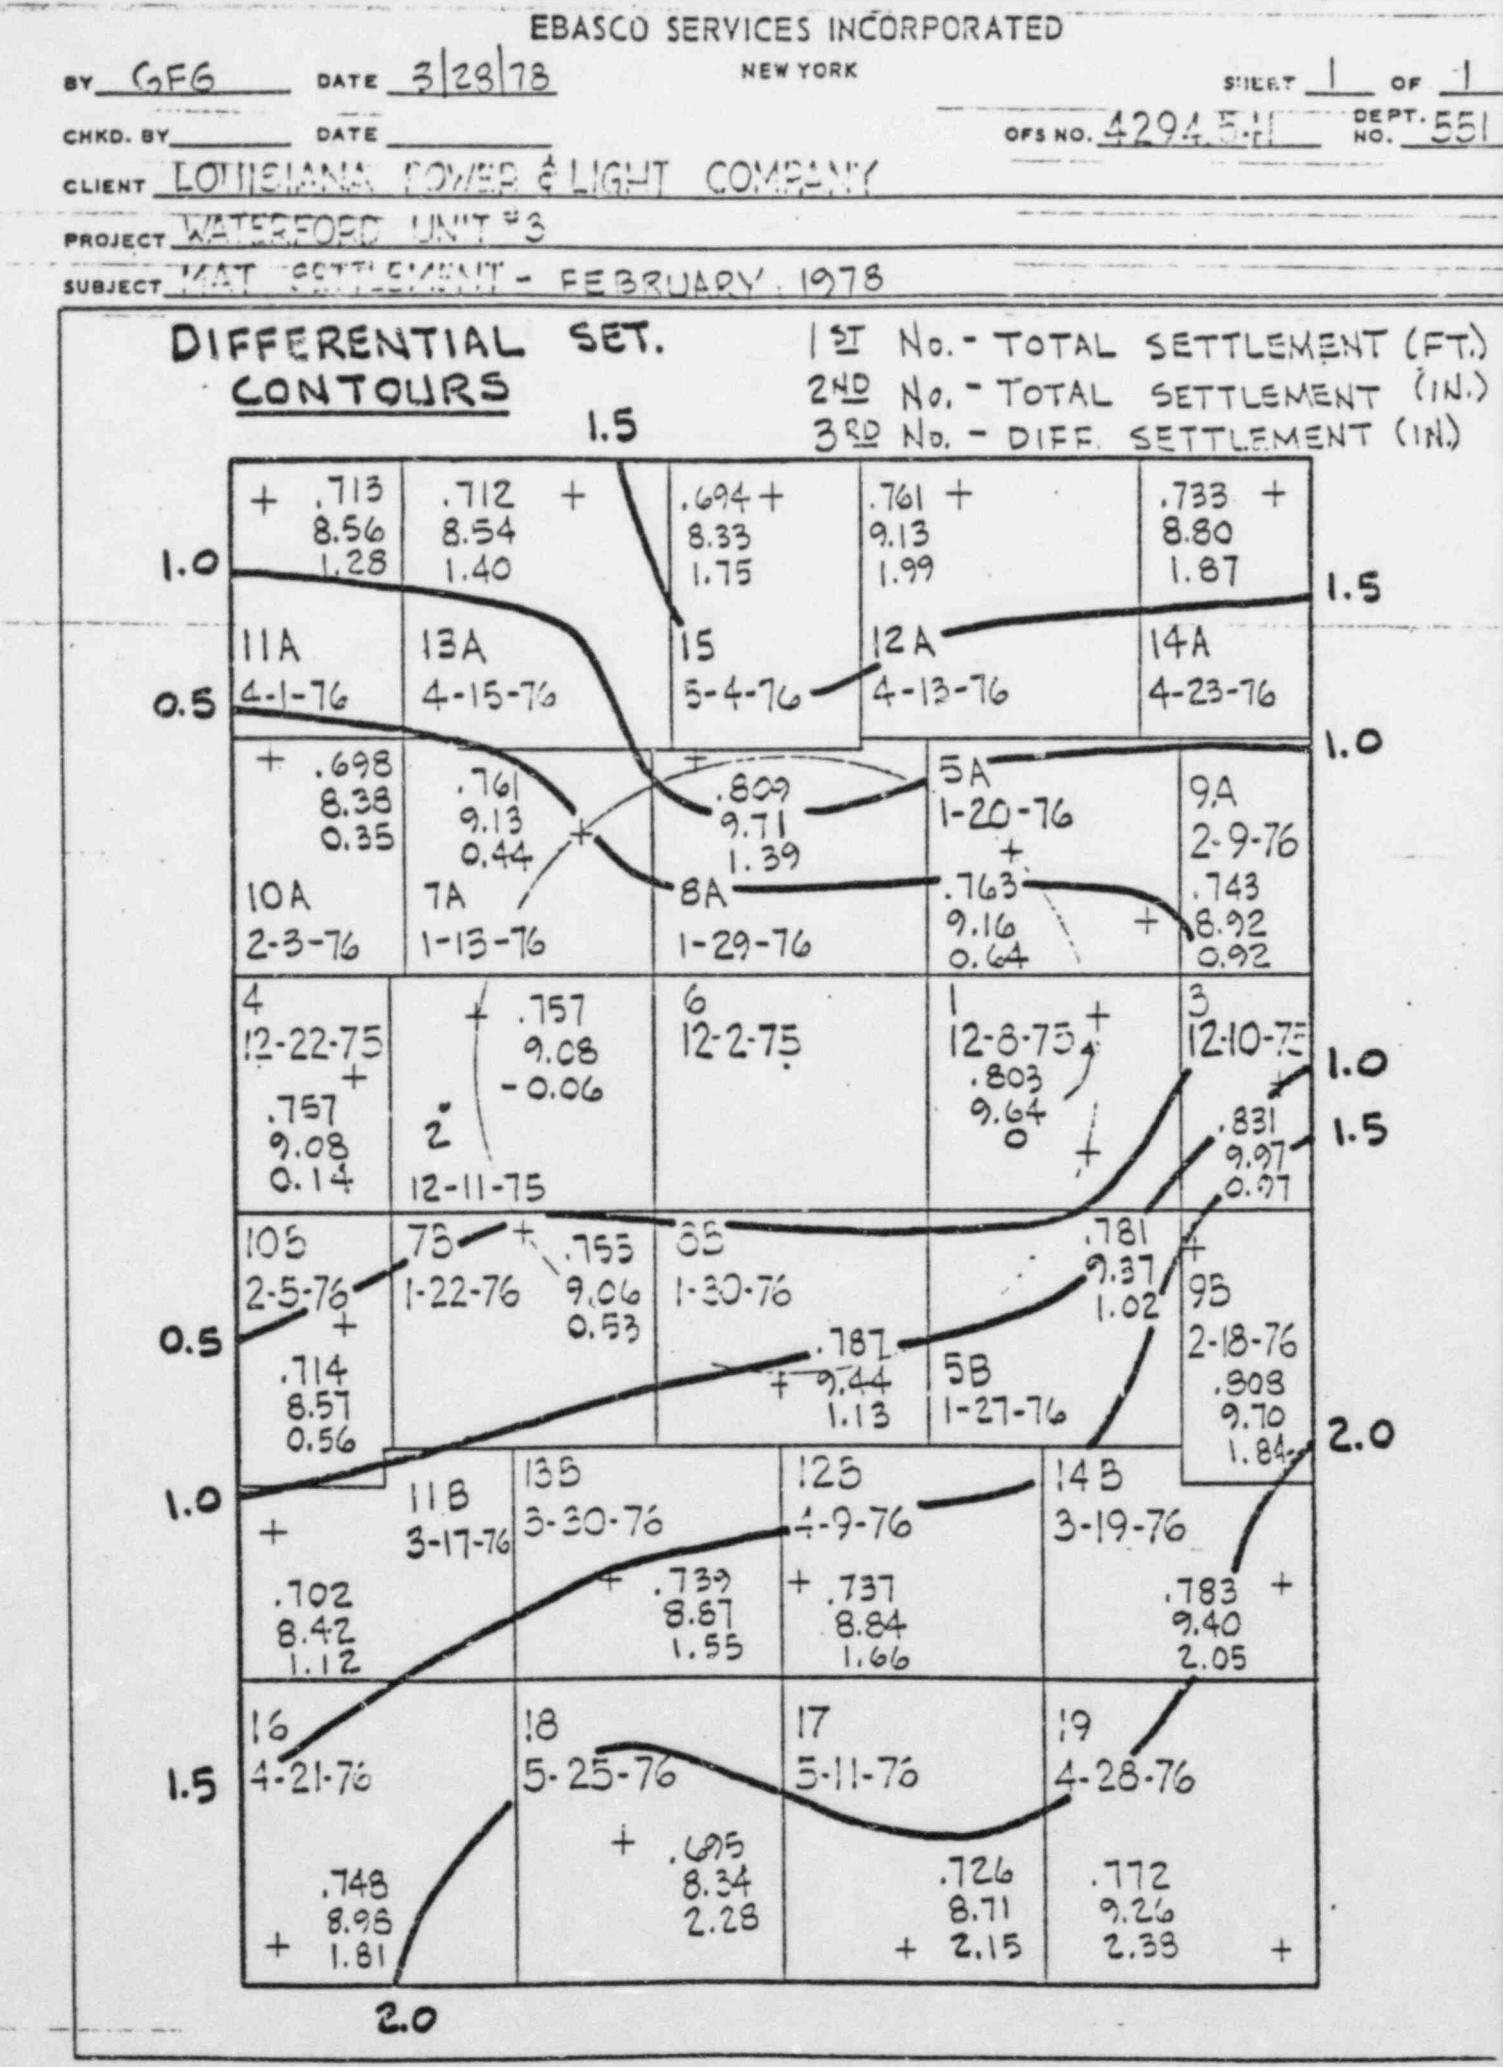
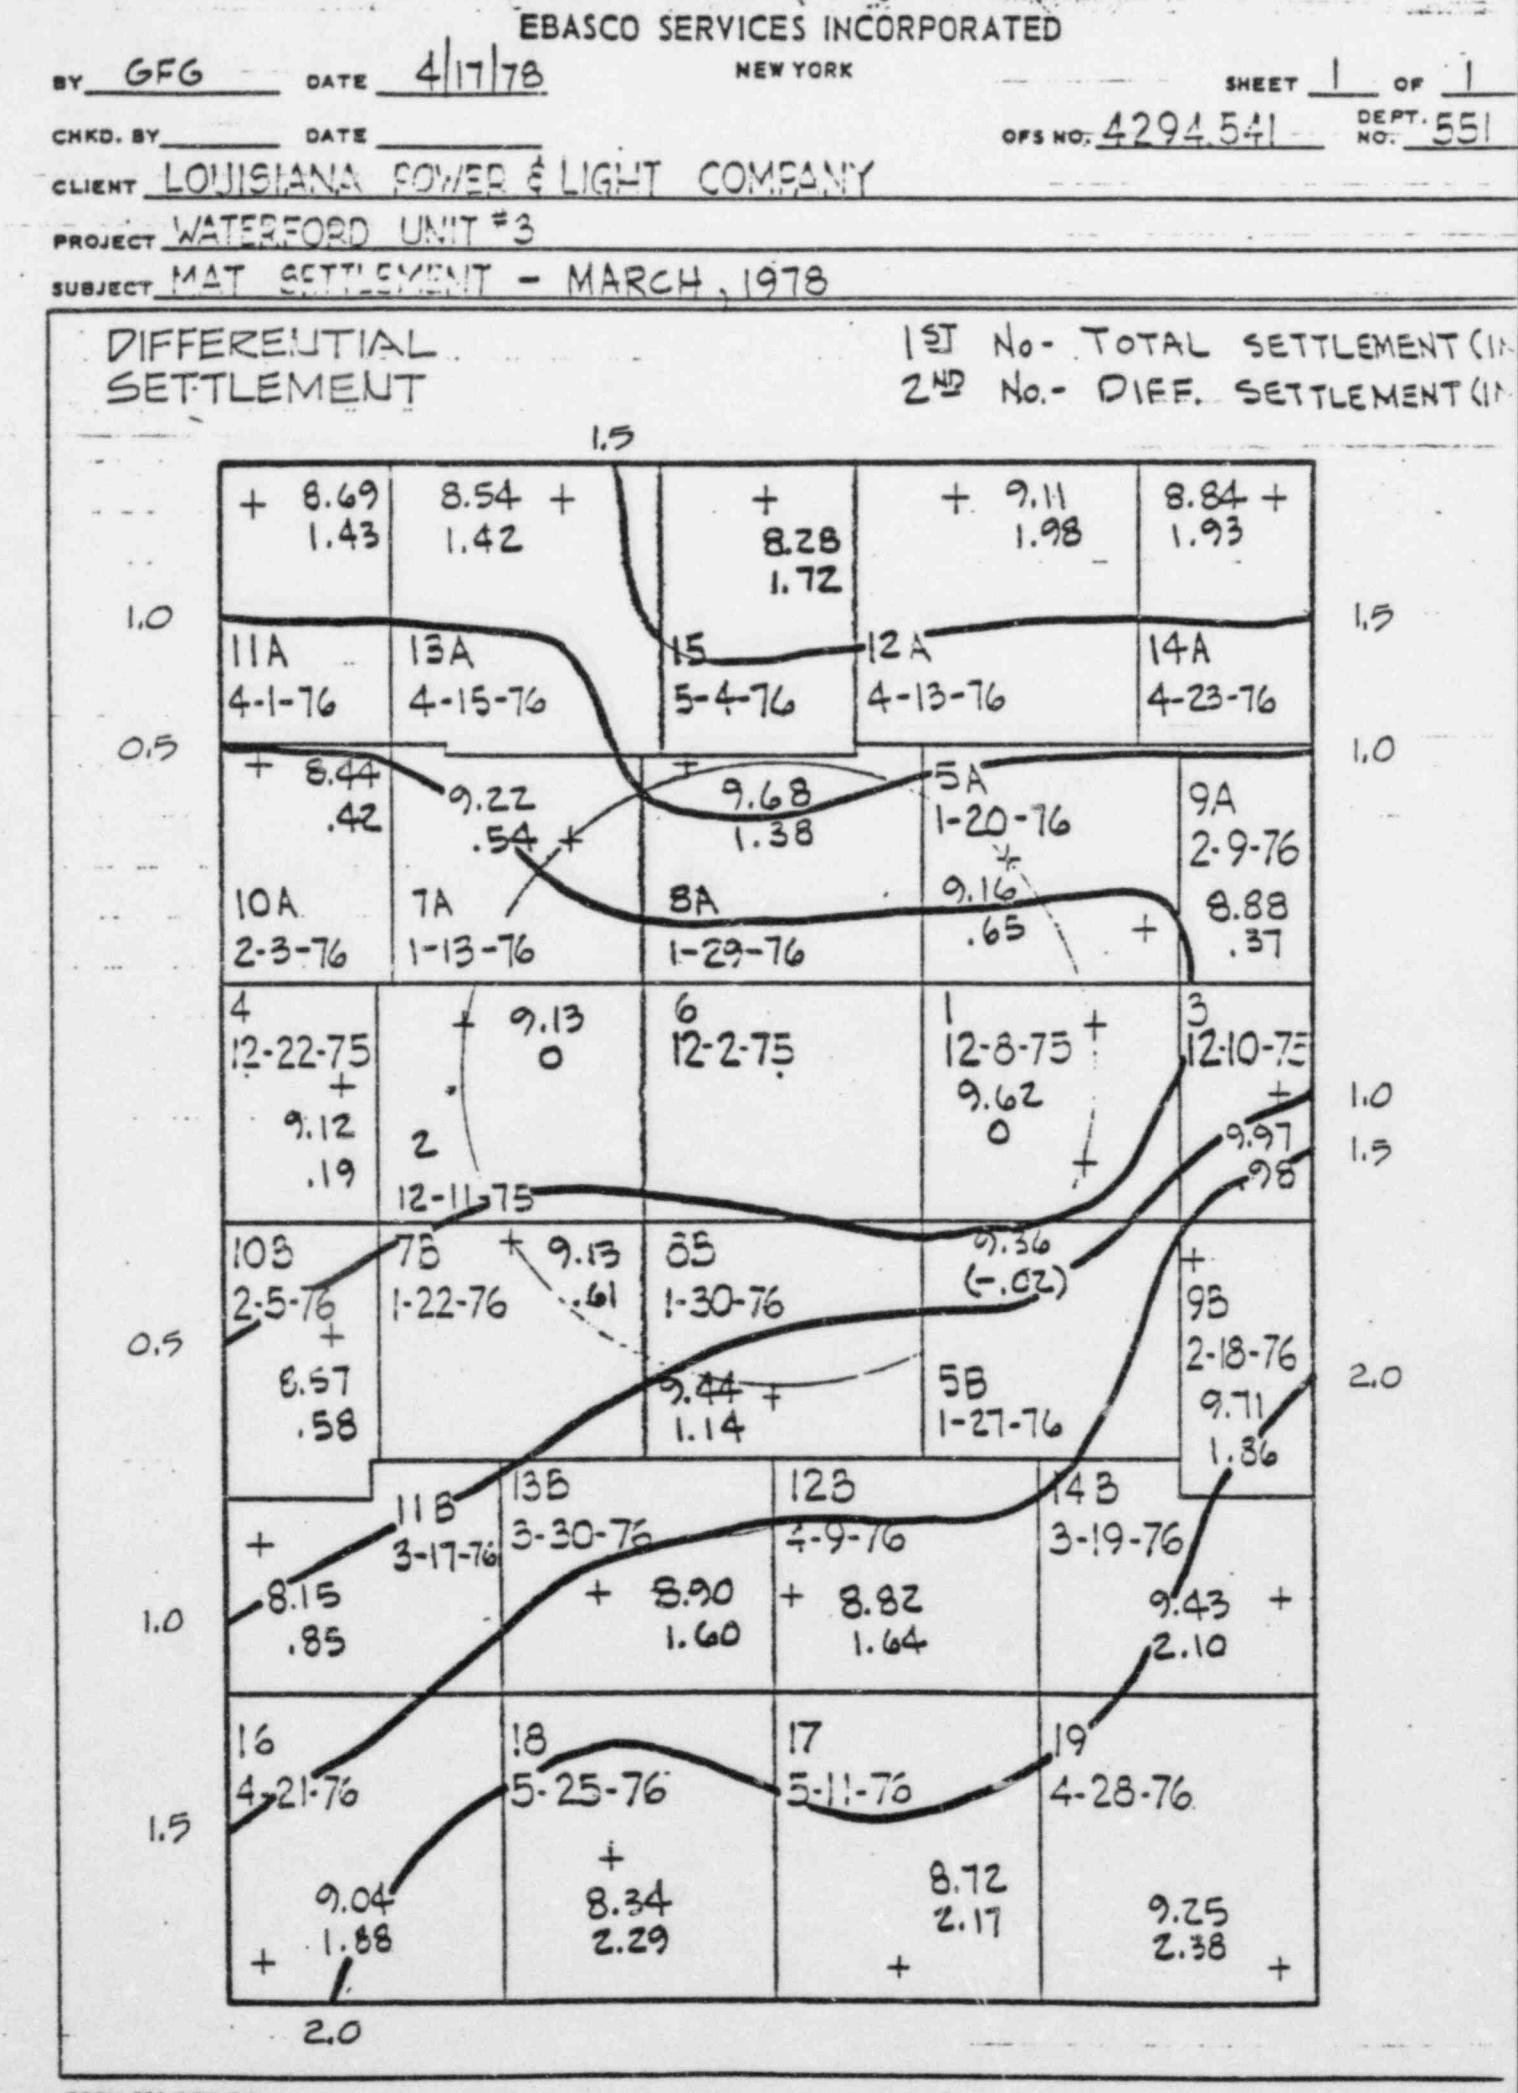
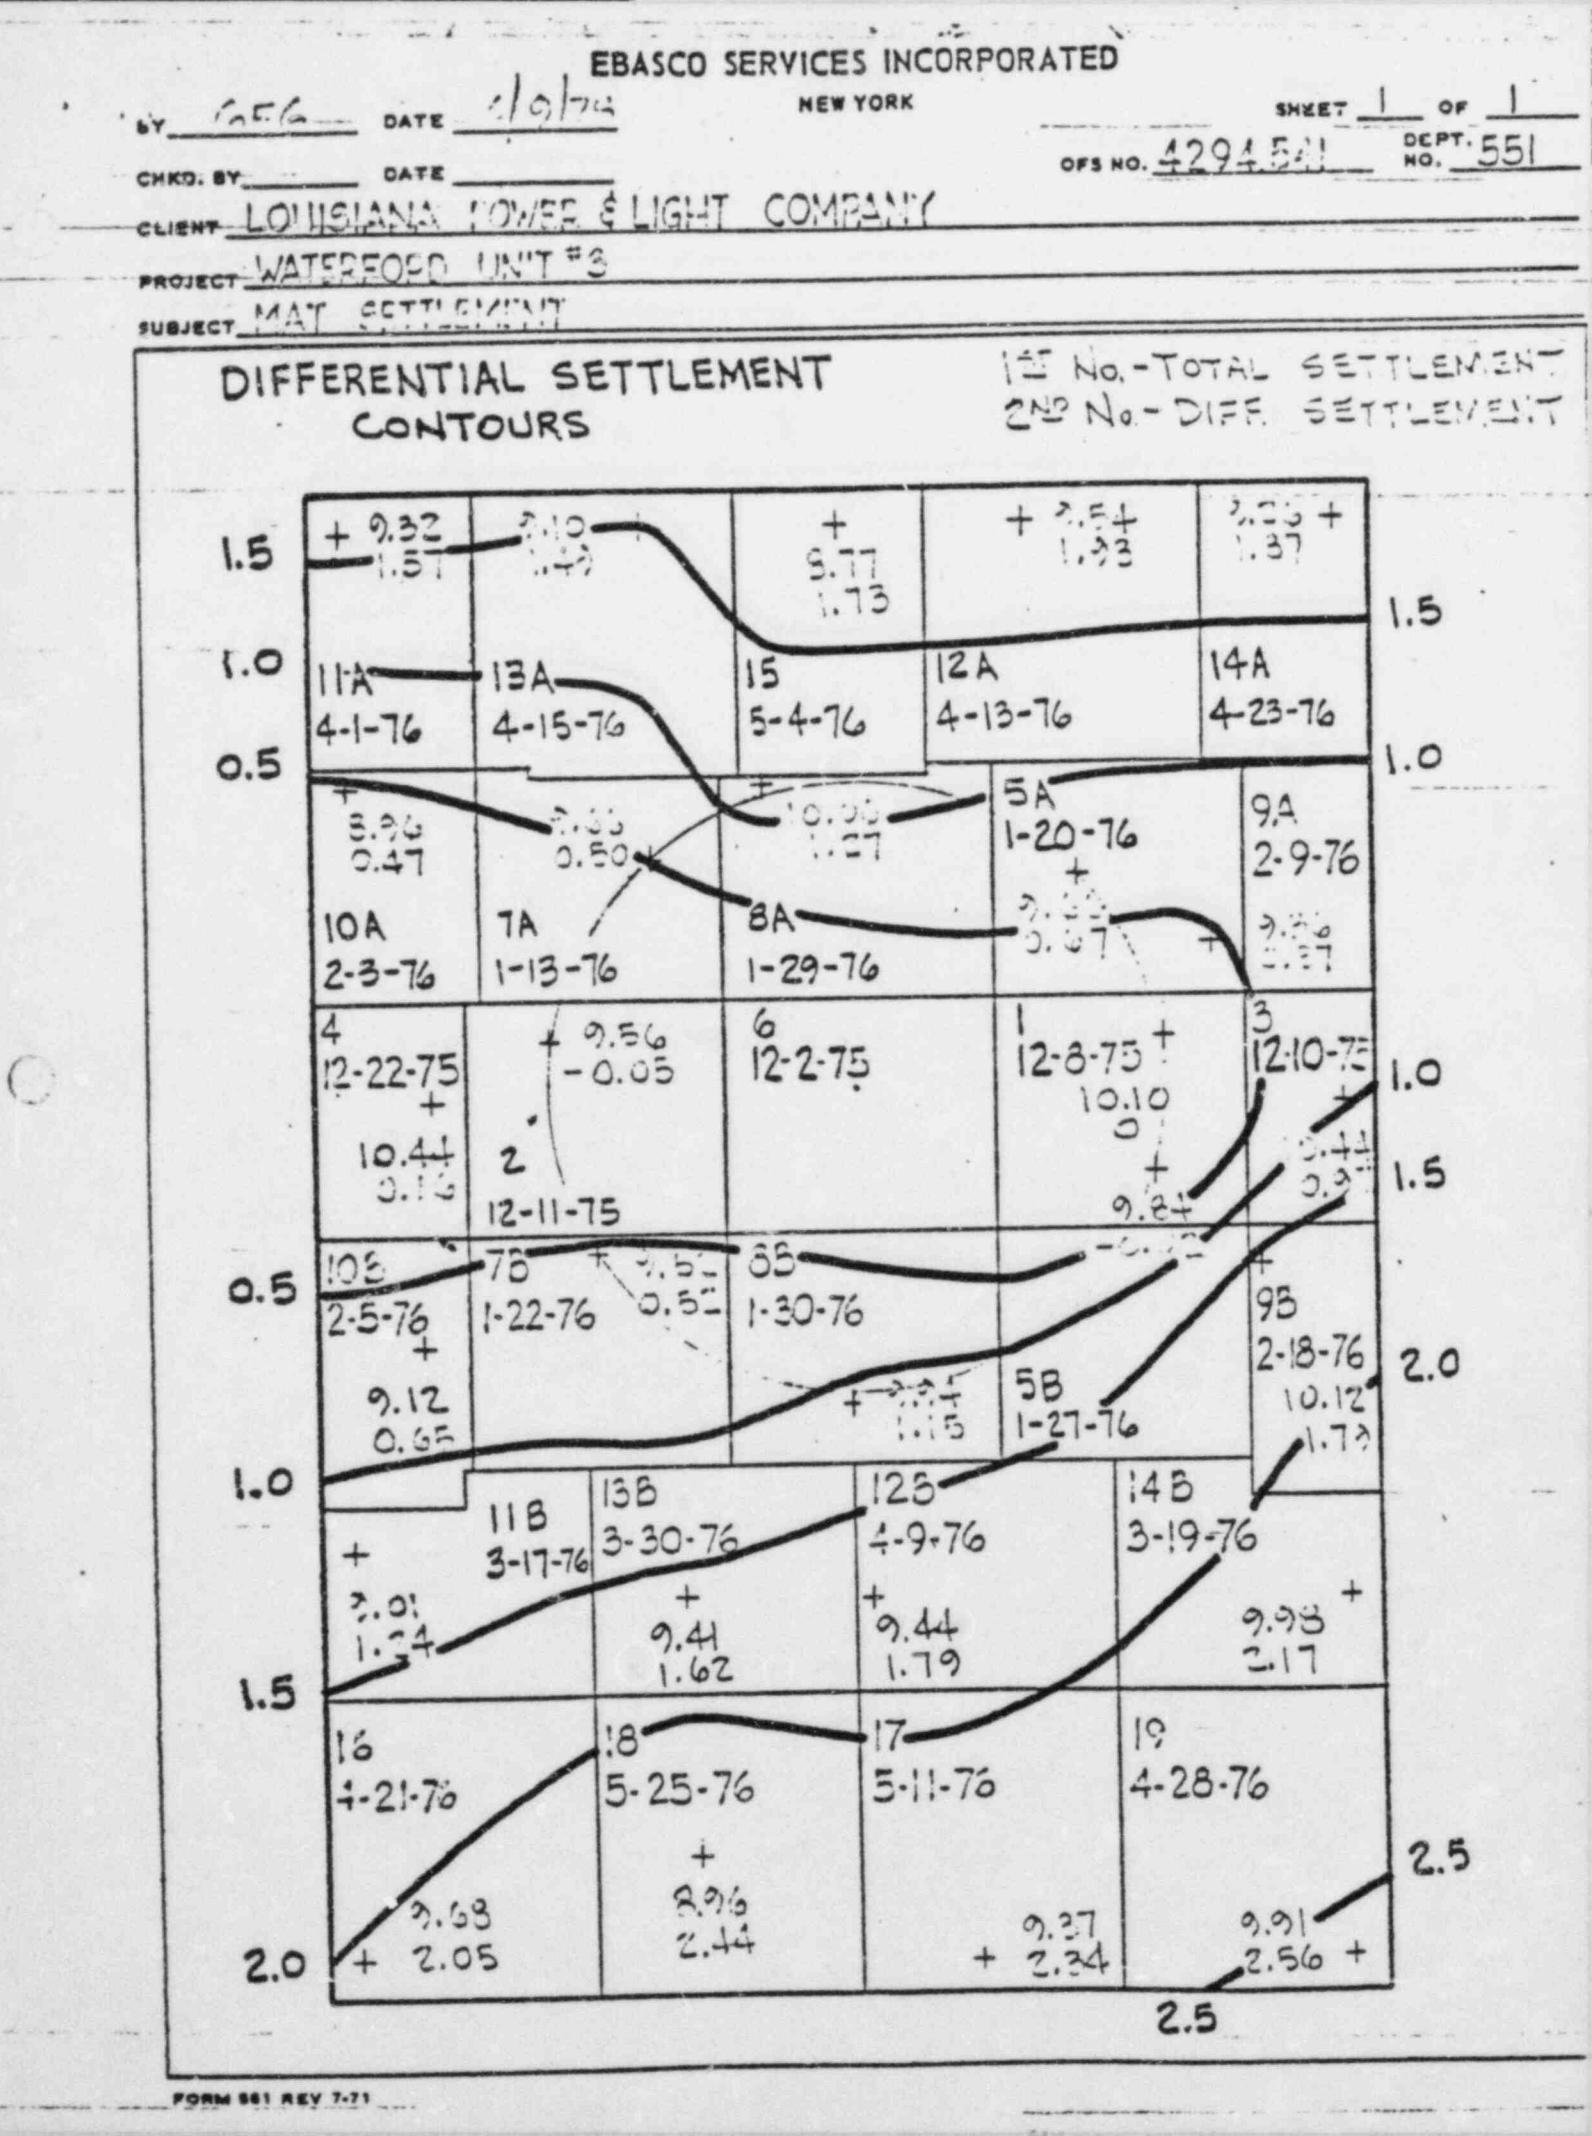
Attachments are provided which present differential settlement contours as available.

These attachments represent a period between April 1977, and August 1979.
