QUESTIONS CONCERNING RIL No. 123: ELECTRICAL TERMINAL BLOCKS

SUBJECT: RESEARCH INFORMATION LETTER # 123 PERFORMANCE OF ELECTRICAL TERMINAL BLOCKS EXPOSED TO A LOCA OR STEAM ENVIRONMENT

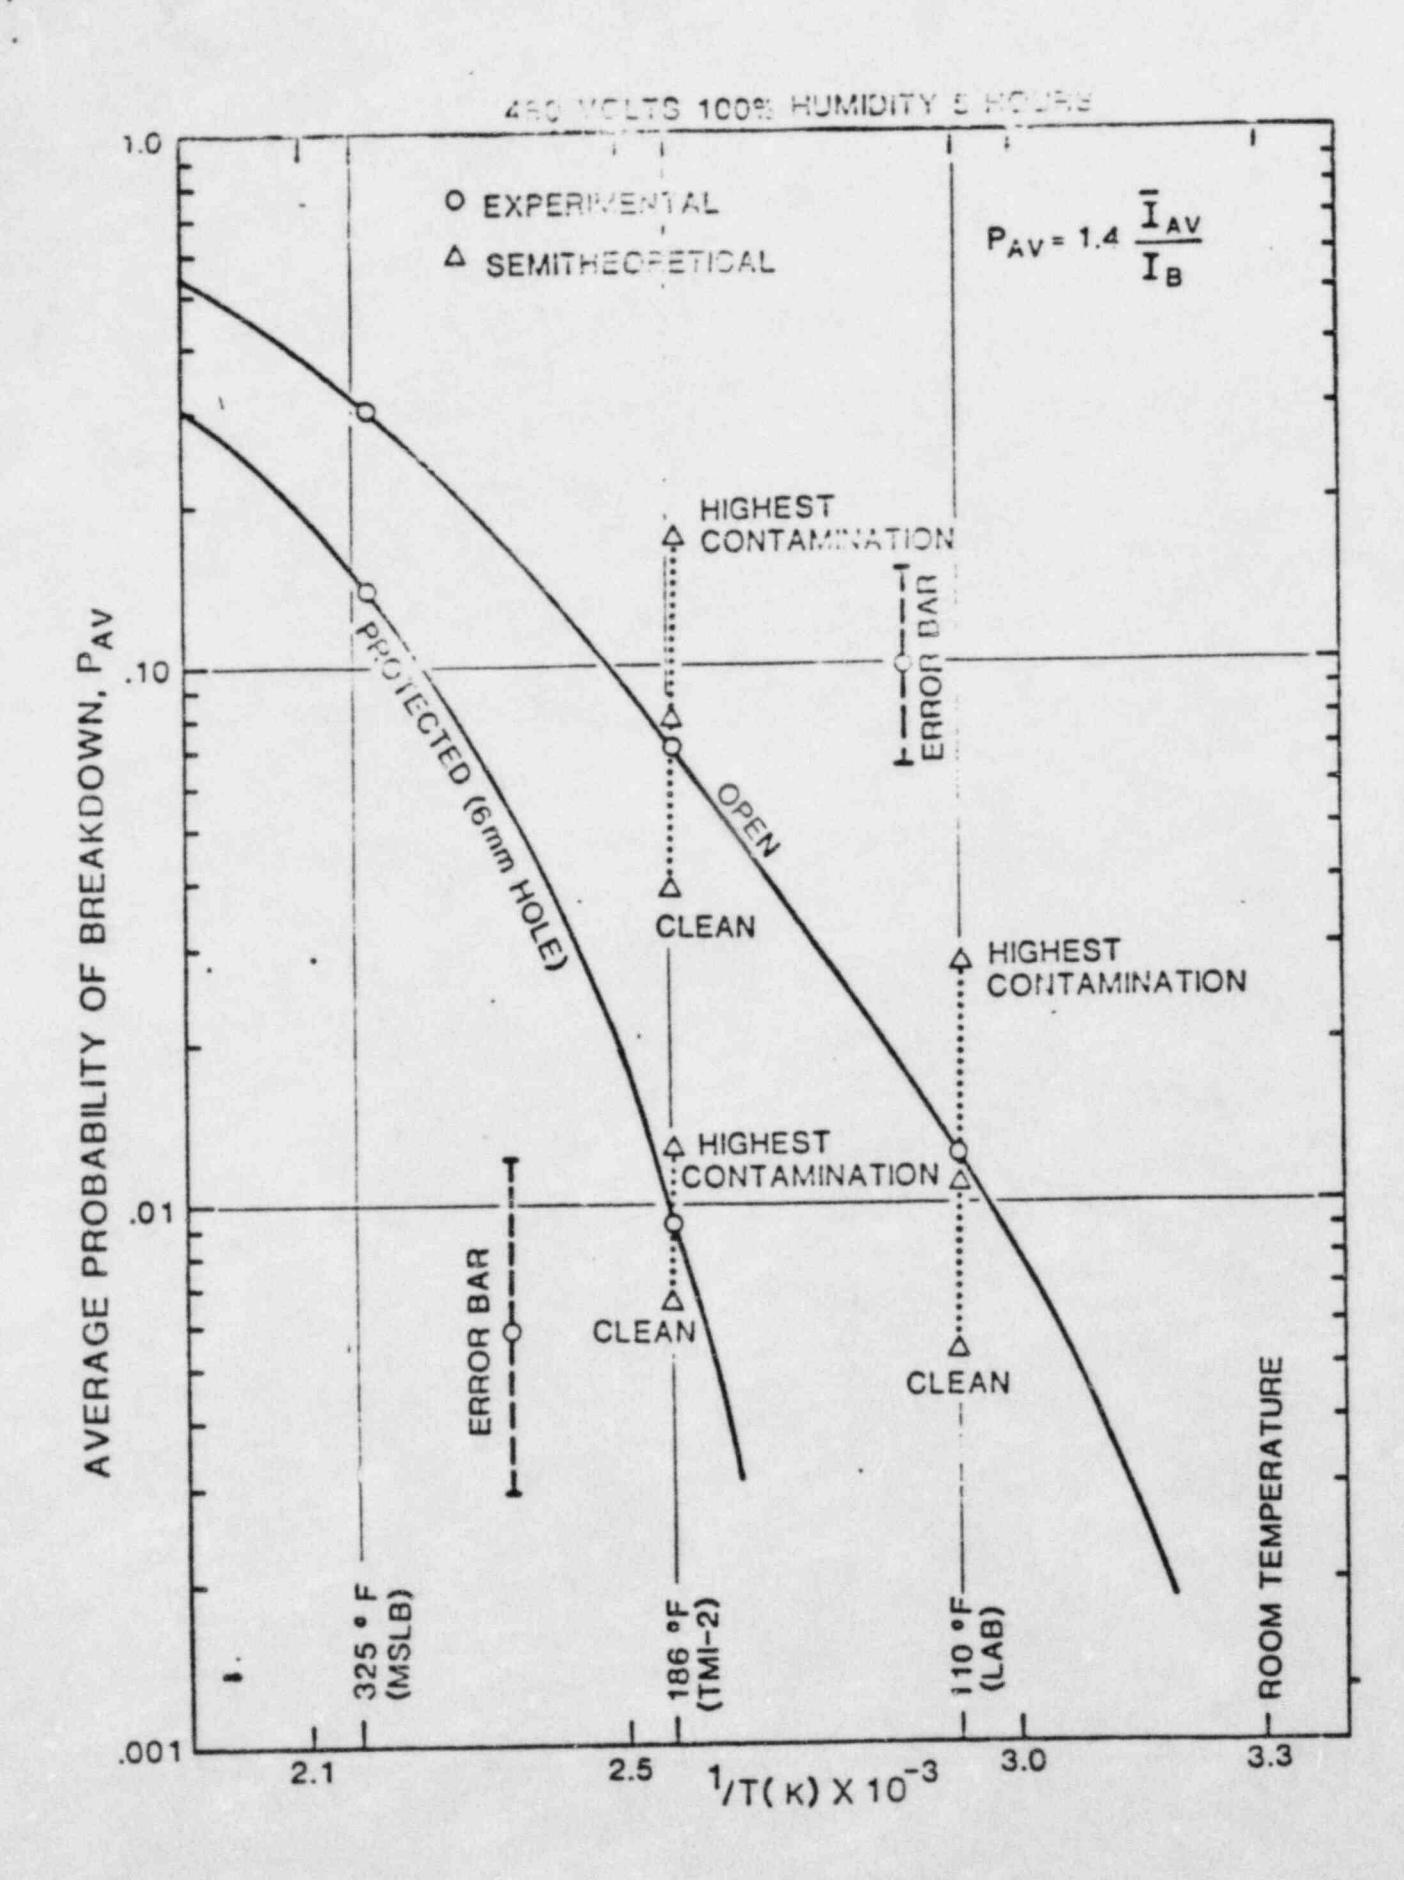
Fig. 1

1. Figure 1 and Table I show, in summary form, the results of the experiments and the conclusions drawn by use of the probability model.

The data relate the probability of terminal-to-ground low-voltage breakdown as a function of the inverse temperature. Curves are drawn through experimental data points for both the open and enclosed terminal blocks. Also, data are shown for various conditions of relative contamination at 186°F. (TMI-2 peak containment emperature) and at 100°F. for both the open and enclosed terminal blocks. All experimental data and model predictions are for an approximate 100° relative humidity condition in the test chamber and for 480 volts applied between the terminals and ground.

The curves drawn through the experimental data represent an average contamination in that they are a composite of both clean and contaminated terminal blocks.

- These data show that, under a full LOCA condition, the probability of failure is 14% for a non-hermetically sealed terminal block with a 6mm drainage hold. As can be seen (from Fig. 1), this failure probability is higher if the terminal blocks are unusually dirty or left uncovered. Table I shows a summary of the data obtained including the terminal failures detected.
