Hope Creek Operations

HOPE CREEK GENERATING STATION DOCKET NO. 50-354 UNIT NO. 1 LICENSEE EVENT REPORT 91-018

Engineered Safet: Feature Actuation - Unplanned start of standby Filtration Recirculation System Recirculation Fan F from non-ESF signal.

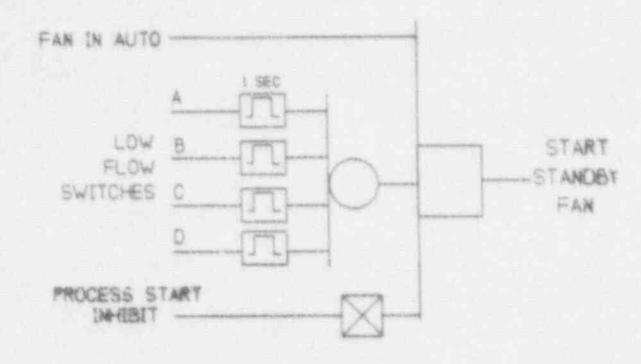
The low flow start signal is generated via flow switches located on the outlet of the recirculation units and is processed through the Bailey Logic panel. When the logic senses low flow on a running fan an auto start signal is generated to start a standby fan. The configuration of the logic will send an auto start signal whenever low flow is sensed; however, the duration of the signal is only one second long. This allows the standby fans to be placed in auto after the running fans have been secured. If the signal is reset by either a valid or spurious flow signal and subsequently low flow is sensed again, a new start signal will be generated to start the standby fan. The I&C Technician troubleshooting the auto start found water in the C FRVS recirc fan low flow switch. The switch has a range of 0 - .15" of water, with the trip setpoint set at .1" of water. The accumulation of water in conjunction with minor fluctuations in system pressure reset the switch momentarily simulating a normal flow condition in the logic. Subsequent pressure perturbation caused the switch to sense low flow and start the standby fan.

The cause of this event is the accumulation of water in the low flow switch combined with minor pressure perturbation in the ventilation system causing actuation of the low flow auto start logic for the F Recirc fan. The failure to revise all related FRVS system procedures when the surveillance procedure was revised also contributed to this event.

- 1. The FRVS system operating procedure will be revised to add a section for draining the low flow switches following fan runs.
- 2. A Design Change has been approved to modify the auto start logic to preclude spurious starts. Planning and System Engineering are reviewing the possibility of performing the design change while the unit is at power; however, due to the location and configuration of the wiring which must be modified there is a risk of rendering vital equipment inoperable and/or possible reactor scram. As the spurious star of the standby FRVS Recirc fan pose minimal safety significance, the design change is currently scheduled for shutdown conditions with implementation no later than the fourth refuel outage.

- Proce ure writers will be advised to consider all relevant system maint nance and operating procedures when improvements are made to one category.
- System Engineering will review the configuration of the instrument tubing to determine if changes can be made to eliminate the accumulation of water in the flow switches.
