James A. FitzPatrick Nuclear Power Plant P.O. Box 41 Lycoming, New York 13093 315 342-3840

January 17, 1992

JAFP-92-0050

SUBJECT: DOCKET NO. 50-333 LICENSEE EVENT REPORT: 91-031-00 DESIGN DEFICIENCY OF THE EMERGENCY SERVICE WATER SYSTEM RETURN PIPING FROM THE EMERGENCY DIESEL GENERATOR JACKET WATER COOLERS

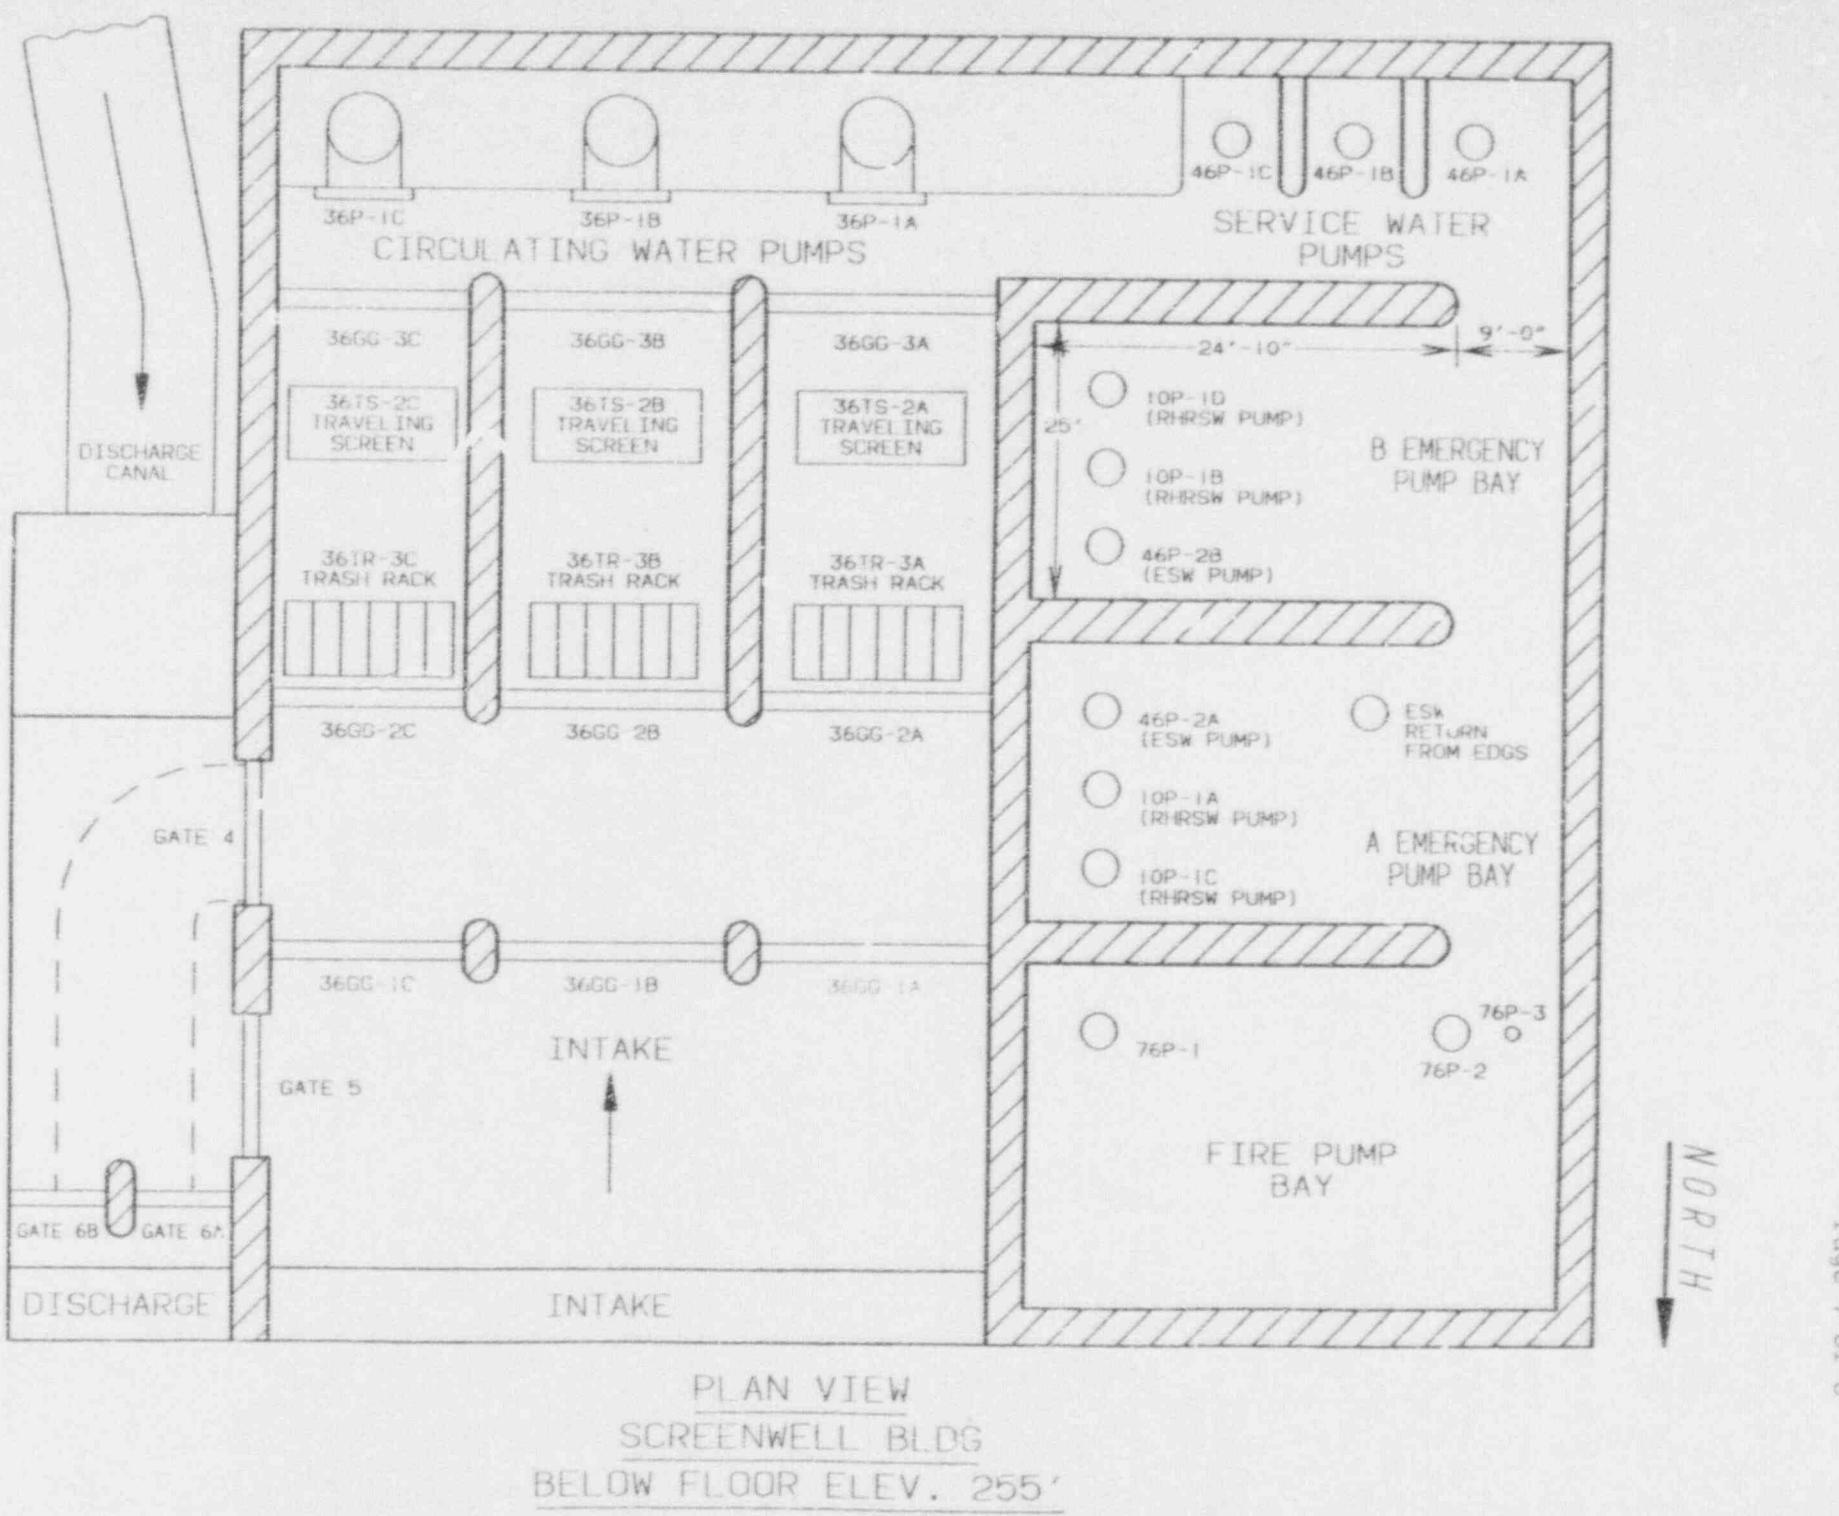
Figure LER-91. Docket Page 7 e 1 1-031-00 t No. 50-333 7 of 8

Geometry of Emergency Pump Bays (See Figure 1)

The three emergency pump bays are arranged with one ESW pump and two RHRSW pumps in each of two bays and two fire pumps [KF] in the third. Lake water enters the plant through the intake tunnel [NN], passes through the trash racks [NN] and traveling screens [NN] and is then supplied to the various raw water system loads. After the water reaches the traveling screens, it enters the circulating water pumps and normal service water [KG] pump bays [NN]. A dividing wall separates the normal service water pump bays from the emergency pump bays. A nine foot wide channel exists at the west end of the dividing wall through which the water enters the B ESW/RHRSW pump bay [MK]. It then flows to the A ESW/RHRSW pump bay [MK] to the north through a nine foot channel at the west end of the dividing wall between the A and B ESW/RHRSW pump bays. The water then enters the fire pump bay through a nine foot wide channel at the west end of the dividing wall which separates the A ESW/RHRSW bay and fire pump suction bay. Since there is no exit point from the three bays, the bays are a stagnant pool until a pump is started.

The ESW system operates as an open cycle system. The ESW pumps automatically start on an EDG start or when low RBCLC header pressure is sensed. ESW injection valves 46MOV-101A and B then open and ESW test line valves 46MOV-102A and B close automatically only for the low RBCLC pressure signal. In this operating configuration, lake water is supplied to the EDG jacket water coolers and various heat exchangers downstream of 46MOV-101A and B (see Figure 2) Otherwise only the EDGs receive ESW flow. Approximately 2,500 gpm (625 gpm per EDG jacket water cooler) is recirculated to the A pump bay it both ESW pumps are running. The ESW return line from the EDGs is located approximately 2.5 feet north of the dividing wall between the A and B pump bays and approximately one foot from the west end of the wall (see Figure 1).

- Procedural changes were made to require running an RHRSW pump during Emergency Diesel Generator operation (completed 12/91).
- Plant operation will not be allowed when Lake Ontario temperature is above 65°F until a modification is performed to reroute the ESW return piping from the EDGs or a more extensive analysis of the existing configuration and the effect on emergency pump bay temperature is performed.

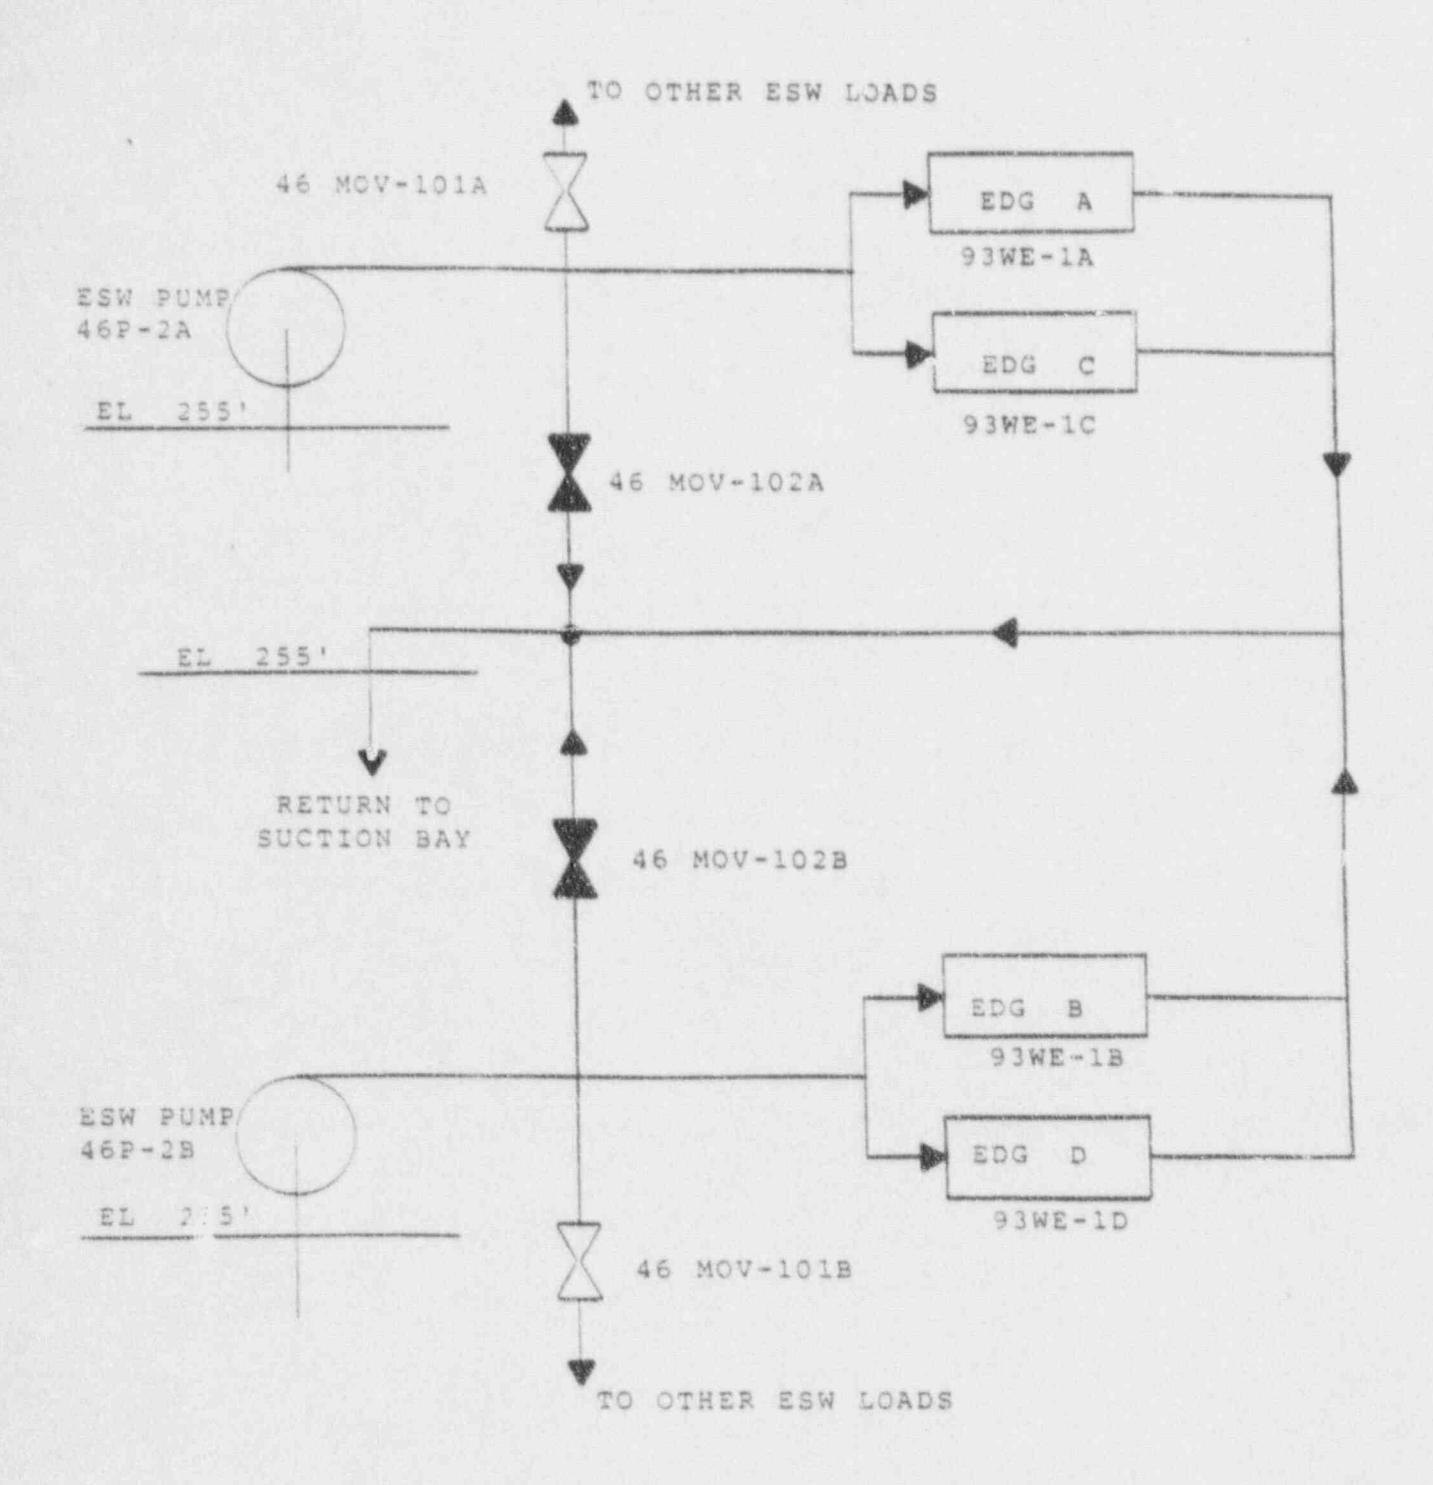
Figure 2 LER-91-031-00 Docket No. 50-333 Fage 8 of 8

The ESW flow to the EDG jacket cooling water heat exchangers cools the EDC engine jackets and is discharged to the A trair. emergency pump bay. Because of this piping configuration, recirculation of heated water to the emergency pump bay occurs and the ESW supply temperature will be higher than the lake temperature. The return piping from other equipment supplied by the ESW system, the normal service water system [KG], and RHRSW system have been verified to be routed to the Circulating Water System (CWS) discharge canal [NN] as required.

ESW SYSTEM FLOW DIAGRAM SHOWN SUPPLYING EDGS AND OTHER ESW LOADS
