Sandia National Laboratories

Enclosed is a preliminary account of the Commission directed test of the Duke Power, Catawba Units 1 and 2, Type K electric penetration connectors. This enclosure addresses tests performed, test results, and conclusions based on observed connector behavior.

#### CONNECTOR ASSEMBLY TEST OF THE DUKE POWER, CATAWBA, UNITS 1 AND 2 TYPE K PENETRATION/CONNECTOR ASSEMBLY

#### A BRIEF LOOK

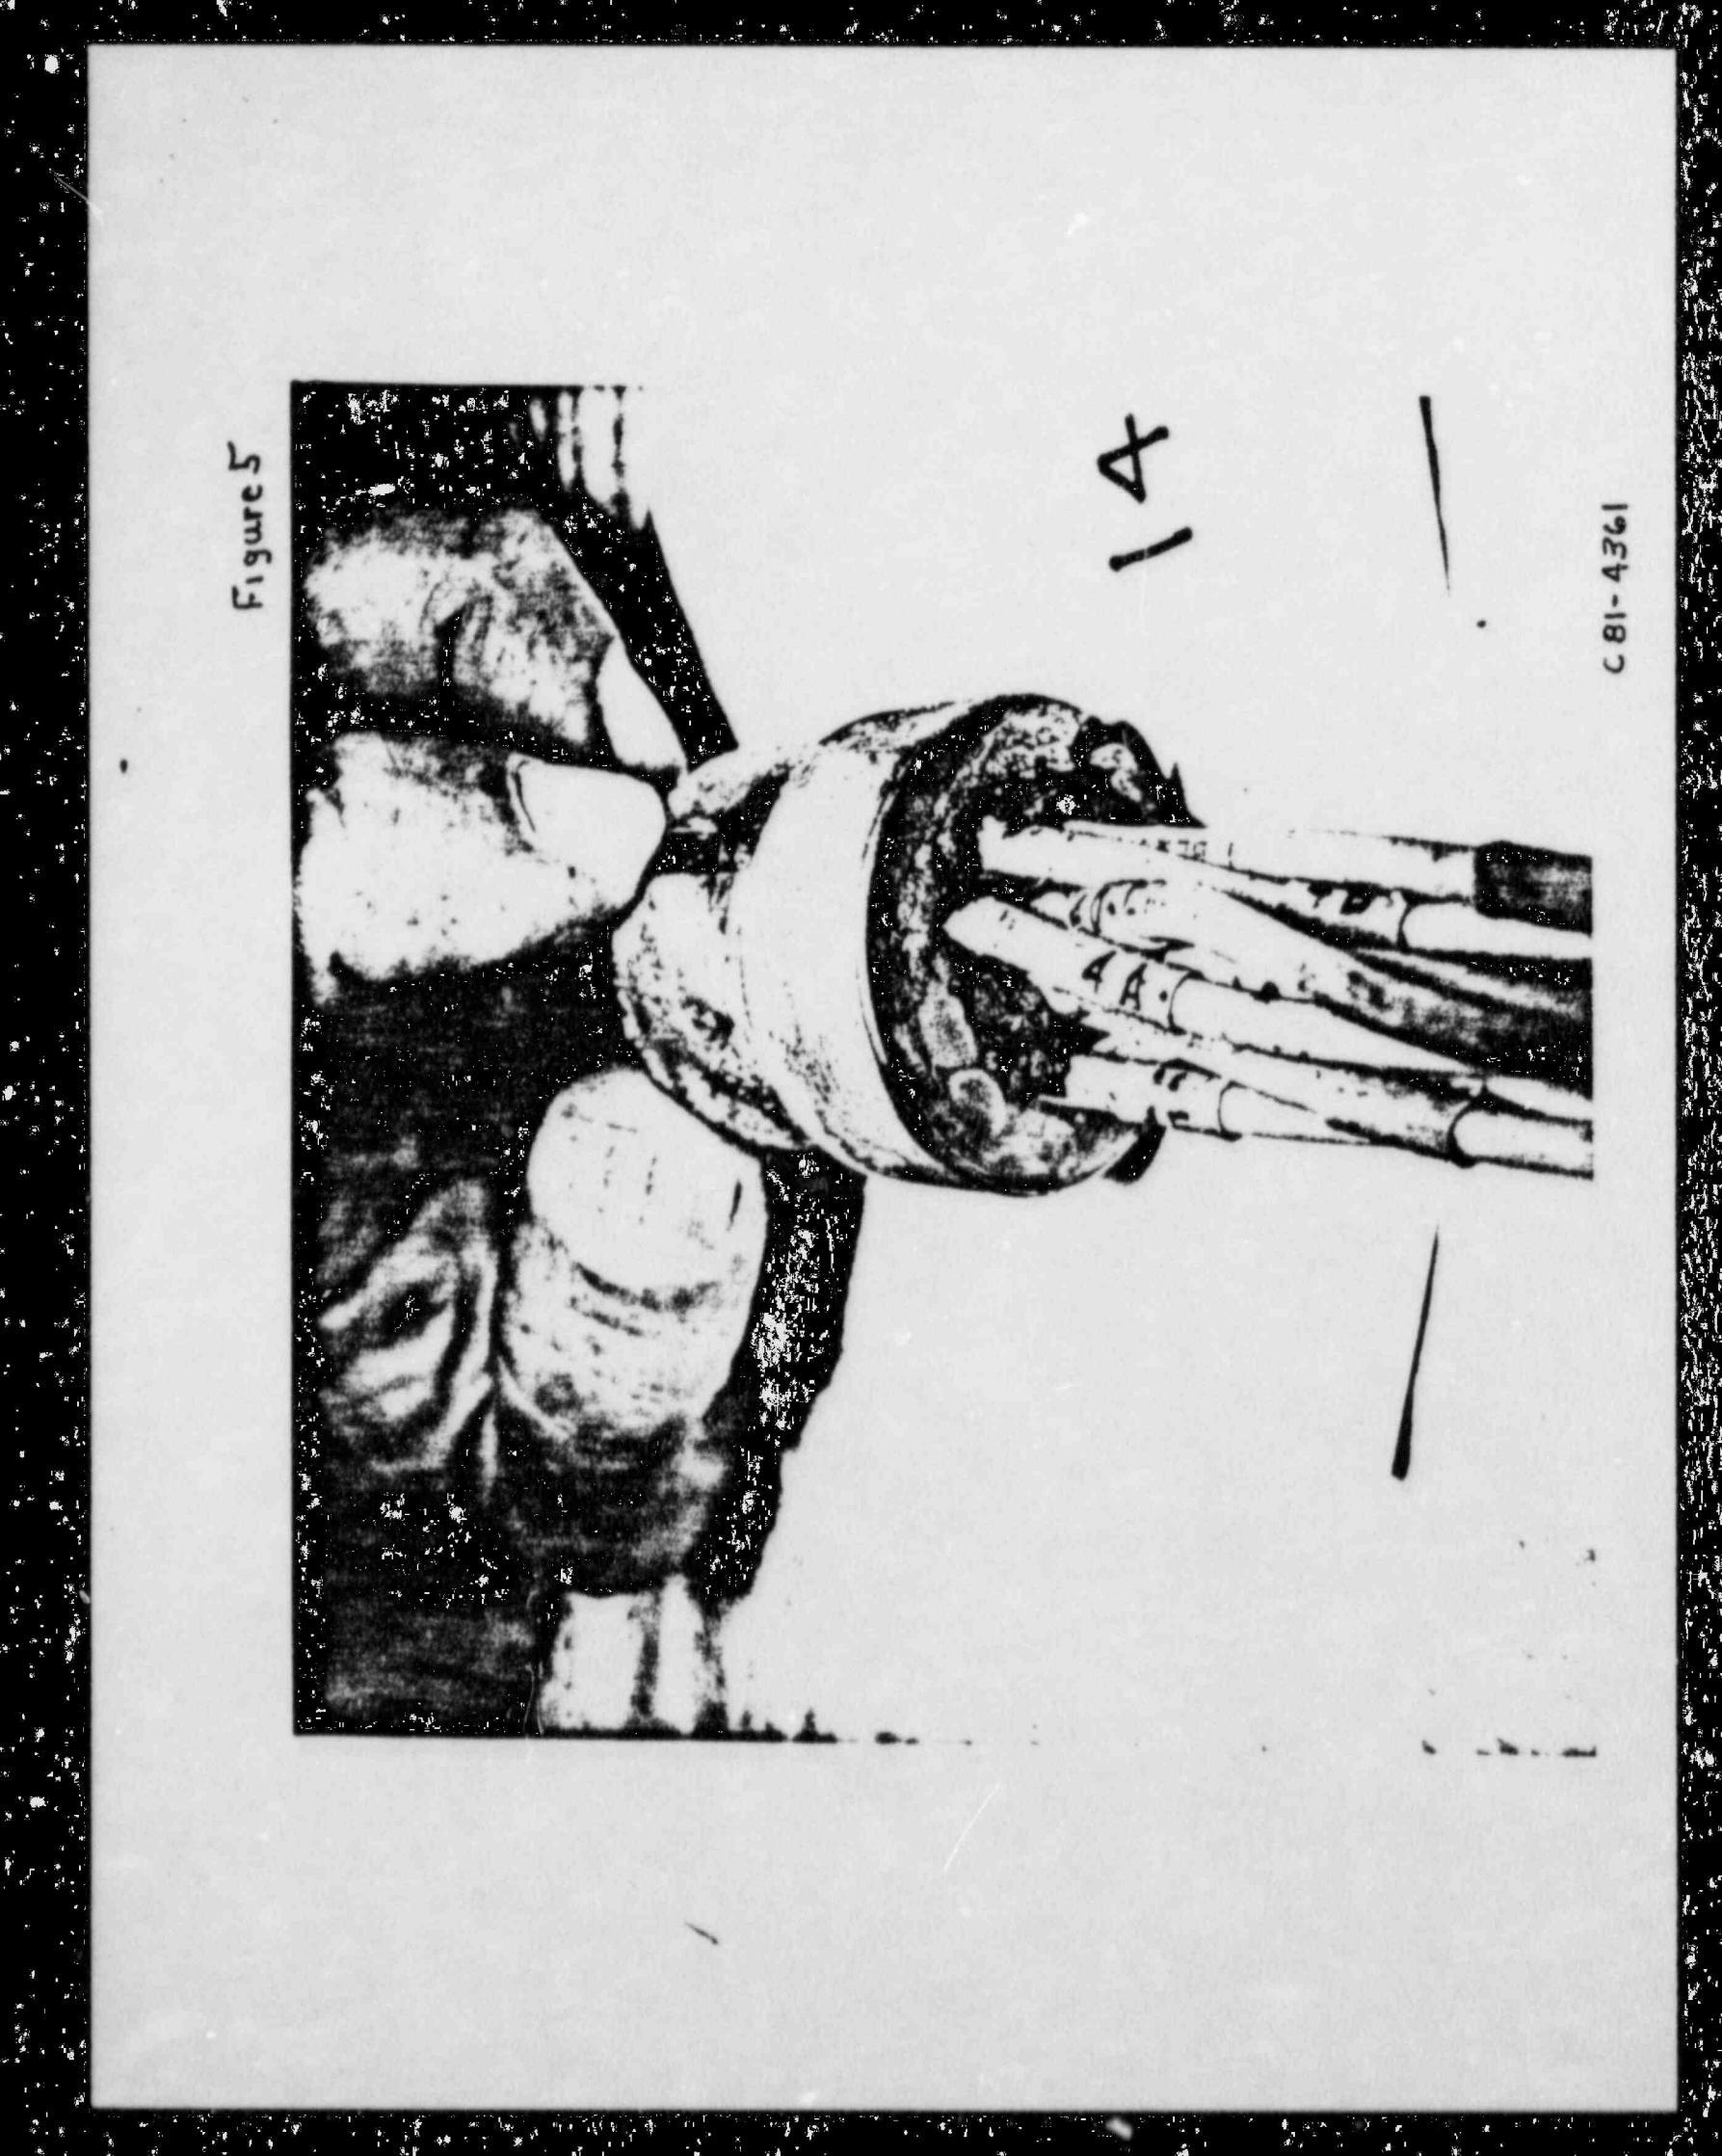
- Cable grommet material had extruded through the conductor feed-through openings in the plug sleeve. In Figure 4 coupling rings have been removed and the extruded black grommet material is clearly visible. Figure 5 is a closeup of the phenomenon.

Examination of the "good" connector assembly showed that the cable grommet had extruded through the conductor feed-through holes in the sleeve plug back surface. In Figure 13 the black material is the extruded grommet. Further examination of the "good" assembly (see again Figure 6) indicated that in the course of grommet extrusion, connector insulation was pinched or necked down and, in some instances, stripped from the conductor.

Disassembly of three failed connector-module pairs showed the same extrusion of grommet material through the plug sleeve back surface conductor feed-through openings. Moiscure was found to be present at the connector-module interface in all cases.
