GEORGIA POWER
POWER GENERATION DEPARTMENT
VOGTLE ELECTRIC GENERATING PLANT

TITLE: LOSS OF CLASS 1E ELECTRICAL SYSTEM NUMBER: LO-LP-60323-01

TITLE:	LOSS OF POWER CASE STUDY	NUMBER:	LO-HO-60991-00-001
PROGRAM:	LICENSED OPERATOR TRAINING	REVISION:	0
AUTHOR:	L. FITZWATER	DATE:	6/24/88
APPROVED:	<i>Robert J. Brown</i>	DATE:	7/26/88
REFERENCES:

This case study material focuses on the cooldown transient experienced at Rancho Seco on December 26, 1985. The material includes an event description that covers major operator actions and equipment failures related to the event. In addition, some instructor aids are provided to assist the instructor.

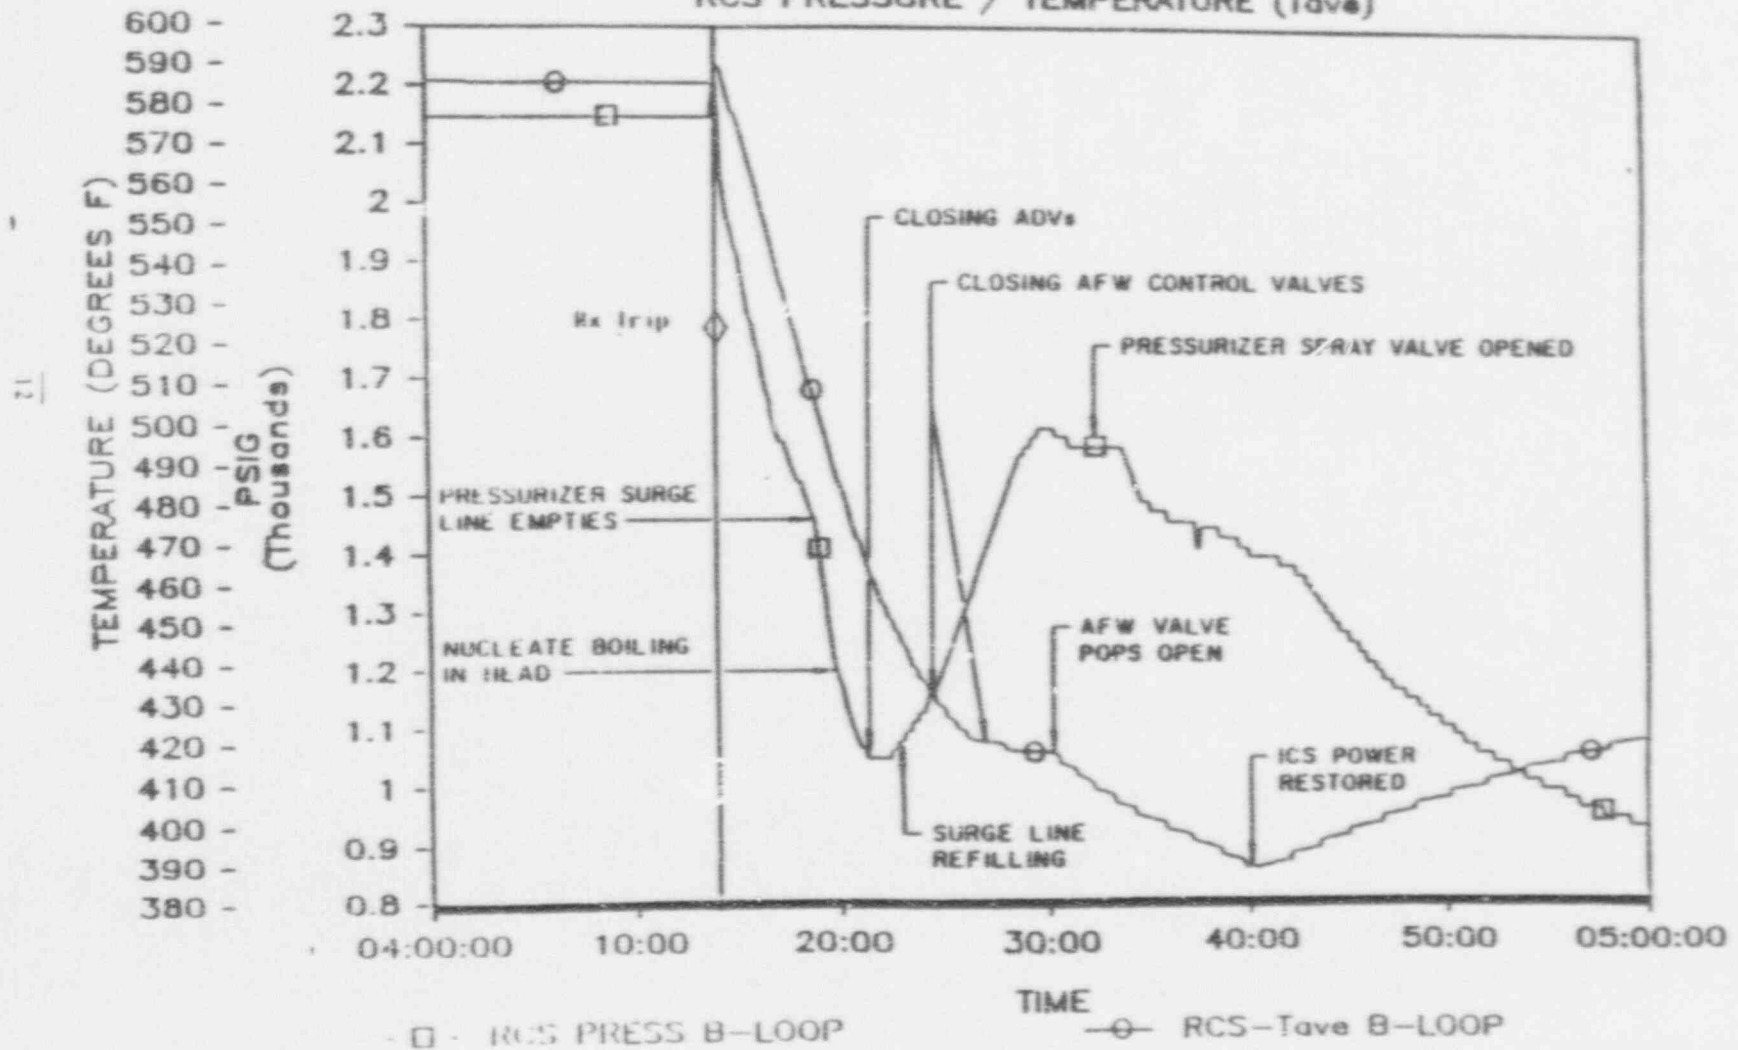
Figure 5
RCS Temperature and Pressure During Transient

generator pressure decreased to the point at which the condensate pumps began feeding each steam generator; this increased flow to the steam generators by an additional 1000 gpm. This condition continued until the main feedwater system was isolated automatically when main steam line pressure dropped below 435 psig. Although the reactor coolant system temperature was still decreasing, its pressure started to rise as the high pressure injection and makeup pumps raised the level in the pressurizer. Reactor coolant system conditions now violated the B&W-designated temperature/pressure limits for pressurized thermal shock of the reactor vessel (Figure 6). The technical specifications limits were not violated.
