UNITED STATES
NUCLEAR REGULATORY COMMISSION

SUBJECT: SOUTH TEXAS PROJECT UNIT 2 RESTART ACTION PLAN, REVISION 0

Enclosure: South Texas Project Unit 2 Restart Action Plan, Revision 0

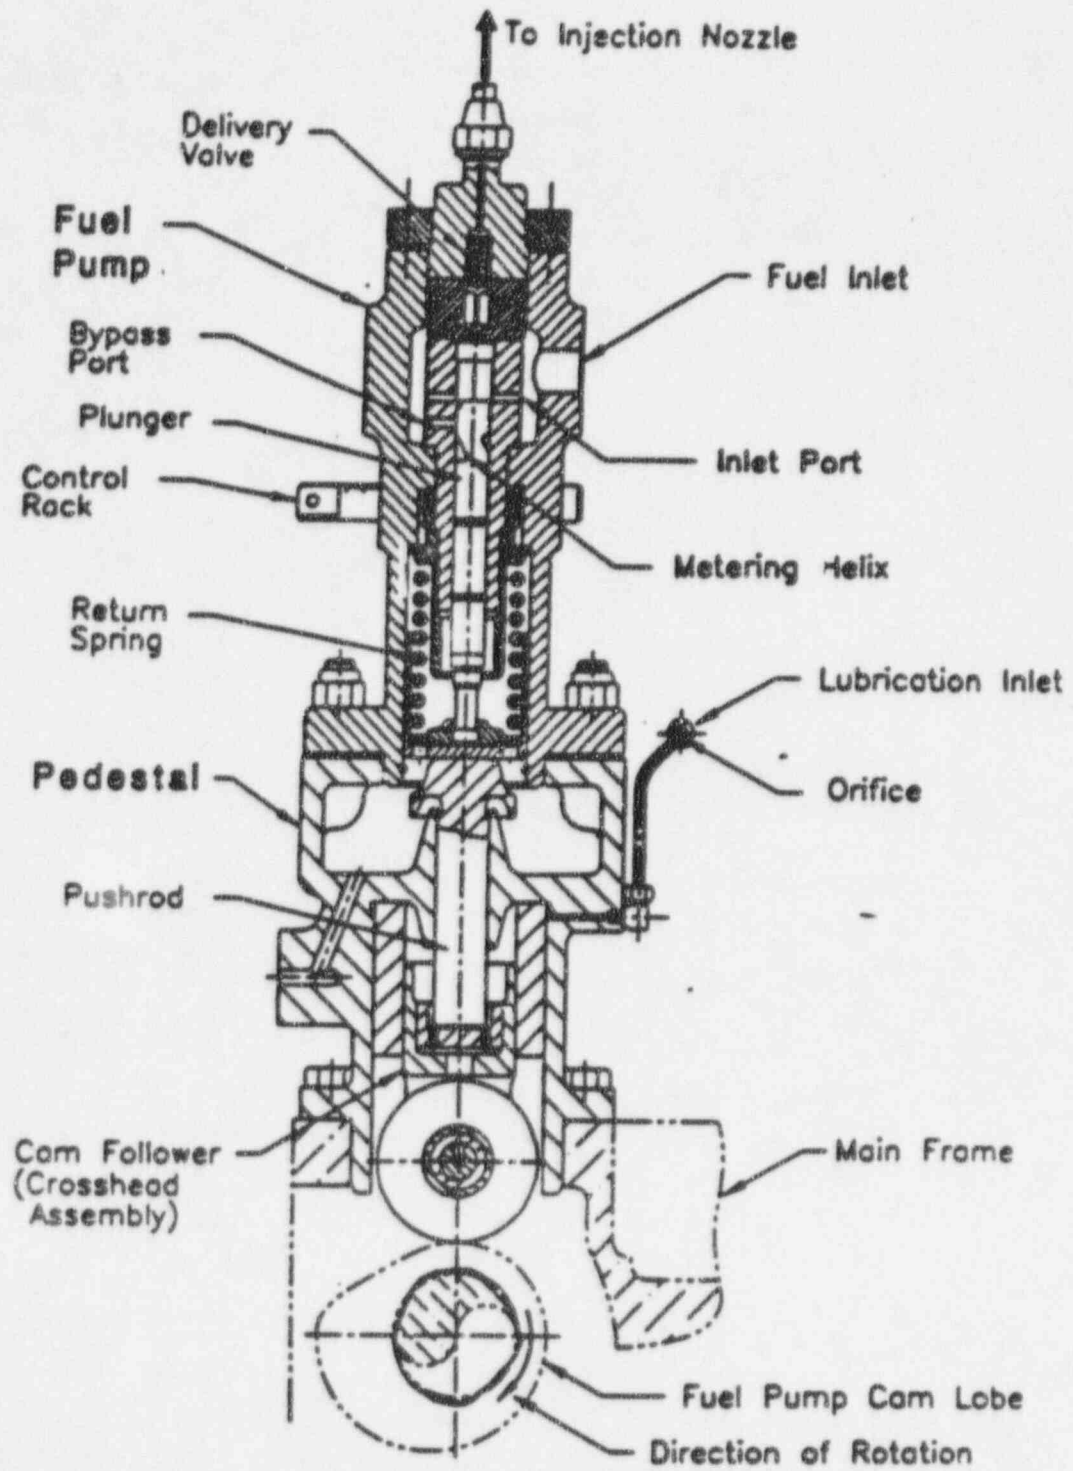
Figure 1 Fuel Pump and Pedestal Assembly

In a memorandum dated June 3, 1994 (Chan to Quay), the staff concluded that the failure of the hollow hold-down studs in the fuel injection pumps (which led to the operability analysis of 18 and 19 cylinder operation) was caused by manufacturing tolerances, inadequate design margins, and deficiencies in installation practices. The new fastener design (solid hold-down studs with Belleville washers) is considered adequate. Additionally, the standby diesel generators would be operable with up to two cylinders out of service, provided the standby diesel generators are required to operate at steady-state or decreasing load conditions. This action is considered closed.
