Condition of 44-Year **Naturally Aged** Cable

Pyrotrol III, Raychem Flamtrol, and RSCC **Firewall III** Cable (15 years)

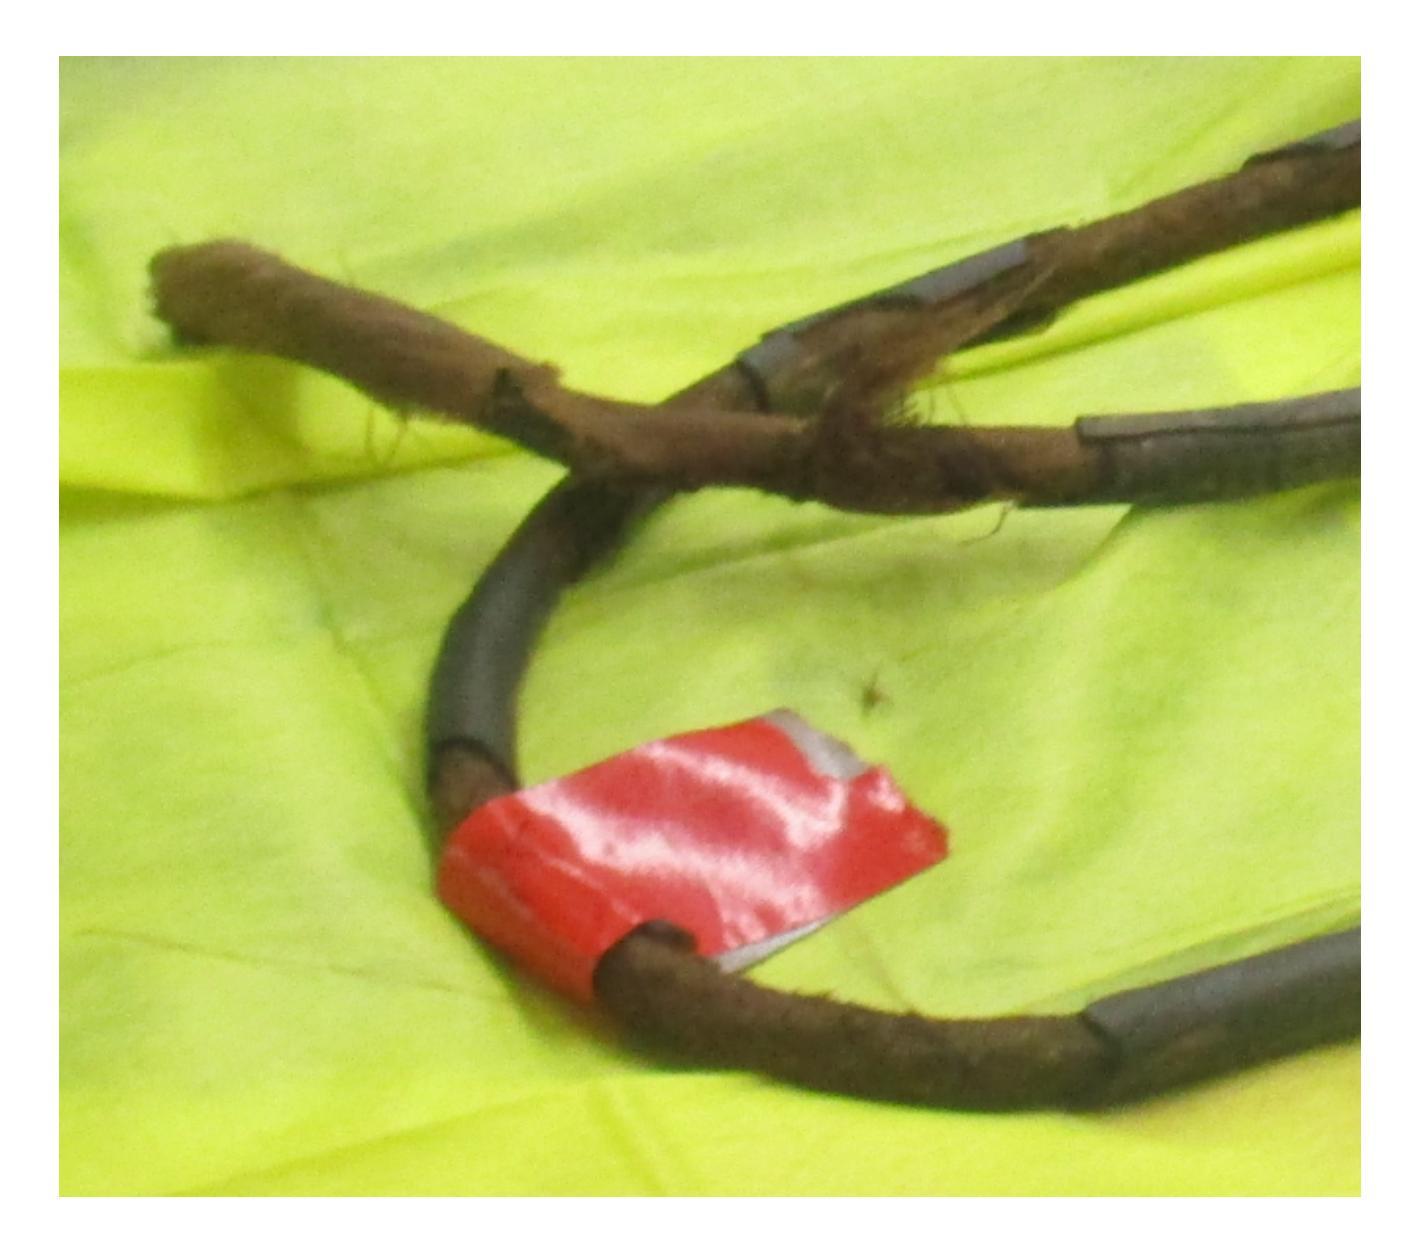
Condition of Rockbestos (Cerro) Pyrotrol III Outer Jacket.

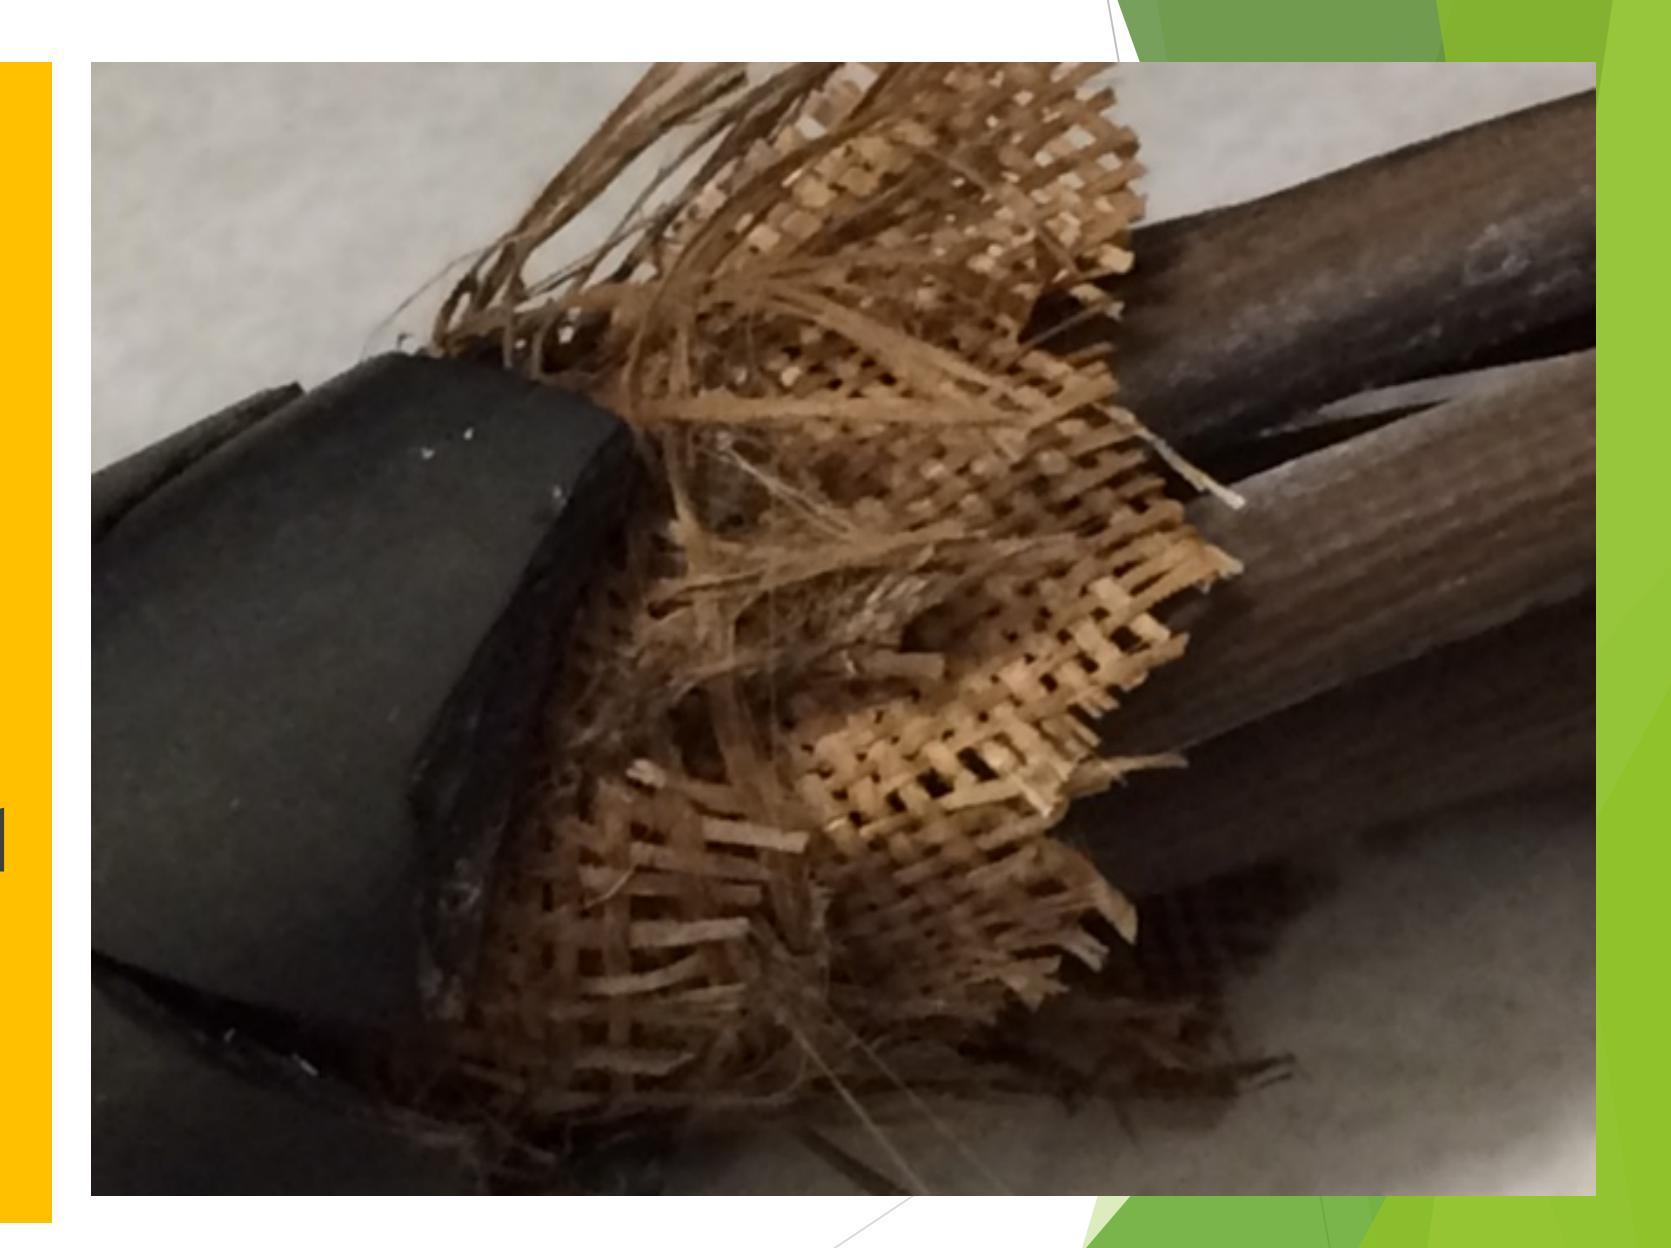
Once the braid and jacket were removed, the underlying conductor insulation was generally in good shape, intact, and moderately flexible

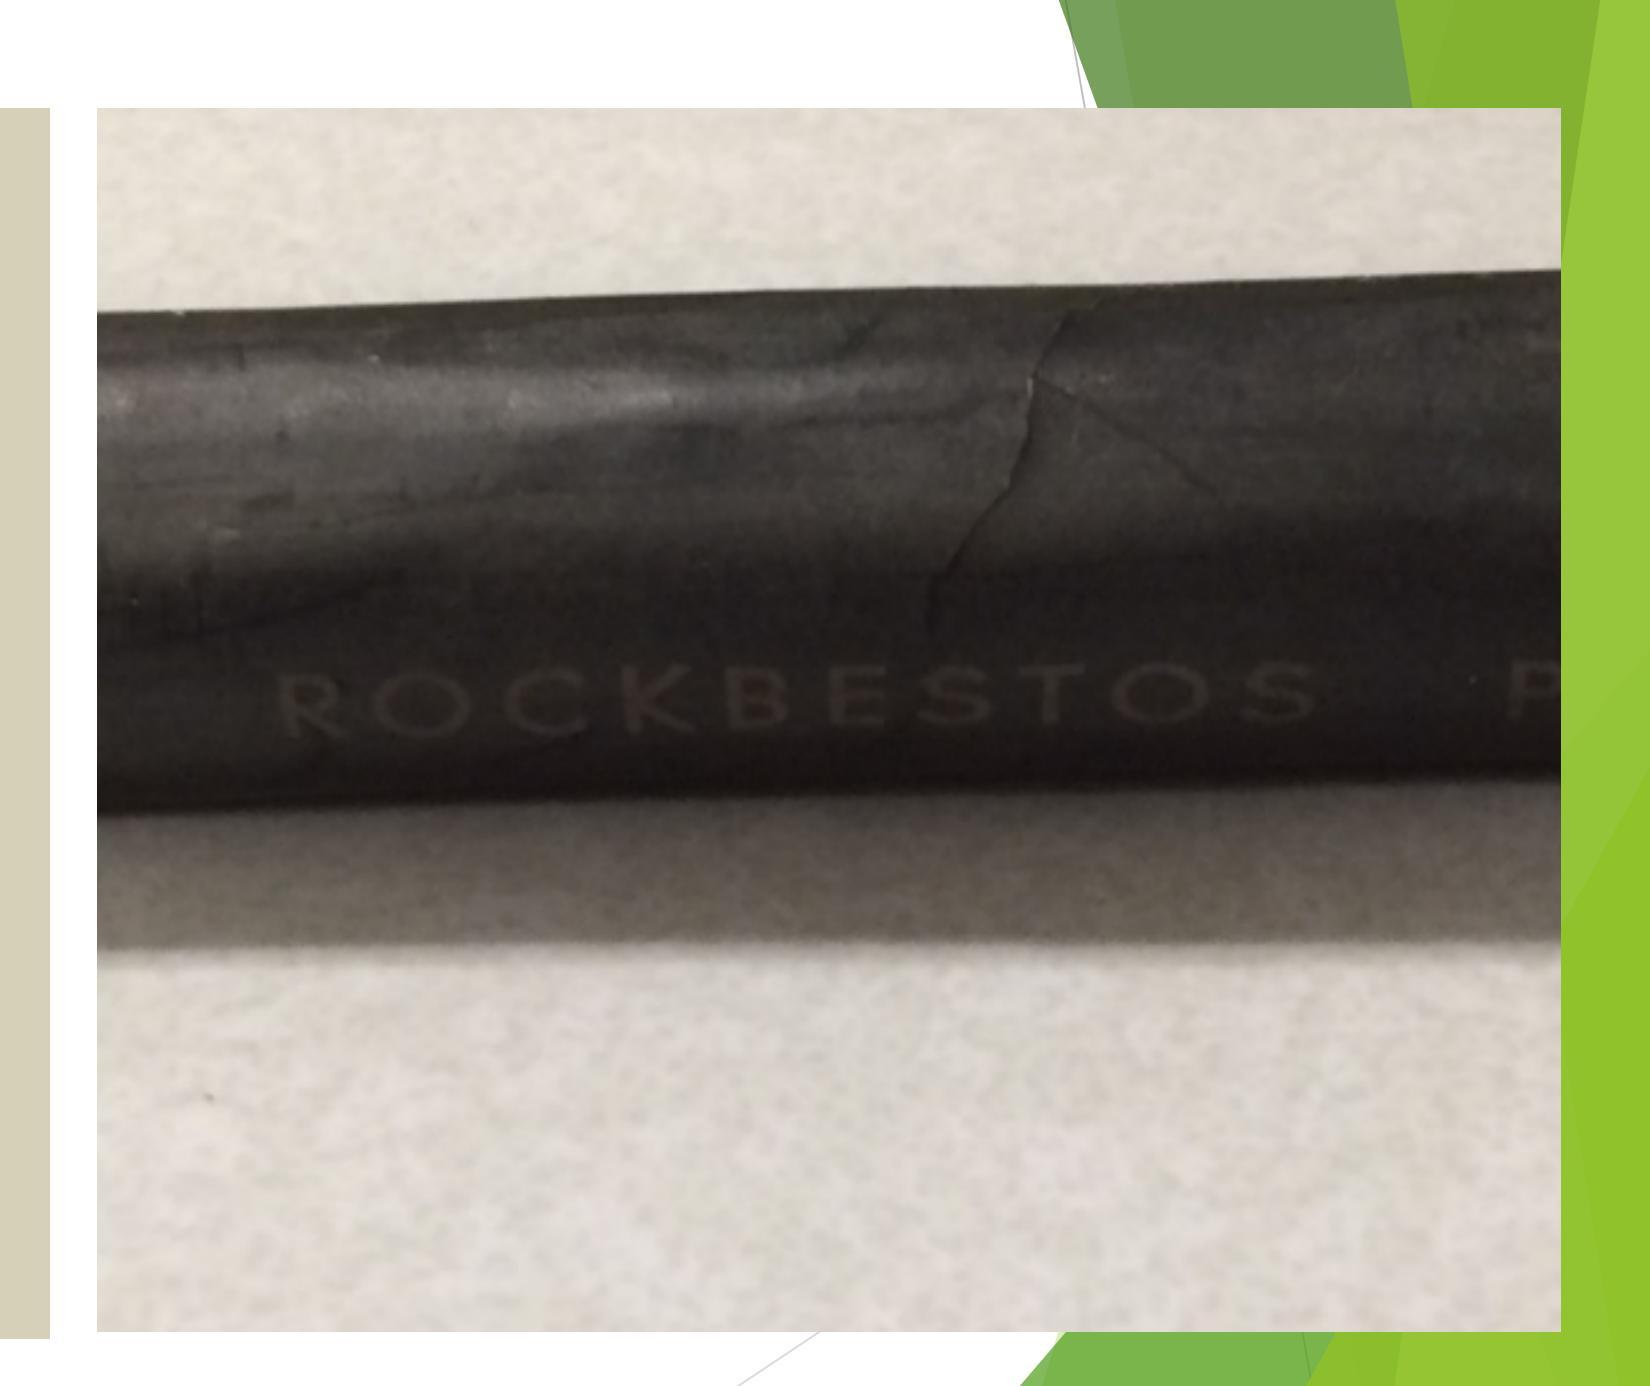
The Surprise: Once we recovered the Cerro Pyrotrol III cable, we discovered that instead of the name "Cerro" they were "Rockbestos" Pyrotrol III cable.

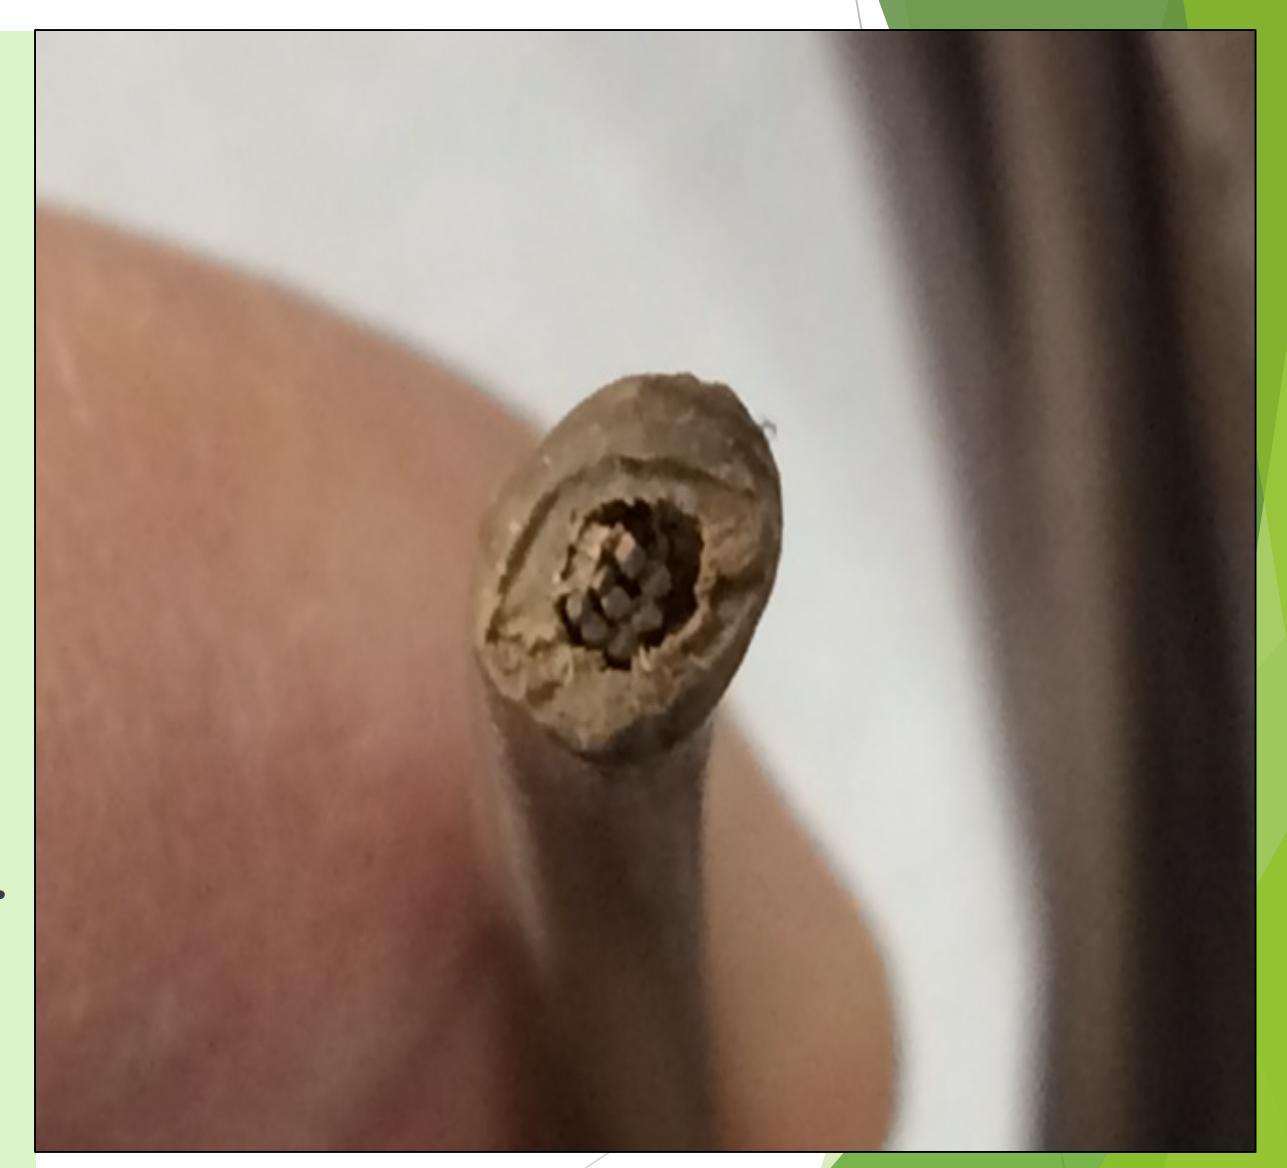
INDIVIDUAL PYROTROL III CONDUCTOR WITH OUTER JACKET REMOVED.

The Chemically Cross-linked polyethylene conductor insulation was in reasonably good condition after 44 years of installation in an average of 150°F (65.5°C) ambient environment. There were ambient excursions up to about 180°F (82.2°C). These were control conductors with little or no heat rise.

The stranded copper conductors did not exhibit any corrosion or rust.

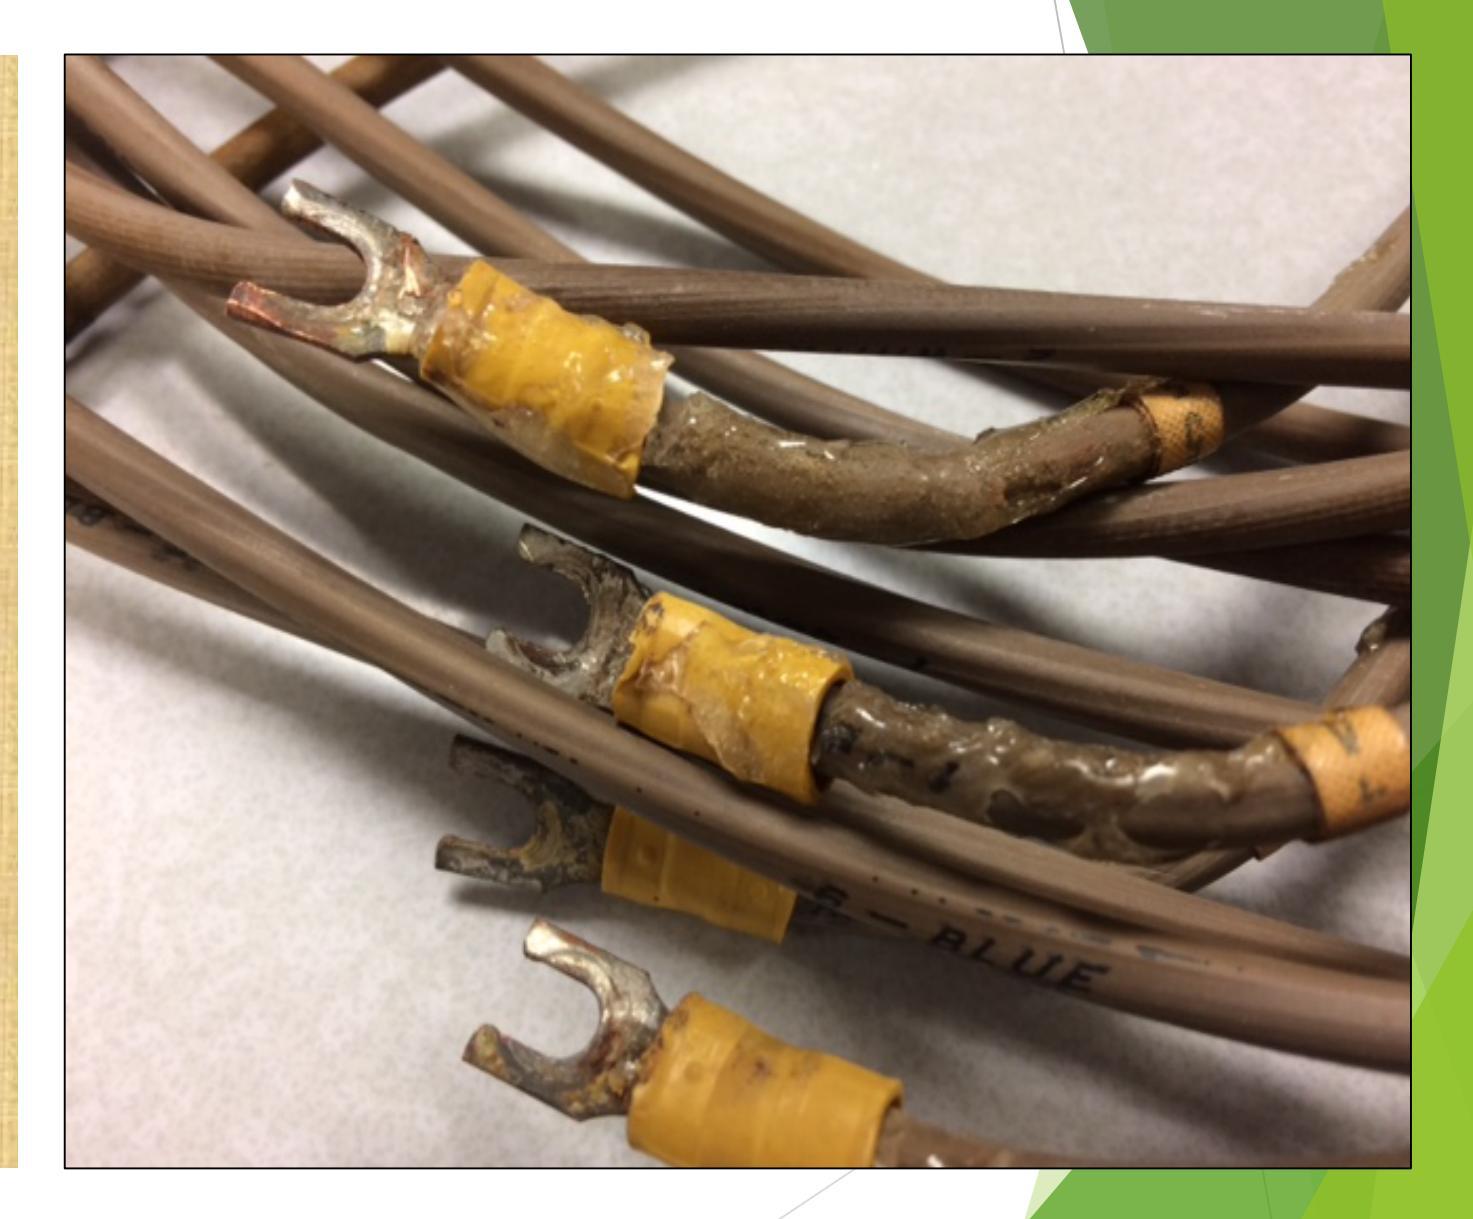
CONDITION OF PYROTROL III AT THEIR **TERMINATION** LUGS. The shiny clear substance on and behind the terminal lug is Patel Engineers **Conformal Coating** (PECC).

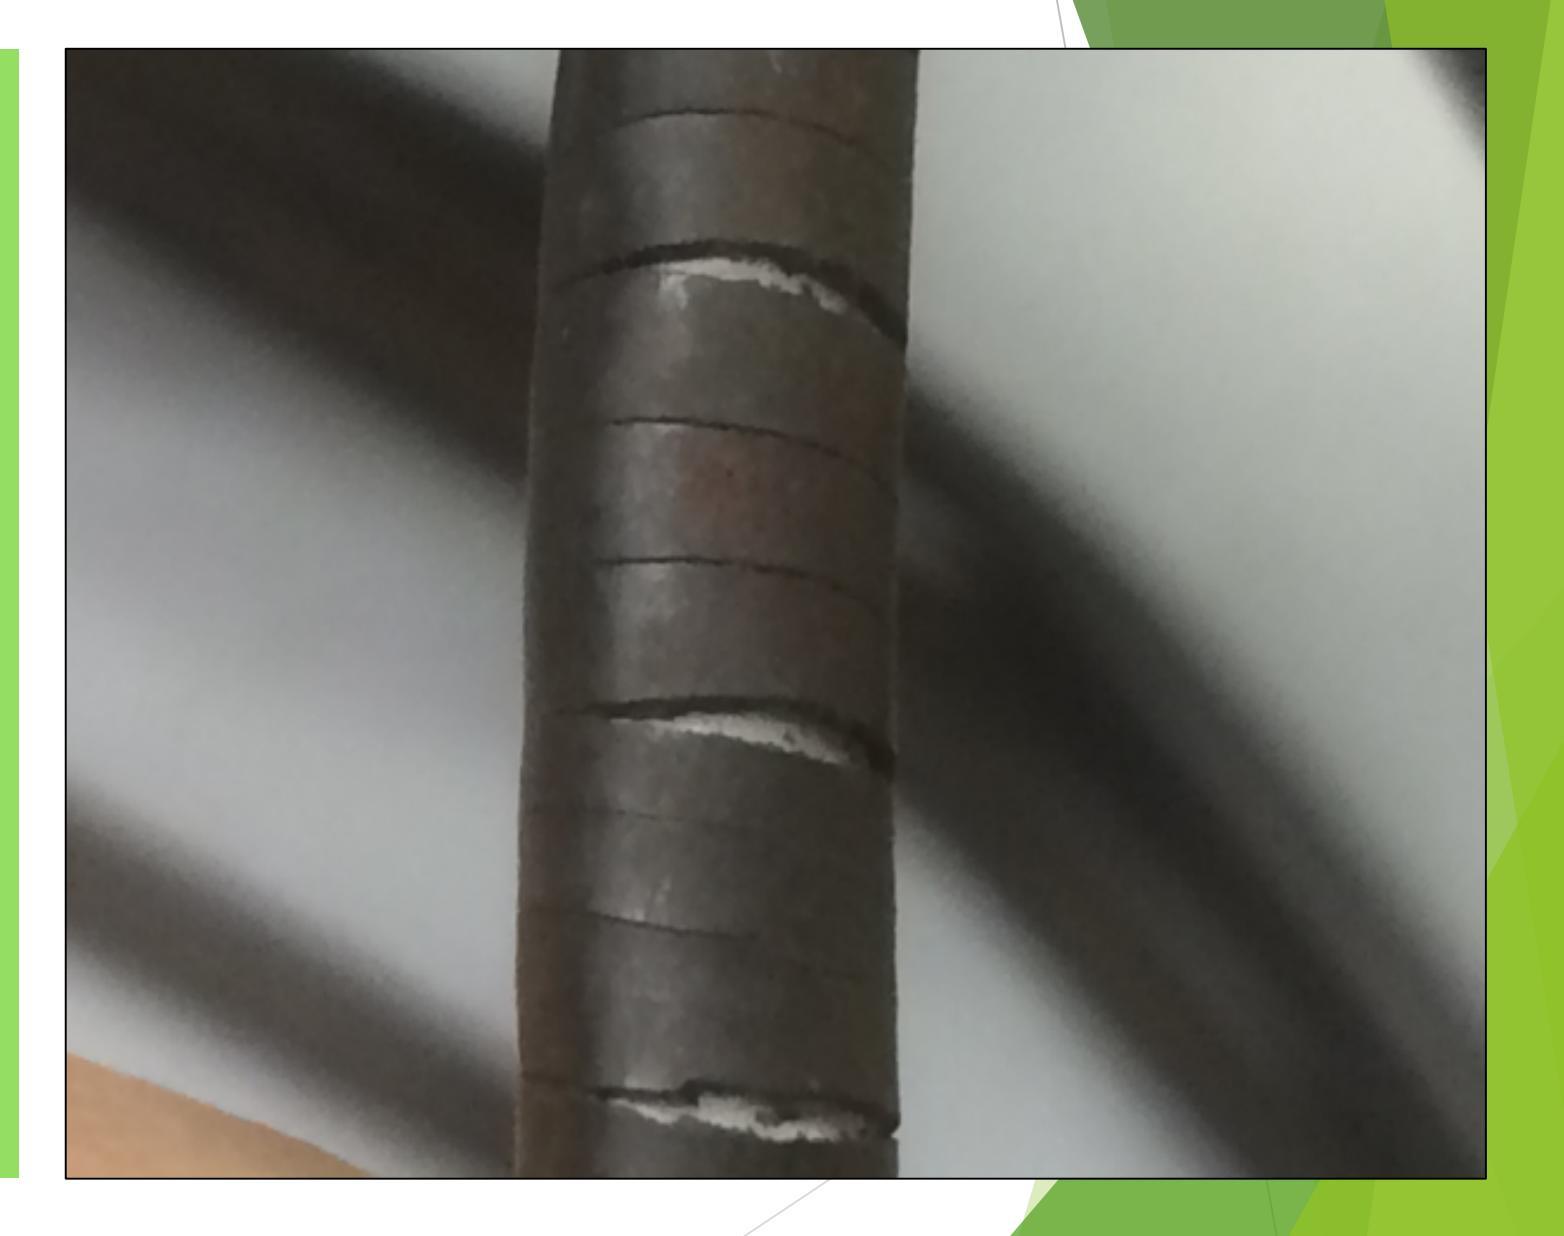
RAYCHEM FLAMTROL wire and cable rated 1000 Volt, Single or Multi-Conductor, Cross-Linked Polyethylene (XLPE) insulated and jacketed Control Cable.

The photo at right shows how the outer jacket had split approximately every 1/8" to every 1/4" along the entire length of the cable.

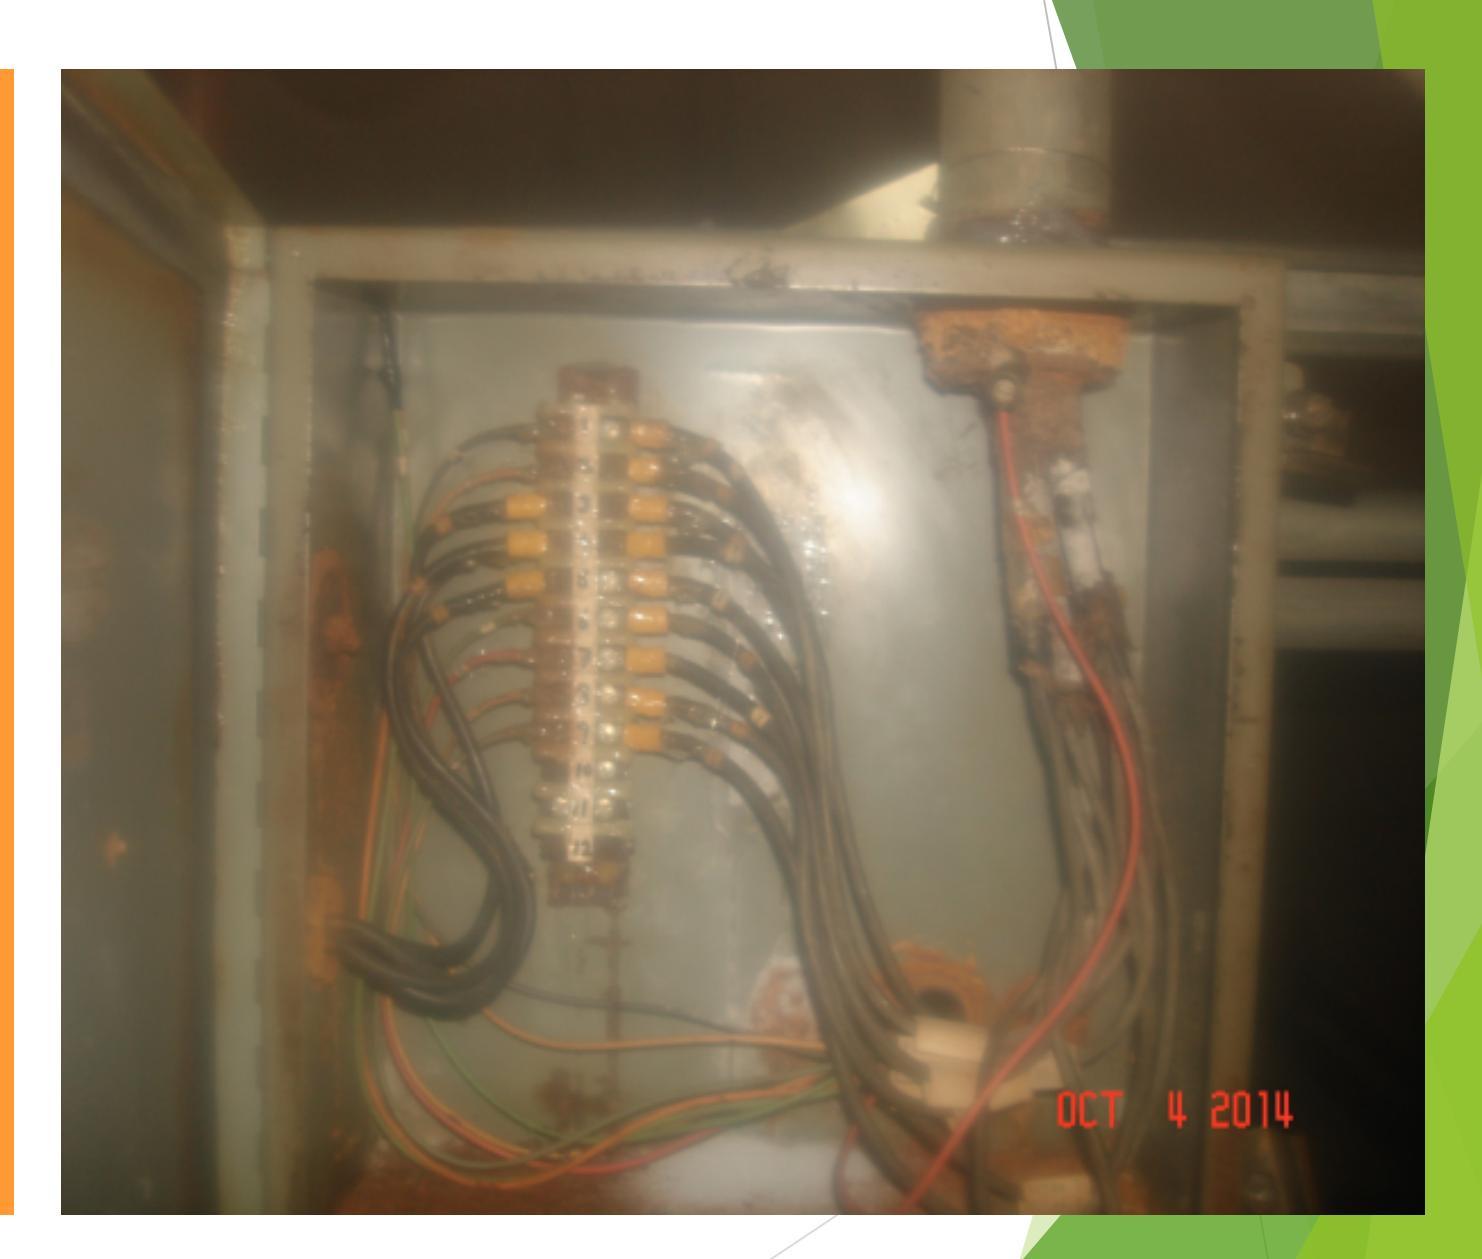
Terminal Box Rust and Corrosion: The photo to the right shows a typical CNS terminal box inside the Steam Tunnel. While not all terminal boxes were rusted and corroded, several were. The pictured terminal box is among the worst case examples (2014).

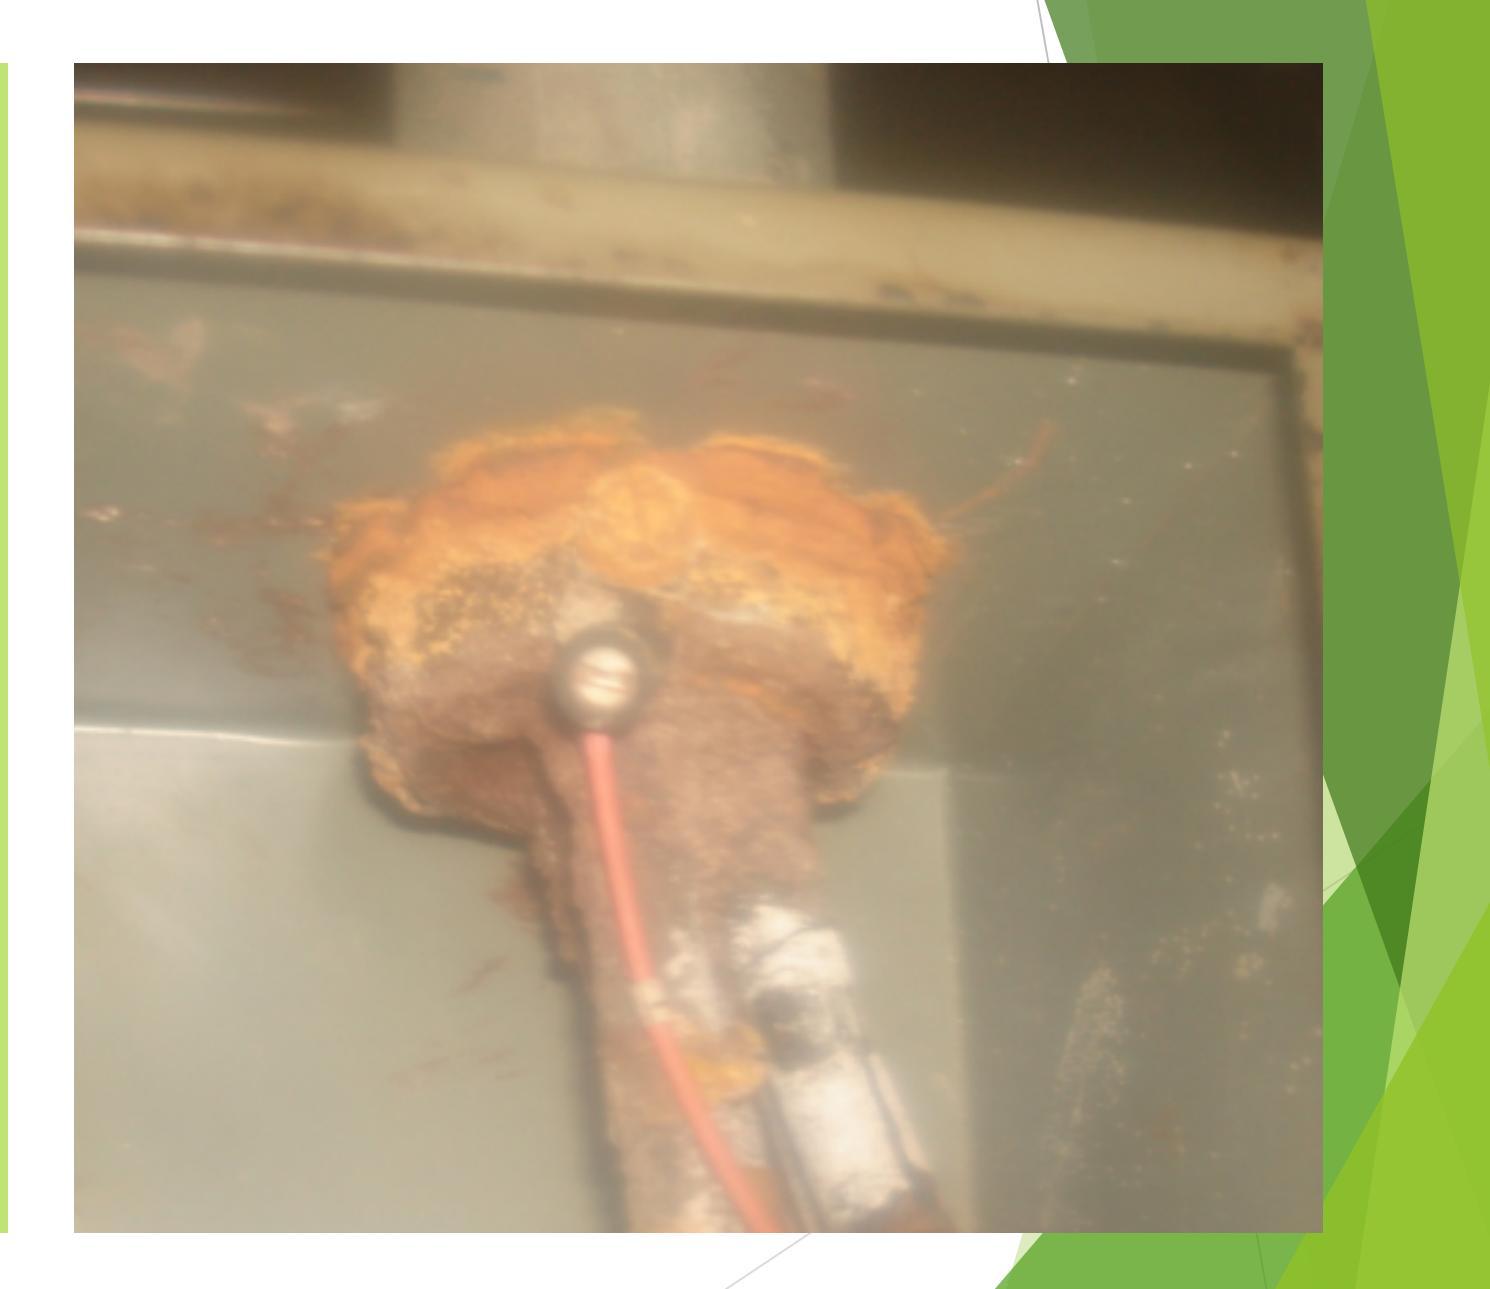
Rust formation in terminal boxes is not necessarily a failure mechanism. In a static state, the outer jacket will prevent rust from reaching the conductor insulation. The evidence for this is shown that after 42 years in the hot and humid Steam Tunnel, the rust had not reached a point where it would cause any damage to the cables.

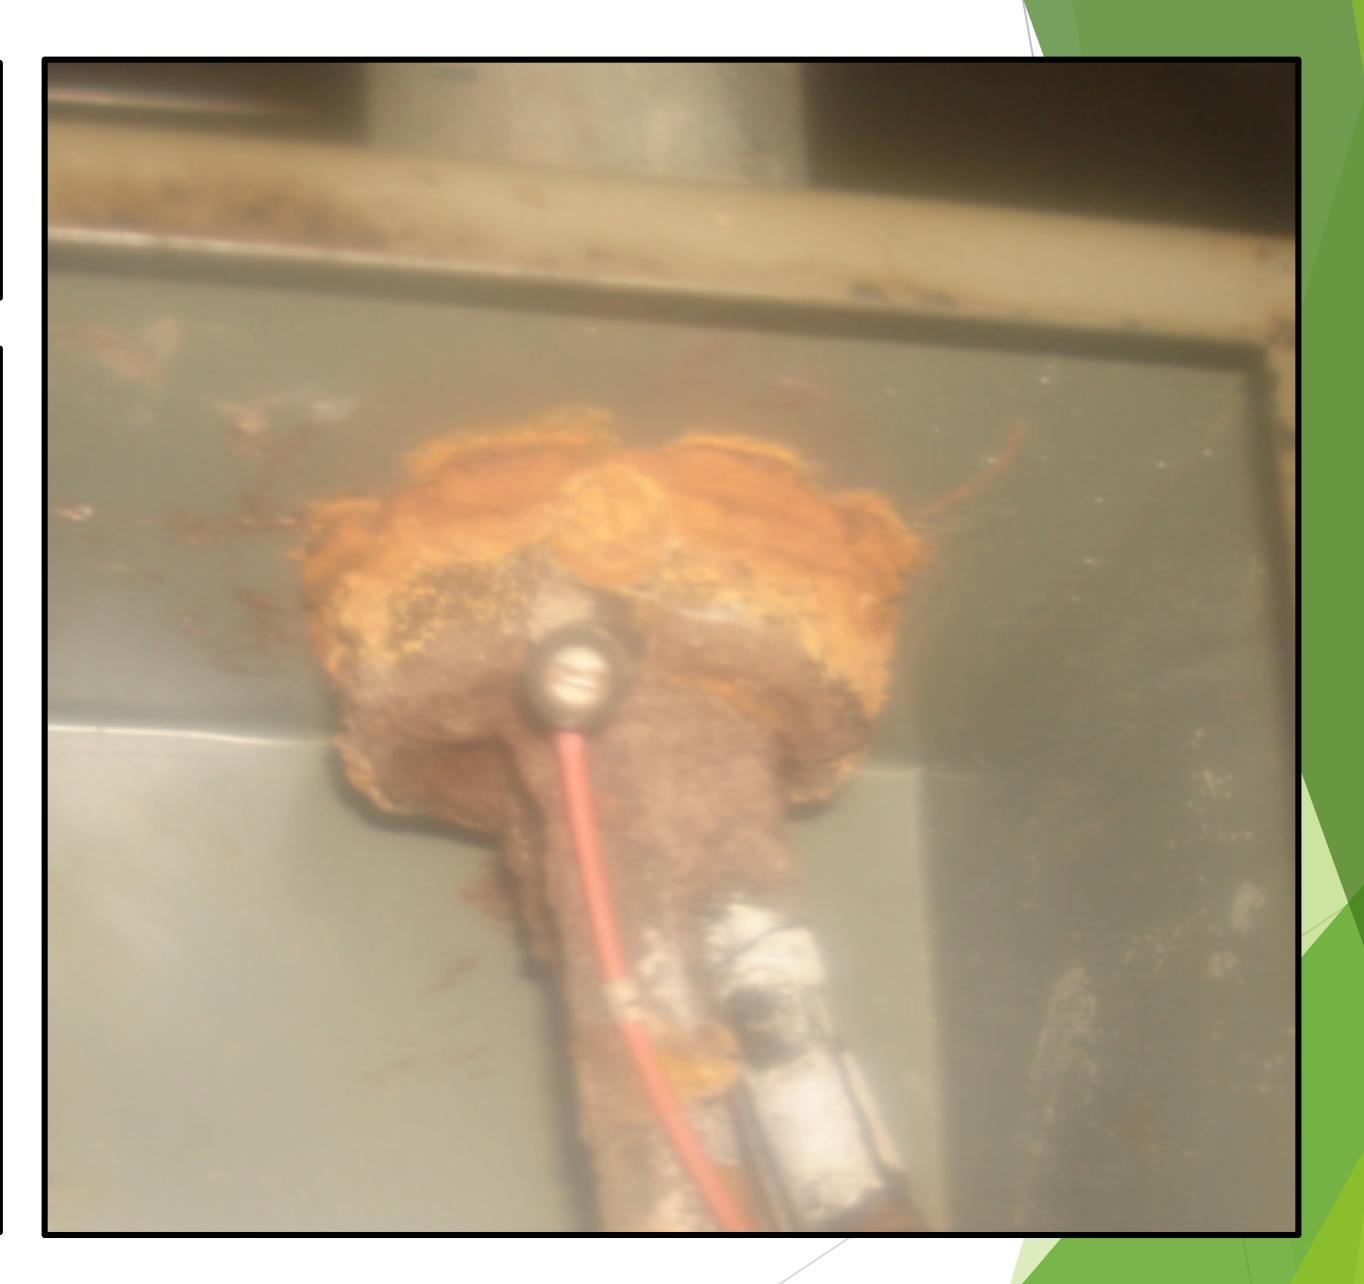
THE PROBLEM WITH EXCESSIVE RUST IS IT MAY AFFECT CABLE RATING

When cables were being removed, the electrical team used brushes as they pulled the old cable out and the new cable in through the conduit.

They reported that there were significant quantities of rust and corrosion from the conduit walls - along with moisture.

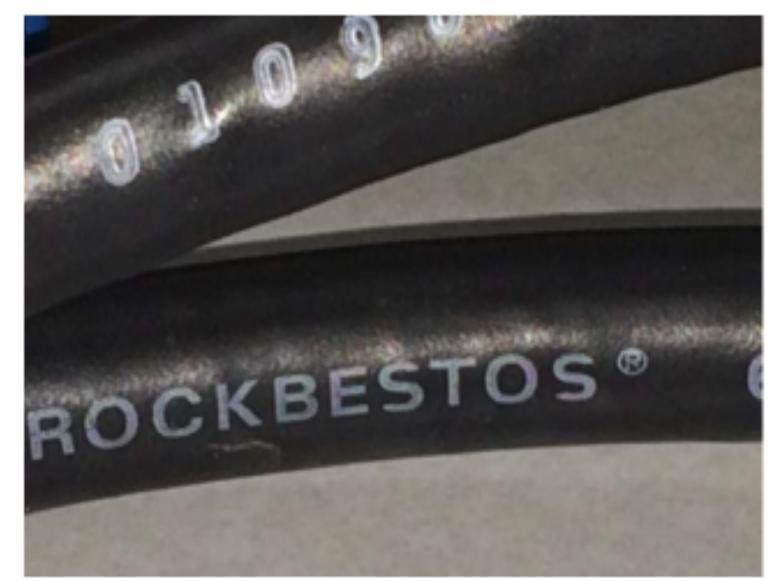
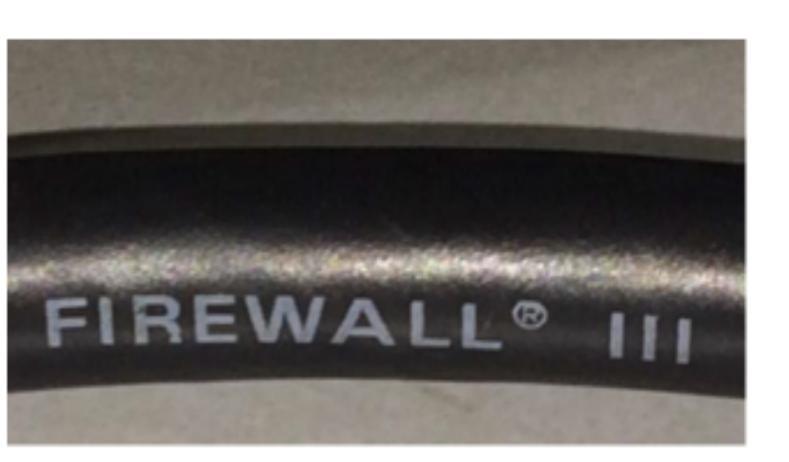
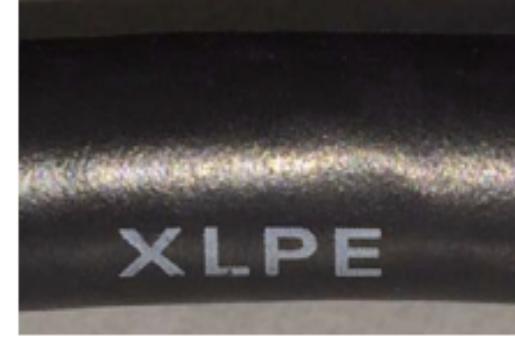
RSCC (Rockbestos) Firewall III cable was also inadvertently removed during the 2016 outage. It was a small length between two terminal boxes in close proximity to one another in the Steam Tunnel.

Rockbestos Firewall III after 15 years in the Steam Tunnel ... in pristine condition The general results are that all cables removed proved to be in good condition, consistent with their aging levels.

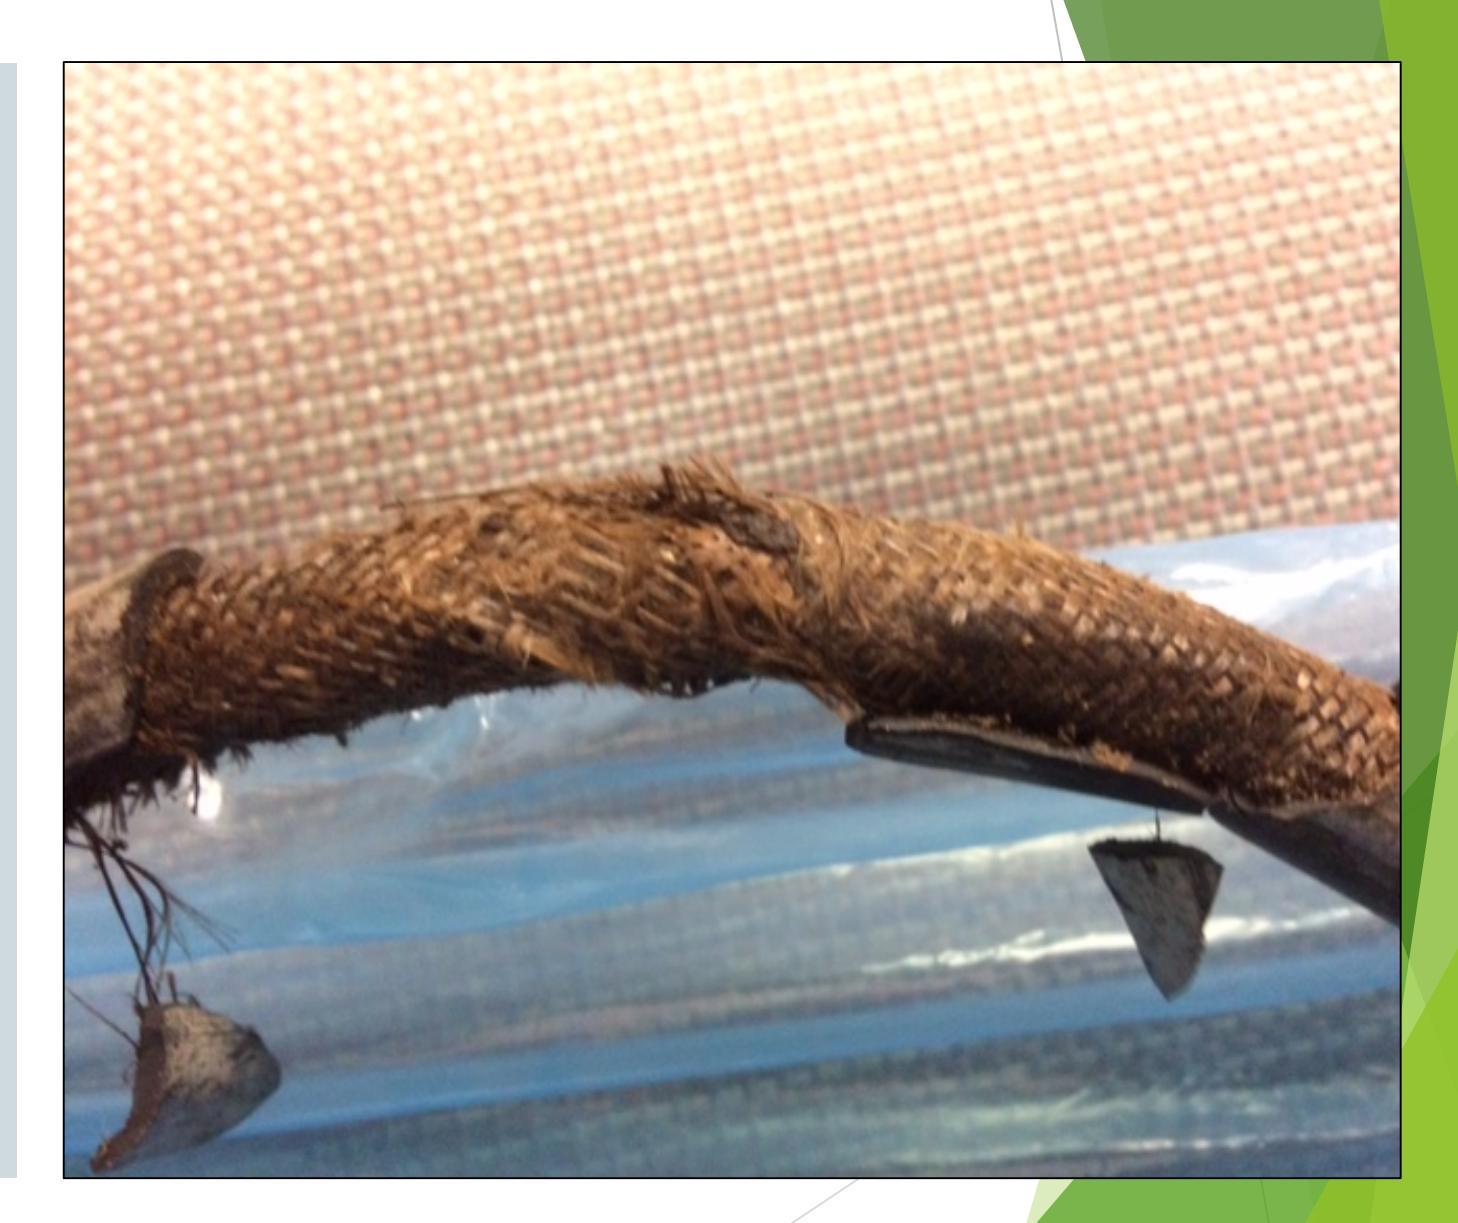
The remaining life of 15-years for the Pyrotrol III cable and 5-years for the Raychem Flamtrol Cable is based on a minimum of 50% EAB as determined by AMS.

CNS conservatively chose to replace the Pyrotrol III Cables

... because the remaining life also has to account for any HELB accident.

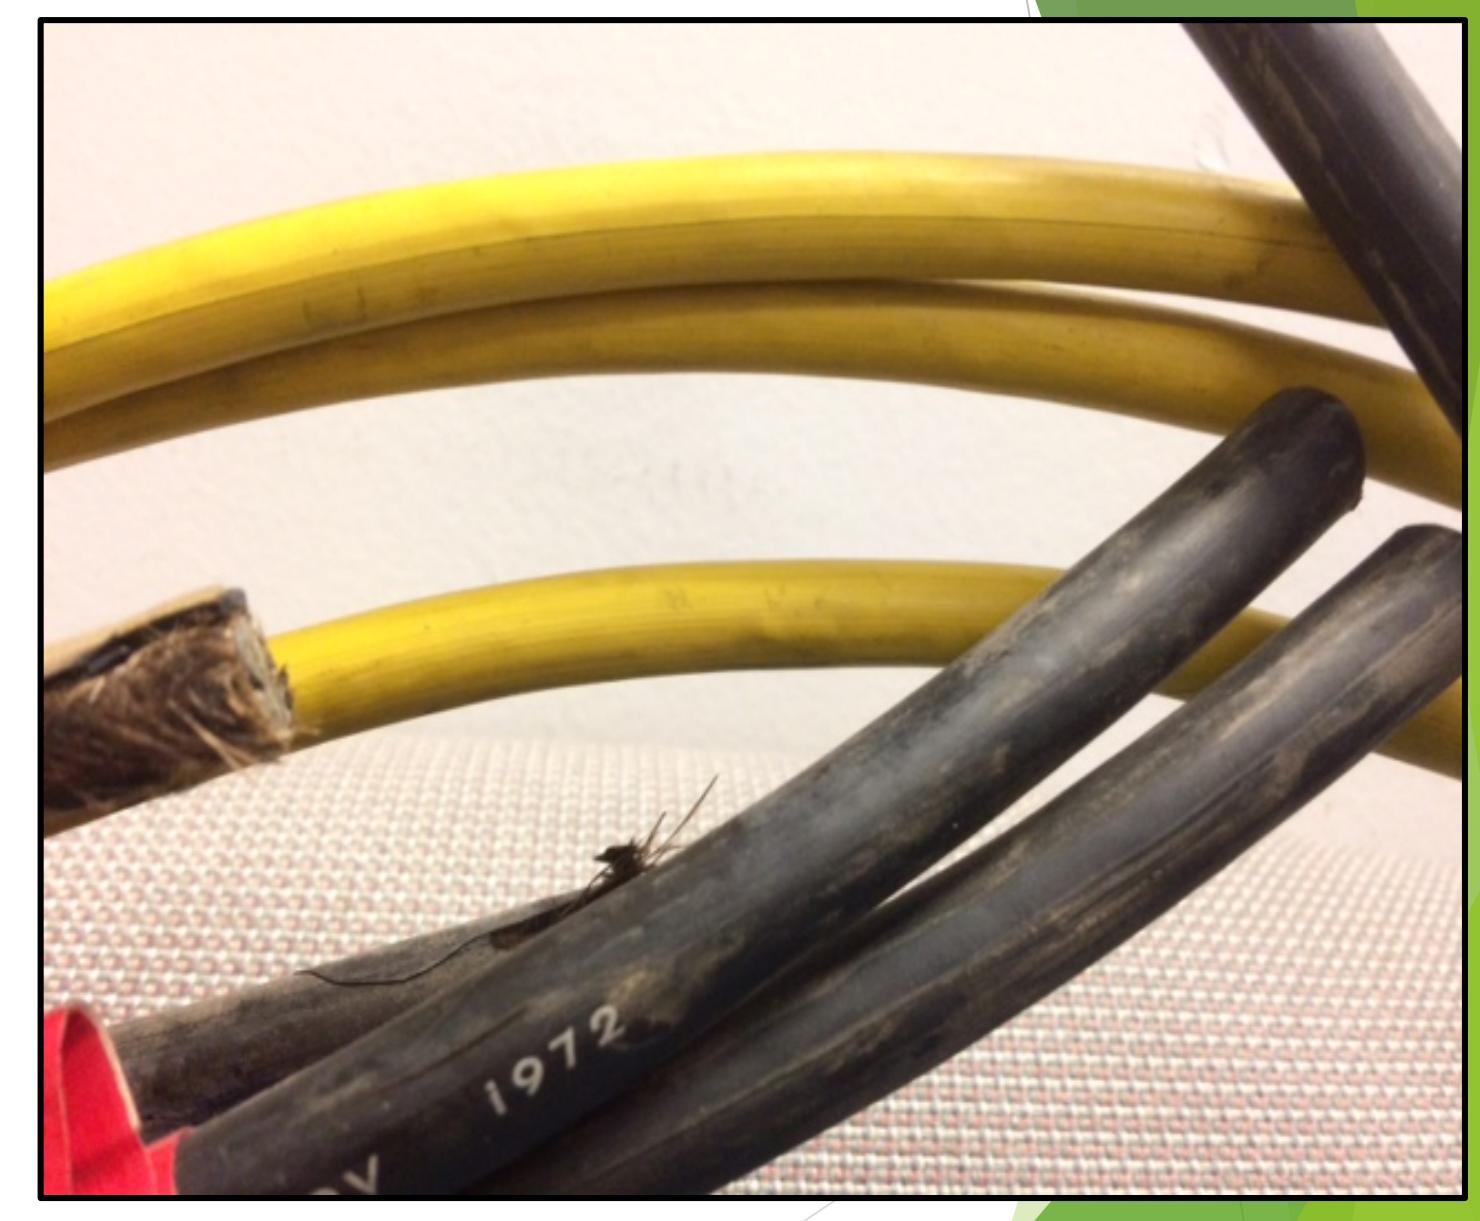
One yellow cable shows a transition from being in very good condition to being severely degraded within about a foot. This suggests that the load or nearby equipment was extremely hot at one end.

The conductors, however, are still in good condition and flexible.

- Know various heat loads affecting cables
- Get Temp Element data to track ambient
- Apply as many TEs or Monitors as possible
- Inspect condition of cable ends periodically
- Inspect terminal boxes & conduit entry for rust and corrosion
- Make sure cable qualified life is solidly based (DOR)
- Have cables replaced in a conservative time frame
