NUREG/CR-3588

SAND83-2406

The Effect of LOCA Simulation Procedures on Cross-Linked Polyolefin Cable's Performance

L. D. Bustard

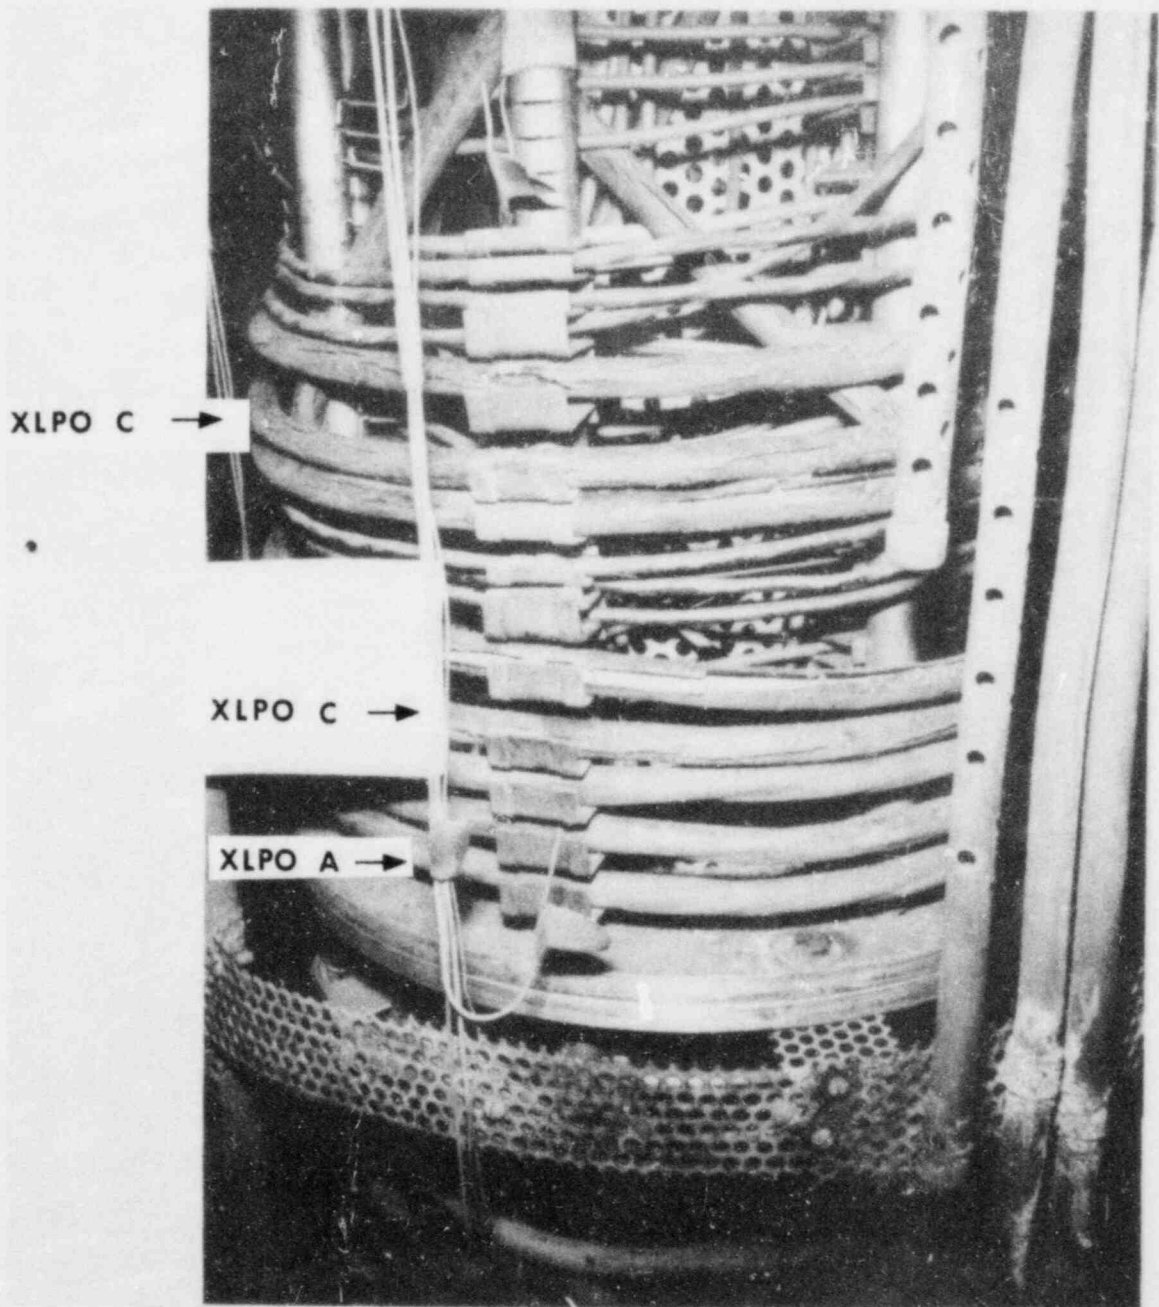
4. The XLPO multiconductor cable constructions included chlorosulfonated polyethylene (CSPE) and Neoprene outer jackets. We observed substantial visual degradation of these jacket materials during our simultaneous testing exposures.

Figure 3.6. CSPE Jacket Condition (XLPO A and XLPO C cables) at Completion of Simultaneous Test #2

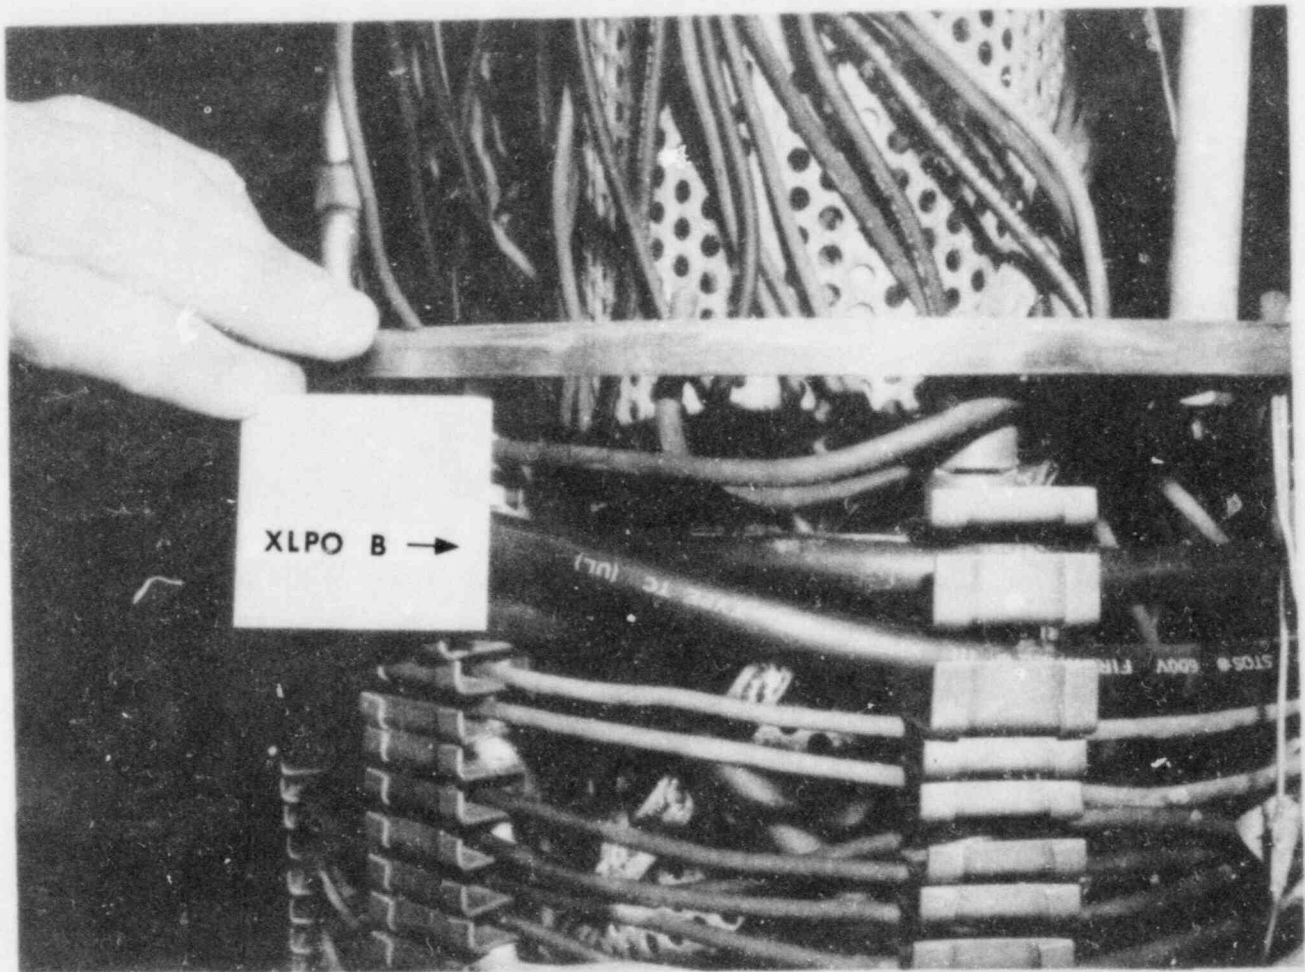
XLPO B with a Neoprene jacket was exposed during the sequential and simultaneous test. At completion of all the tests, the Neoprene jacket exhibited longitudinal cracking. The degradation was more severe for the simultaneous testing techniques. Figures 3.7 and 3.8 illustrate XLPO B's jacket condition at completion of the sequential test. XLPO B's Neoprene jacket condition at the completion of simultaneous test #1 is shown in Figure 3.9 while its condition during the unanticipated cooldown of simultaneous test #2 is shown in Figure 3.10.

Figure 3.7. Neoprene Jacket (XLPO B cable) at Completion of the Sequential Test

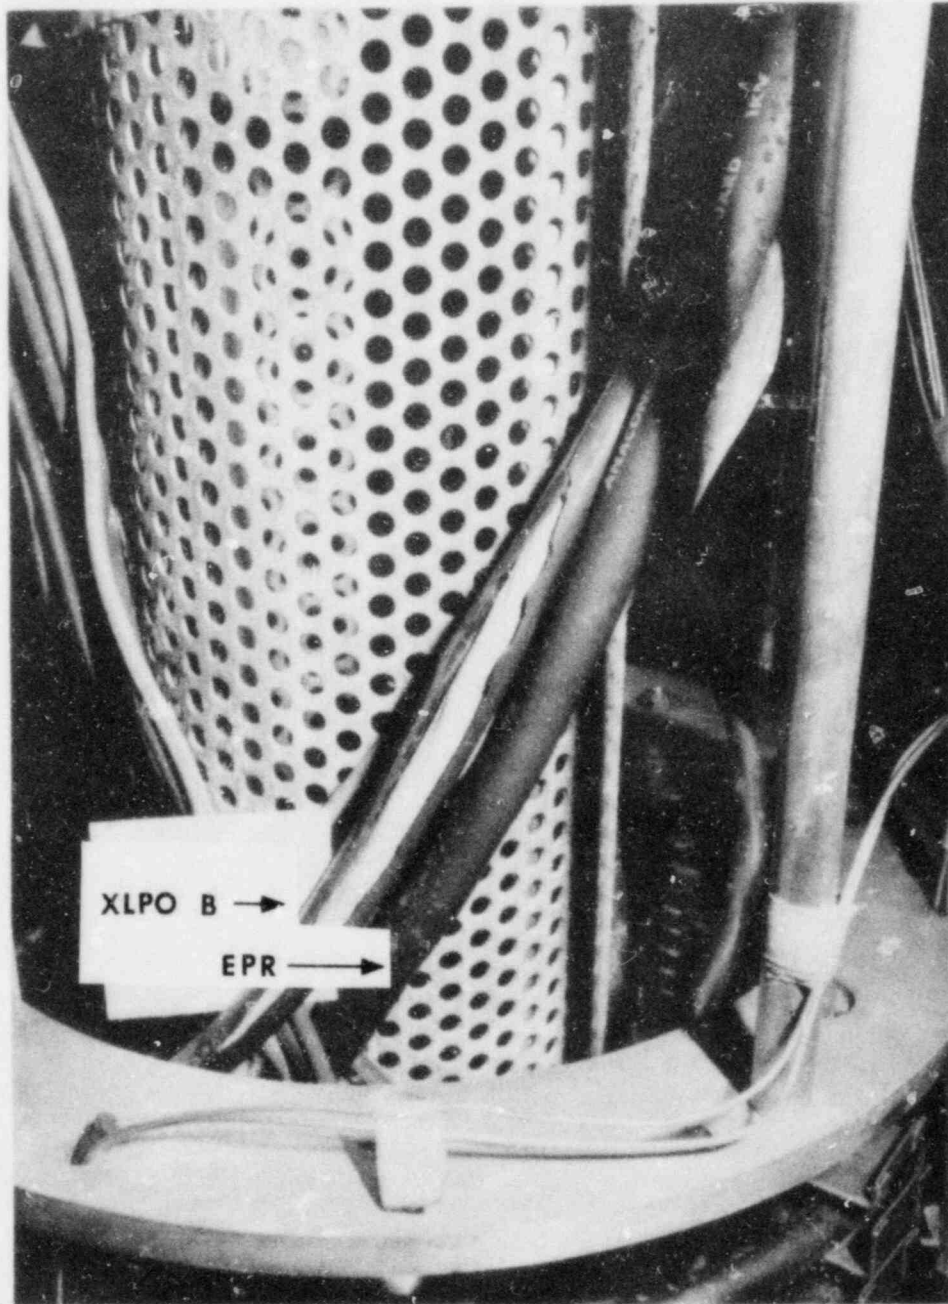
Figure 3.8. Neoprene Jacket (XLPO B cable) at Completion of the Sequential Test

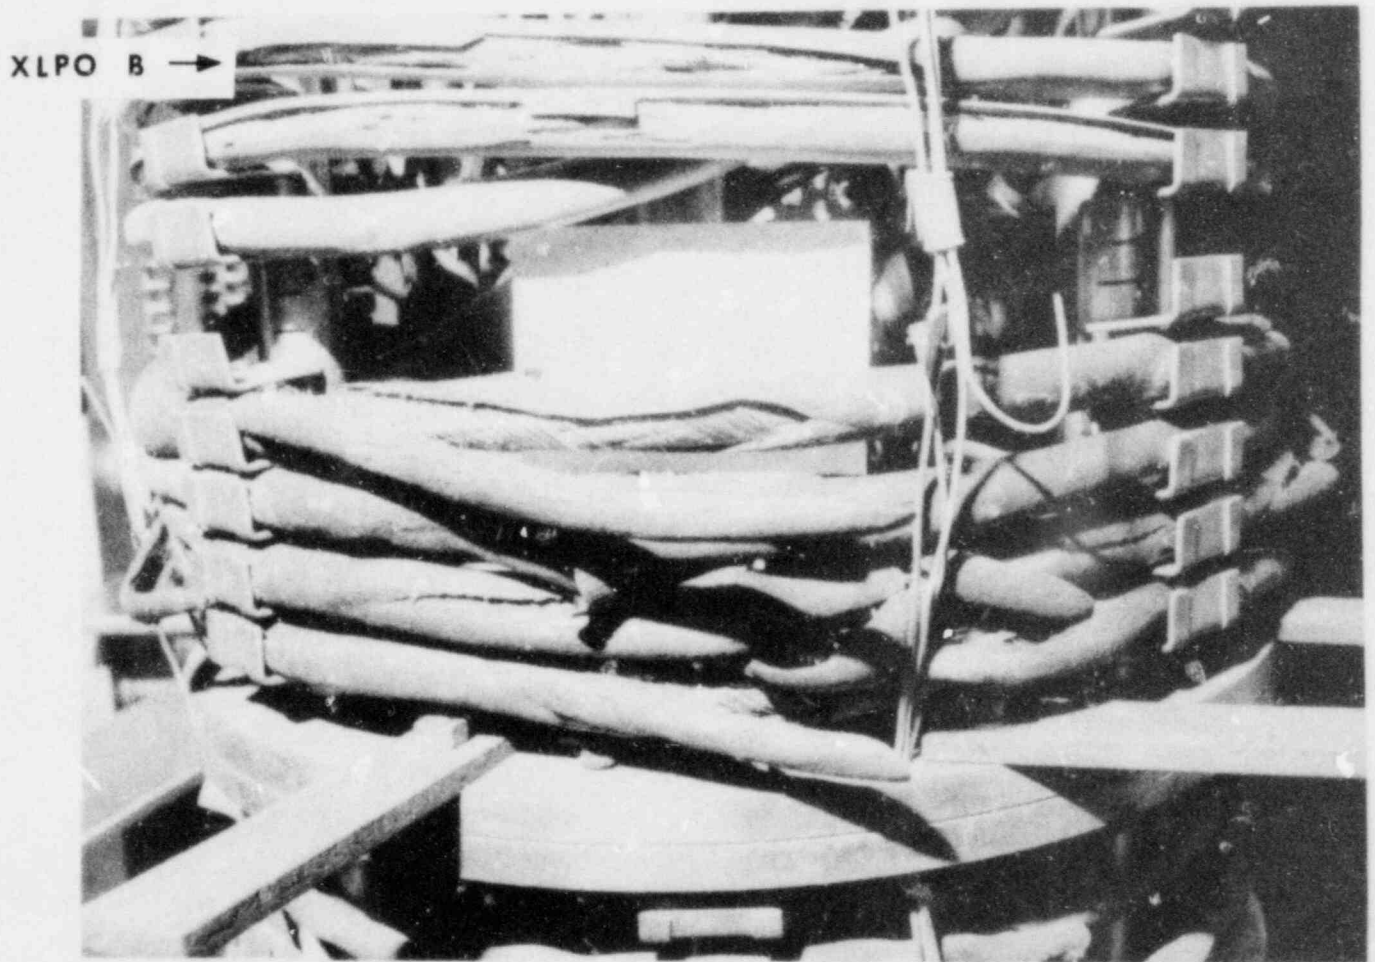
Figure 3.9. Neoprene Jacket (XLPO B cable) at Completion of Simultaneous Test #1

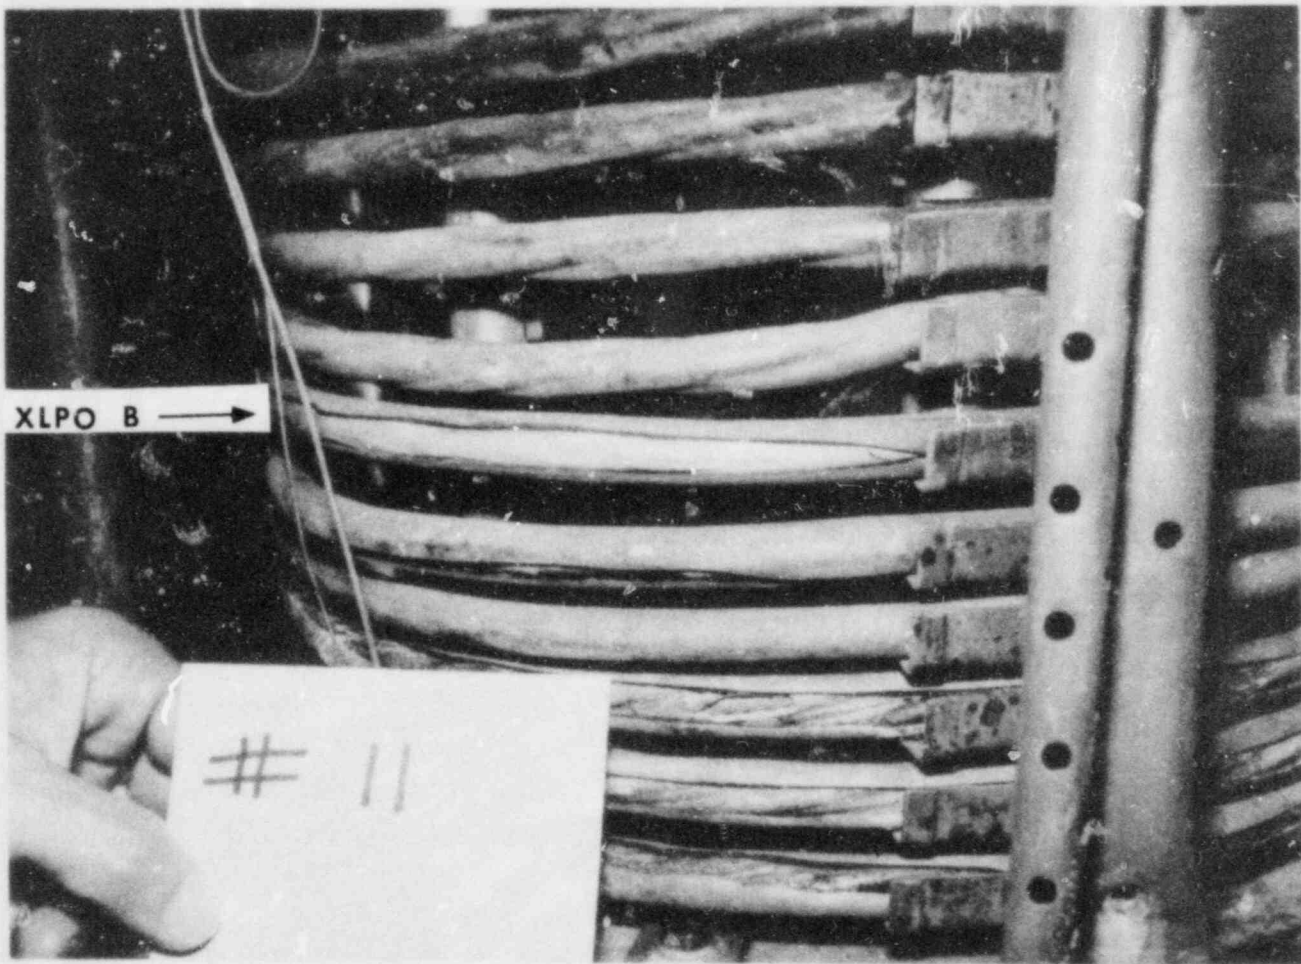
Figure 3.10. Neoprene Jacket (XLPO B cable) During Unanticipated Cooldown of Simultaneous Test #2
