REVISION 1 TO THE DETAILED CONTROL ROOM DESIGN REVIEW SUMMARY REPORT FOR SNUPPS

Wolf Creek Plant - Kansas Gas and Electric Co. Docket No. STN 50-482

Callaway Plant - Union Electric Company Docket No. STN 50-463

> In Response To: NRC Generic Letter 82-33 Supplement 1 to NUREG 0737

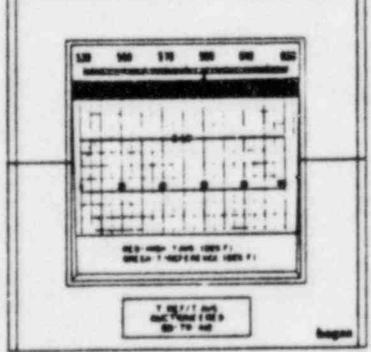
- (3) The label for the T REF/T AVG AUCTIONEERED trend recorder is located at the bottom of the recorder, rather than above as is the plant convention.
- Response The location of the label is such that there is no question at all as to which device it refers to. There is inadequate room to locate the label above the re-corder. See sketch

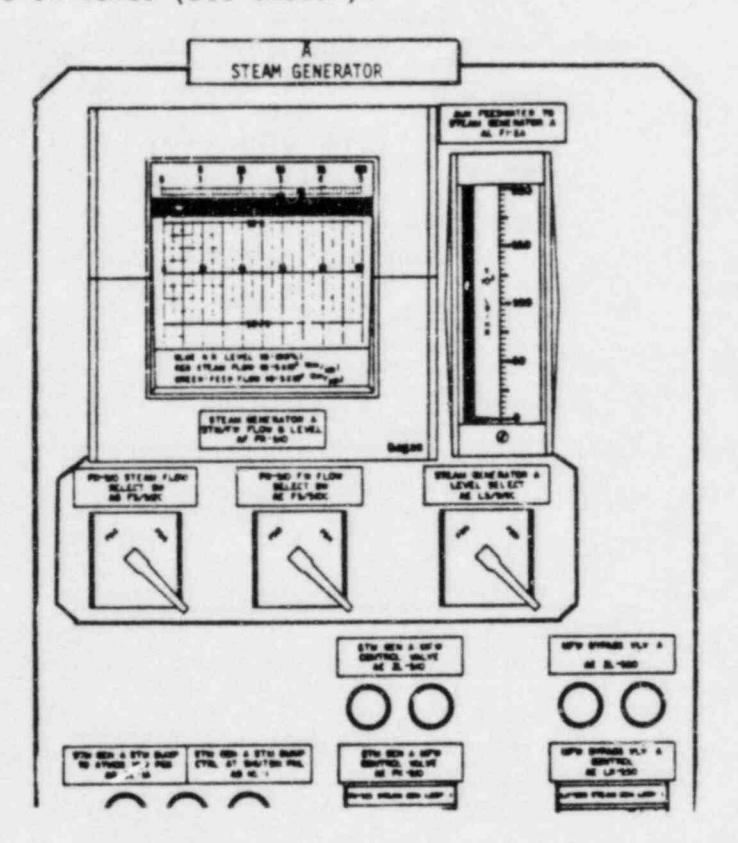
Finding 4 The STM GEN A through D LVL SEL SW controls are not located directly below their associated trend recorders. These switches may be inadvertently associated with the AUX FEEDWATER display that they are located directly beneath.

Response Demarcation lines will be added to clearly group these three switches (see sketch).
