U.S. NUCLEAR REGULATORY COMMISSION
Region I

Report No. 50-388/84-34
Docket No. 50-388
License No. NPF-22 Priority -- Category C
Licensee: Pennsylvania Power and Light Company
2 North Ninth Street
Allentown, Pennsylvania 18101

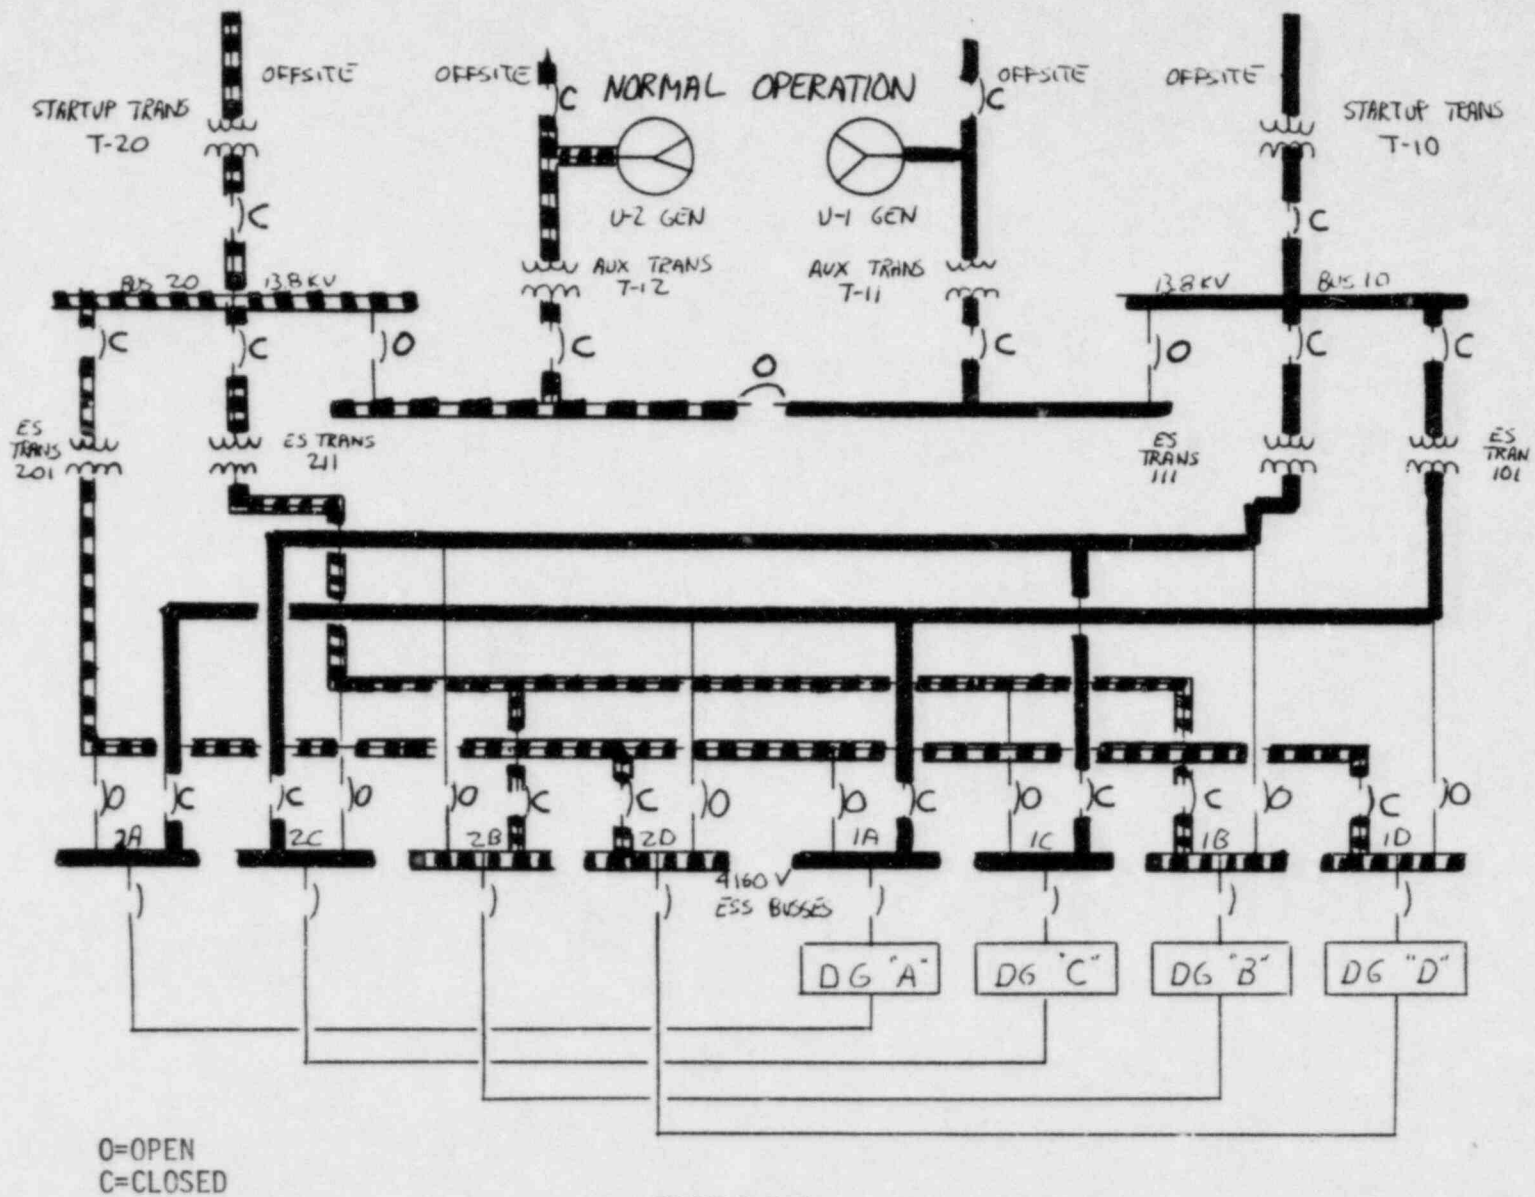
FIGURE 2-1 NORMAL OPERATION

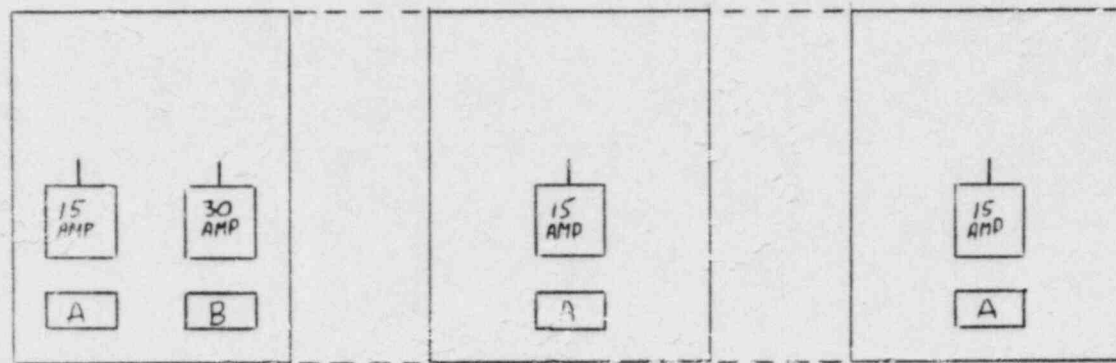
BREAKER
COMPARTMENT 01
