RENSSELAER POLYTECHNIC INSTITUTE

REQUEST FOR ADDITIONAL INFORMATION

IE INFORMATION NOTICE NO. 83-66, SUPPLEMENT 1: FATALITY AT ARGENTINE CRITICAL FACILITY

REPORT OF THE ACCIDENT THAT OCCURRED TO THE
CRITICAL ASSEMBLY RA-2 REACTOR ON SEPTEMBER 23, 1984

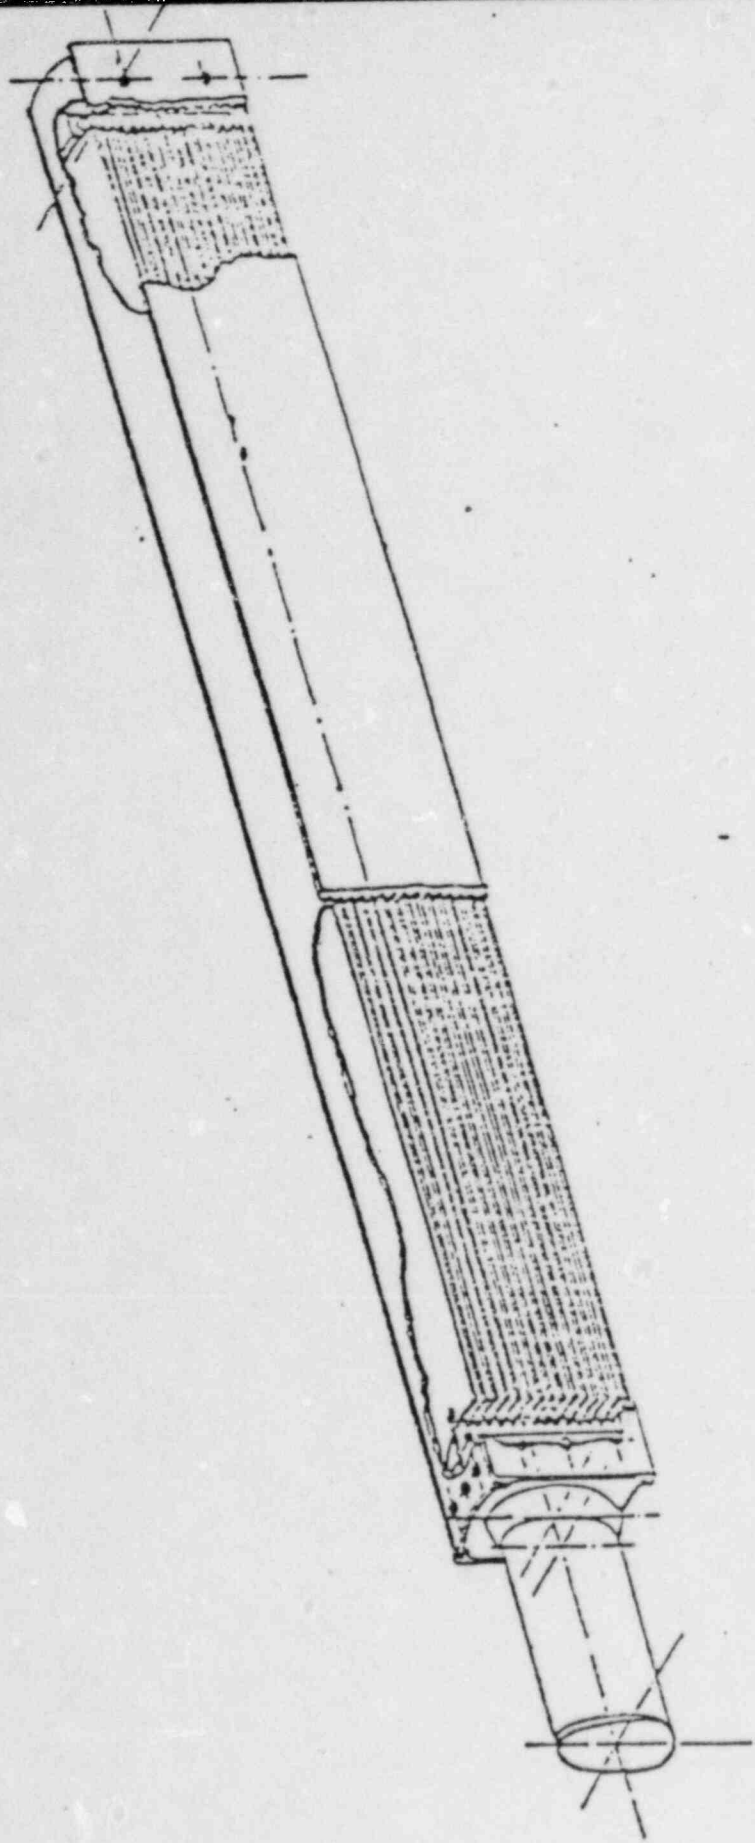
Figure 1 Fuel element

- (a) The moderator was not completely removed from the core before the core configuration was modified.
- (b) Two fuel elements, which should have been removed, were left inside the reactor in contact with the graphite reflector.

- (c) Sequences were performed to change the positions of fuel elements; this decreased the subcriticality of the system.
- (d) Two fuel elements of 15 plates were inserted without the corresponding cadmium control plates. The second fuel element was found to be only partially inserted, wherefore it is deemed that its insertion caused the accident.
- (e) All of the operations were performed without the concurrence or presence of a safety official or the operations supervisor.

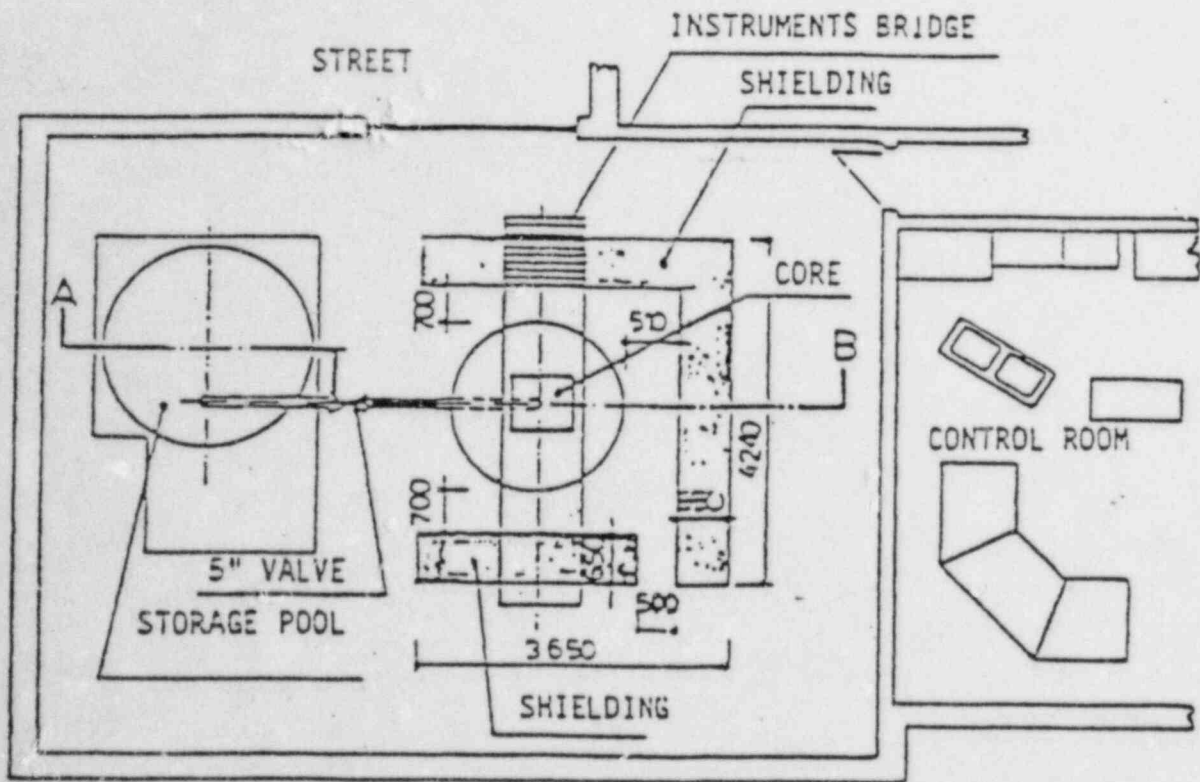
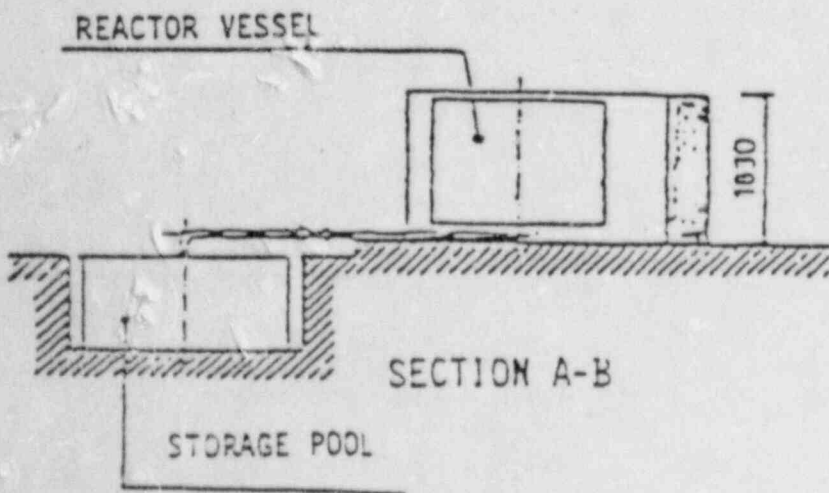
Figure 2 RA-2 reactor facility

The installation is shown in Figure 2.
