RECORD OF TELEPHONE CONVERSATION

PROJECT: Midland

MAIN SUBJECT OF CALL: ADOPTED SOIL SPRING STIFFNESSES USED IN DESIGN OF AUXILIARY BUILDING UNDERPINNING AND START OF PHASE 2 CONSTRUCTION

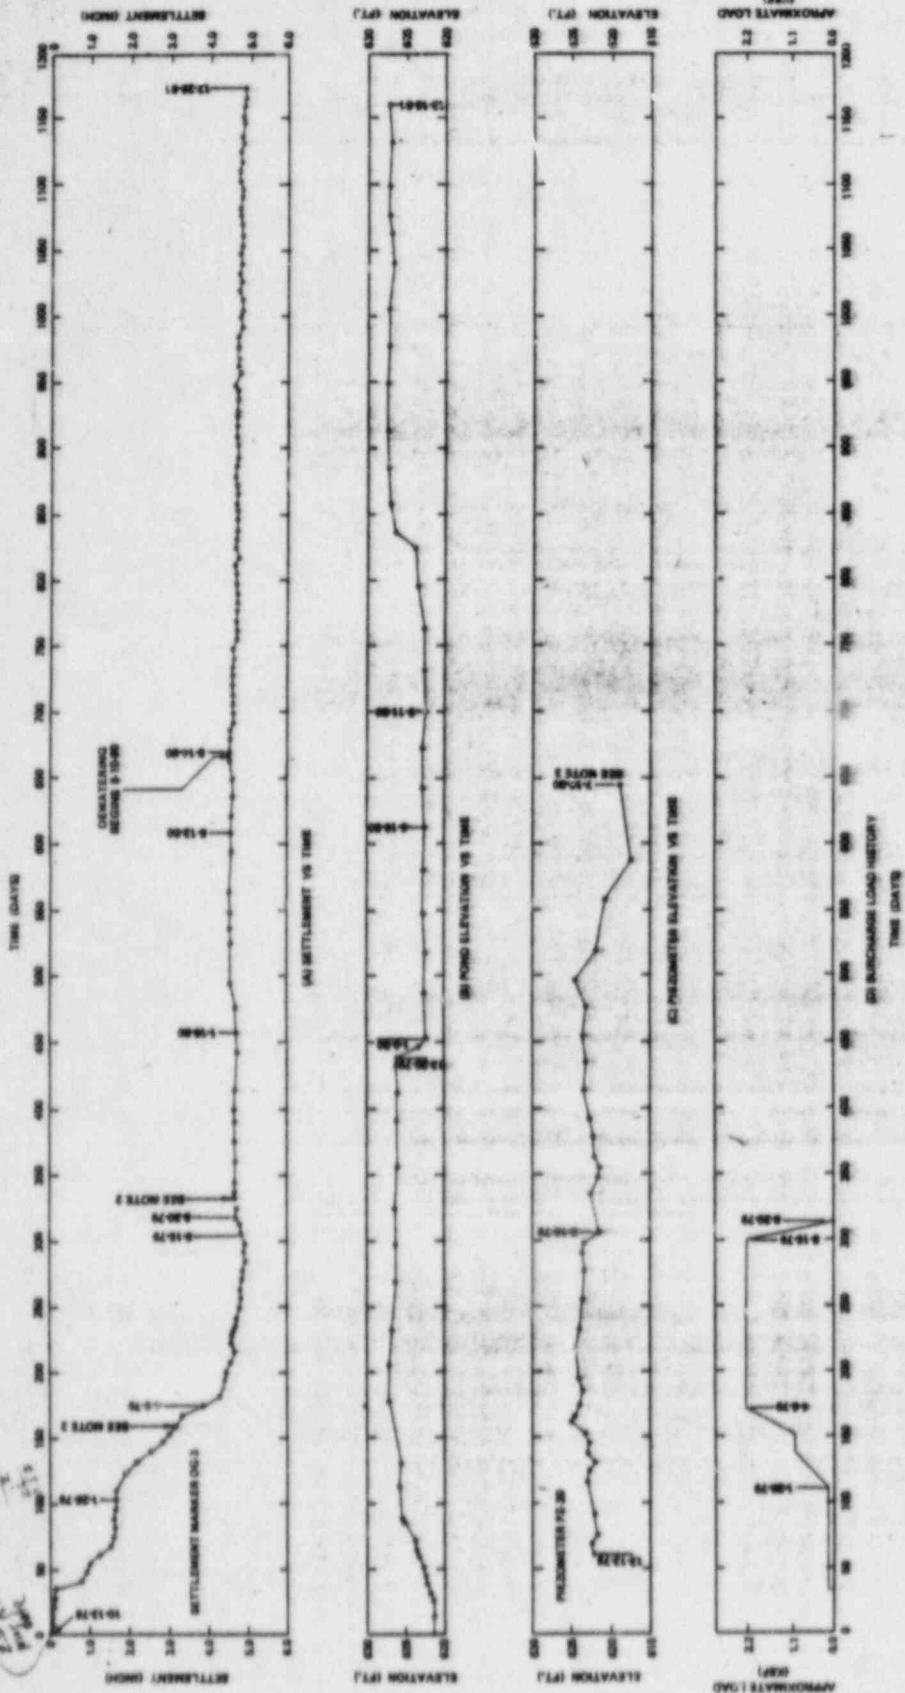
FIGURE I-2

In July 1978, approximately 60% of the building was completed and the pedestals were already in place. The recorded settlements of the building at that time exceeded those which should be anticipated under normal conditions. It appeared that the building was settling due to the consolidation of the backfill and was supported along the north portion by four electrical duct banks acting as vertical piers and resting on the natural soil below the fill.

**DIESEL GENERATOR BUILDING
TYPICAL SETTLEMENT, COOLING
POND LEVEL, PIEZOMETER LEVEL,
AND SURCHARGE LOAD HISTORY**

After review of settlement observations and results of an exploration program, it was decided that remedial action was necessary and several options were evaluated. Based on consultants' recommendations, it was decided to surcharge the area within and around the building.

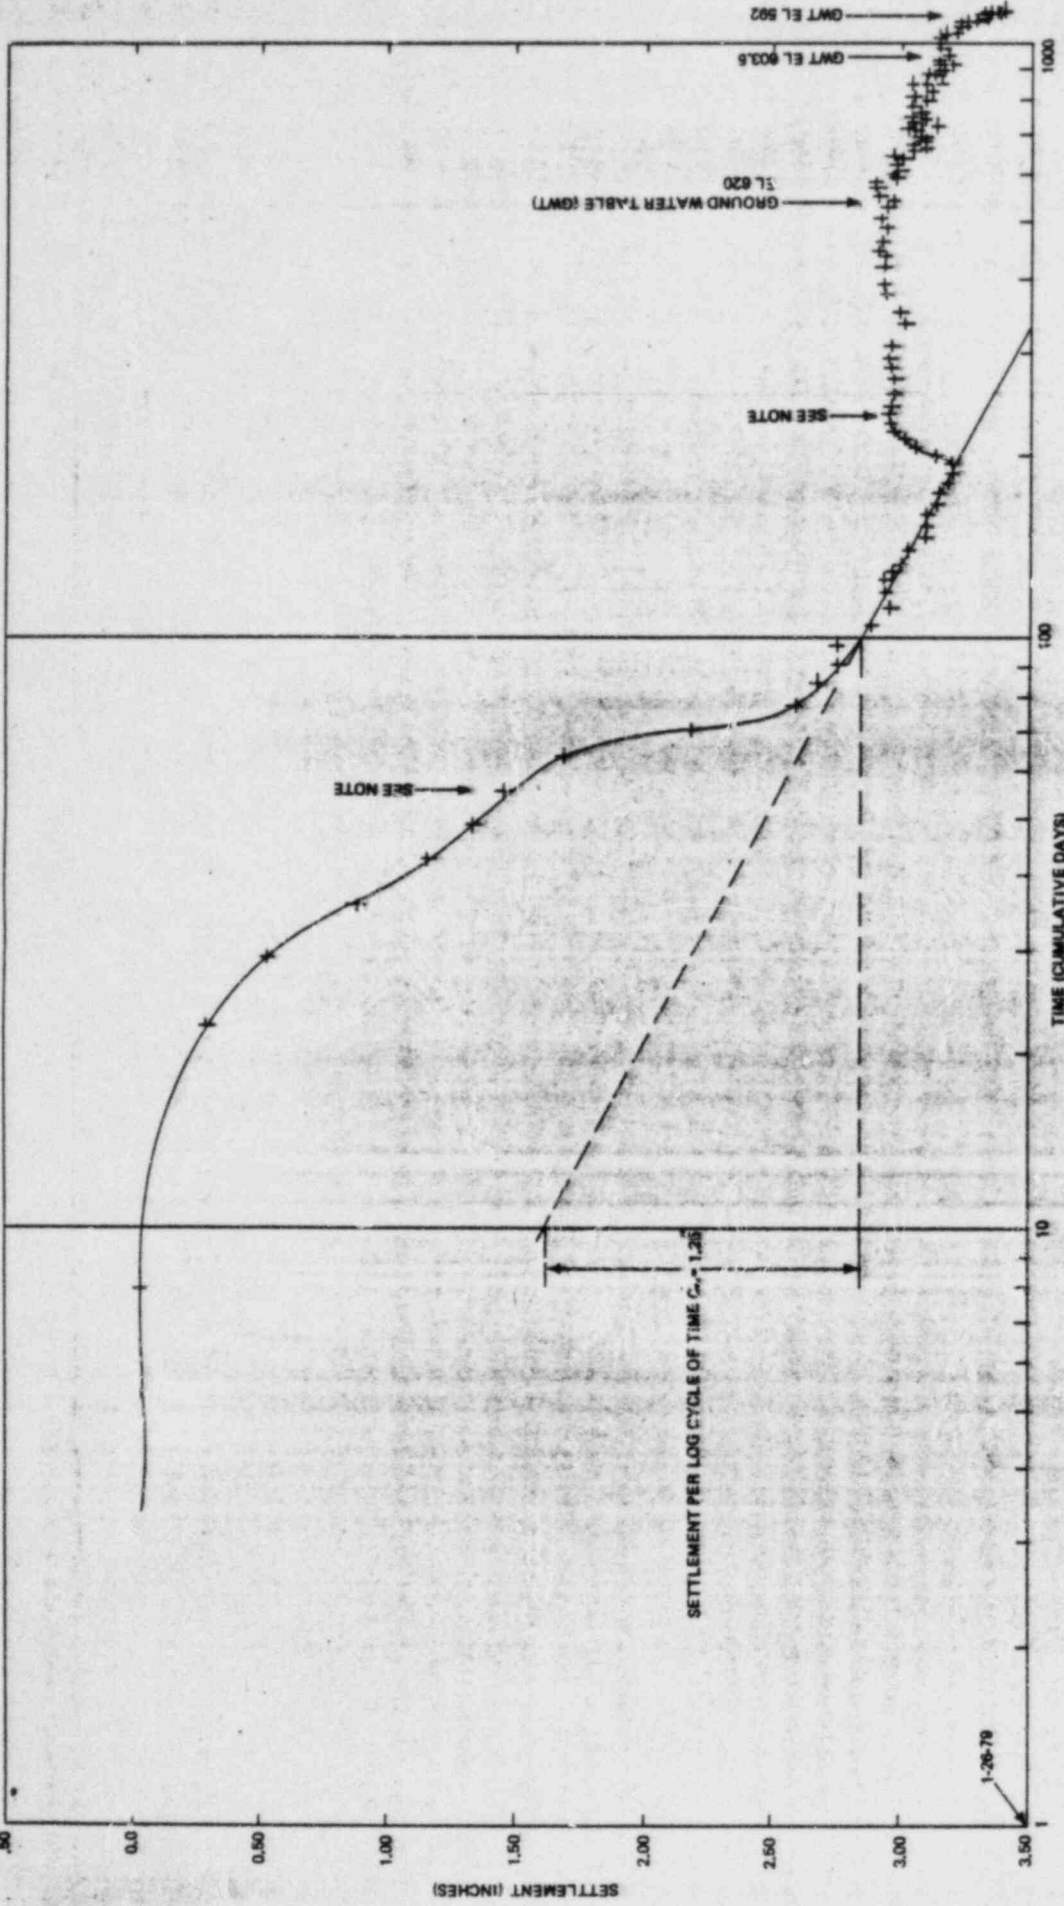
TYPICAL SETTLEMENT VS
LOGARITHM OF TIME DURING AND
AFTER SURCHARGE
(MARKER DG-3)

NOTE
The permanent marker could not be monitored from 3-22-79 to 8-14-79 due to surcharge. Temporary markers at elevation 894'-0" ± were used during this period to estimate the settlement of the permanent markers. On 8-14-79 the settlement was again based directly upon the permanent markers.

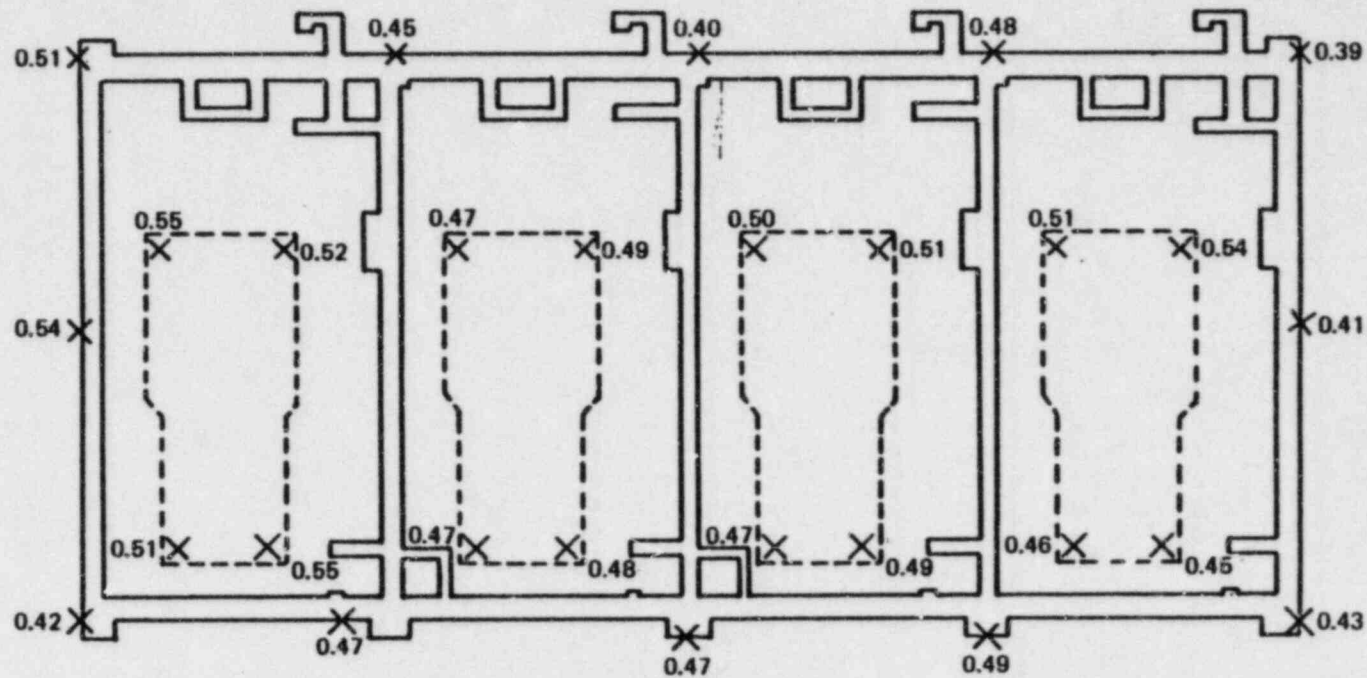
FIGURE I-5

**MEASURED SETTLEMENT S₂, FROM
9/14/79 TO 12/31/81**

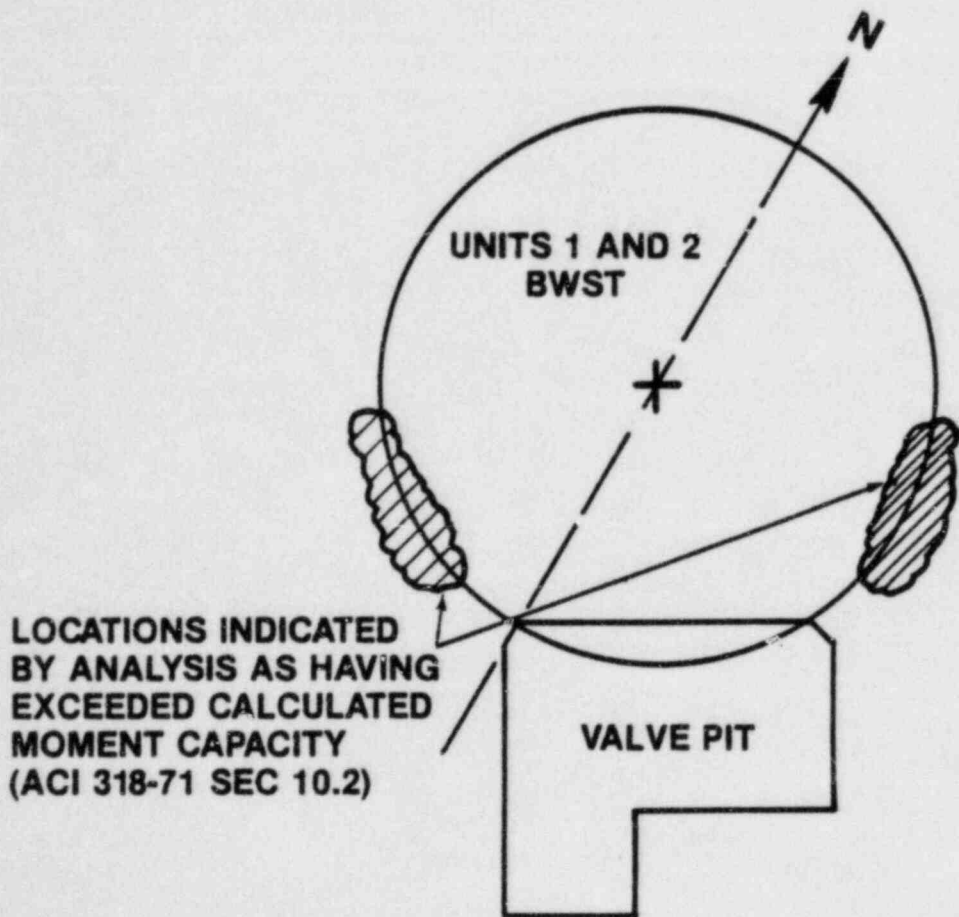
<p>CONSUMERS POWER COMPANY MIDLAND UNITS 1 AND 2</p>
<p>LOCATIONS OF EXCESSIVE MOMENT</p>
<p>FIGURE IV-2</p>

In addition to the soils-related issues, remedial actions are necessary to correct a problem affecting the two borated water storage tank (BWST) foundations. Failure of the design to consider nonuniform loading led to overstressing during a load test. This condition was aggravated by the soils conditions.

During 1981, the Applicant discovered a problem with the borated water storage tank (BWST) foundations. These foundations, which consist of a concrete ring beam and valve pit, are placed on fill. A structural design error resulted in overstressing the ring beam, creating cracks and the potential for yielding of reinforcing steel. To resolve this problem, the Applicant decided to reinforce the old ring beam with a new concentric ring beam to be constructed after preloading the valve pit. The NRC staff has concurred with this remedial concept.

- o Design problems associated with the BWST foundation will be resolved by the preload of the valve pit, which has been completed, and reinforcing the old ring beam with a new concentric ring beam.
