MIDLAND PROJECT

BOARATED WATER STORAGE TANK (BWST) - SURCHARGE PROGRAM

MIDLAND PROJECT -
DOCKET NOS 50-329, 50-330
CRACKS IN BORATED WATER STORAGE TANK FOUNDATION
FILE: O.4.9.49 UFI: 73*10*01, 02362(S), 01100(E) SERIAL: 11201

The Existence of Cracks in the Borated Water Storage
Tank Foundation - Units 1 and 2

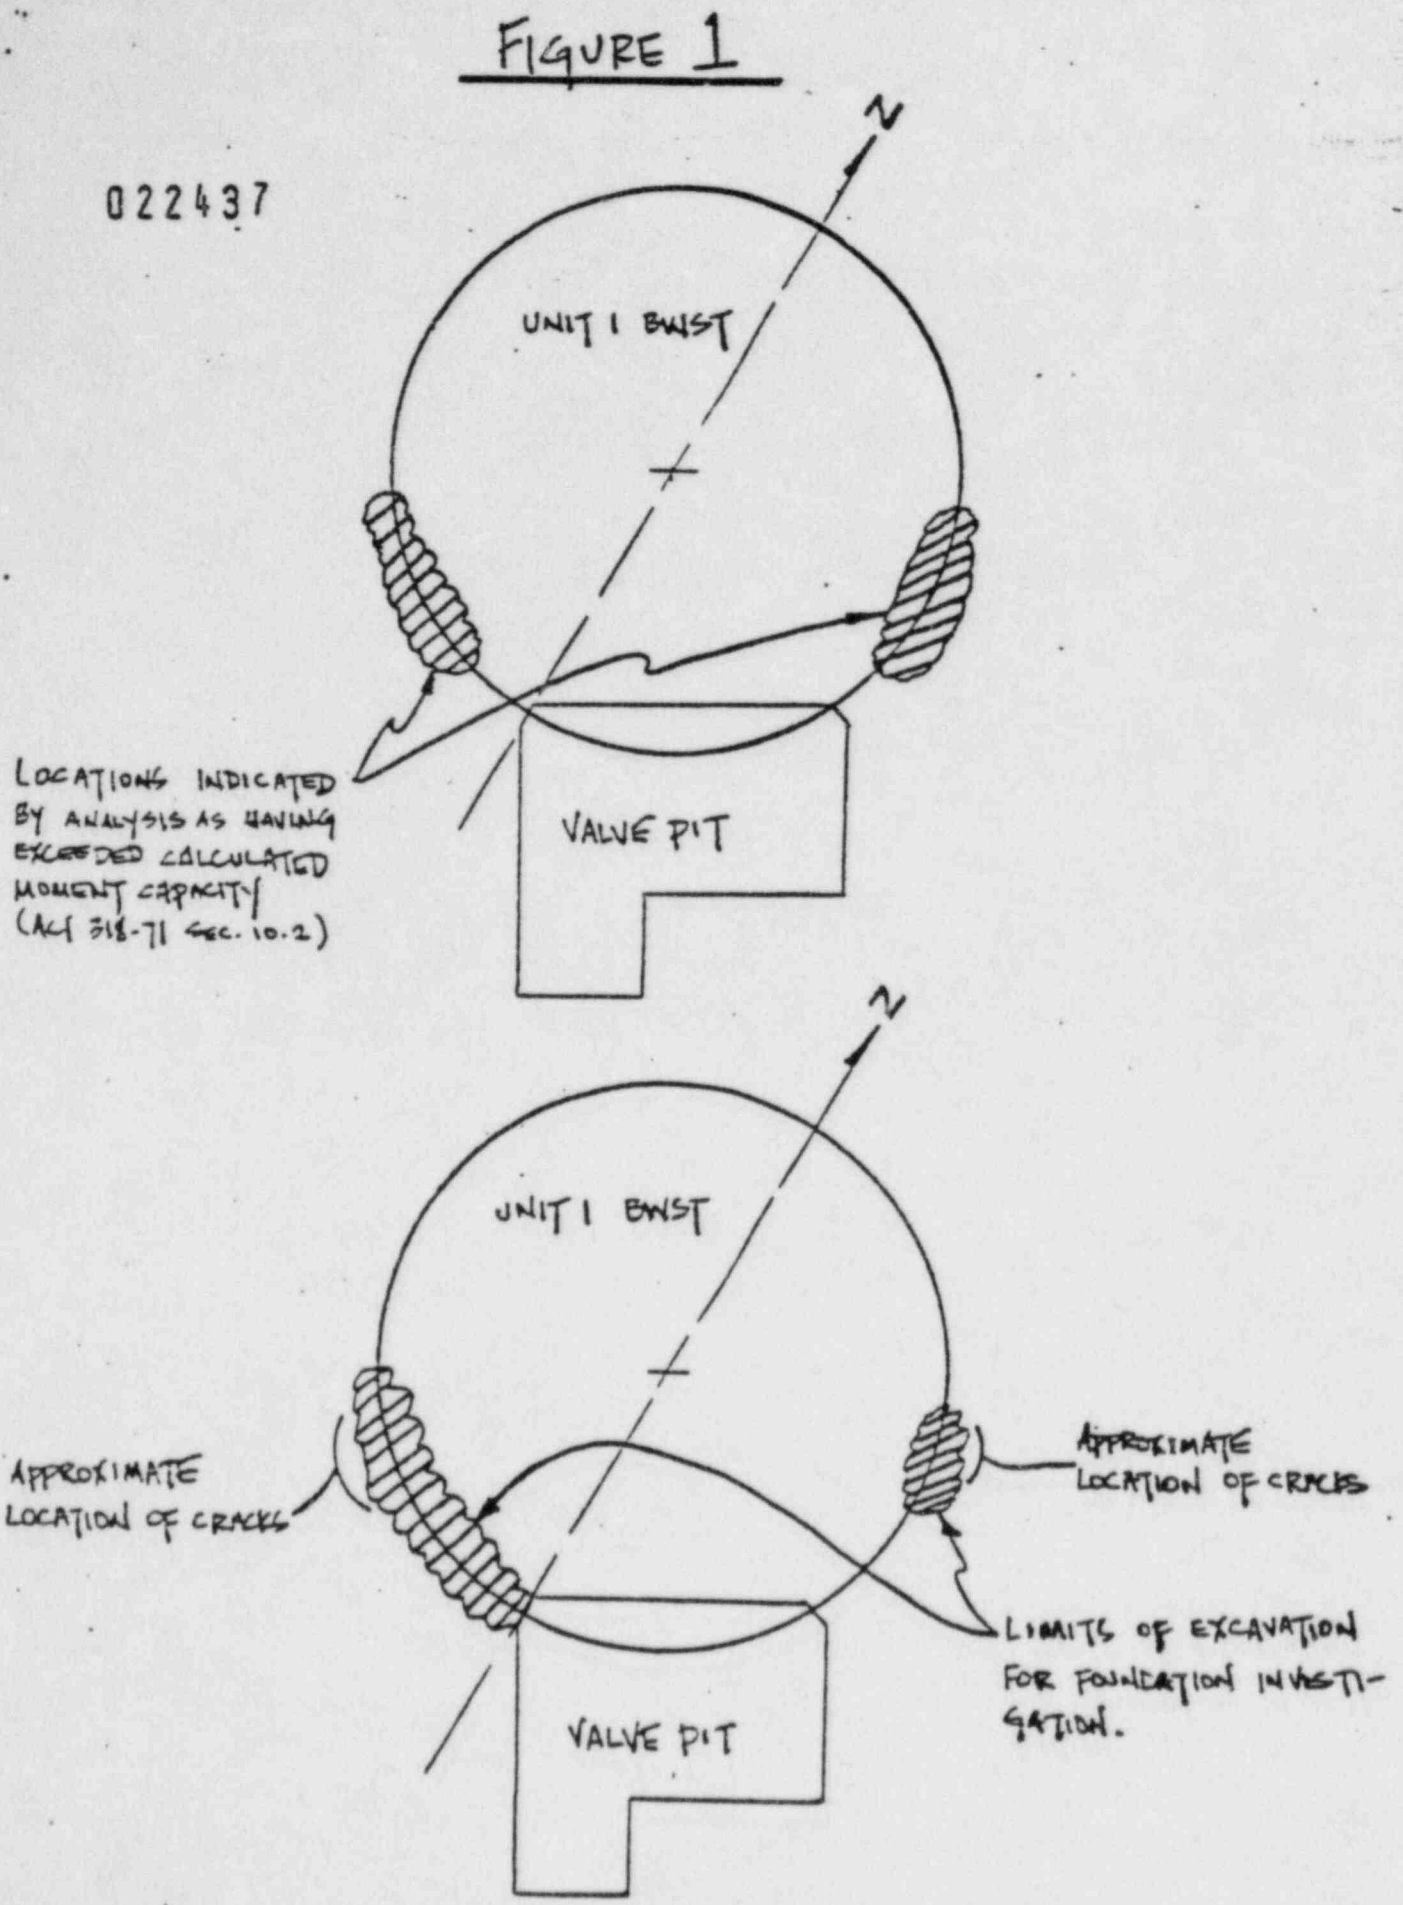
FIGURE 1

During the load test on the Unit 1 tank (conducted in compliance with the response to 10 CFR 50.54(f), Question 4), a discrepancy was noted between measurements of settlements recorded at the jobsite and the computed displacements derived from the structural analysis used at that time. As a result, the analysis was modified to include a finite element model of the soil subgrade. A number of analyses were completed using various values for the modulus of elasticity (E) of the soil. The results of the analyses predicted that greater than allowable moments existed at several locations in the foundation structure (see Figure 1).

The foundation at these locations was examined to verify whether visible signs of high reinforcement strain existed. Cracks were found in the structure at those locations indicated by the analysis as having greater than allowable moments. The largest crack measured 0.063 inch. Subsequently, the Unit 2 tank foundation was also examined; similar cracks were found, and the largest crack measured 0.035 inch. The smaller bearing area of the Unit 2 valve pit partially explains why the cracks in the Unit 2 tank foundation are smaller than the cracks in the Unit 1 tank foundation.

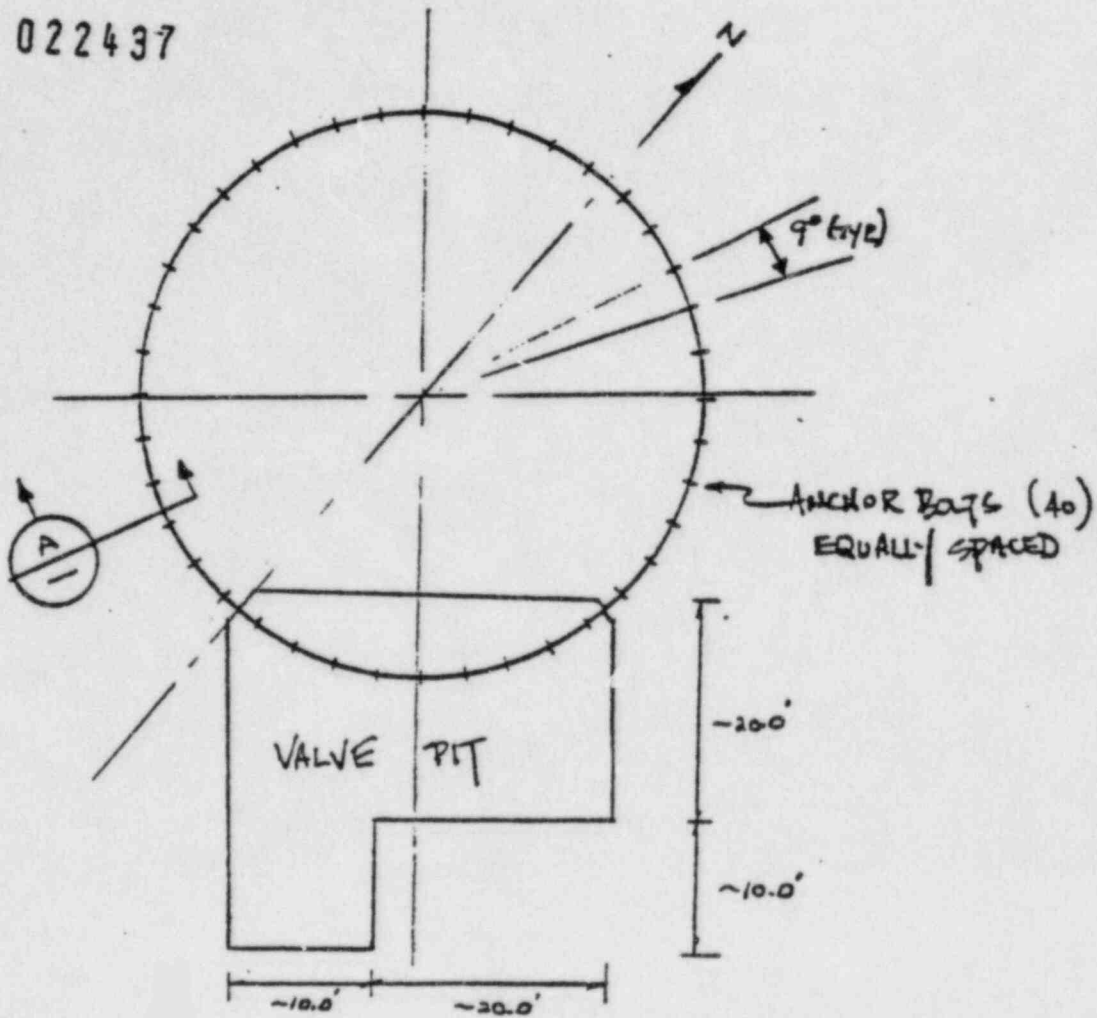
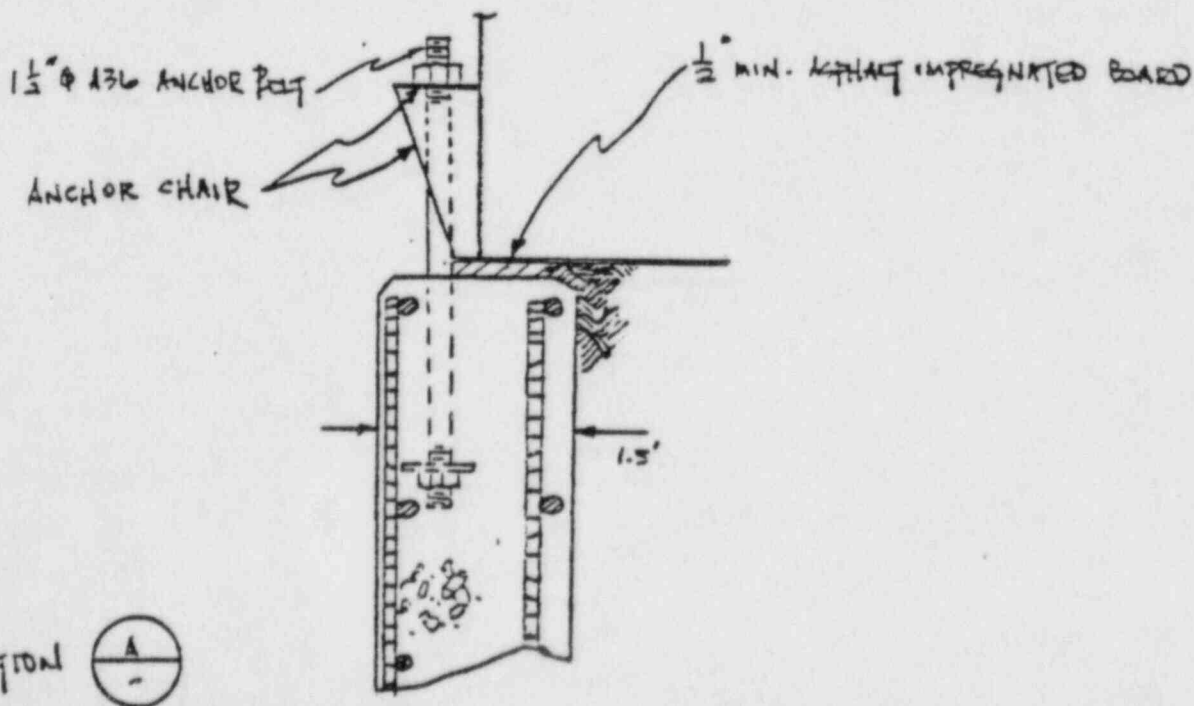
FIGURE 2

The cracks in the foundation structure of the Unit 1 tank indicate that high reinforcement strain exists in the ring wall foundation. As shown in Figure 2, the tank's outside periphery is attached to the ring wall foundation by equally spaced anchor bolts that transfer induced forces through an anchor chair. A check with jobsite construction personnel indicated that all anchor bolts were installed in a snug-tight condition

consistent with installation requirements and were in contact with the top of the anchor chair when the tank was erected. However, recent field observations indicate that gaps exist between the anchor bolt nut and anchor bolt chair in several locations around the periphery of the tank; whereas, in other locations the horizontal plates of the anchor bolt chairs are deflected, indicating high tensile stress in the bolts.

This anchor bolt behavior results from the distortion of the foundation ring which is caused by differential settlement; this agrees with the conclusions of the modified structural analysis. The tension induced in the bolts is similar to the tension induced by a preload phenomenon and does not affect the ability of the bolts to resist design loads. Although the ring wall is cracked, it is capable of providing the necessary dead load anchorage for the anchor bolts and confinement of the tank foundation support material. Therefore, resistance will be provided for externally applied forces which induce tension in the anchor bolts.

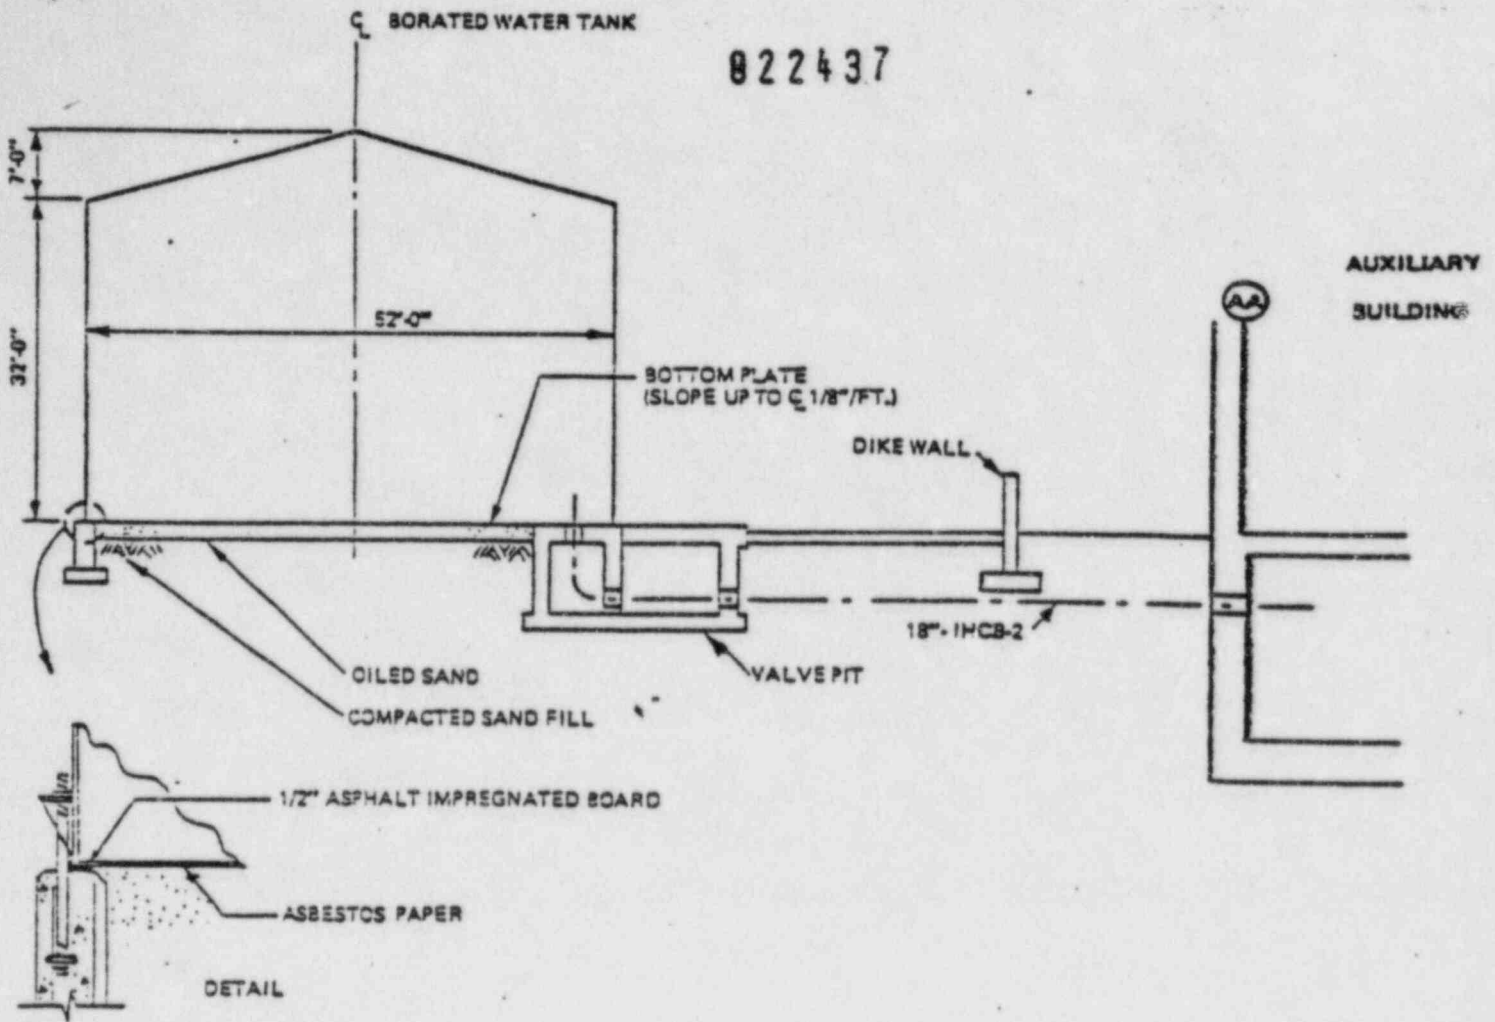
Figure 3

The 52-foot diameter, stainless steel borated water storage tanks are 32 feet high and rest on compacted, granular backfill material contained within a reinforced-concrete ring wall. On one side is an integral valve pit that houses connections and valves for the two 18-inch diameter pipelines that service each tank. Figure 31.1 from the response to NRC 10 CFR 50.54(f), Question 31 is attached for reference (see Figure 3).

Section Through Borated
Water Storage Tank
Foundation and Valve Pit
