Subject: Relief from Inservice Inspection Requirements for Residual Heat Removal Heat Exchanger Nozzle-to-Vessel Welds

> Byron Nuclear Power Station, Units 1 and 2 Facility Operating Licenses NPF-37 and NPF-66 NRC Docket Nos. 50-454 and 50-455

Braidwood Nuclear Power Station, Units 1 and 2 Facility Operating Licenses NPF-72 and NPF-77 NRC Docket Nos. 50-456 and 50-457

Relief Request NR-18

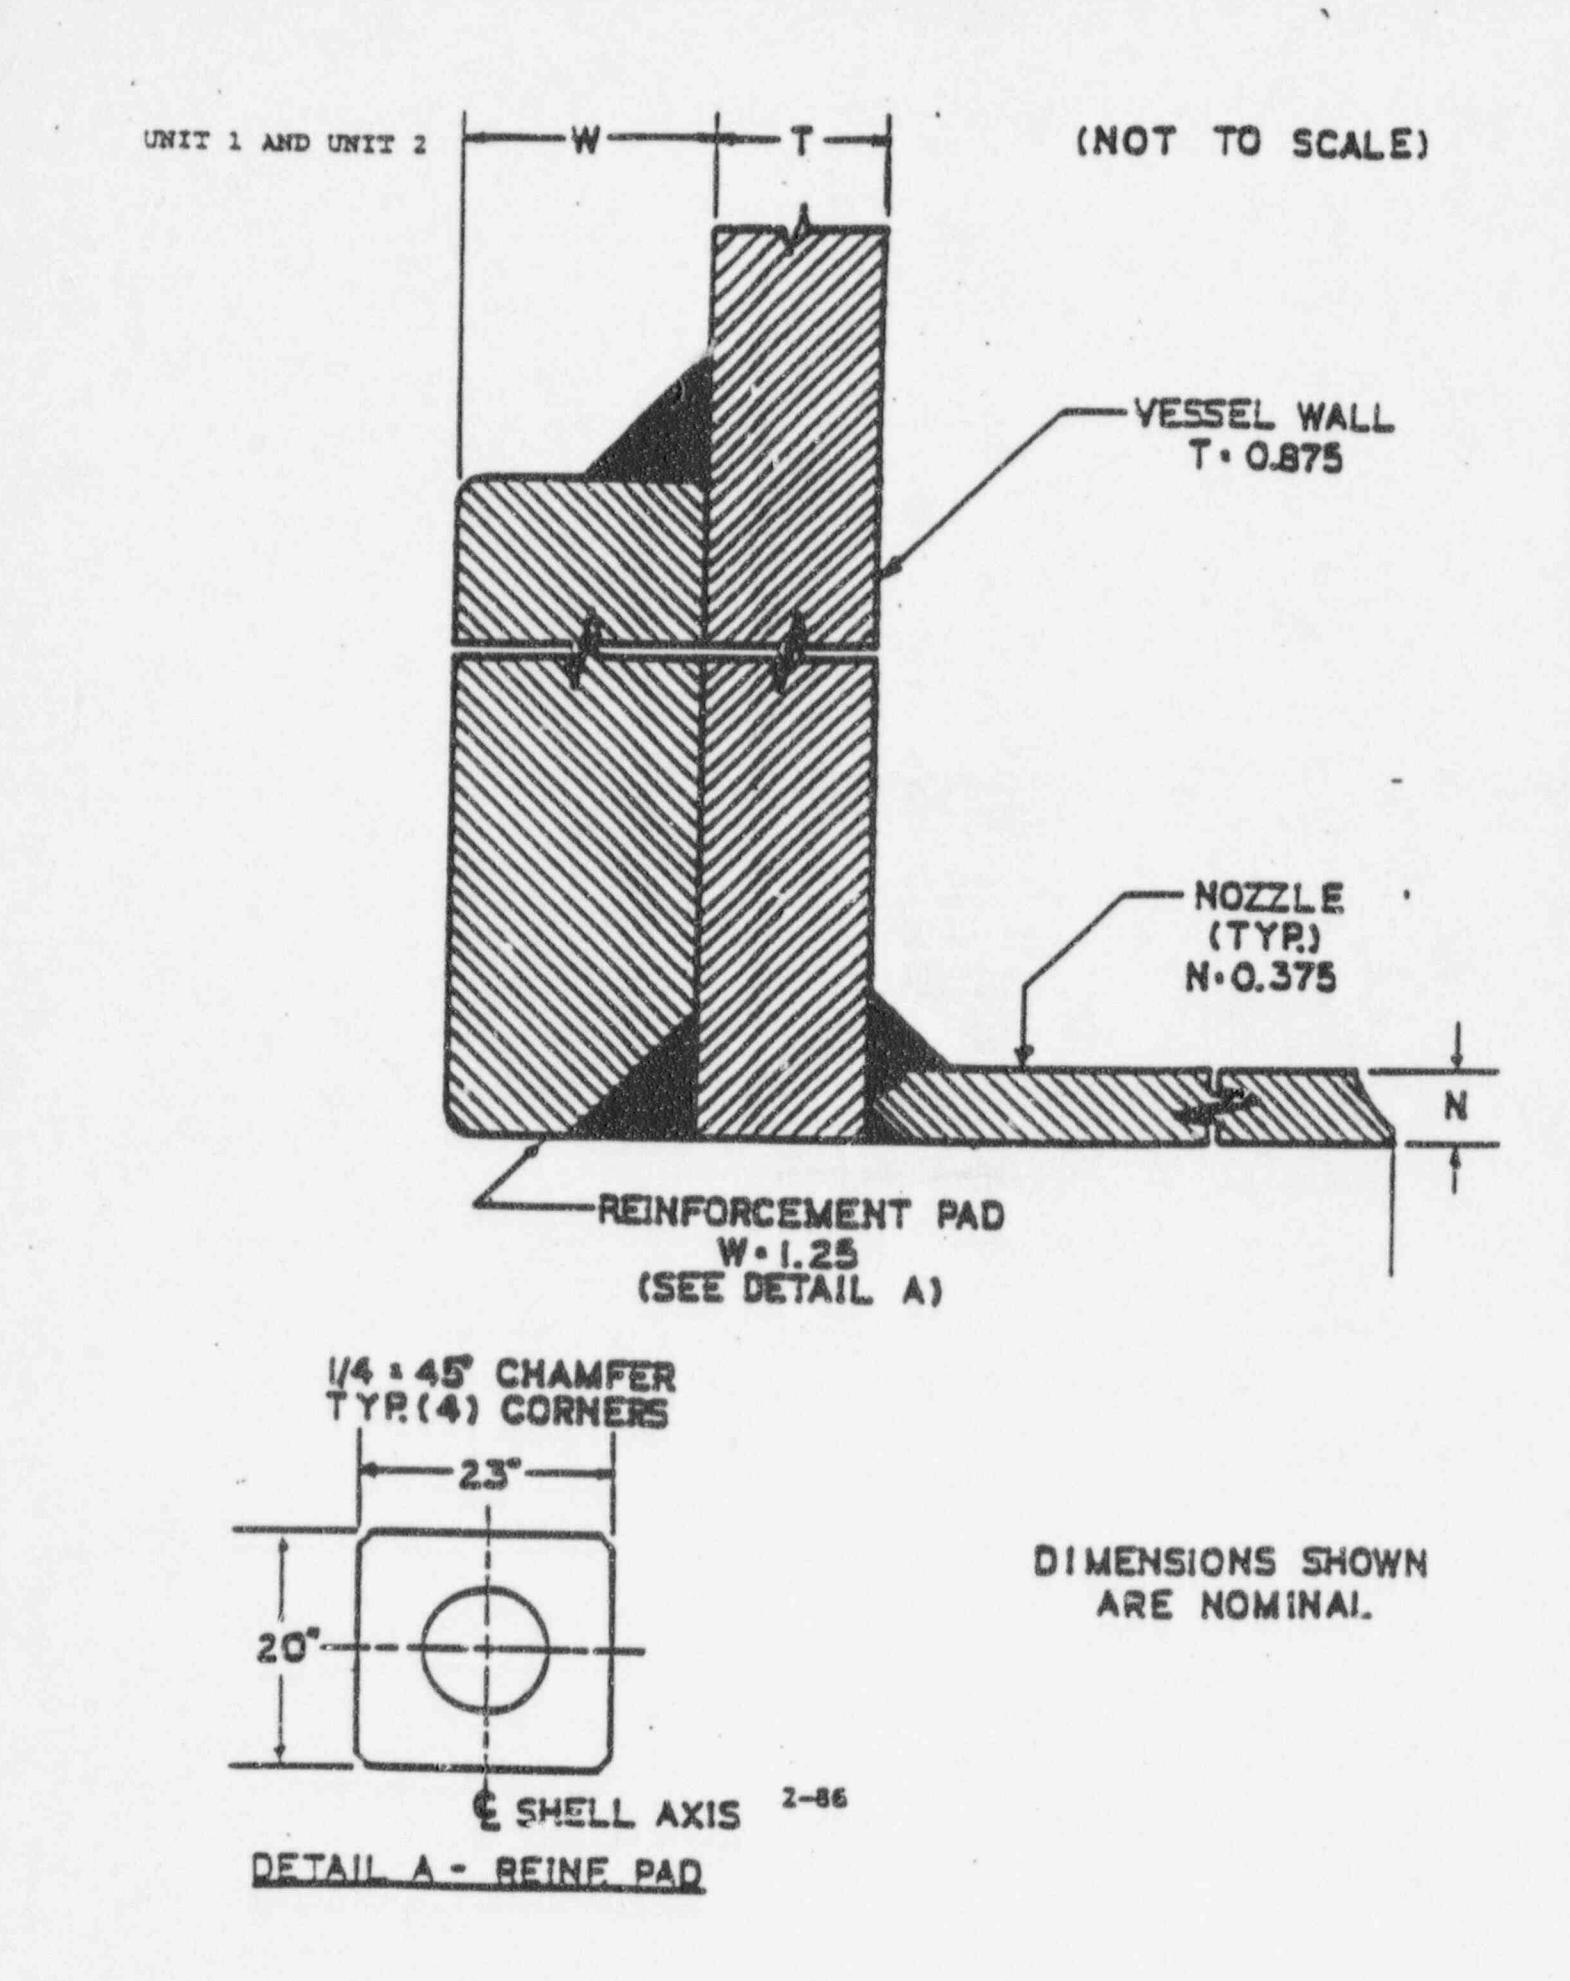
1.	Residual	Heat	Removal	(RHR)	Heat	Exchanger	Nozzle 1	to Vesse	l Detail
				1			a consideration of

The initial UT inspection (1991) performed on the Braidwood Unit 2 "A" RHR heat exchanger found indications which exceeded the ASME Section XI 1983 Edition, Summer 1983 Addenda, Subarticle IWC-3000 allowable limits. The indications which exceeded the acceptance standards of IWC-3000 were subjected to further evaluation in accordance with ASME Section XI Subarticle IWB-3600. The required Fracture Mechanics Analysis was submitted to the NRC (Reference 2) and the indications were found to be acceptable for continued service (Reference 3). Additional examinations were performed in 1992 for Byron Unit 2 and Braidwood Unit 1 heat exchangers, in 1993 for Byron Unit 1 and Braidwood Unit 2 heat exchangers, in 1994 for Braidwood Unit 2 heat exchangers, and in 1995 for Byron Unit 2 heat exchangers. All examinations confirmed the existence of fabrication flaws in the nozzle to vessel welds.

The examination results from the inspections performed in 1994 at Braidwood Unit 2 included flaws on the outlet nozzle weld of the 2B RHR vessel which exceeded the 60% acceptance criteria. The size change from previous inspections was attributed to enhancement in the volumetric examination technique. An ASME section XI repair by excavation was completed; the unacceptable flaws were removed.

Observations made of the excavation areas on the Braidwood Unit 2 "B" Outlet RH HX Nozzle (2RHX-01) repair verified that the indications found in the RH HX Nozzles are fabrication flaws, slag, incomplete fusion and excess porosity. No service induced flaws were found.

The nozzle-to-vessel welds on the A and B RHR Heat Exchangers for Byron Units 1 and 2 will receive a Section XI surface examination each inspection period. In addition, a visual examination (VT-2) shall be performed each inspection period on all pressure retaining components.

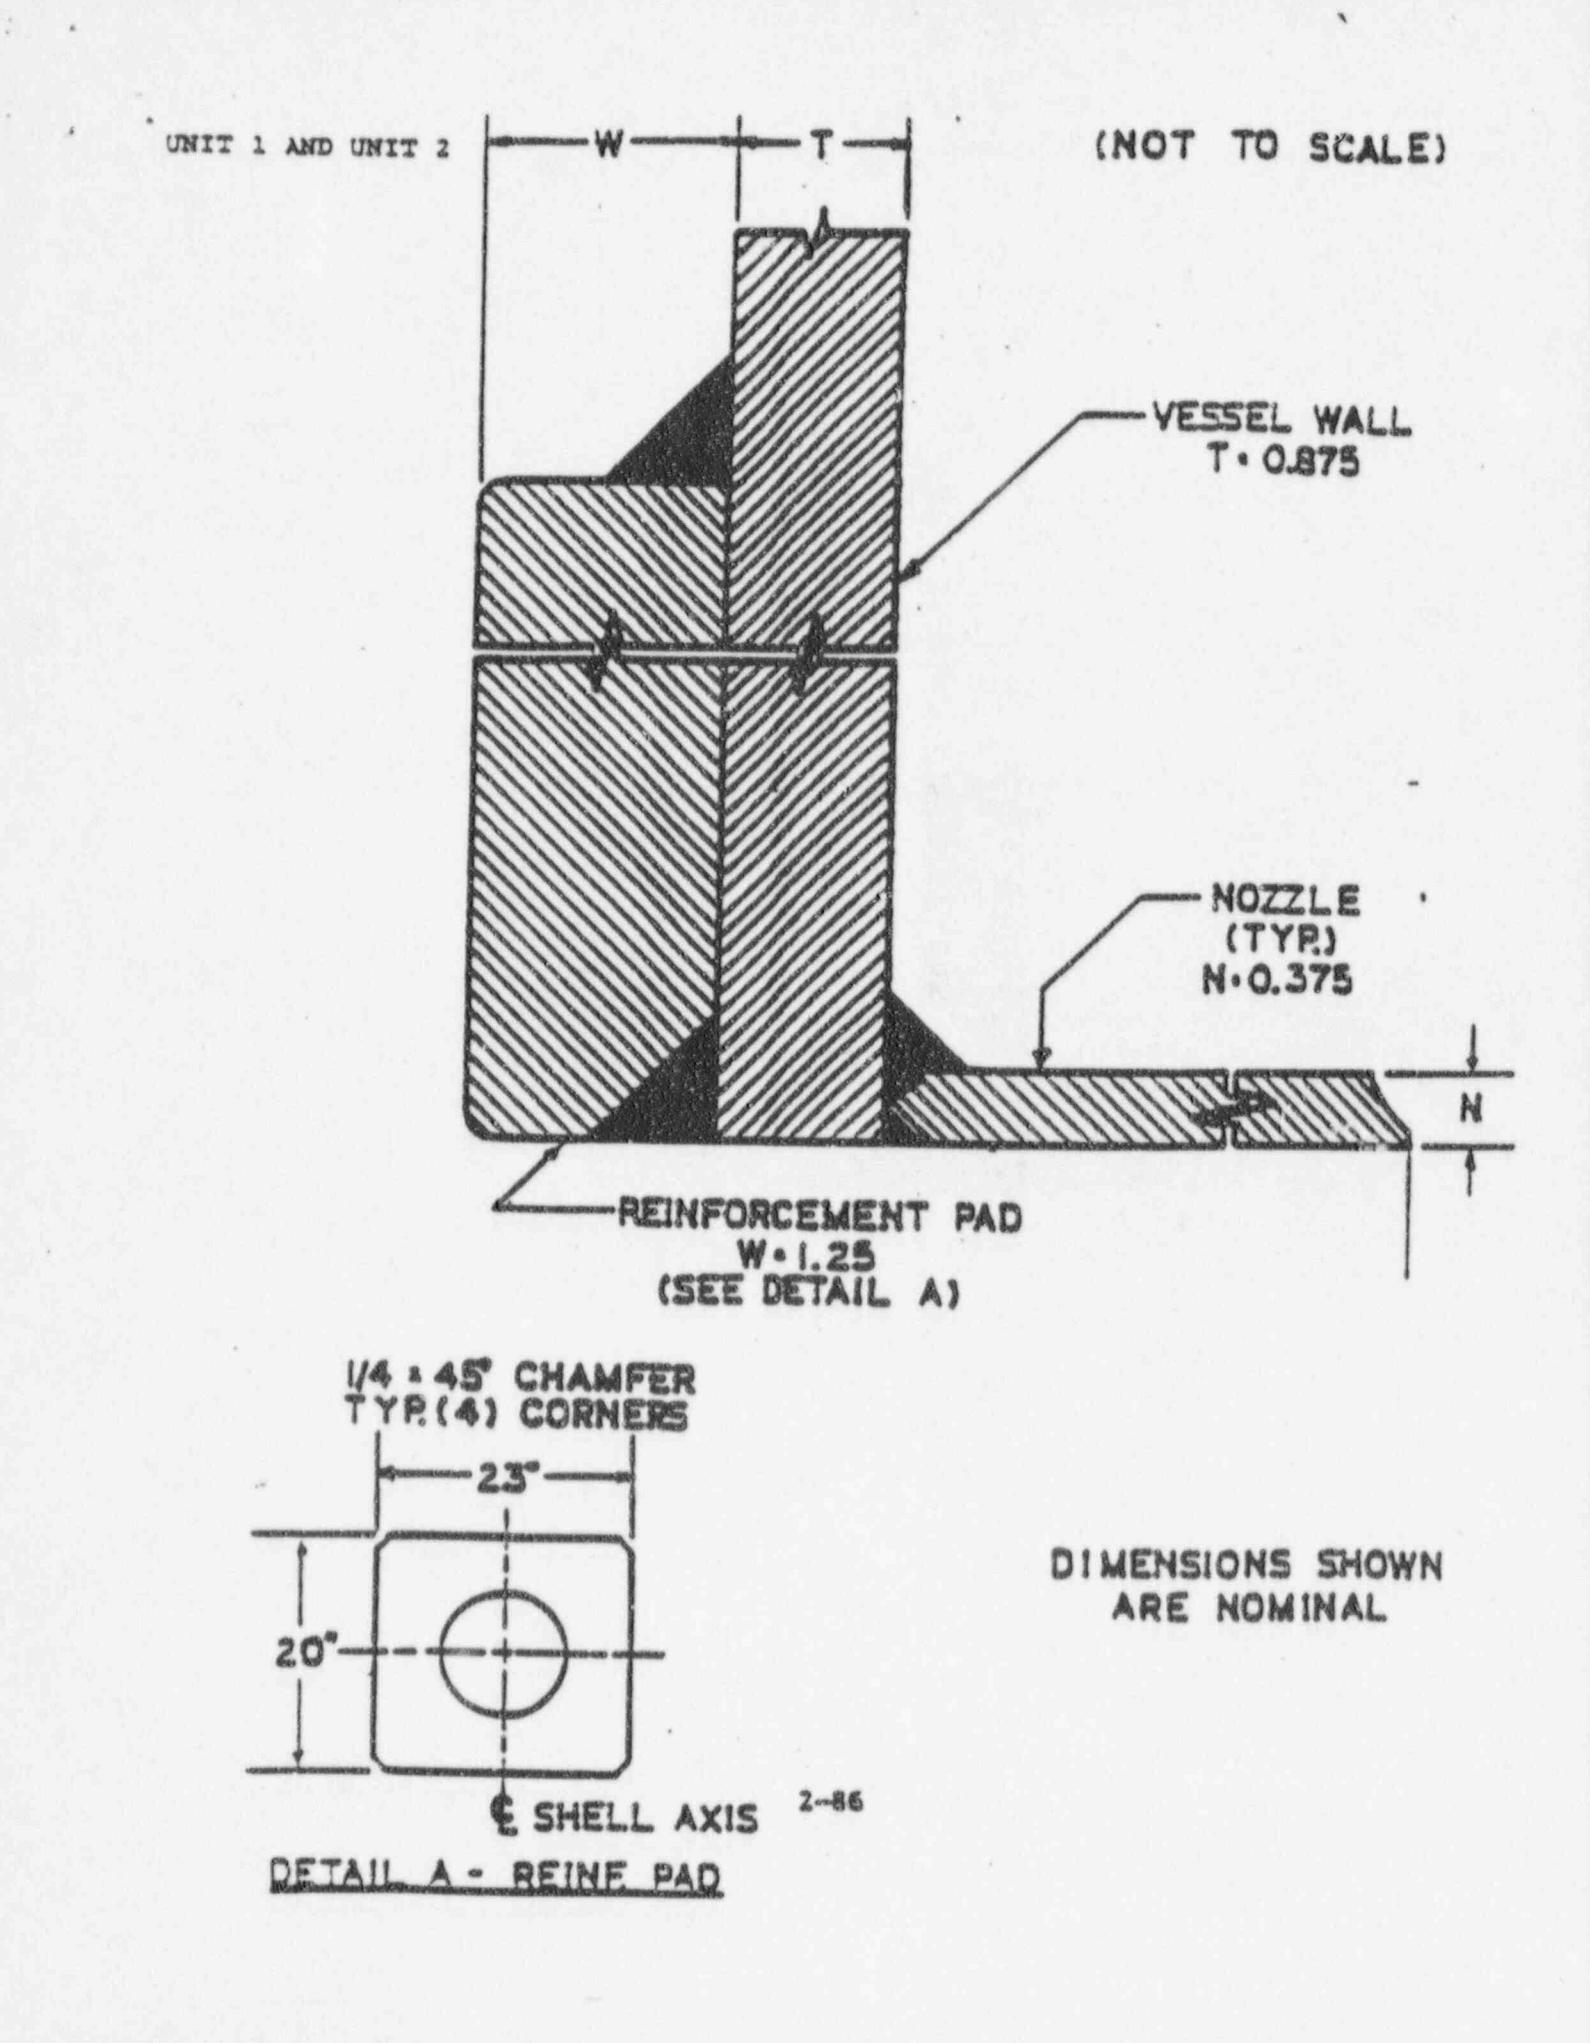
1. Re	sidual H	eat Remov	I (RHR)	Heat	Exchanger	Nozzle	to	Vessel	Detail
-------	----------	-----------	---------	------	-----------	--------	----	--------	--------

The initial UT inspection (1991) performed on the Braidwood Unit 2 "A" RHR heat exchanger found indications which exceeded the ASME Section XI 1983 Edition, Summer 1983 Addenda, Subarticle IWC-3000 allowable limits. The indications which exceeded the acceptance standards of IWC-3000 were subjected to further evaluation in accordance with ASME Section XI Subarticle IWB-3600. The required Fracture Mechanics Analysis was submitted to the NRC (Reference 2) and the indications were found to be acceptable for continued service (Reference 3). Additional examinations were performed in 1992 for Byron Unit 2 and Braidwood Unit 1 heat exchangers, in 1993 for Byron Unit 1 and Braidwood Unit 2 heat exchangers, in 1994 for Braidwood Unit 2 heat exchangers, and in 1995 for Byron Unit 2 heat exchangers. All examinations confirmed the existence of fabrication flaws in the nozzle to vessel welds.

The examination results from the inspections performed in 1994 at Braidwood Unit 2 included flaws on the outlet nozzle weld of the 2B RHR vessel which exceeded the 60% acceptance criteria. The size change from previous inspections was attributed to enhancement in the volumetric examination technique. An ASME section XI repair by excavation was completed; the unacceptable flaws were removed.

Observations made of the excavation areas on the Braidwood Unit 2 "B" Outlet RH HX Nozzle (2RHX-01) repair verified that the indications found in the RH HX Nozzles are fabrication flaws, slag, incomplete fusion and excess porosity. No service induced flaws were found.

The nozzle-to-vessel welds on the A and B RHR Heat Exchangers for Braidwood Units 1 and 2 will receive a Section XI surface examination each inspection period. In addition, a visual examination (VT-2) shall be performed each inspection period on all pressure retaining components.
