## U.S. NUCLEAR REGULATORY COMMISSION REGION 1

Report No. 92-001

Facility Name: Grinnell Corporation

Inspection Summary: special unannounced safety inspection conducted on March 5 and 13, 1992 (Report No. 9999-0001/92-001)

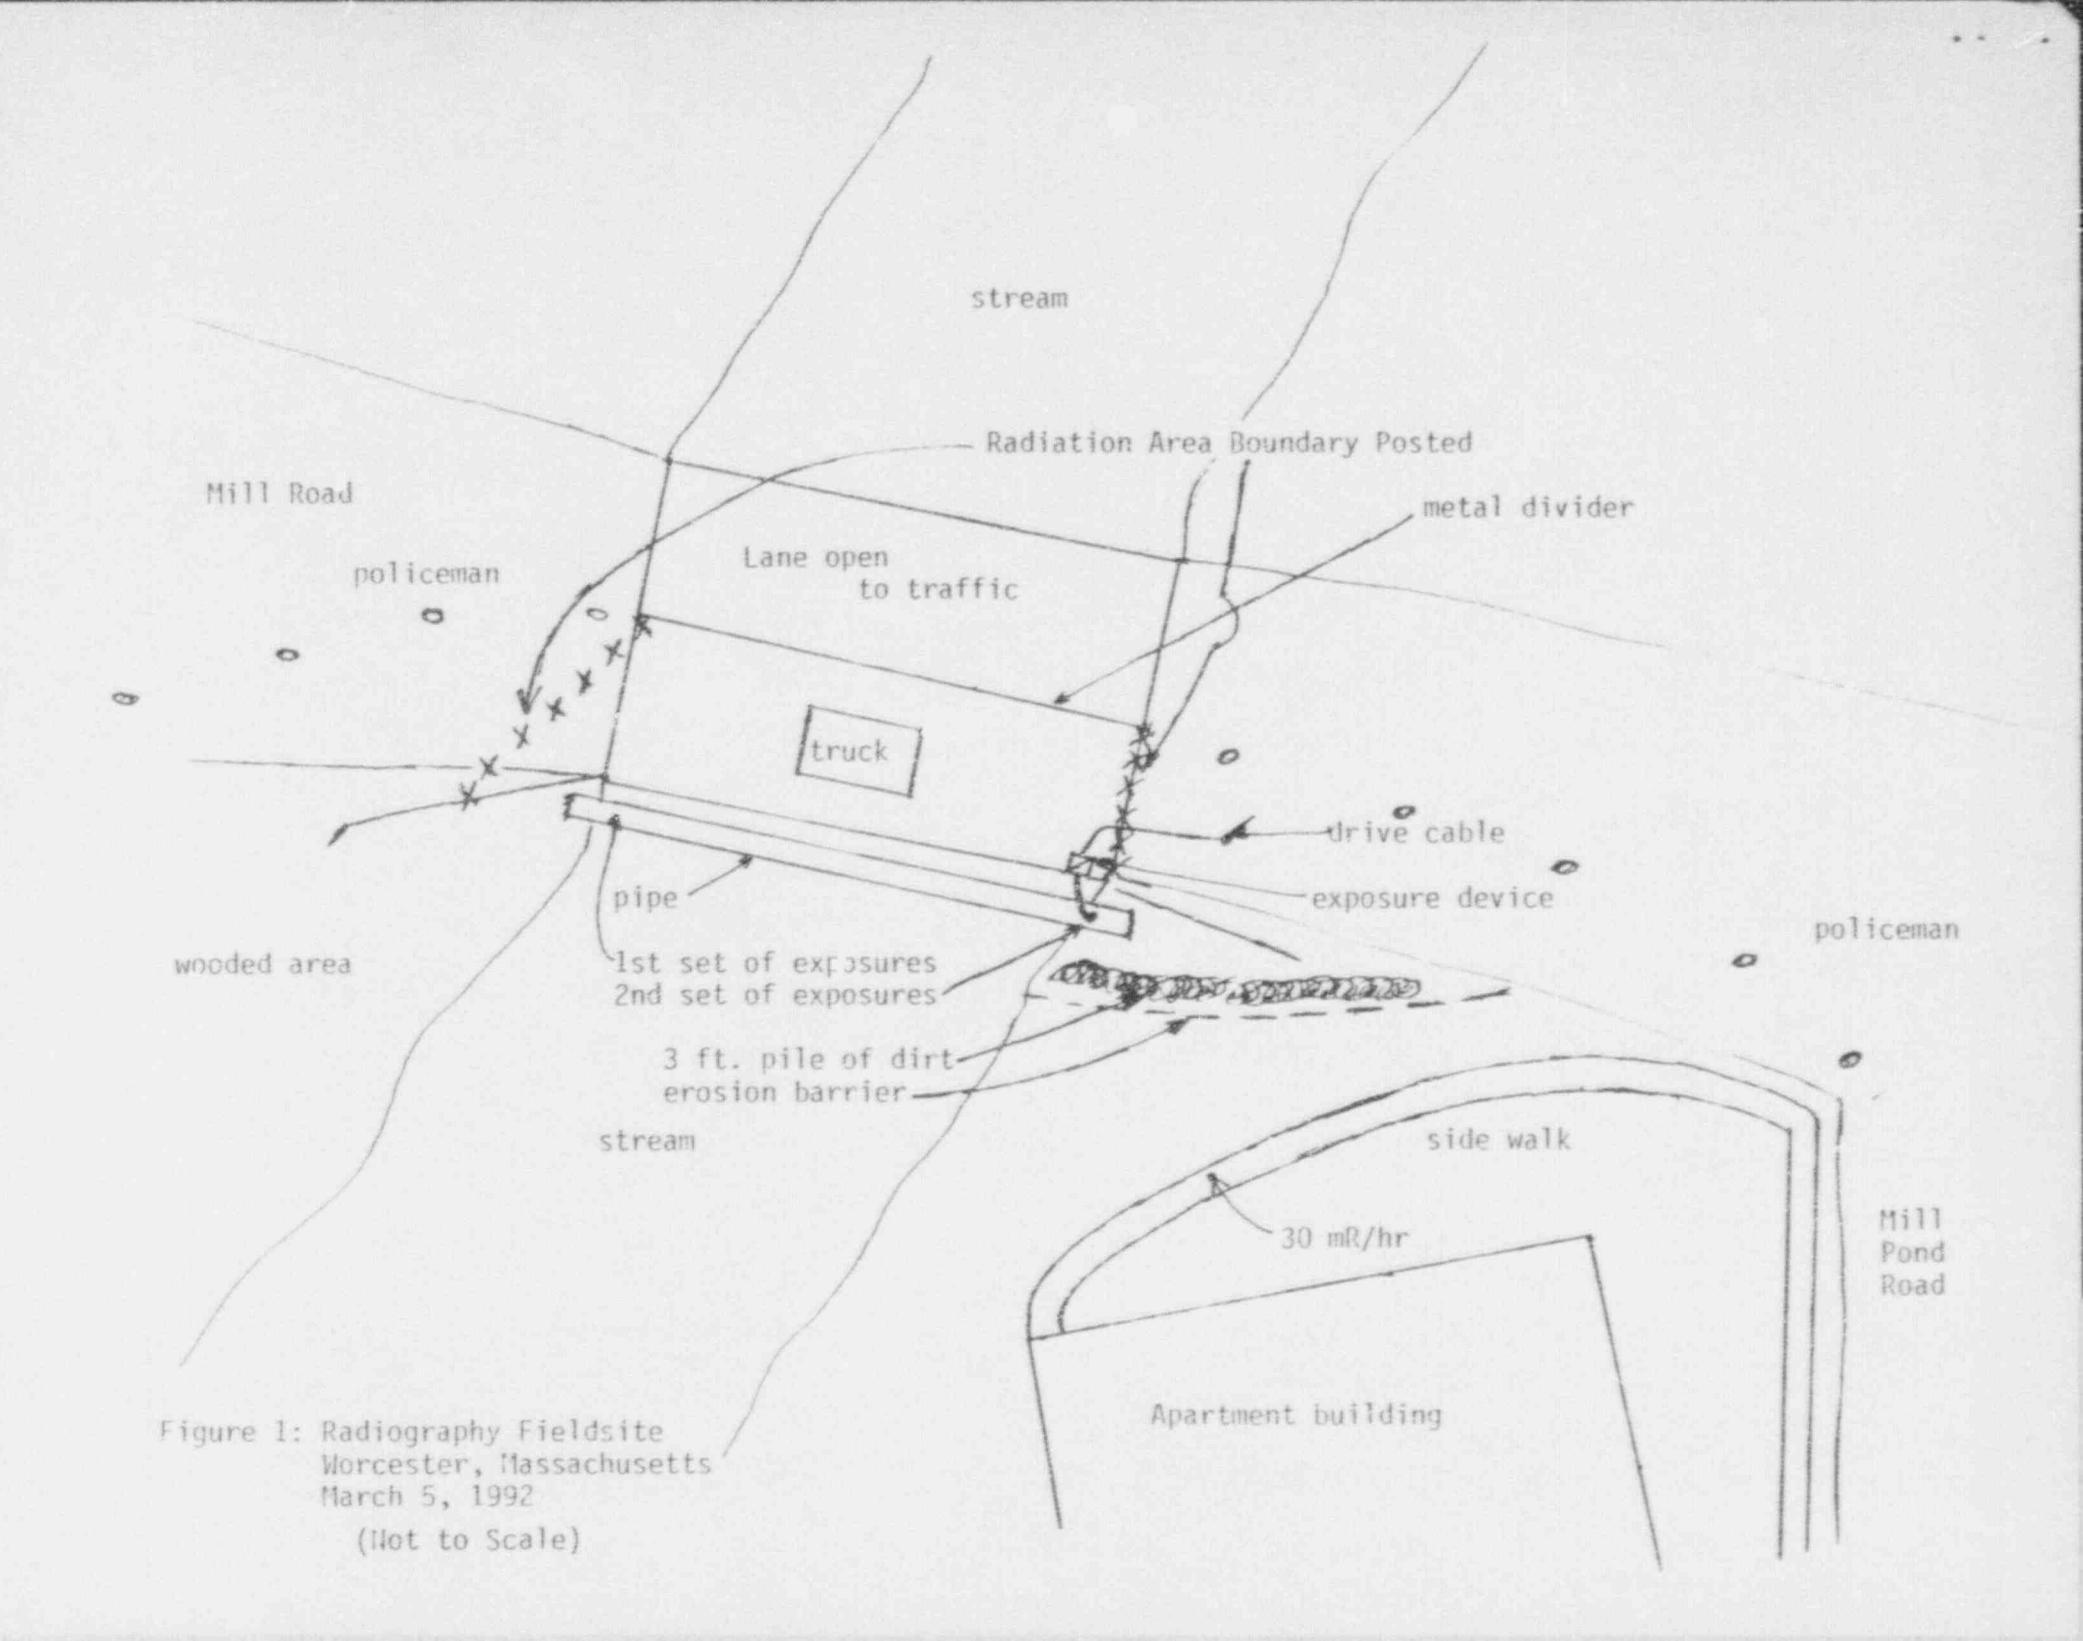
Upon the inspector's arrival at the site, the radiographer was concluding a set of exposures on welds at one end of the bridge. The inspector observed the sacond set of radiographic exposures done on the welds located closest to Mill Pond Road from two observation points. The first observation point was approximately 150 feet from the bridge in the apartment complex located between the stream, Mill Road and Mill Pond Road. The second observation point was located at the intersection of Mill Pond Road and Mill Road approximately 100 feet from the radiography site. One exposure was observed from the intersection which permitted an unobstructed view of the radiographic operations. Figure 1 provides a layout of the area in the vicinity of radiographic operations.

a. The radiographer roped off the ends of the lane occupied by the truck and posted radiation area signs. There was an entrance to one of the apartments facing the bridge approximately 40 feet from the welds being radiographed. Radiation levels measured on the sidewalk located approximately 30 feet from radiographic operations were 30 milliroentgens per hour (mR/hr).

No radiation area or high radiation area signs were visible or posted in the direction of the apartment complex. The only barrier between the radiographic operations and a member of the public exiting the apartment or walking into the area from another section of the complex was a pile of dirt approximately 3 feet high along a ditch in which the pipe was installed and an erosion barrier. Although an individual could walk to within 10 feet of the radiography exposure, the inspector determined that this area was under the surveillance and control of the radiographer as evidenced by the radiographer's request to the inspector (who had not announced his presence) to leave the area prior to conducting an exposure.
