**TESTING OF NUCLEAR GRADE LUBRICANTS AND  
THEIR EFFECT ON A540 B24 AND A193 B7  
BOLTING MATERIALS**

Carl J. Czajkowski

March 1984

**MATERIALS TECHNOLOGY DIVISION  
DEPARTMENT OF NUCLEAR ENERGY, BROOKHAVEN NATIONAL LABORATORY  
UPTON, LONG ISLAND, NEW YORK 11973**

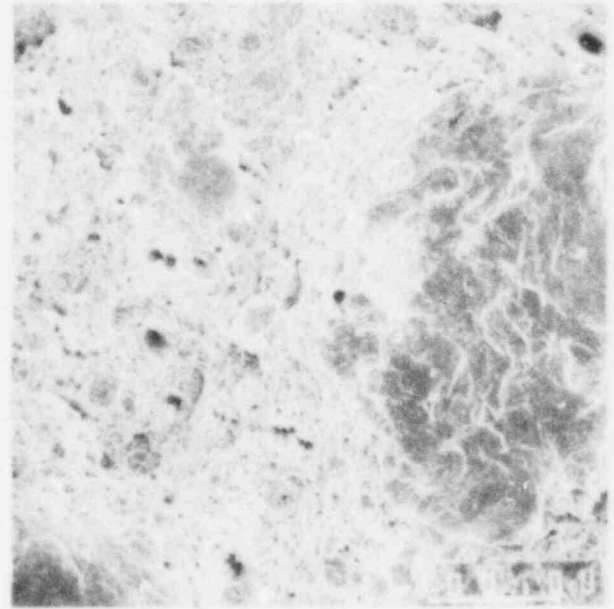
The first six specimens were tested, Figures 15-26, at 100°C in demineralized H<sub>2</sub>O with no lubricants added and at a strain rate of approximately  $5.0-9.0 \times 10^{-7}$  sec.<sup>-1</sup>. It was seen in all of the SEM photographs that each of the fracture faces is ductile in nature (dimpled rupture). The surprising observation was in the wide range of tensile strength results (195 Ksi - 277 Ksi) considering the fact that all of the A540 B24 specimens were machined from the same bar. On these specimens, there was no discernable difference in the fracture faces to account for the different strength levels. This variation in strength level from the same bar is consistent with the hardness variations previously discussed and should be taken into account prior to critical bolting installations.

Figure 15. 27X  
SEM Photo of Fracture Face for  
Specimen #1.

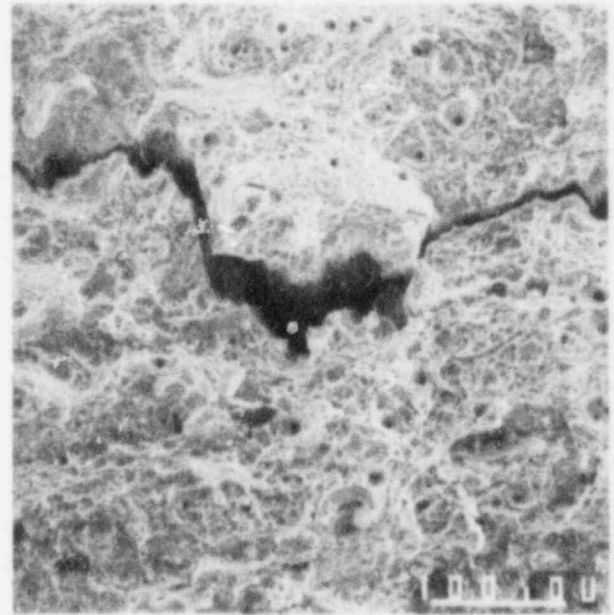
Figure 17. 27X  
SEM Photo of Fracture Face for  
Specimen #2.

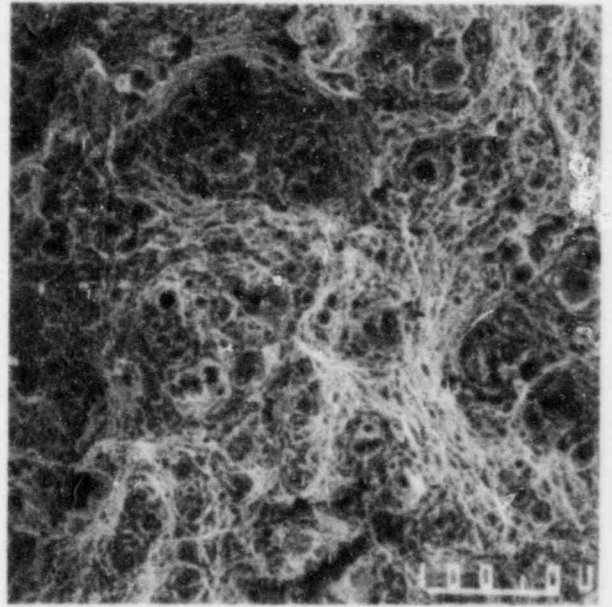
Figure 19. 27X  
SEM Photo of Fracture Face for  
Specimen #3.

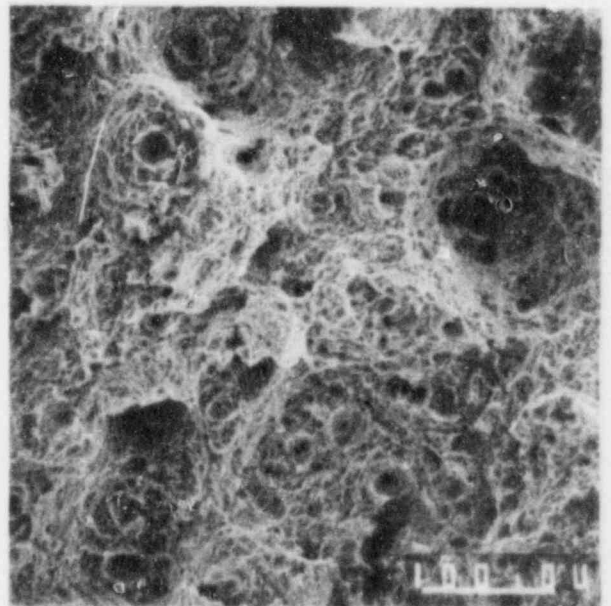
Figure 21. 27X  
SEM Photo of Fracture Face for  
Specimen #4.

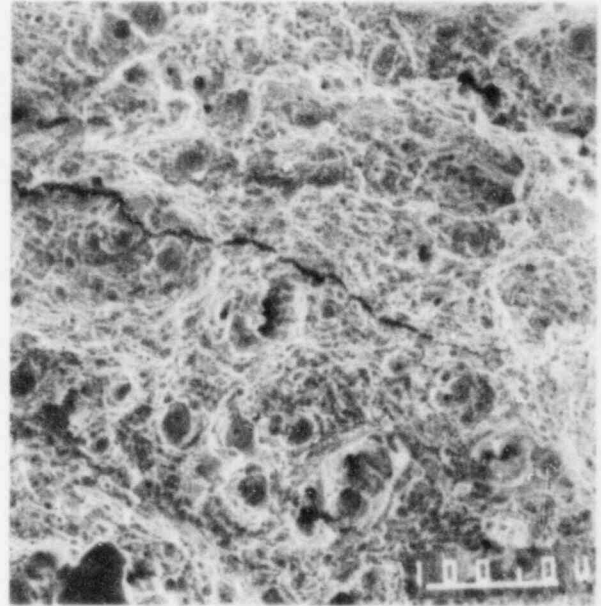
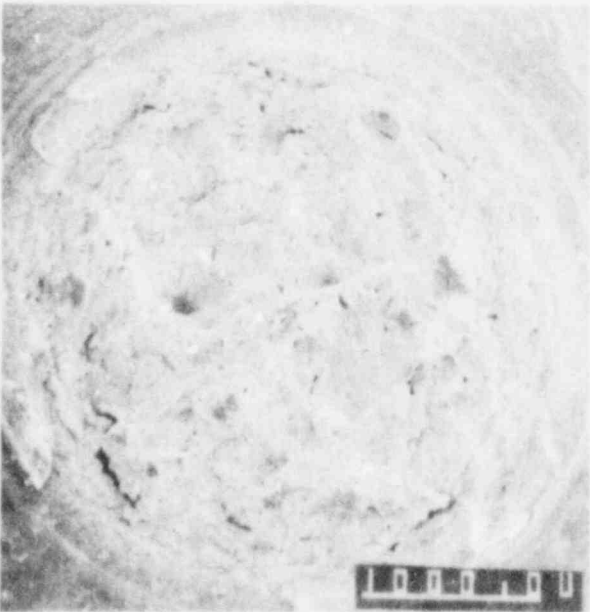
Figure 23. 27X  
SEM Photo of Fracture Face for  
Specimen #5.

Figure 24. 200X  
Higher Magnification Fractograph  
Showing Typical Ductile Fracture.

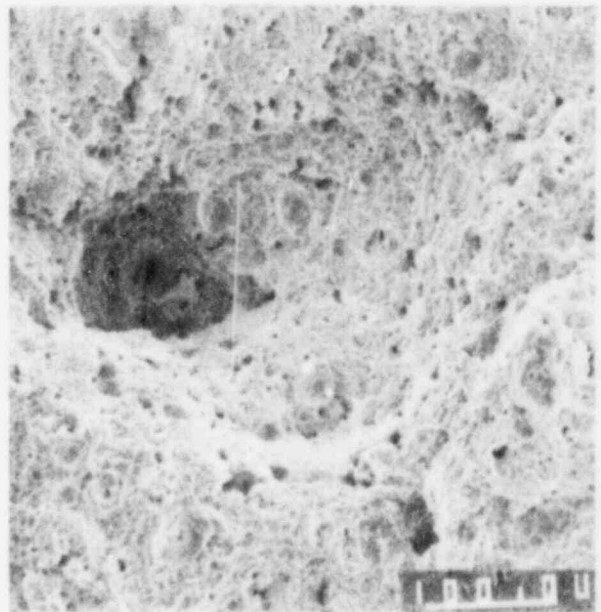
Figure 25. 27X  
SEM Photo of Fracture Face for  
Specimen #6.

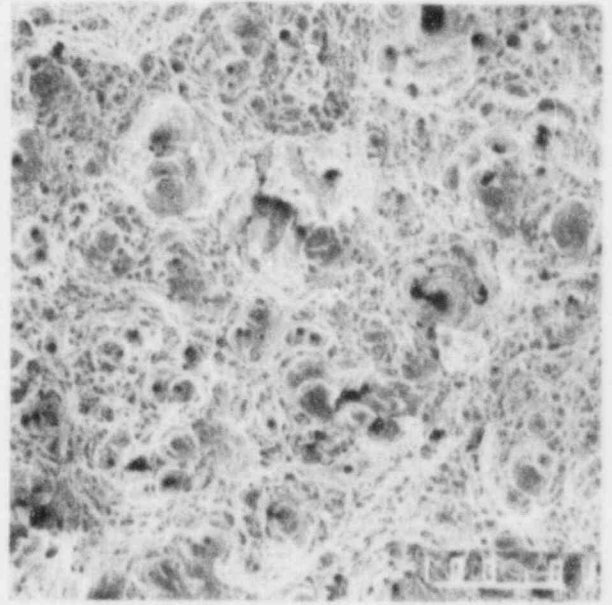
Specimen #7 was tested at 280°C in demineralized water and displayed a tensile value of approximately 210 Ksi. The fracture face (Figures 27 and 28) exhibited a typical overload failure.

Figure 27. 27X  
SEM Photo of Fracture Face for  
Specimen #7.

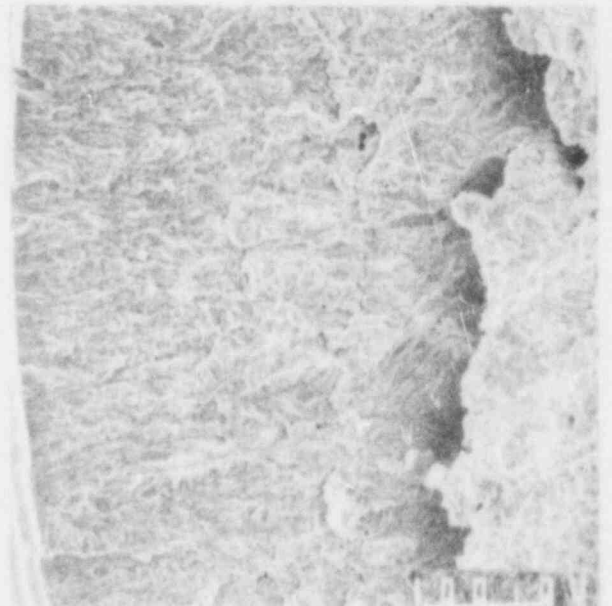
The next three tests (Specimens #8, 9, 10) were also conducted at 280°C but exhibited a transgranular (quasi cleavage) area around the circumference of each specimen (Figures 29-34). The tensile strength of these specimens ranged between 189 Ksi - 216 Ksi. This area of transgranular fracture would be indicative of a brittle fracture, probably induced by the environment.

Figure 29. 27X  
SEM Photo of Fracture Face for  
Specimen #8.

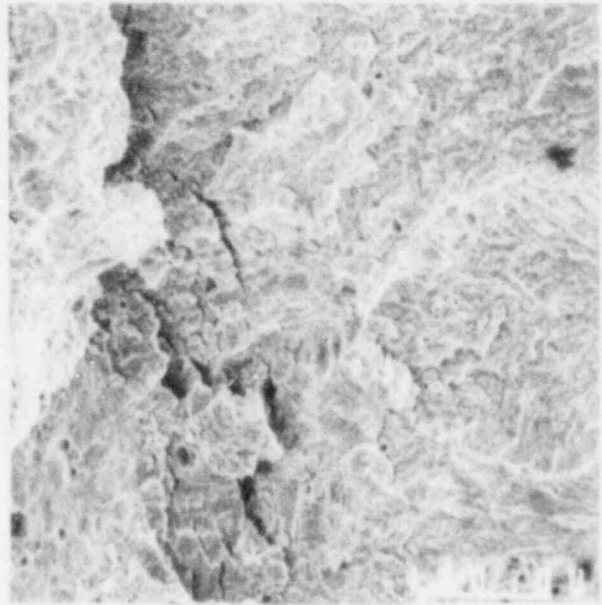
Figure 31. 27X  
SEM Photo of Fracture Face for  
Specimen #9.

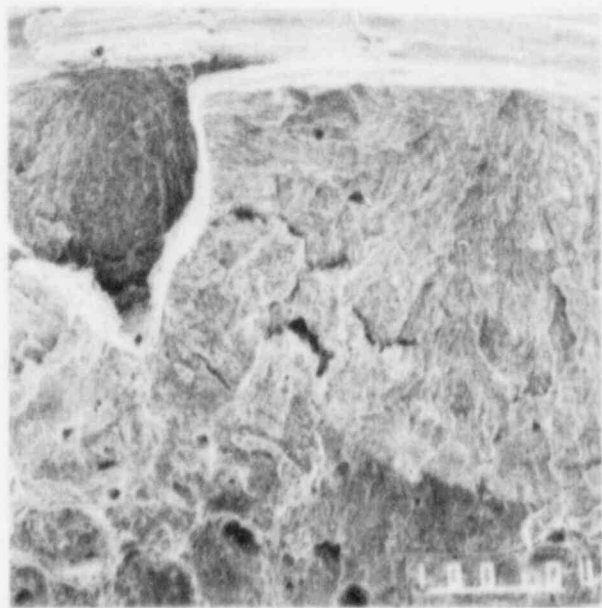
Figure 33. 27X  
SEM Photo of Fracture Face for  
Specimen #10.

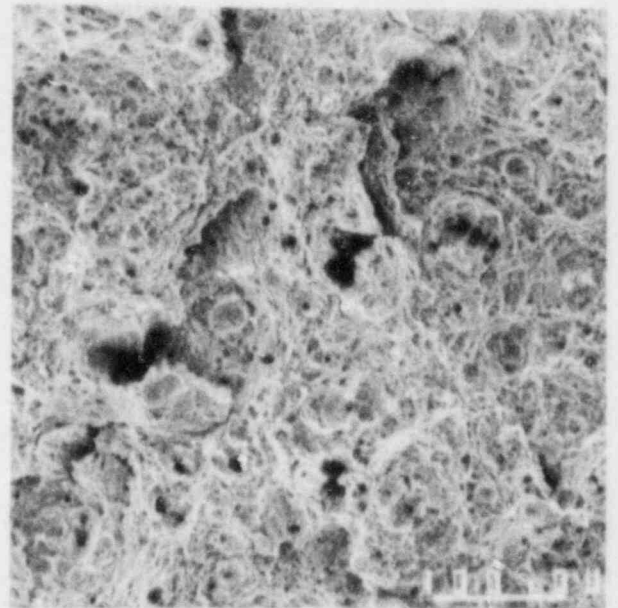
Specimens #11 and 12 (Figures 35-38) were tested at 100°C but had diametrically half of the notch coated with chemically pure MoS<sub>2</sub> lubricant #1. Both specimens exhibited a ductile overload failure, but differed in tensile strengths by almost 60 Ksi (#11-207 Ksi; #12-265 Ksi).

Figure 35. 27X  
SEM Photo of Fracture Face for  
Specimen #11.

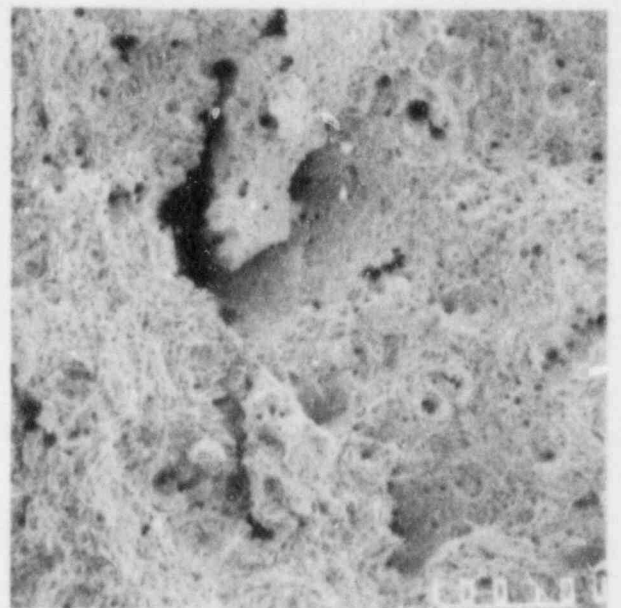
Figure 37. 27X  
SEM Photo of Fracture Face for  
Specimen #12.

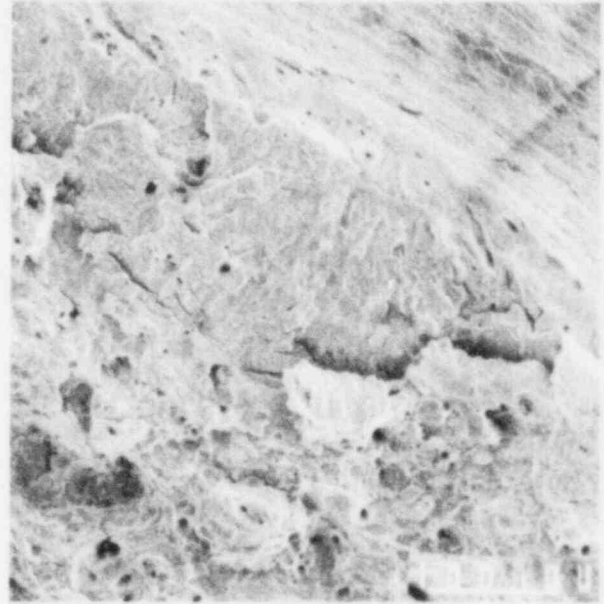
The next five specimens (tests #13-17) were all tested at 280°C with chemically pure MoS<sub>2</sub> on half of the notch. Specimens #13 and 14 only attained notch tensile values of 155 Ksi and 171 Ksi. The fracture faces for these tests (Figures 39-42) had transgranular areas associated with them, indicating an environmental interaction. Specimens #15-17 all attained tensile values in excess of 240 Ksi and the fracture faces (Figures 43-48) all exhibited a dimpled rupture appearance; typical of ductile overload.

Figure 39. 27X  
SEM Photo of Fracture Face for  
Specimen #13.

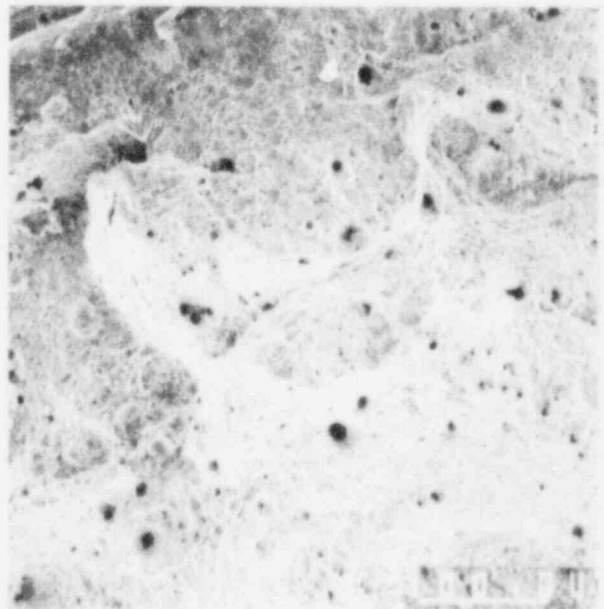
Figure 41. 27X  
SEM Photo of Fracture Face for  
Specimen #14.

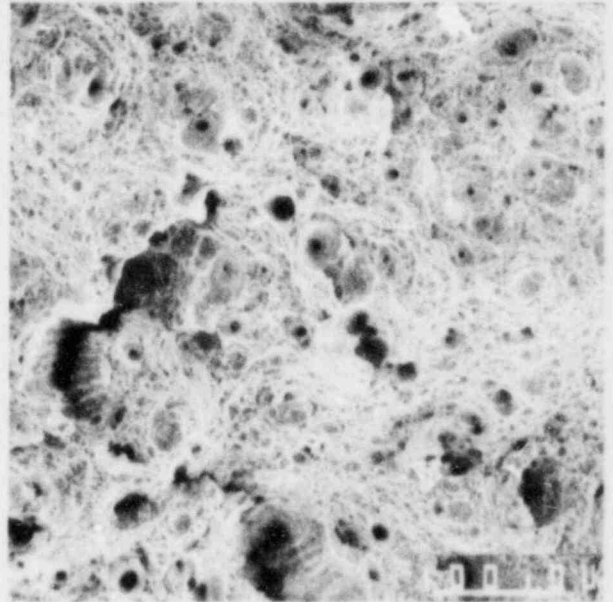
Figure 43. 27X  
SEM Photo of Fracture Face for  
Specimen #15.

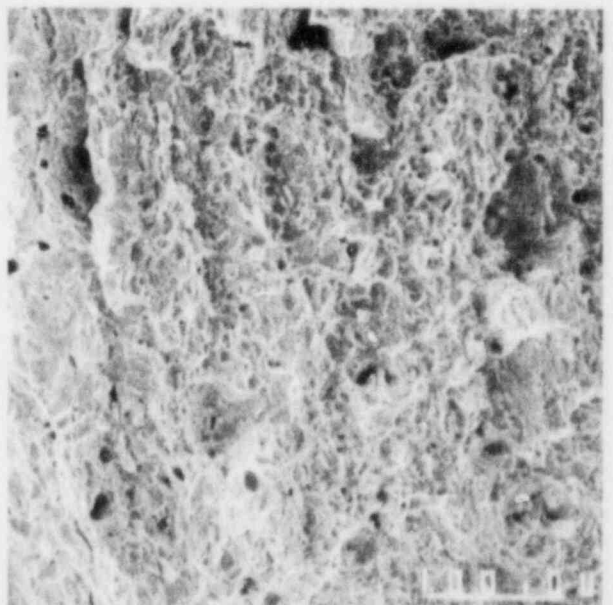
Figure 45. 27X  
SEM Photo of Fracture Face for  
Specimen #16.

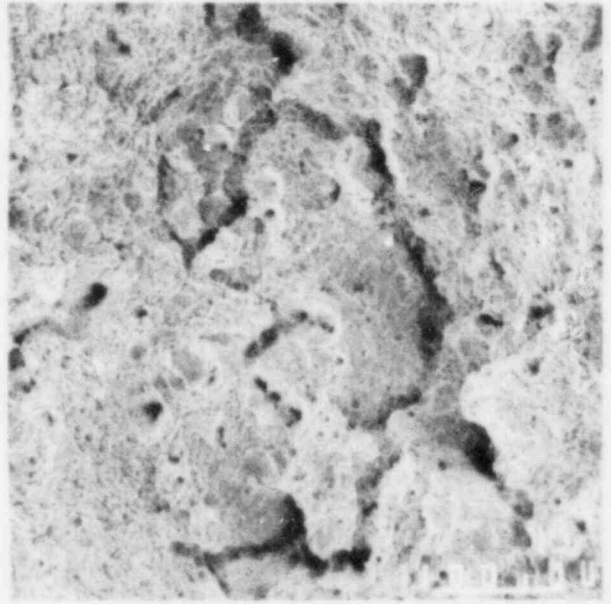
Figure 47. 27X  
SEM Photo of Fracture Face for  
Specimen #17.

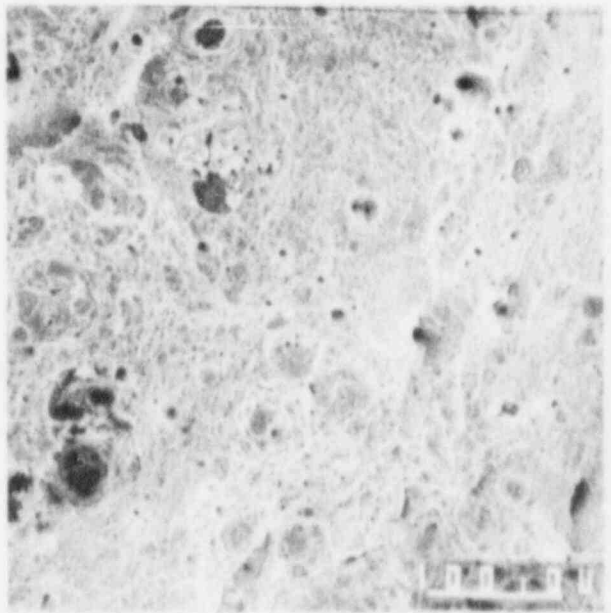
Specimens #18 and 19 were tested under the same environmental conditions as the prior five tests, except the strain rate was reduced by a factor of about 2. Both specimens attained very low (144 Ksi and 120 Ksi) notch tensile strengths and their fracture faces were primarily dimpled with possibly some small areas of transgranularity evident (Figures 49-52).

Figure 49. 27X  
SEM Photo of Fracture Face for  
Specimen #18.

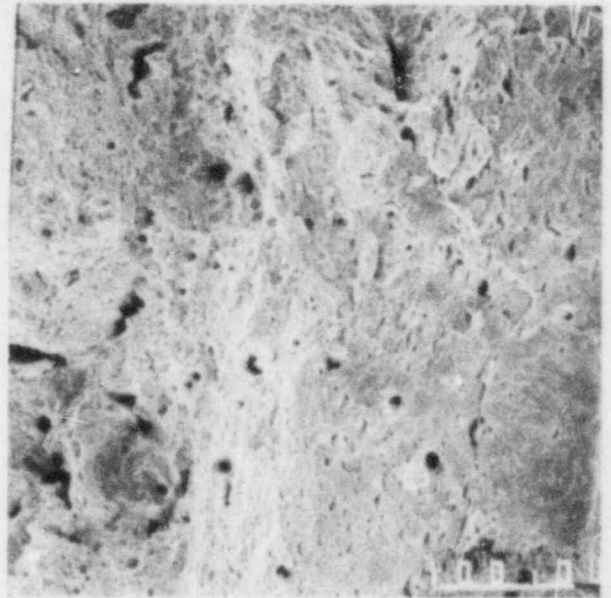
Figure 51. 27X  
SEM Photo of Fracture Face for  
Specimen #19.
