-			-	-		-							-	Ip	OCKE	TNU	MRER	(2)			PA	GE (3)
ACILITY	NAME (SI	JRR	Y PO	WE	R	STAT	10	N, U	NIT 2						0	15	10	10	10	2 1	811	1 0	F o la
ITLE (4)			PE	AC	TOR	TR	IP	(L(DAD	SHE	DDING	ACTU	ATED)								_				1-1-
EVE	NT DATE	(6)	-			LER	NUN	BER	6)		RE	PORT DA	TE (7)			01	HER F	ACILI	TIES	INVOI	VED	(8)			
MONTH	DAY	YE	TEAR YEAR SEQUENTIAL					П		MONTH	DAY	YEAR	FACILITY NAMES					DOCKET NUMBER(S)

1. Description of the Event

SURRY POWER STATION, UNIT 2 TEXT (If more space is required, use additional NRC Form 366A's) (17)

84-015-00

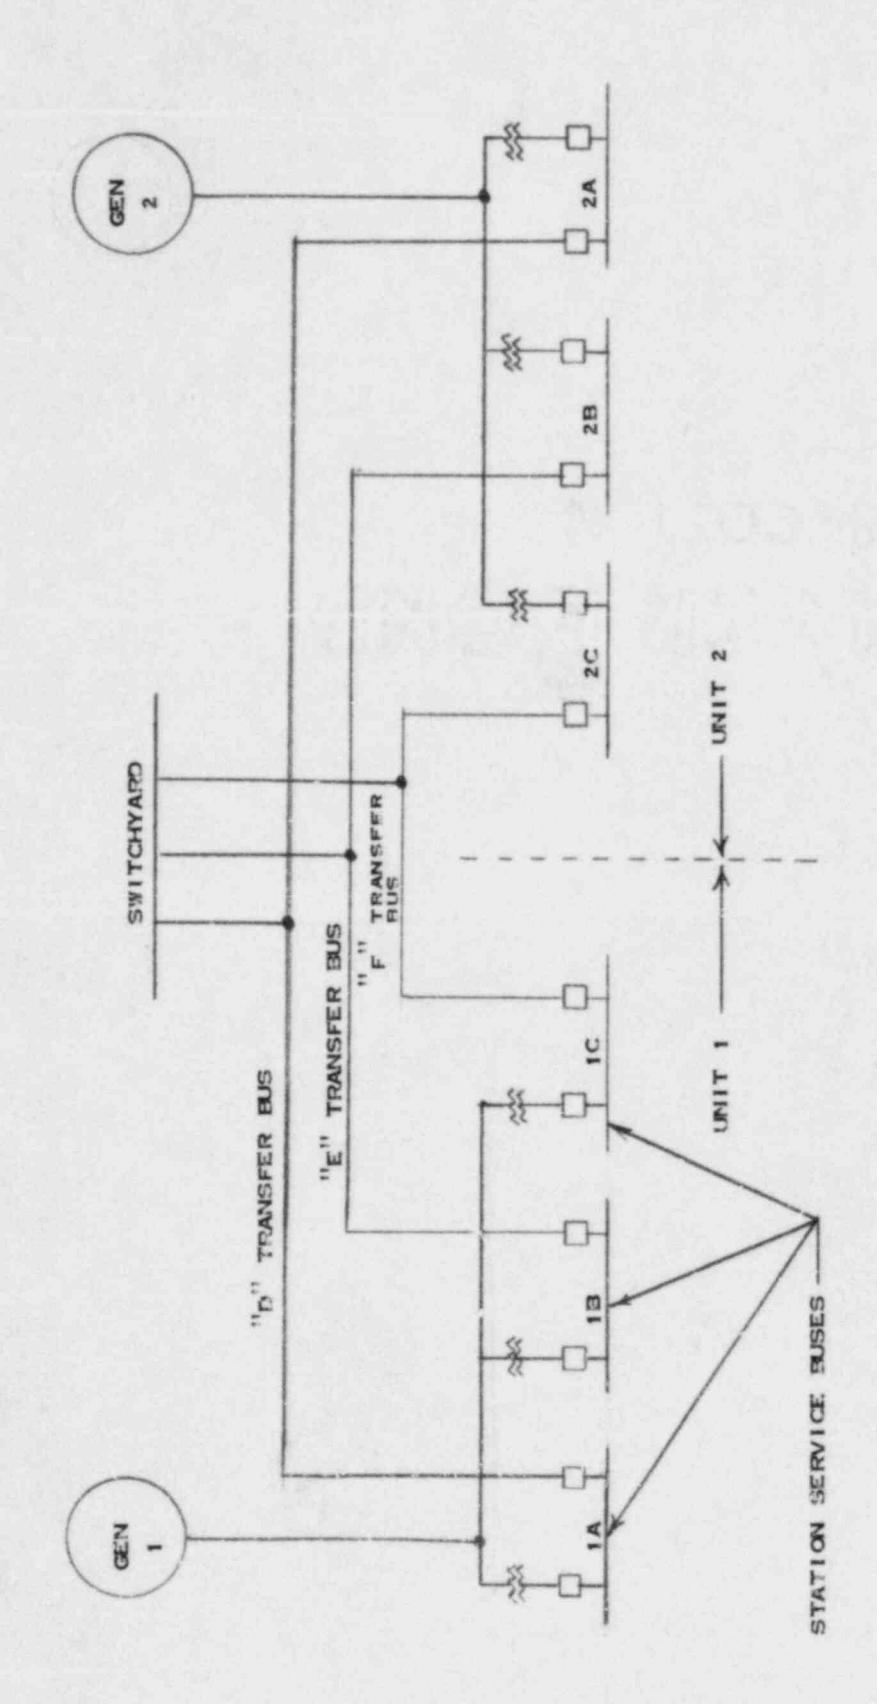
FIGURE 1

On October 29, 1984, unit 1 was in refueling shutdown and unit 2 was at full power. The "D" transfer bus (See figure 1) was deenergized for unit 1 breaker testing being conducted by Control Operations. The load shed selector switch was in enable with testing in progress. As a result of this testing, load shedding was initiated. The unit 2 "A" main feedpump (2-EW-P-1A) tripped as a result of load shedding leading to a low steam generator level and a reactor trip.

When the auto transfer from station service to reserve station service occurred, "A" reactor coolant pump (RCP) lost power because the "D" transfer bus was deenergized for testing.

The load shed switch should have been in bypass since unit 1 was shutdown and all of its large electrical loads were deenergized. If it had been in bypass, the unit would not have tripped.

The Control Operations procedures for breaker testing did not contain instructions relating to load shedding.

The "D" transfer and "A" station service electrical buses were reenergized to return the station electrical distribution to normal. The load shed switch was also placed in the bypass position.

A plant specific Control Operations staff is being developed. Surry will revise the appropriate operating procedures to clear up any ambiguities relating to bypassing and enabling the load shed system.
